MINERALS PROGRAM INSPECTION REPORT
PHONE: (303) 866-3567

MINE NAME: Corliss Sand Pit	MINE/PROSPECTING ID#: M-2007-001	MINERAL: Sand	COUNTY: Yuma
INSPECTION TYPE: Monitoring	WEATHER: Sunny, Clear	INSP. DATE: August 31, 2023	INSP. TIME: 10:00
OPERATOR: Ritchey's Redi-Mix Concrete, Inc.	OPERATOR REPRESENTATIVE: Jerry Ritchie	TYPE OF OPERATION: 110c - Construction Limited Impact	
REASON FOR INSPECTION: Normal I&E Program	BOND CALCULATION TYPE: Complete Bond	BOND AMOUNT: \$16,600.00	
DATE OF COMPLAINT: NA	POST INSP. CONTACTS: None	JOINT INSP. AGENCY: None	
INSPECTOR(S): Nikie Gagnon	INSPECTOR'S SIGNATURE:

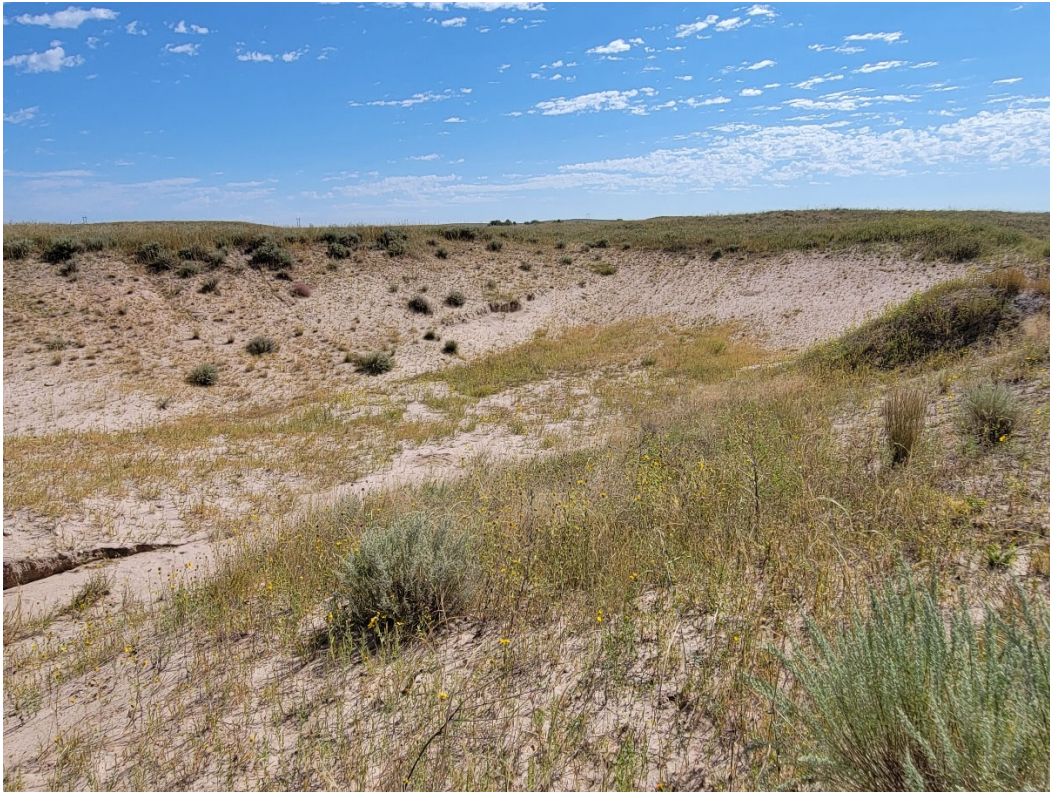
Photo 1: Looking northeast across the excavated pit. The north slope is steeper than 3:1. Operator state he plans to use fill from the pit floor to regrade the slope.

This site was last inspected by the Division on August 7, 2019. Based on the description in the 2019 inspection report, very little has changed over the past four years. During this inspection, Mr. Ritchie stated he is no longer mining and plans to complete reclamation, which includes repairs to the deep erosion rills observed on the south slope, backfill the northern slope with material from the pit floor to achieve a slope no steeper than 3H:1V.

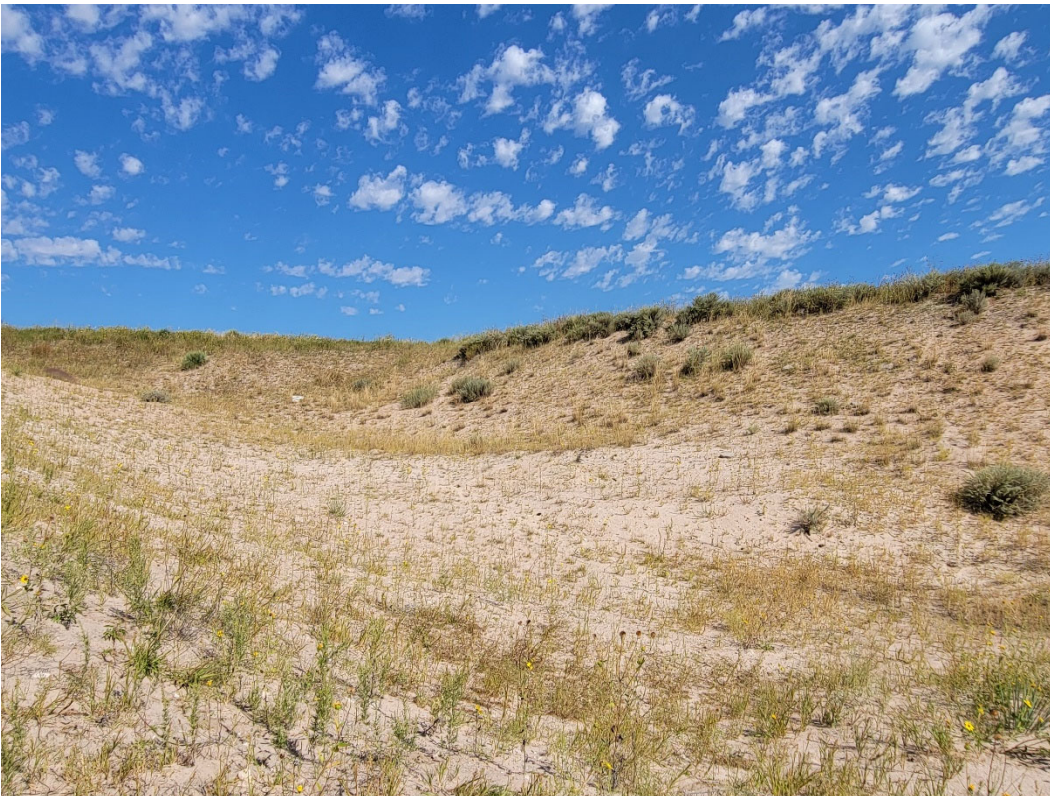
Photo 2: Looking northwest from the pit floor.

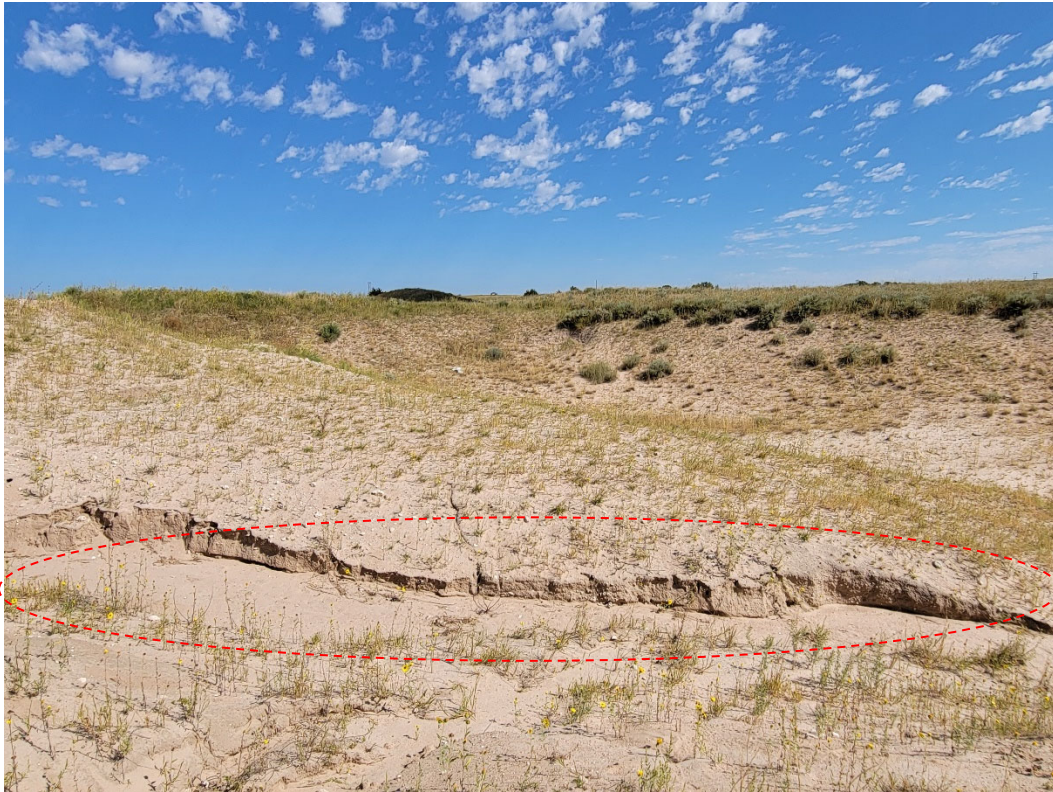
Photo 3: Deep erosion rills noted in the southwestern corner of the excavated pit.

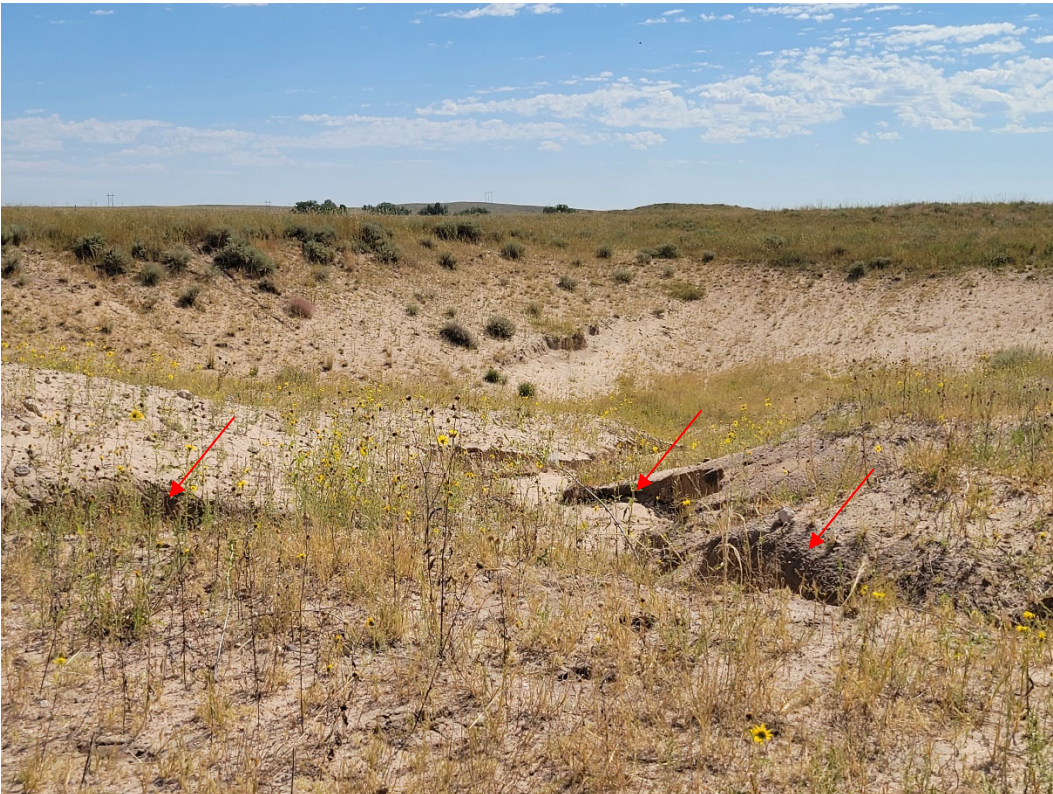
Photo 4: Erosion rills on the south slope of the pit.

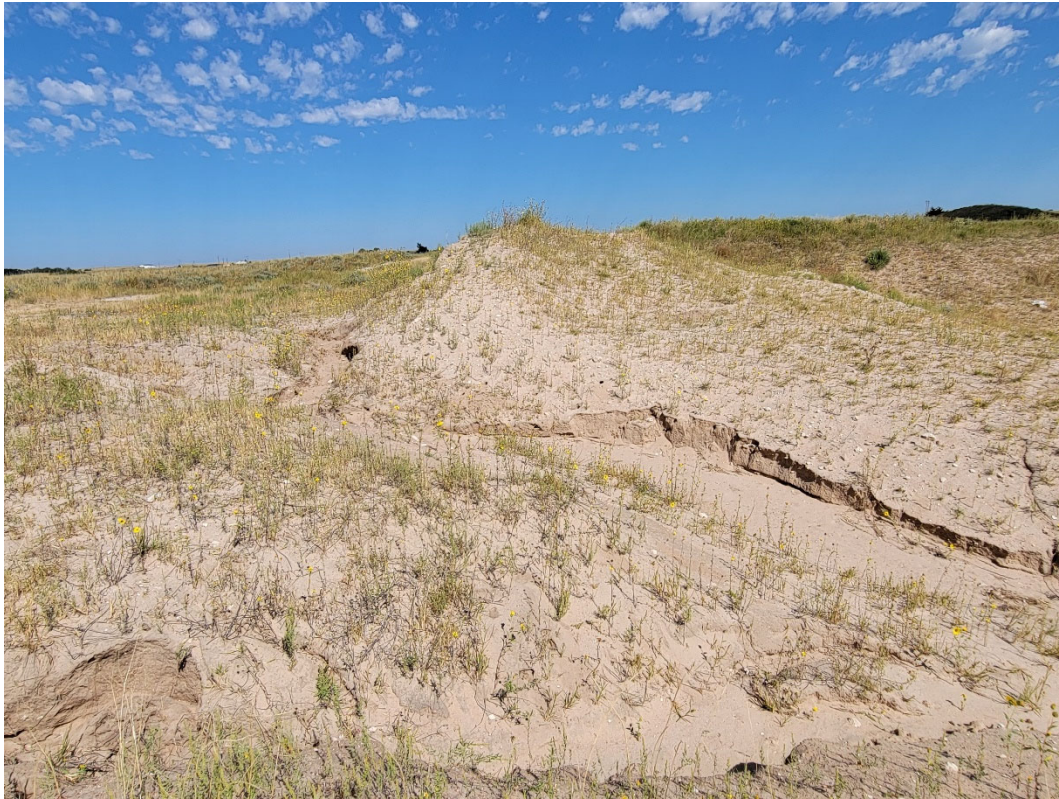
Photo 5: Stockpiled material stored on the western end of the pit.

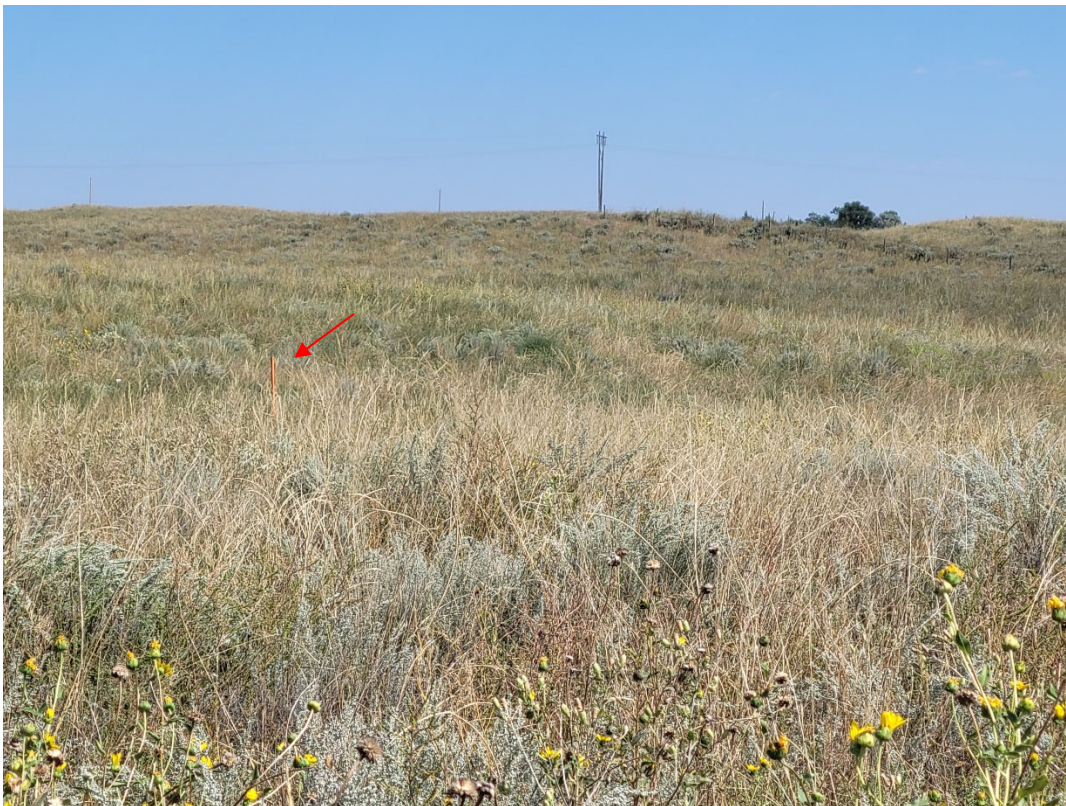
A mine sign was posted in accordance with Rule 3.1.12(1) at the entrance to the pit and the boundaries are marked in the metal posts with orange cones.

Photo 6: Permit boundary in northwestern corner, outside the disturbance area.

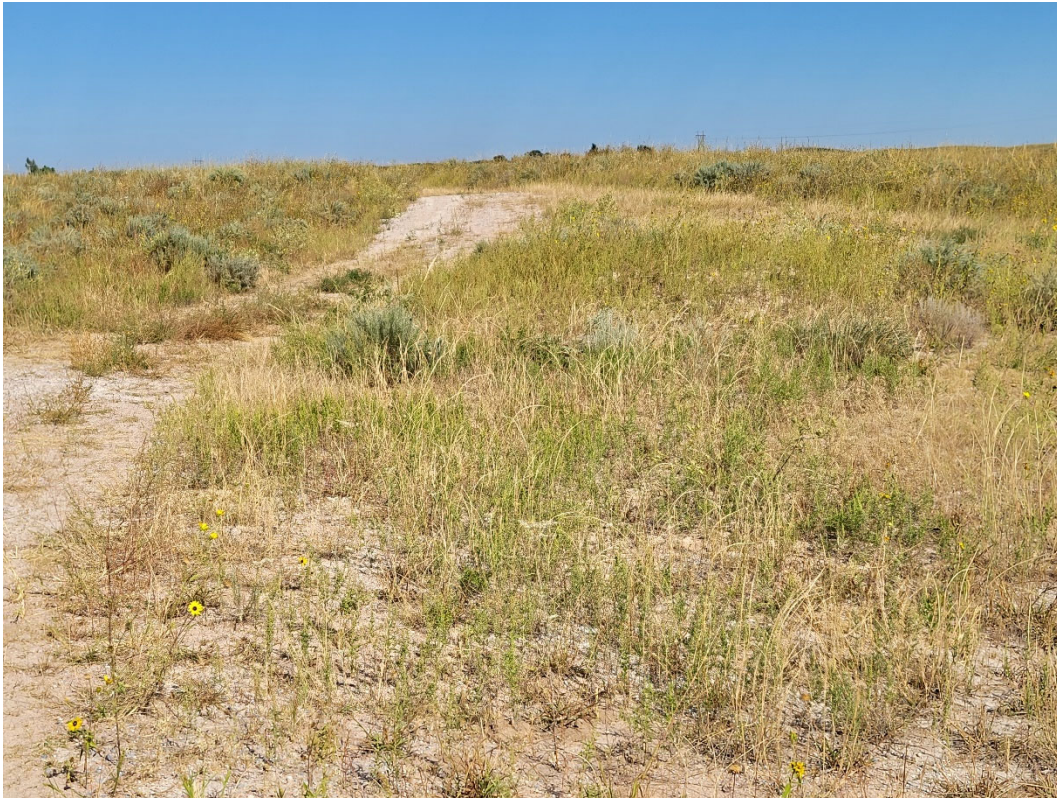
The service road/trail leading to the mine was heavily overgrown with vegetation further indicating no recent activity has occurred at the site. The approved Reclamation Plan states the trail roadway will be left in place at the end of the operation for use by the landowner.

Photo 7: Trail/access road to the pit.

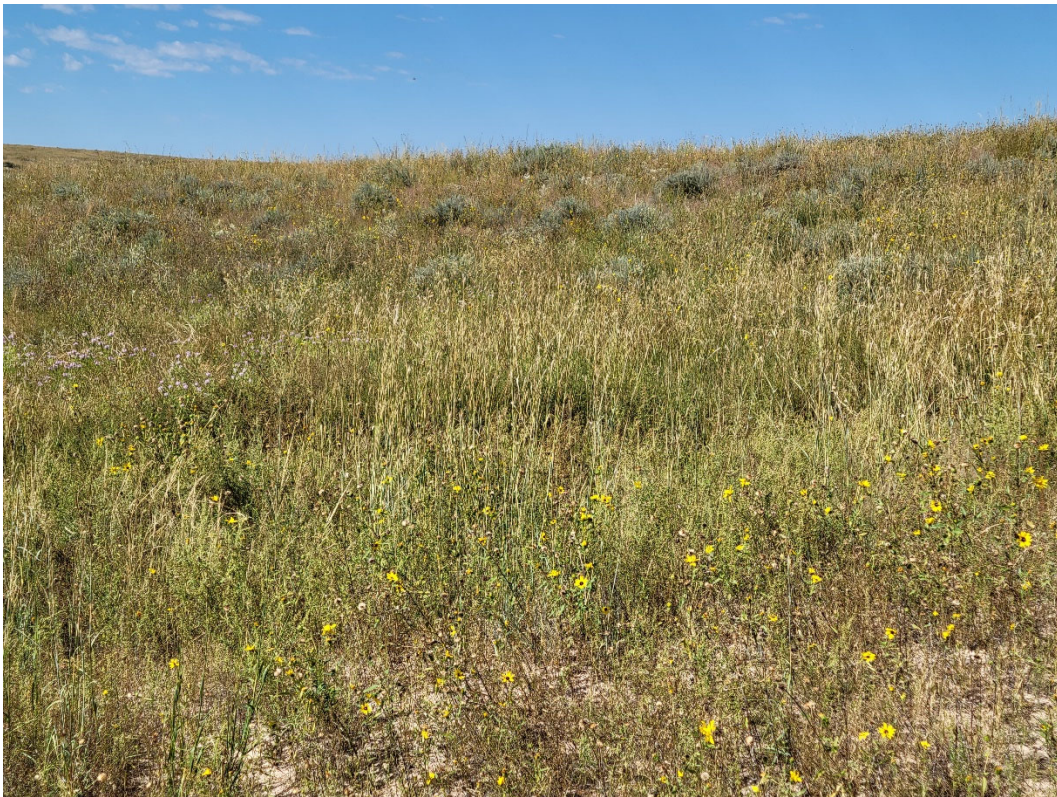
Photo 8: Undisturbed area within the permit area. This represents the long-term anticipated vegetation type/density in the reclaimed area.

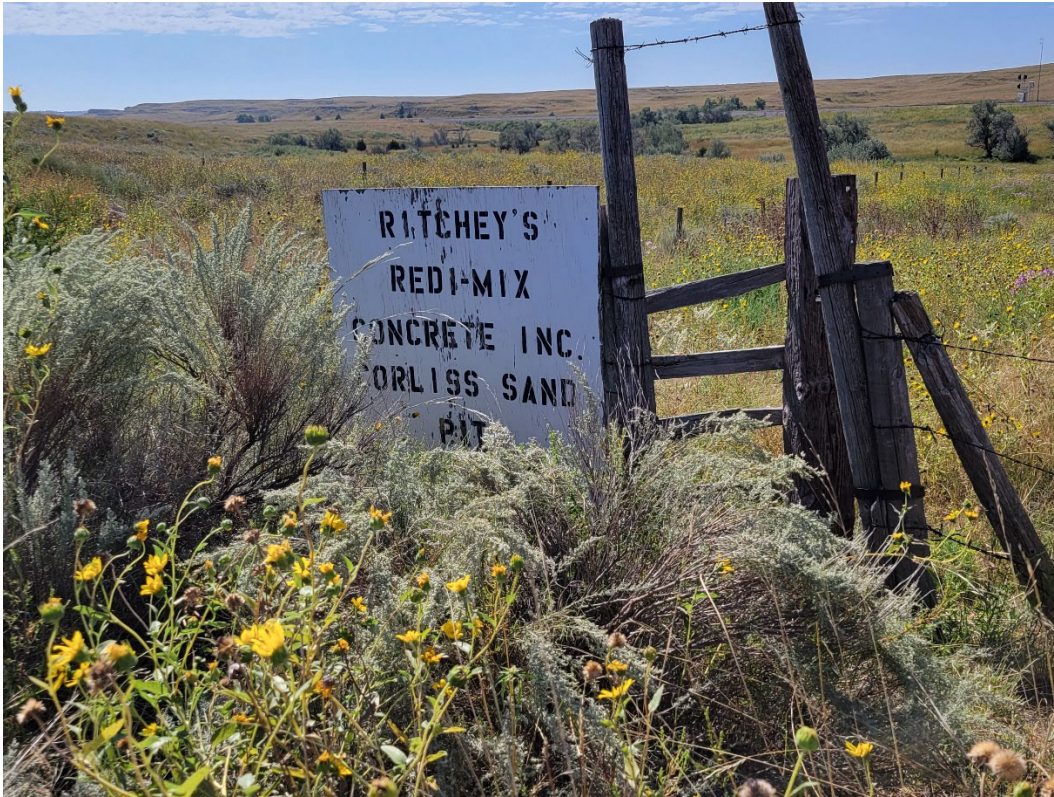
Photo 9: Mine sign posted at a metal gate at the front entrance to the permit area.

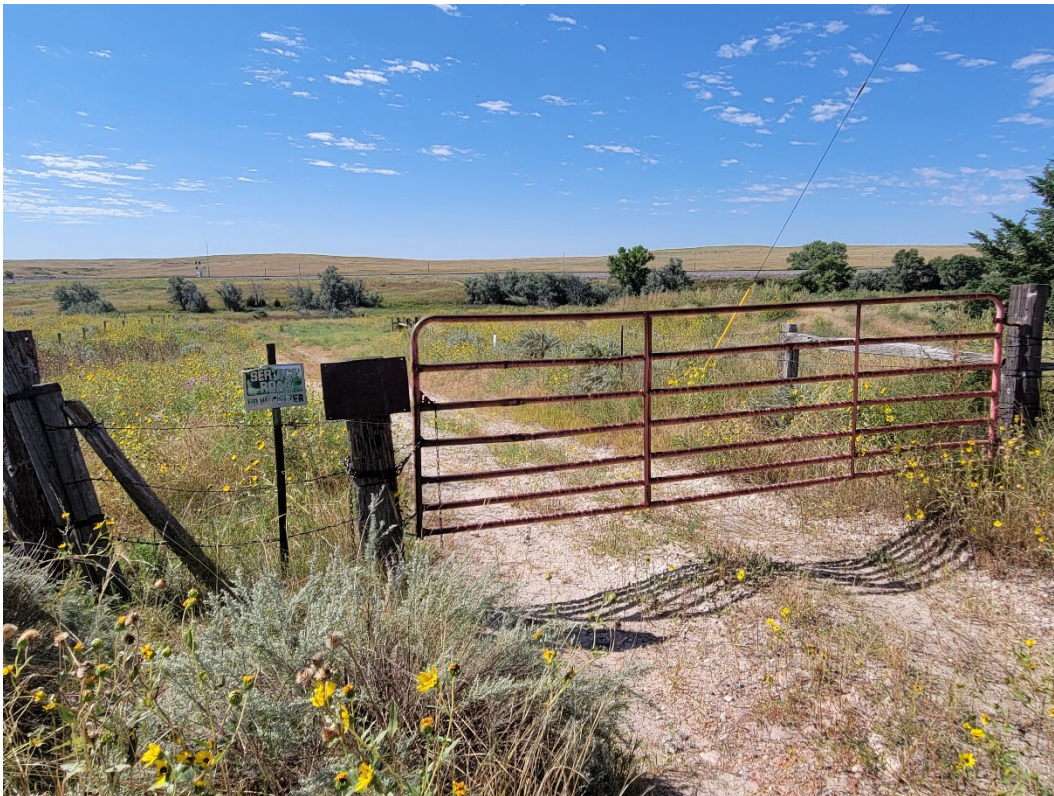
Photo 10: Gate at entrance to the mining area.
