**MINERALS PROGRAM INSPECTION REPORT**  
**PHONE: (303) 866-3567**

<b>MINE NAME:</b> Sacramento Access Tunnel	<b>MINE/PROSPECTING ID#:</b> M-2016-084	<b>MINERAL:</b> Gold and silver	<b>COUNTY:</b> Gunnison
<b>INSPECTION TYPE:</b> Monitoring	<b>INSPECTOR(S):</b> Dustin Czapl	<b>INSP. DATE:</b> October 10, 2023	<b>INSP. TIME:</b> 10:00
<b>OPERATOR:</b> CRG Mining, LLC	<b>OPERATOR REPRESENTATIVE:</b> Jake Wilkinson	<b>TYPE OF OPERATION:</b> 110(2) - Hard Rock Limited Impact	
<b>REASON FOR INSPECTION:</b> Normal I&E Program	<b>BOND CALCULATION TYPE:</b> Complete Bond	<b>BOND AMOUNT:</b> \$7,600.00	
<b>DATE OF COMPLAINT:</b> NA	<b>POST INSP. CONTACTS:</b> None	<b>JOINT INSP. AGENCY:</b> None	
<b>WEATHER:</b> Clear	<b>INSPECTOR'S SIGNATURE:</b>

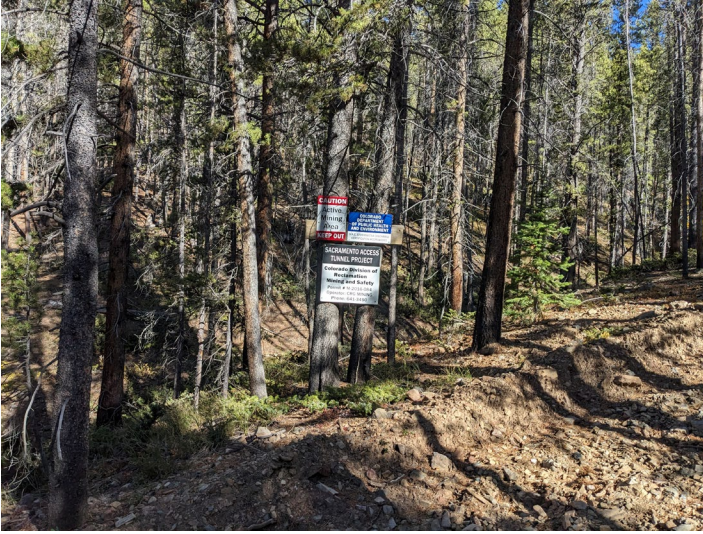
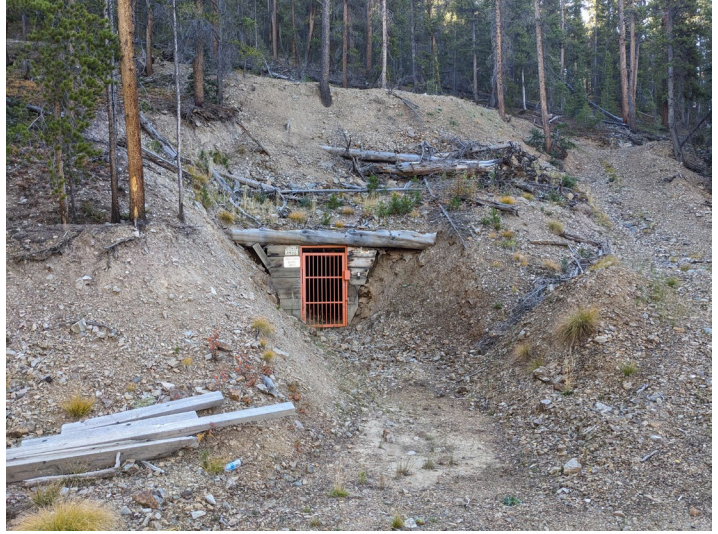
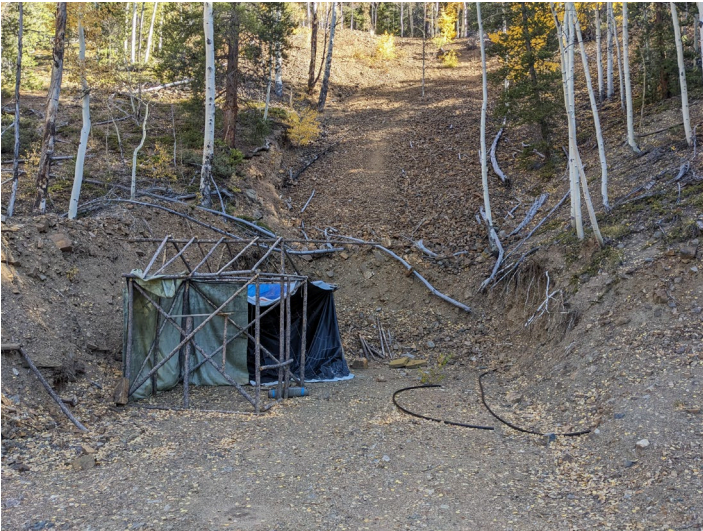
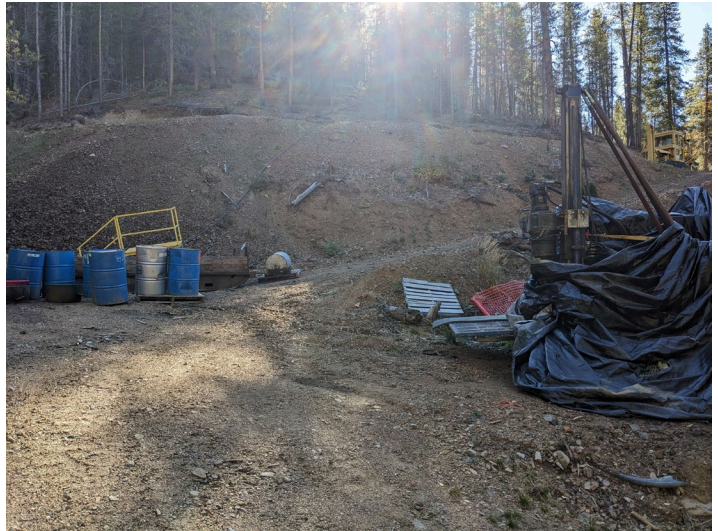
Adequate mine identification signage was noted at the entrance to the site.

Mining has not commenced at the site yet. Roads to the portals have been constructed. The portals are secured with locked steel doors.
