MINERALS PROGRAM INSPECTION REPORT
PHONE: (303) 866-3567

MINE NAME: Raymond Mine	MINE/PROSPECTING ID#: M-2020-013	MINERAL: Gold and silver	COUNTY: Gunnison
INSPECTION TYPE: Monitoring	INSPECTOR(S): Dustin Czaplá	INSP. DATE: October 10, 2023	INSP. TIME: 9:15
OPERATOR: CRG Mining, LLC	OPERATOR REPRESENTATIVE: Jake Wilkinson	TYPE OF OPERATION: 110(2) - Hard Rock Limited Impact	
REASON FOR INSPECTION: Normal I&E Program	BOND CALCULATION TYPE: Complete Bond	BOND AMOUNT: \$20,586.00	
DATE OF COMPLAINT: NA	POST INSP. CONTACTS: None	JOINT INSP. AGENCY: None	
WEATHER: Clear	INSPECTOR'S SIGNATURE:

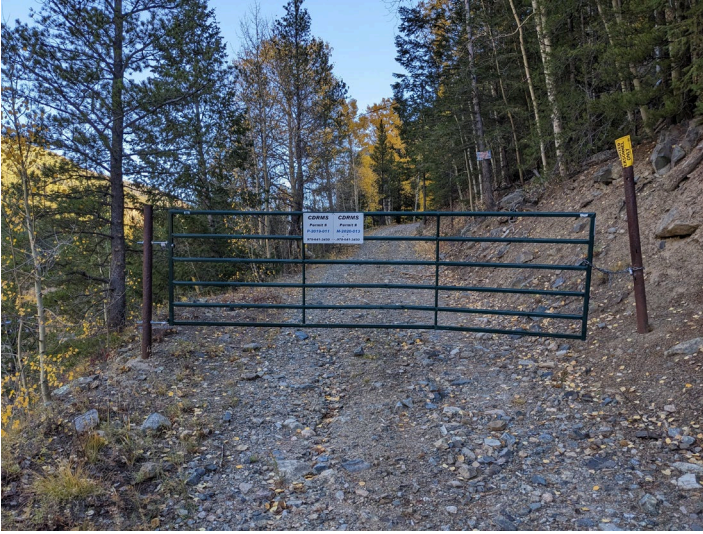
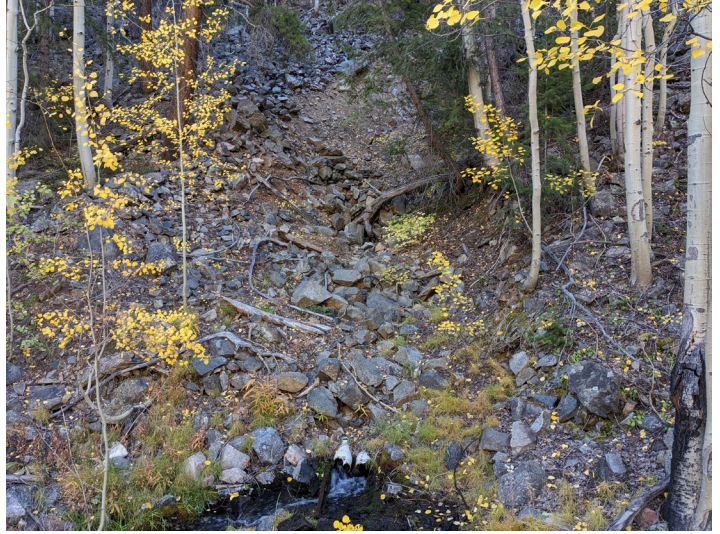
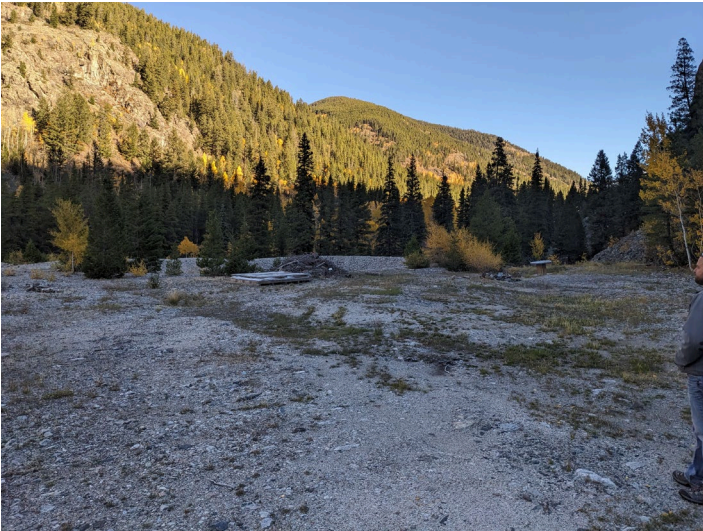
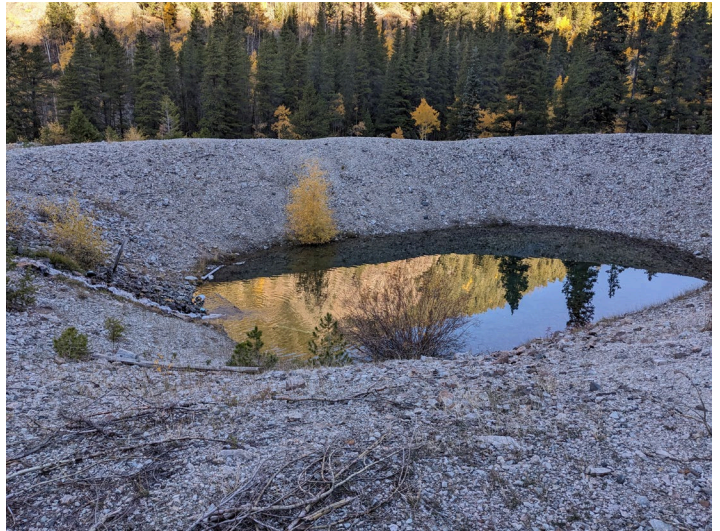
Adequate mine identification signage was noted at the entrance to the site.

The Raymond Portal is currently collapsed.
