**MINERALS PROGRAM INSPECTION REPORT**  
**PHONE: (303) 866-3567**

<b>MINE NAME:</b> Carter Mine	<b>MINE/PROSPECTING ID#:</b> M-2020-014	<b>MINERAL:</b> Silver and gold	<b>COUNTY:</b> Gunnison
<b>INSPECTION TYPE:</b> Monitoring	<b>INSPECTOR(S):</b> Dustin Czapl	<b>INSP. DATE:</b> October 10, 2023	<b>INSP. TIME:</b> 9:30
<b>OPERATOR:</b> CRG Mining, LLC	<b>OPERATOR REPRESENTATIVE:</b> Jake Wilkinson	<b>TYPE OF OPERATION:</b> 110(2) - Hard Rock Limited Impact	
<b>REASON FOR INSPECTION:</b> Normal I&E Program	<b>BOND CALCULATION TYPE:</b> Complete Bond	<b>BOND AMOUNT:</b> \$20,586.00	
<b>DATE OF COMPLAINT:</b> NA	<b>POST INSP. CONTACTS:</b> None	<b>JOINT INSP. AGENCY:</b> None	
<b>WEATHER:</b> Clear	<b>INSPECTOR'S SIGNATURE:</b>

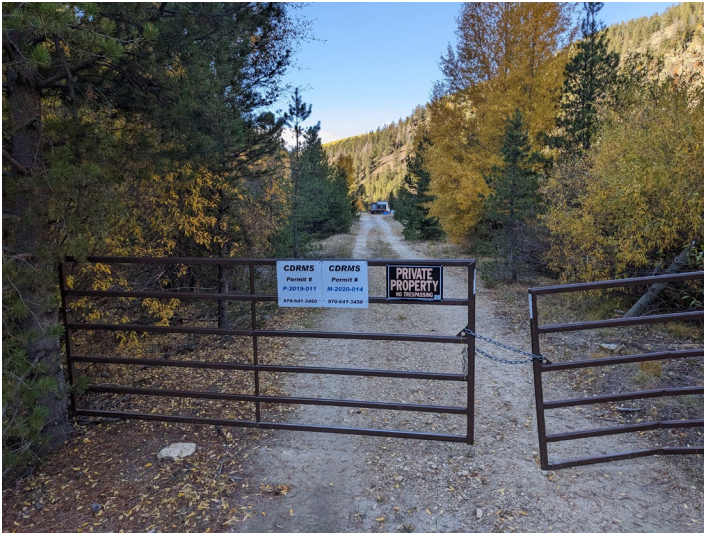
Adequate mine identification signage was noted at the entrance to the site.

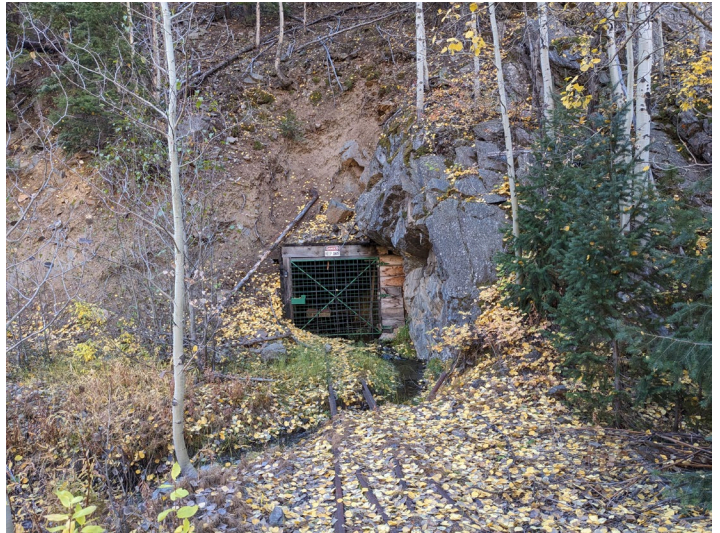
The Carter Mine portal is secured with a locked grate.
