## MINERALS PROGRAM INSPECTION REPORT PHONE: (303) 866-3567

MINE NAME:	MINE/PROSPECTING ID#:	MINERAL:	COUNTY:
C8 Drilling NOI	P-2016-025	Gold and silver	Gunnison
INSPECTION TYPE:	WEATHER: Clear	INSP. DATE:	INSP. TIME:
Surety Release Inspection		October 10, 2023	10:00
OPERATOR:	OPERATOR REPRESENTATIVE:	TYPE OF OPERATION:	
CRG Mining, LLC	Jake Wilkinson	MP - Mineral Prospecting	
REASON FOR INSPECTION:	BOND CALCULATION TYPE:	BOND AMOUNT:	
Surety Release Requested		\$10,400.00	
DATE OF COMPLAINT:	POST INSP. CONTACTS:	JOINT INSP. AGENCY:	
NA	None	None	
INSPECTOR(S):	INSPECTOR'S SIGNATURE:	SIGNATURE DATE:	
Dustin Czapla		October 17, 2023	
	In-

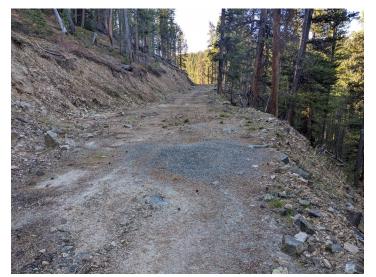
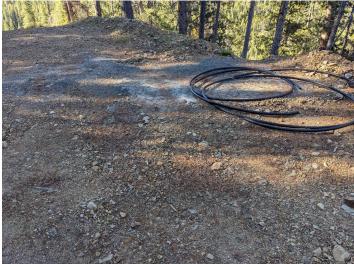
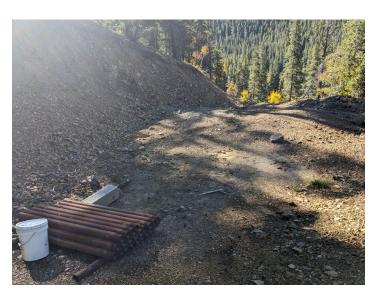
The site is located on private land within the Gold Links Mine complex (M-1987-143, M-2016-083, M-2016-084). 53 holes were authorized to be drilled by the NOI. The holes were to be backfilled after drilling. An inspection conducted on May 17, 2022 found that except for one hole, the drilled holes had been backfilled with no sign of subsidence. One hole had drill pipe stuck in it that had not yet been removed by the drill operator. This inspection confirmed that the drill pipe had been removed and the hole has been backfilled pursuant to the reclamation plan requirements.

No problems or violations were noted during this inspection. Reclamation is complete at the site.
