**MINERALS PROGRAM INSPECTION REPORT**  
**PHONE: (303) 866-3567**

<b>MINE NAME:</b> Carter - Raymond Exploration	<b>MINE/PROSPECTING ID#:</b> P-2019-011	<b>MINERAL:</b> Silver and gold	<b>COUNTY:</b> Gunnison
<b>INSPECTION TYPE:</b> Surety Release Inspection	<b>WEATHER:</b> Clear	<b>INSP. DATE:</b> October 10, 2023	<b>INSP. TIME:</b> 10:30
<b>OPERATOR:</b> CRG Mining, LLC	<b>OPERATOR REPRESENTATIVE:</b> Jake Wilkinson	<b>TYPE OF OPERATION:</b> MP - Mineral Prospecting	
<b>REASON FOR INSPECTION:</b> Surety Release Requested	<b>BOND CALCULATION TYPE:</b>	<b>BOND AMOUNT:</b> \$19,575.00	
<b>DATE OF COMPLAINT:</b> NA	<b>POST INSP. CONTACTS:</b> None	<b>JOINT INSP. AGENCY:</b> None	
<b>INSPECTOR(S):</b> Dustin Czaplá	<b>INSPECTOR'S SIGNATURE:</b>

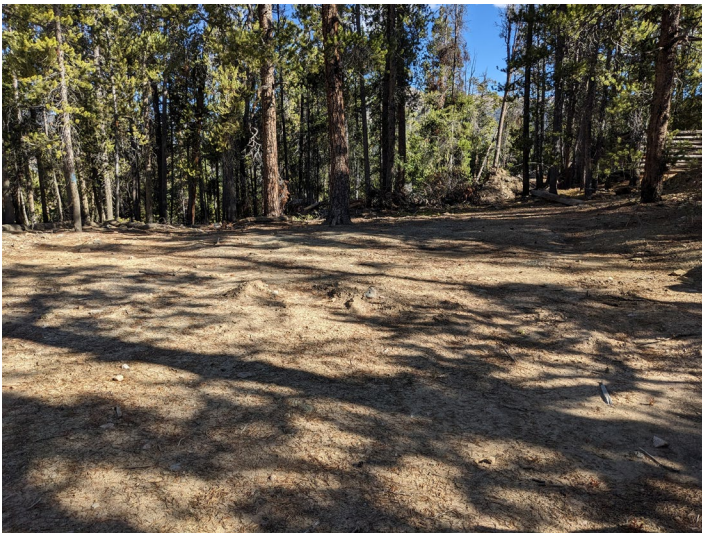
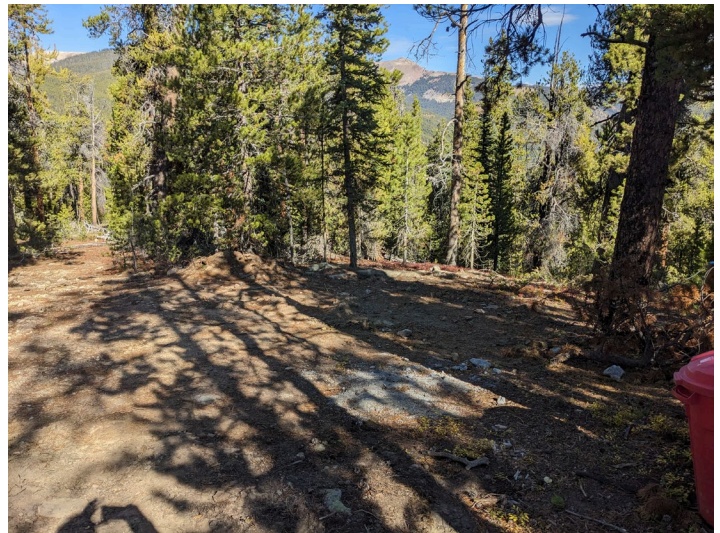
The site is located approximately four miles north of Ohio City. Work authorized by the NOI included up to 20 boreholes, with no more than 3 open at any given time, and up to 30 trenches. The operator drilled 9 of the holes. All of the drilled holes have been sealed and reclaimed.
