MINERALS PROGRAM INSPECTION REPORT PHONE: (303) 866-3567

MINE NAME:	MINE/PROSPECTING ID#:	MINERAL:	COUNTY:
JD-9 Mine	M-1977-306	Uranium and vanadium	Montrose
INSPECTION TYPE:	WEATHER: Clear	INSP. DATE:	INSP. TIME:
Monitoring		October 4, 2023	13:30
OPERATOR:	OPERATOR REPRESENTATIVE:	TYPE OF OPERATION:	
Highbury Resources Inc.	Scott Pottorffs	112d-1 - Designated Mining Operation	
REASON FOR INSPECTION:	BOND CALCULATION TYPE:	BOND AMOUNT:	
Normal I&E Program		\$100.00	
DATE OF COMPLAINT:	POST INSP. CONTACTS:	JOINT INSP. AGENCY	:
NA	None	U.S.Energy	
INSPECTOR(S):	INSPECTOR'S SIGNATURE:	SIGNATURE DATE:	
Dustin Czapla	De	October 16, 2023

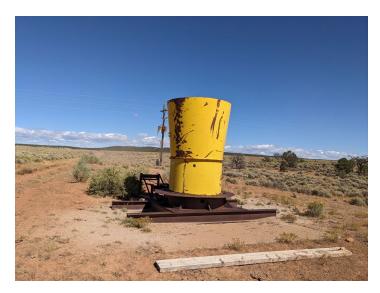
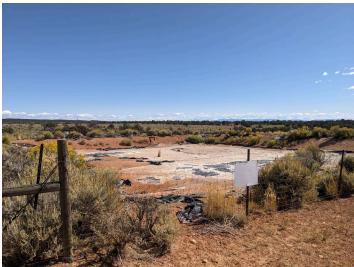
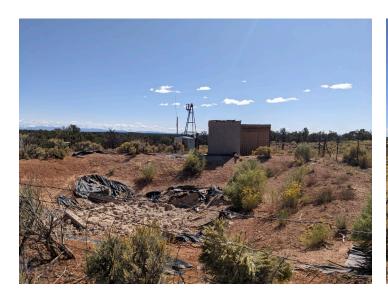
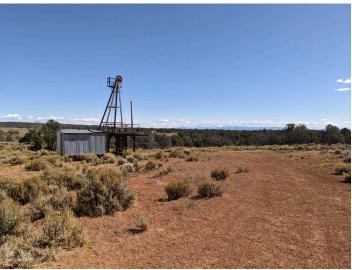
Upper Monogram Area

Vent fans and water treatment plant are located in this area. The water treatment plant is not currently in use. Pond liners are dilapidated and not functional. Water was not observed in any of the ponds. Conditions are similar to those observed during the Division's last inspection.
