MINERALS PROGRAM INSPECTION REPORT
PHONE: (303) 866-3567

MINE NAME: JD-6 Mine	MINE/PROSPECTING ID#: M-1977-310	MINERAL: Uranium and vanadium	COUNTY: Montrose
INSPECTION TYPE: Monitoring	WEATHER: Clear	INSP. DATE: October 04, 2023	INSP. TIME: 12:30
OPERATOR: Highbury Resources Inc.	OPERATOR REPRESENTATIVE: Scott Pottorffs	TYPE OF OPERATION: 110d - Designated Limited Impact	
REASON FOR INSPECTION: Normal I&E Program	BOND CALCULATION TYPE:	BOND AMOUNT: \$200.00	
DATE OF COMPLAINT: NA	POST INSP. CONTACTS: None	JOINT INSP. AGENCY: DOE	
INSPECTOR(S): Dustin Czapla	INSPECTOR'S SIGNATURE:

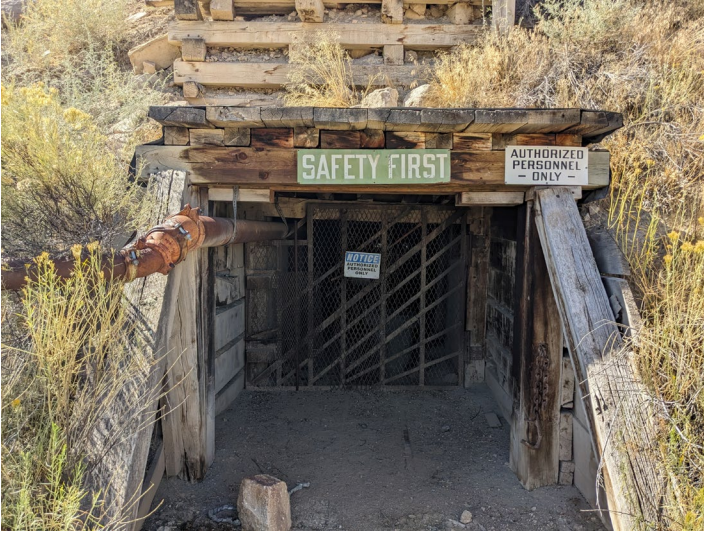
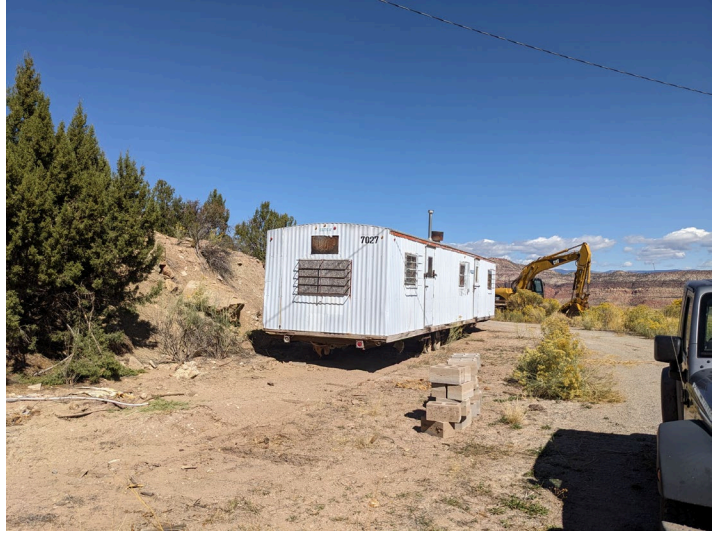
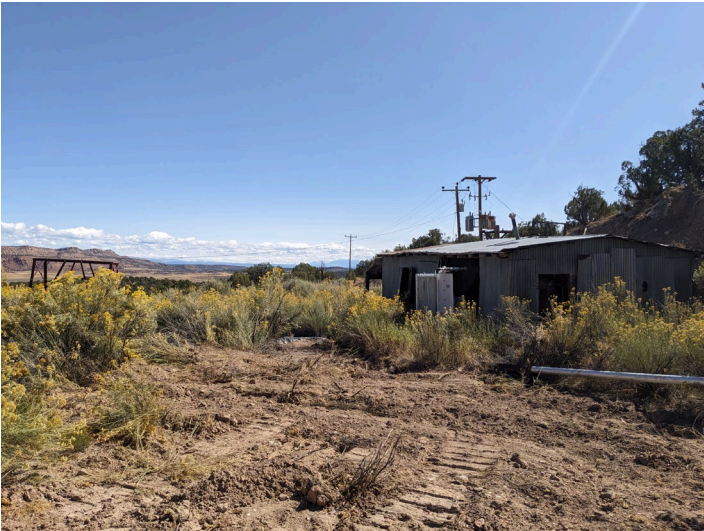
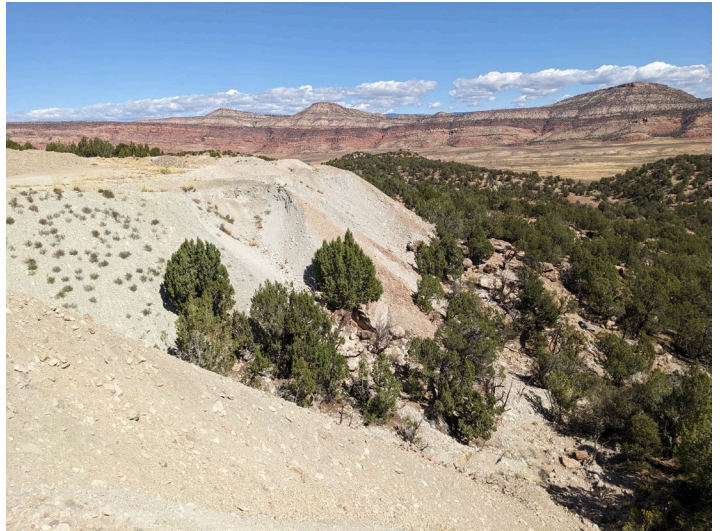
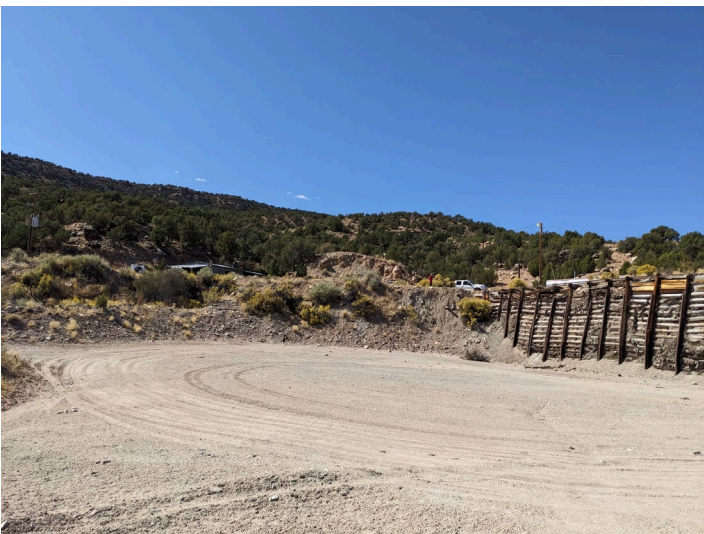
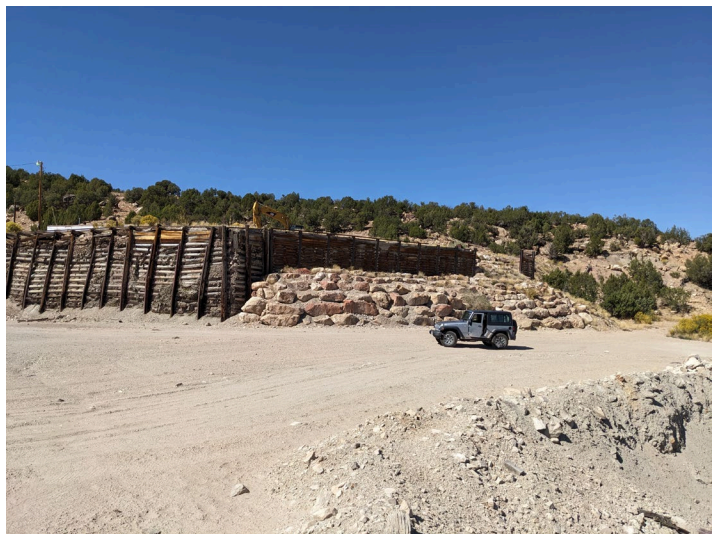
Site activity has been limited to cleanup and maintenance. The repaired retaining wall continues to appear stable.
