MINERALS PROGRAM INSPECTION REPORT
PHONE: (303) 866-3567

MINE NAME: Van 4 Shaft	MINE/PROSPECTING ID#: M-1997-032	MINERAL: Uranium and vanadium	COUNTY: Montrose
INSPECTION TYPE: Monitoring	WEATHER: Clear	INSP. DATE: October 4, 2023	INSP. TIME: 14:00
OPERATOR: Pinon Ridge Mining LLC	OPERATOR REPRESENTATIVE:	TYPE OF OPERATION: 110d - Designated Limited Impact	
REASON FOR INSPECTION: Normal I&E Program	BOND CALCULATION TYPE:	BOND AMOUNT: \$75,057.00	
DATE OF COMPLAINT: NA	POST INSP. CONTACTS: None	JOINT INSP. AGENCY: None	
INSPECTOR(S): Dustin Czapla	INSPECTOR'S SIGNATURE:

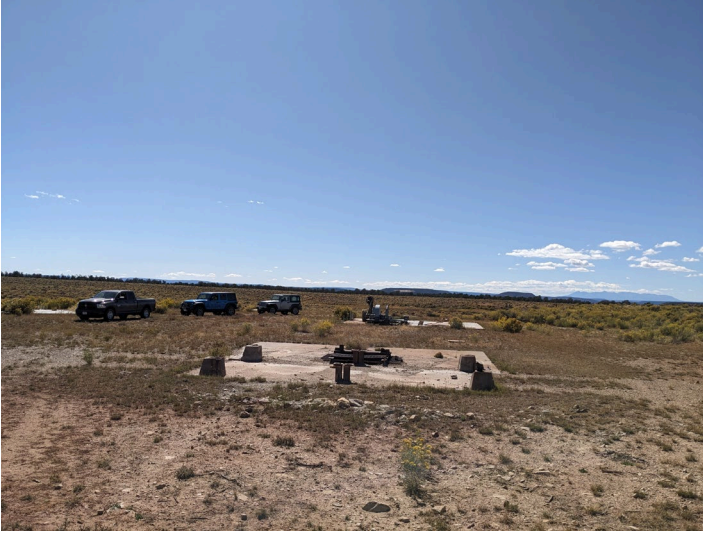
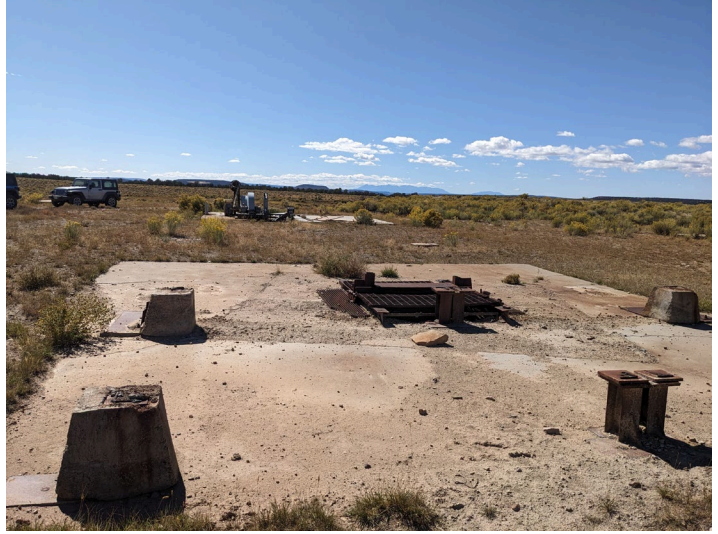
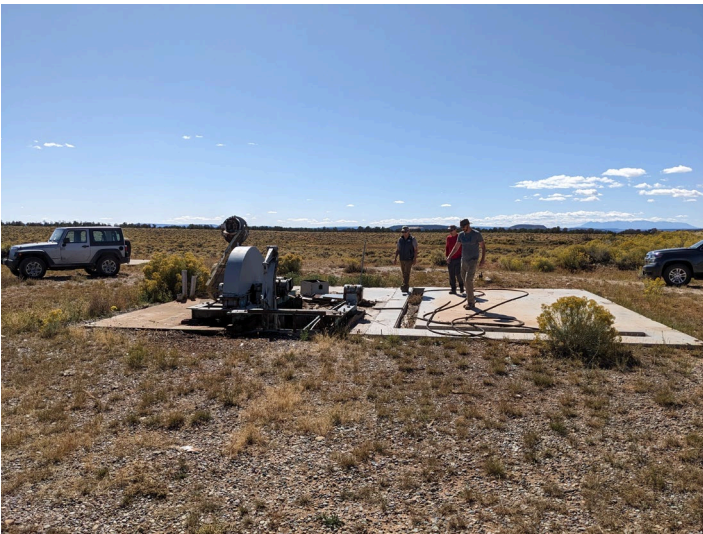
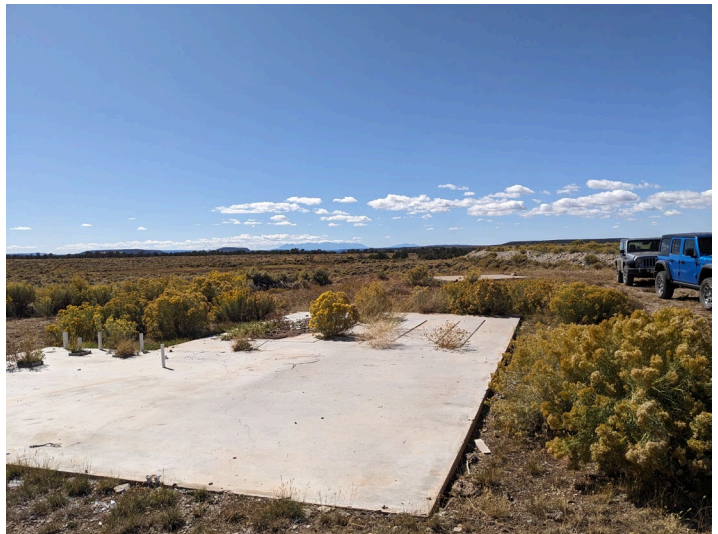
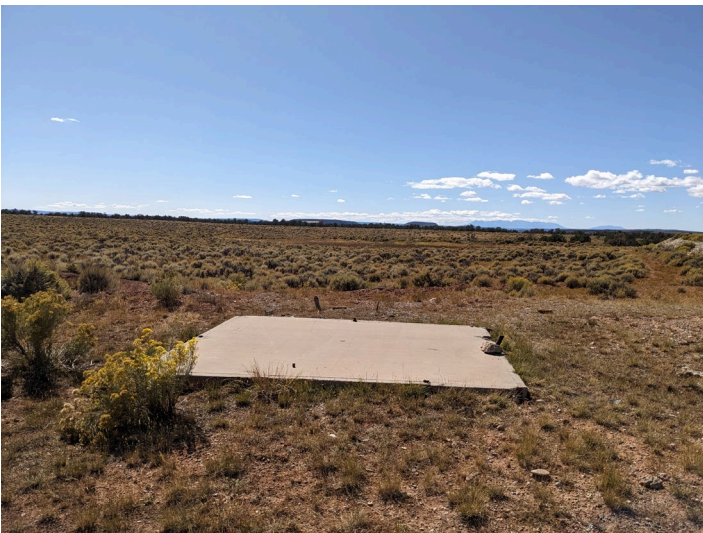
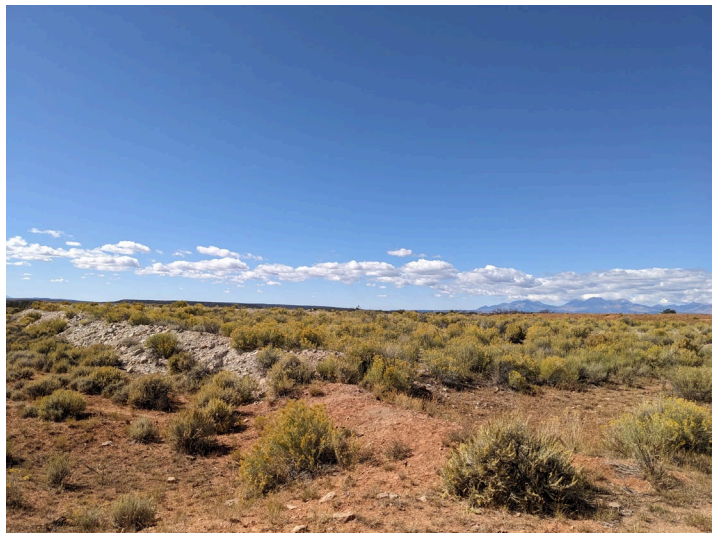
The metal shop building, headframe, shed and hoist house have been removed. The slab foundations are still in place. The hoist winch is still in place. The shaft is secured with metal grating, but not yet sealed.
