Inspection Trapper SL24

10 October 2023

Permit Number: C1981010 Mine Name: Trapper Mine Operator: Trapper Mining, Inc. Operator Address: Mr. Graham Roberts P.O. Box 187 Craig, CO 81626	County: Moffat Operation Type: Surface Permit Status: Active Ownership: Federal
	Operator Representative Present: Graham Roberts
This report was issued electronically from the Divisions' Denver Office.

Inspection Start Date: 11 October 2023 Inspection Start Time: 9:00 a.m. Inspection End Date: 11 October 2023 Inspection End Time: 3:30 p.m.	Inspection Type: Coal Partial Inspection Inspection Reason: Surety Release Requested Weather: Cloudy
Joint Inspection Agency: OSM	Joint Inspection Contacts: Dan MacKinnon, Haley Hampstead
Post Inspection Agency: None	Post Inspection Contacts:
Inspector(s): Robin A. Reilley, M.S. GISP Hunter Ridley	Inspector's Signature:   Signature Date: 17 October 2023

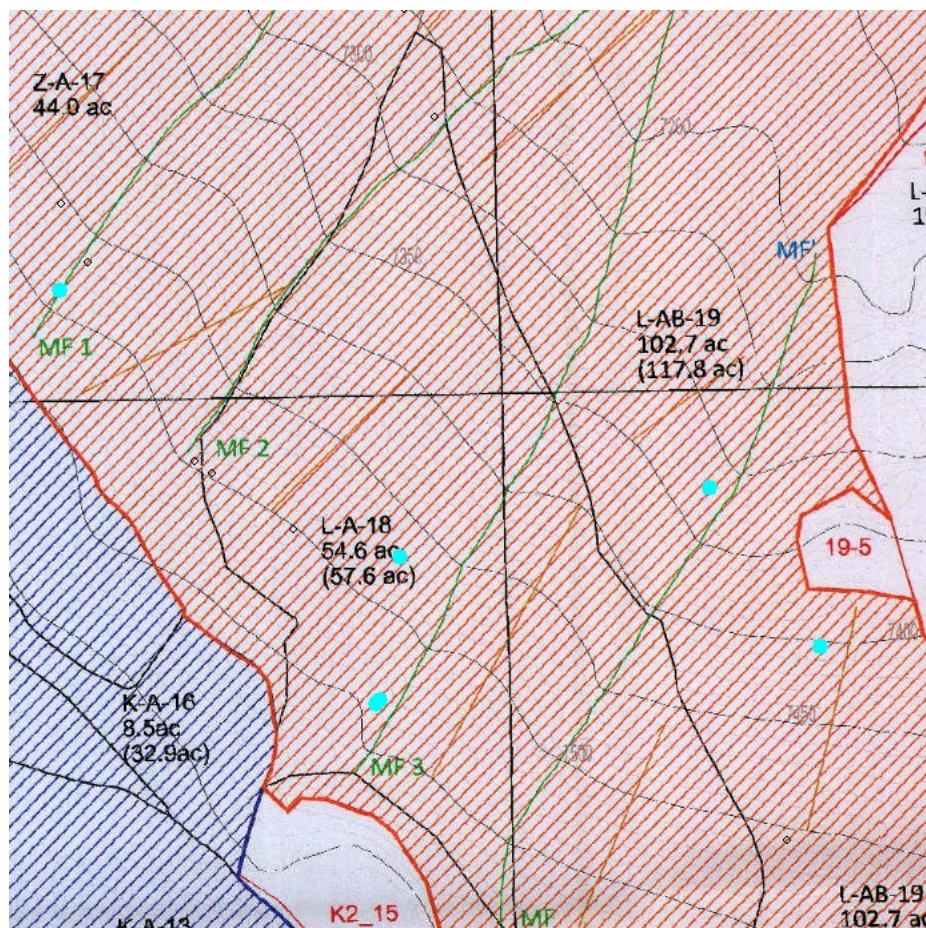
- Overall the slopes were well vegetated with mature and adequate cover effectively reducing erosion. Some rilling was identified across the bond release block as shown on the map below. The operator agreed to make the required repairs in the next few days.
- Contour ditches intersecting the constructed drainages were removed so as not to concentrate runoff into the constructed drainages.

Map I: Location of rills in east reclamation block.**TOPSOIL – RULE 4.06***Removal 4.06.2; Substitute Materials 4.06.4(4); Storage and Protection 4.06.3; Redistribution 4.06.4*

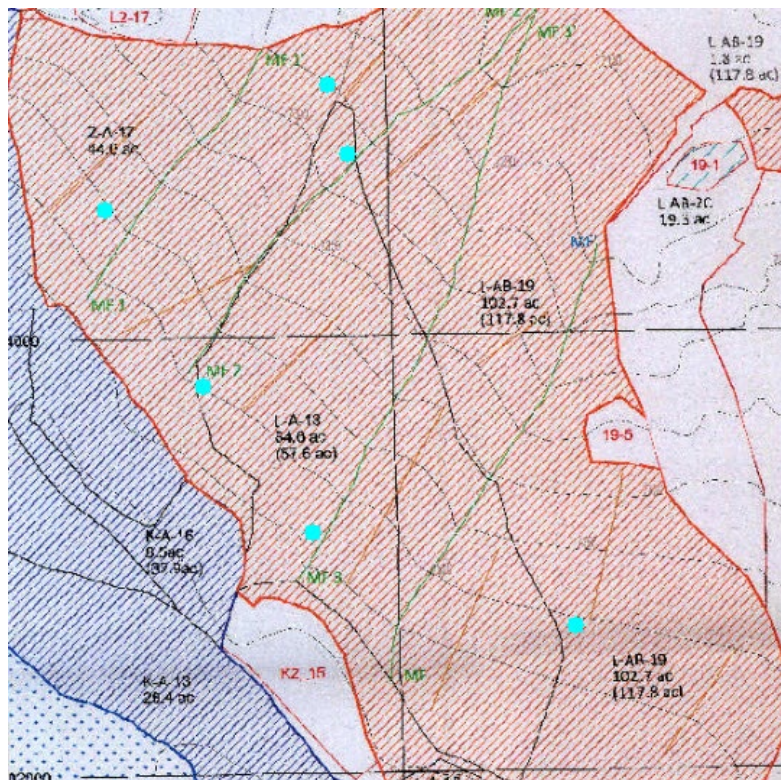
- Revegetation in the two bond release blocks appeared stable and mature with a diversity of species as approved in the seed mixture. Some weeds are present in places. Thistles were noted as was cheat grass. No infestations were noted.
- Vegetation comprised shrubs; rabbit brush various types of Artemisia, wheat and wild rye grasses and perennials such as penstemon, burnet, yarrow, alfalfa, and asters among other species.
- A couple areas of sparsely vegetated areas were identified and will be monitored over the next years.

Map II: Areas of cheat grass to be monitored.

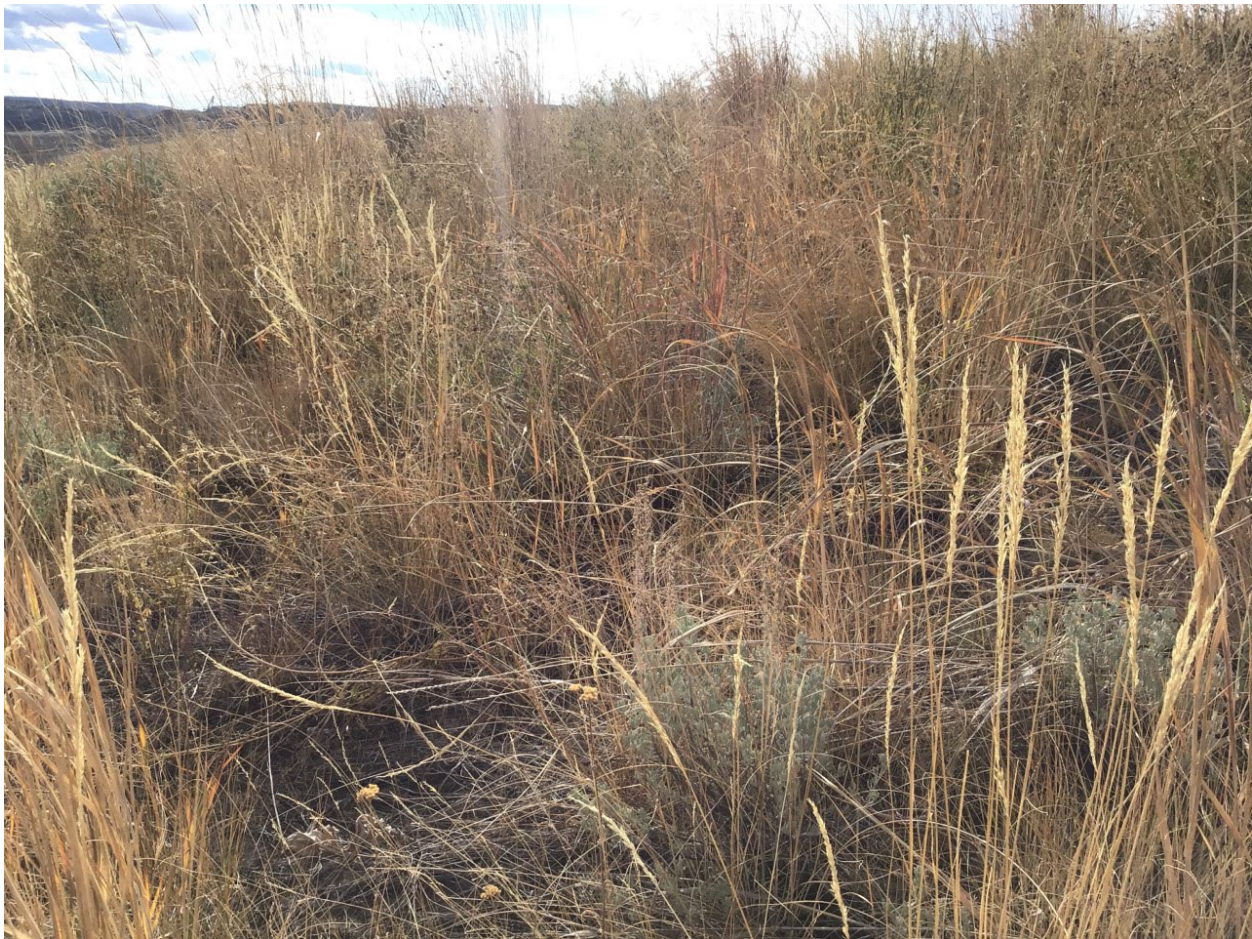
***Photo 1:** Vegetation in parcel ZA17.*

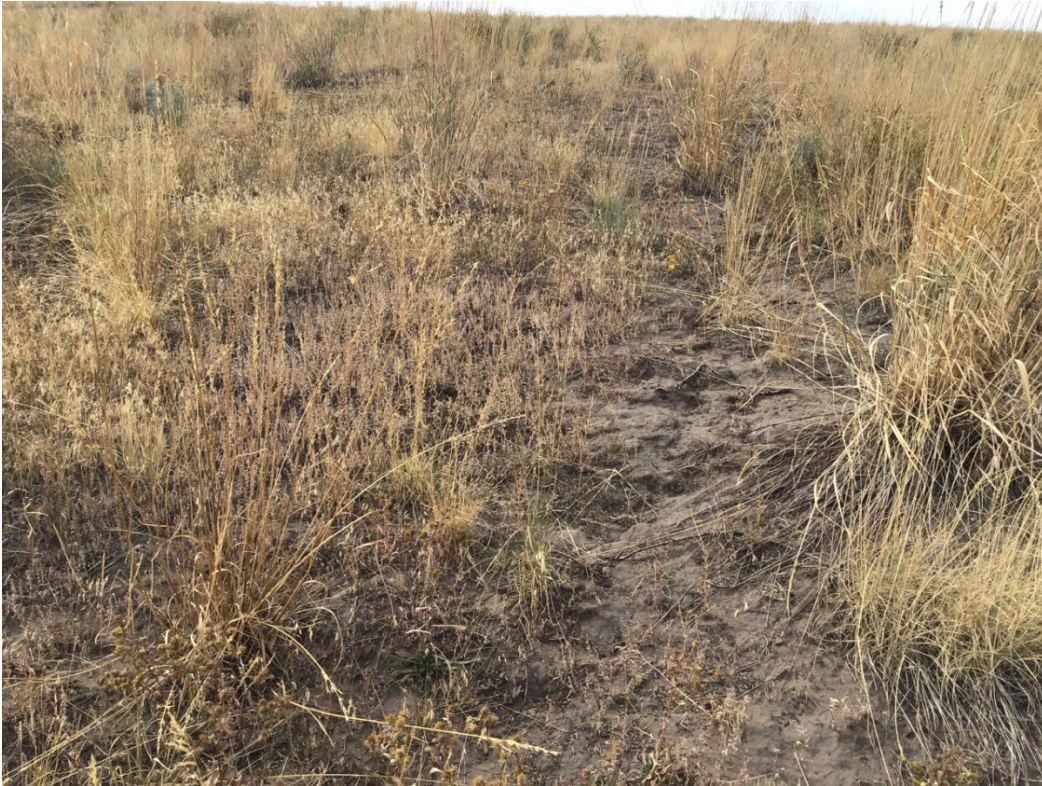
***Photo 2:** Area of sparse vegetation to monitor in parcel ZA17*

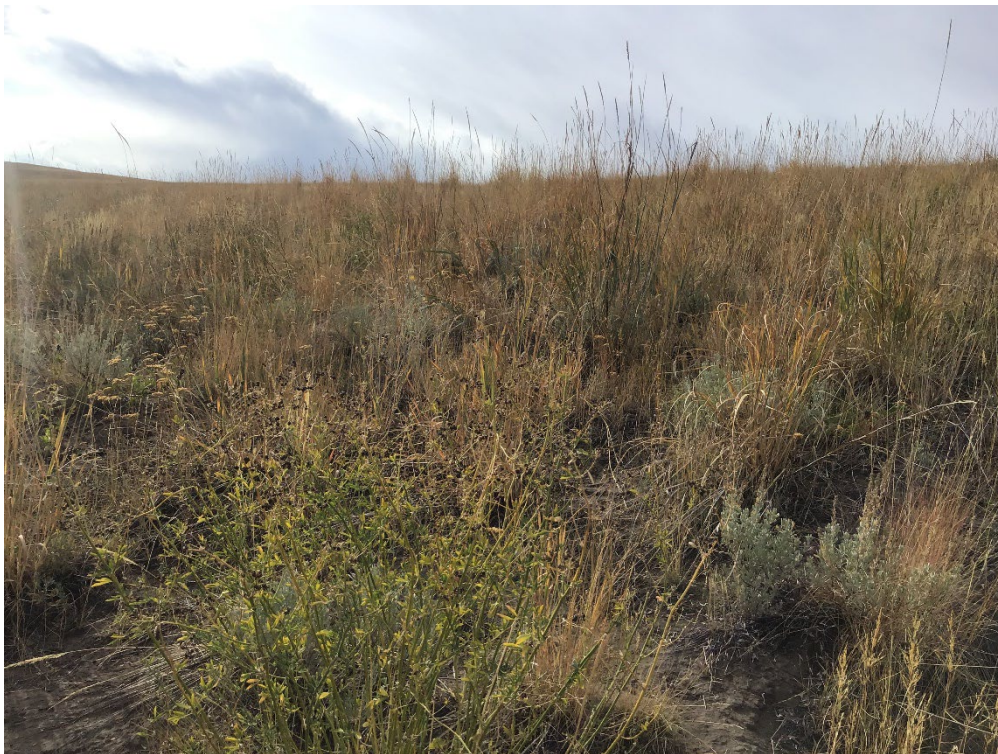
Photo 3: Diversity of vegetation showing shrubs forbs and grasses.

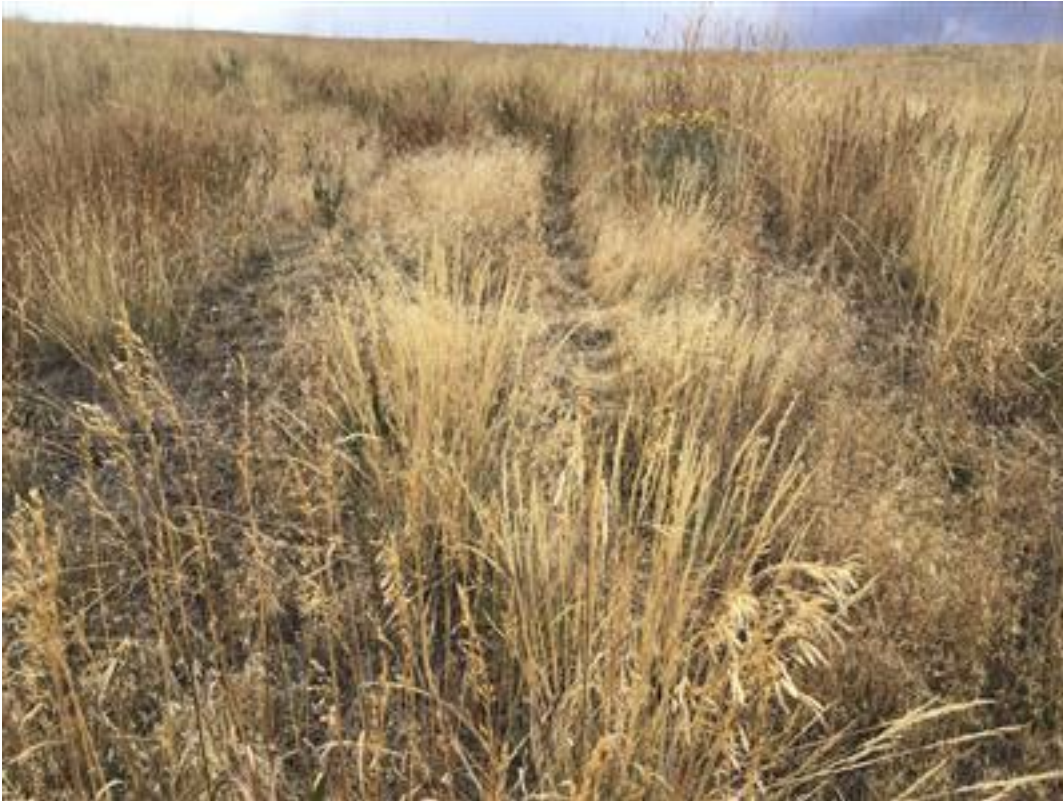
Photo 4: Parcel LA18 area of cheat grass at MF2 at 7500 contour.

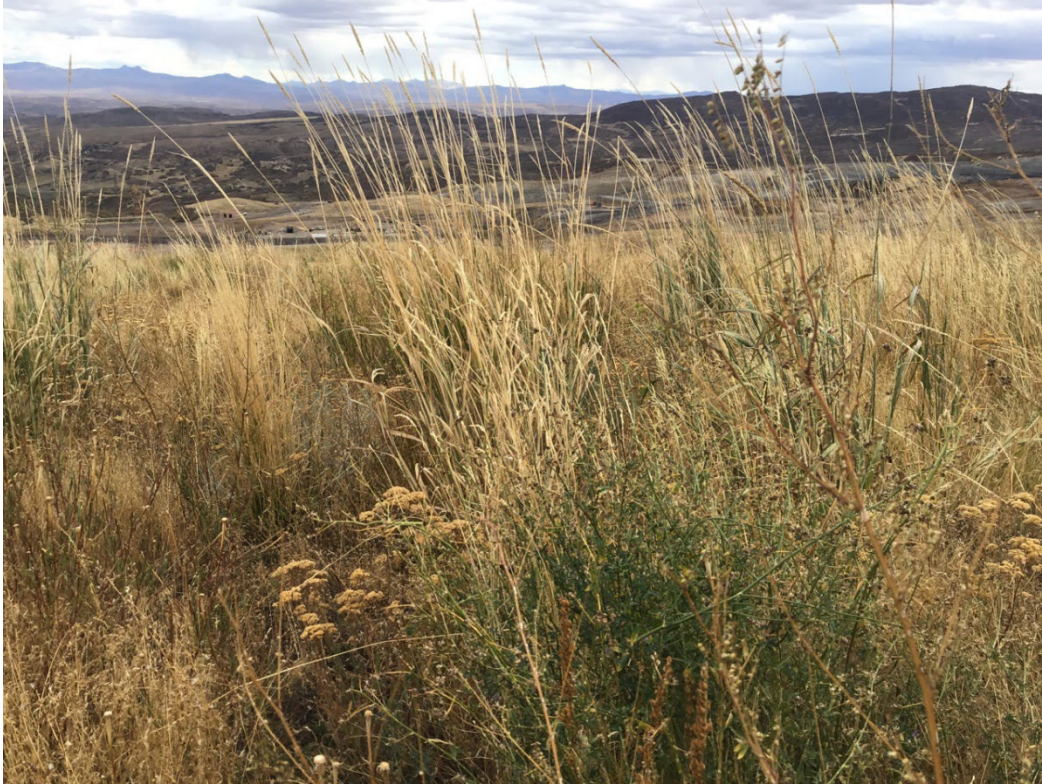
***Photo 5:** Vegetation diversity and cover in parcel LA18.*

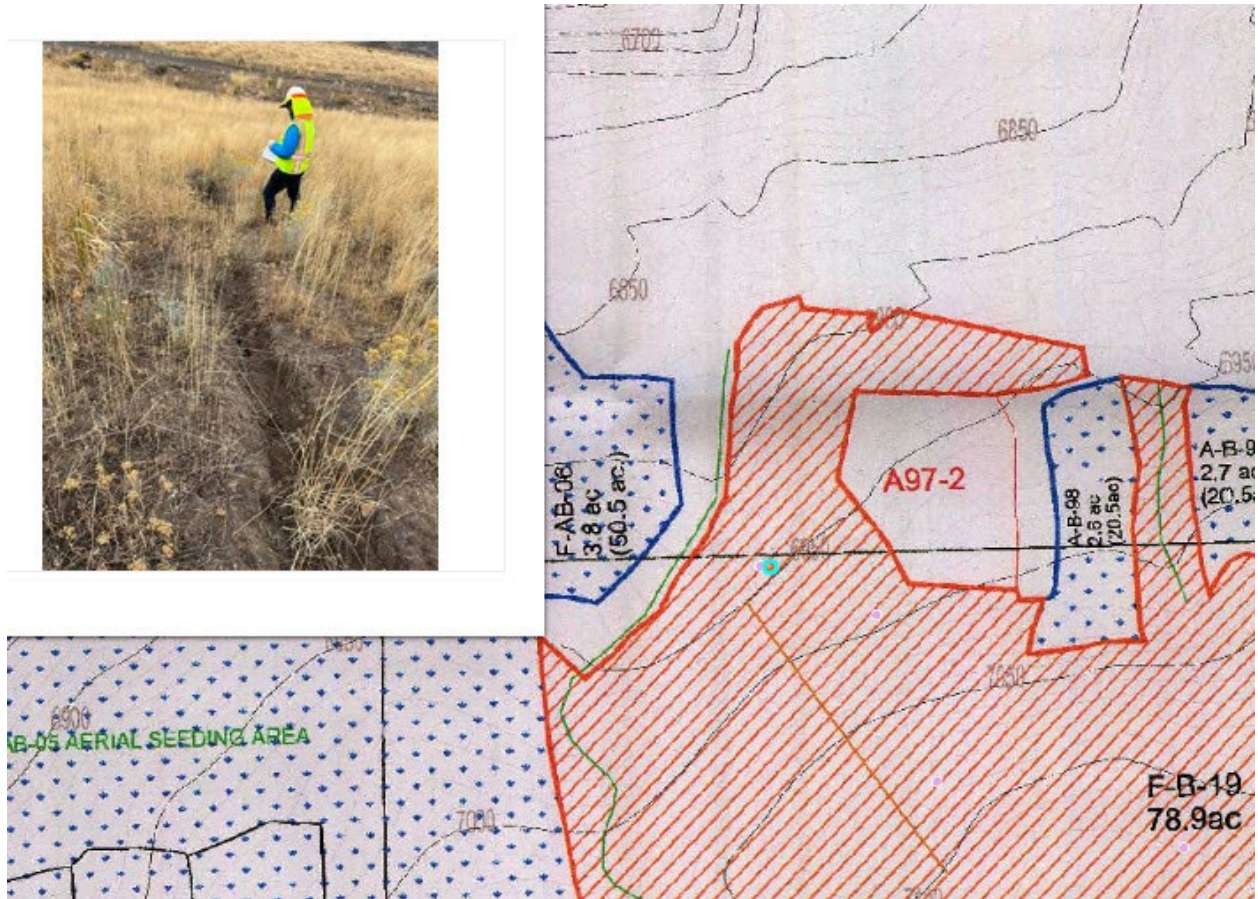
Photo 6: Rill in the west portion of parcel FB19 near the 6950 elevation contour.

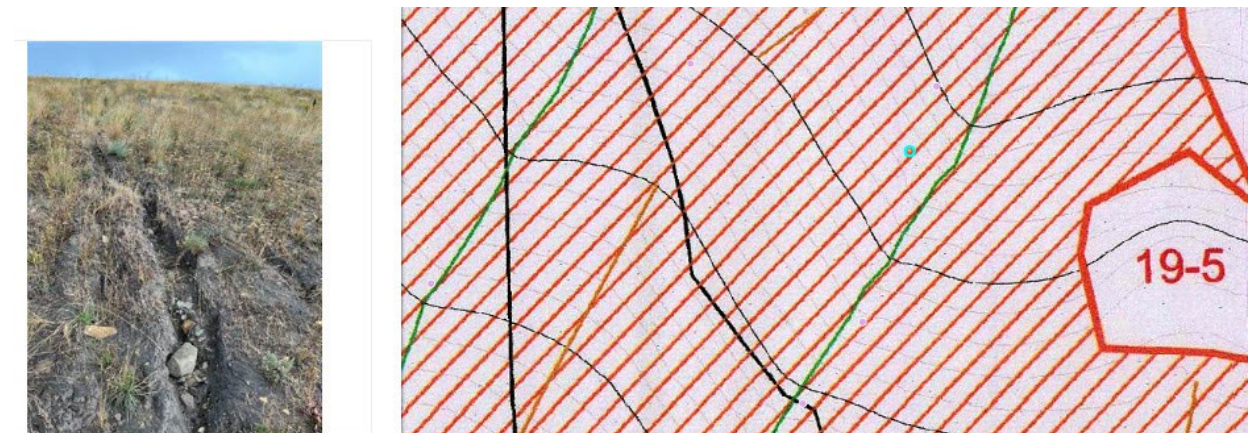
Photo 7: Rill in parcel LAB19 at 7225 elevation contour.

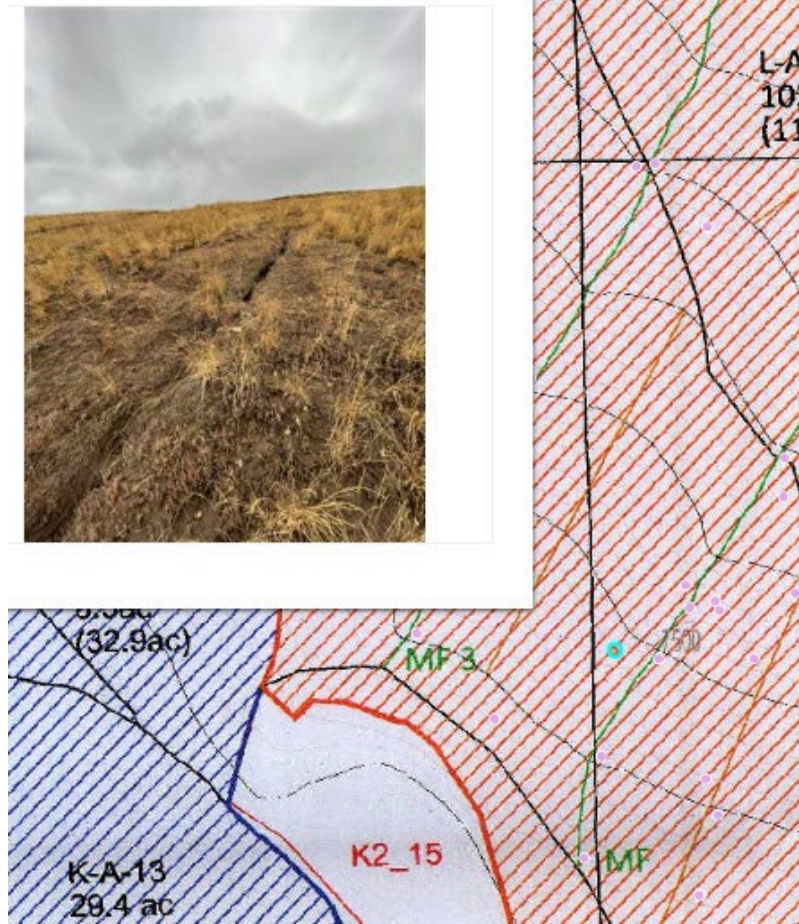
Photo 8: Rill in parcel LAB19 at 7510 elevation contour.

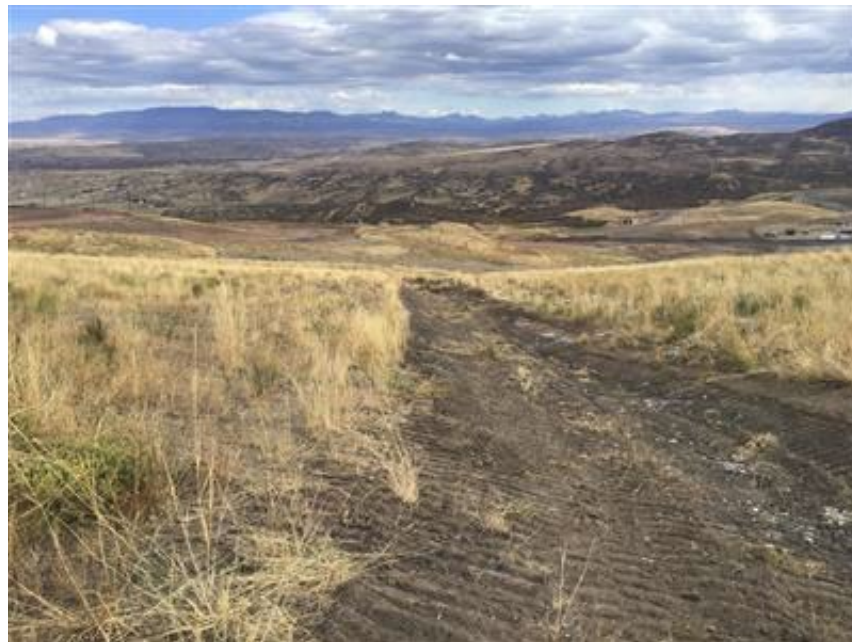
Photo 9: MFI Constructed Drainage looking north, downslope.

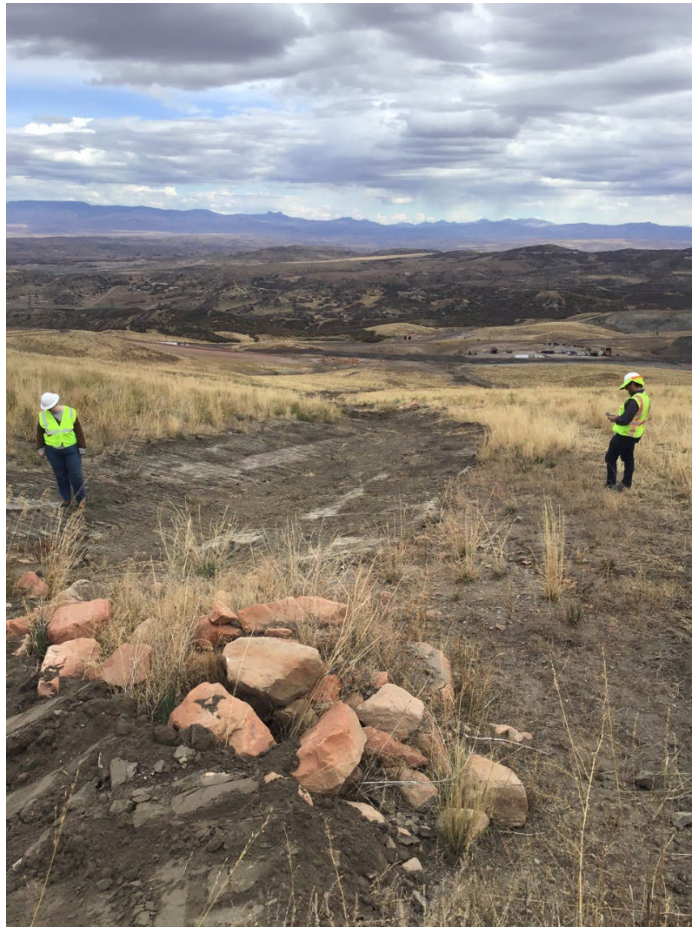
Photo 10: *Constructed Drainage MF2 looking north, downslope.*

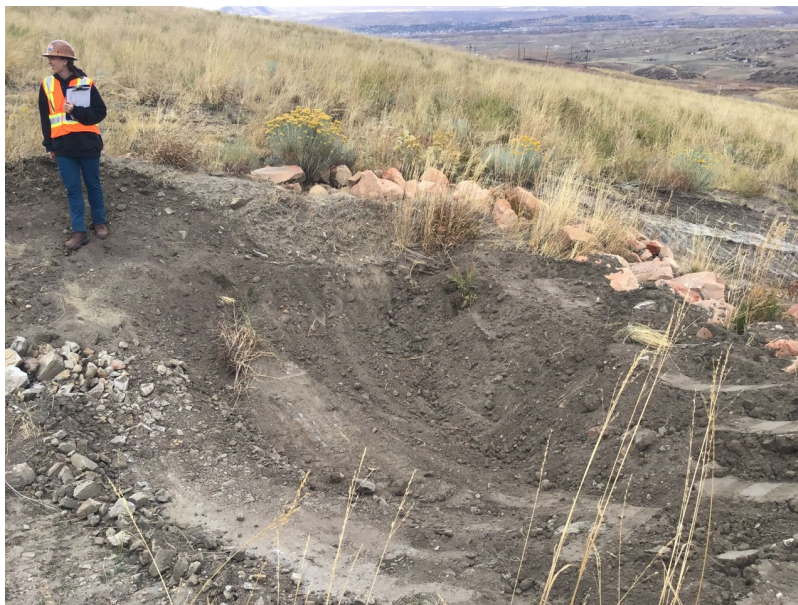
Photo 11: *Check dam basin at Drainage MF2.*
