MINERALS PROGRAM INSPECTION REPORT
PHONE: (303) 866-3567

MINE NAME: Phil Sheridan Lode	MINE/PROSPECTING ID#: M-1988-081	MINERAL: Gold and silver	COUNTY: Boulder
INSPECTION TYPE: Monitoring	WEATHER: Clear	INSP. DATE: October 19, 2023	INSP. TIME: 09:00
OPERATOR: Harry Covey	OPERATOR REPRESENTATIVE: Janice Wheeler	TYPE OF OPERATION: 110(1) - Hard Rock Limited Impact	
REASON FOR INSPECTION: Normal I&E Program	BOND CALCULATION TYPE: None	BOND AMOUNT: \$6,100.00	
DATE OF COMPLAINT: NA	POST INSP. CONTACTS: None	JOINT INSP. AGENCY: None	
INSPECTOR(S): Patrick Lennberg	INSPECTOR'S SIGNATURE:

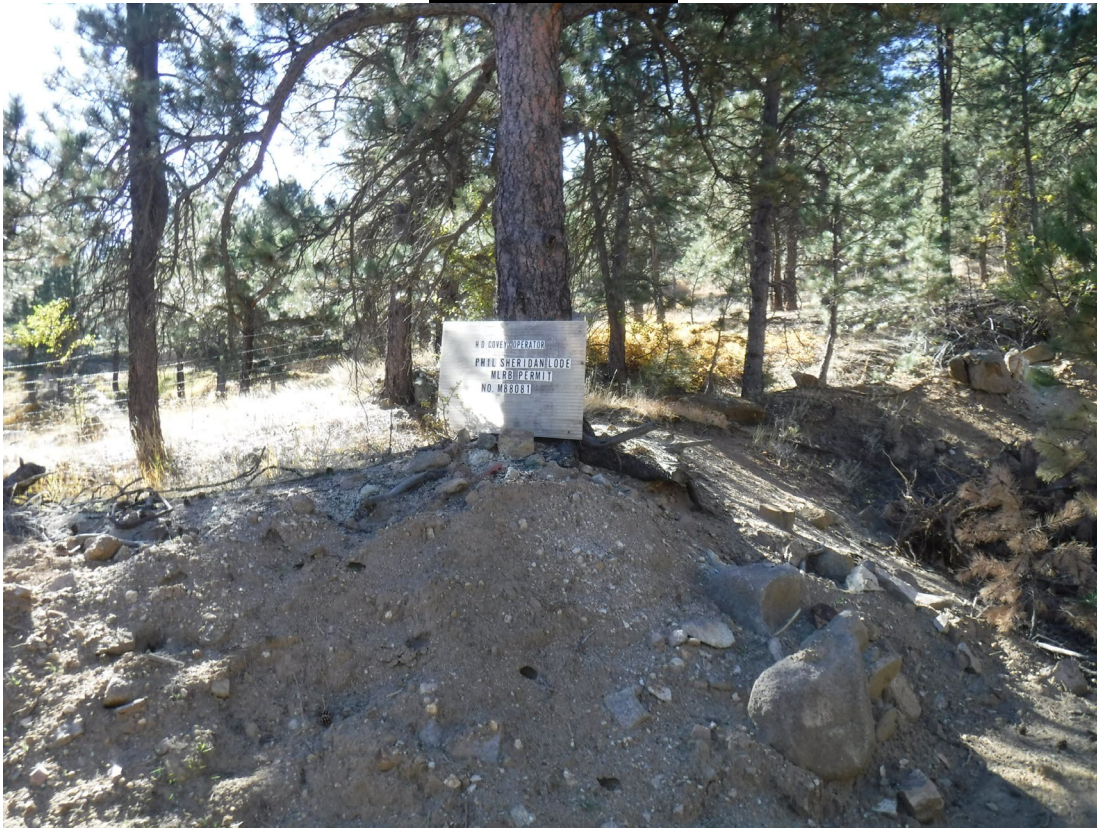
The site is located approximately 6 miles west of Boulder, CO in Boulder County. The site can be accessed by turning north off of Sunshine Canyon Road onto Co Rd 83, then turning west onto a private residential road. A mine sign was observed at the primary mine entrance as required by Rule 3.1.12. and the permit boundary is delineated with wooden stakes and a barbed wire fence.

Photo 1: Mine sign at the primary mine entrance location

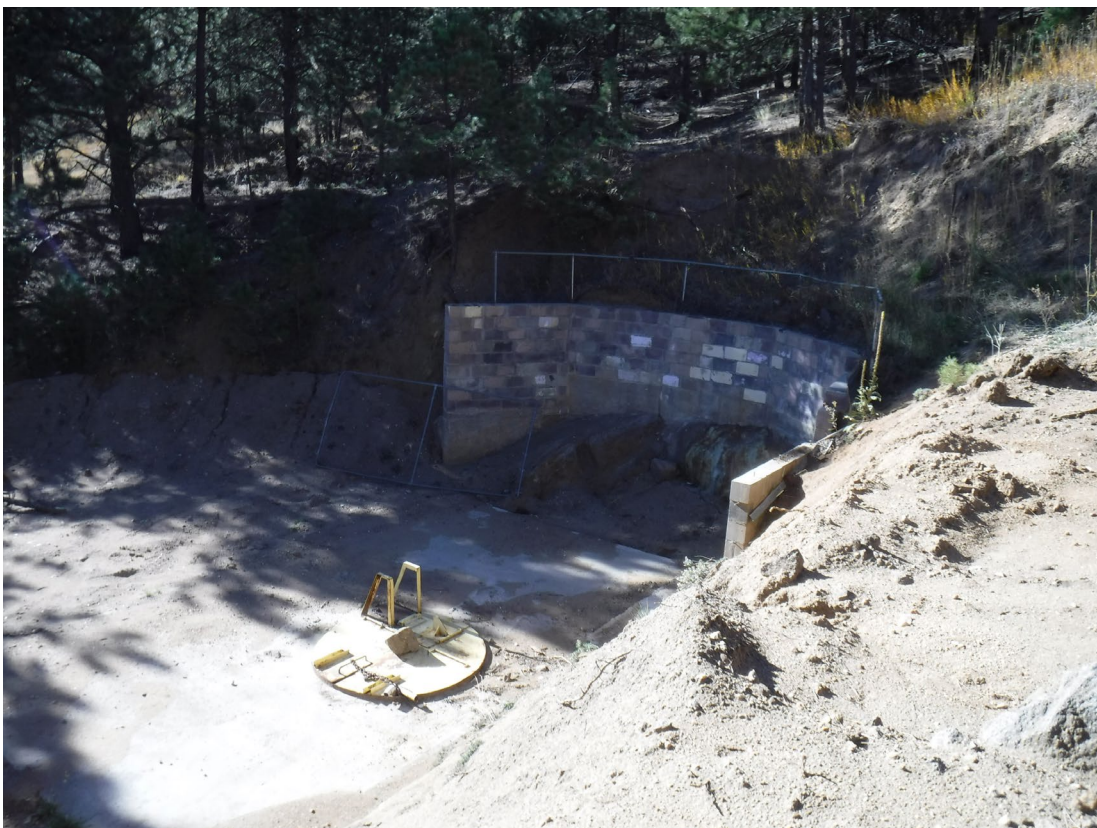
In June of 2023 the winch, winch house and headframe were removed from the site. In August 2023 the property where the permit resides was sold. The operator provided the Division a copy of an easement agreement giving the operator legal right to enter to complete reclamation.

Photo 2: Looking at the location of the former winch house and headframe

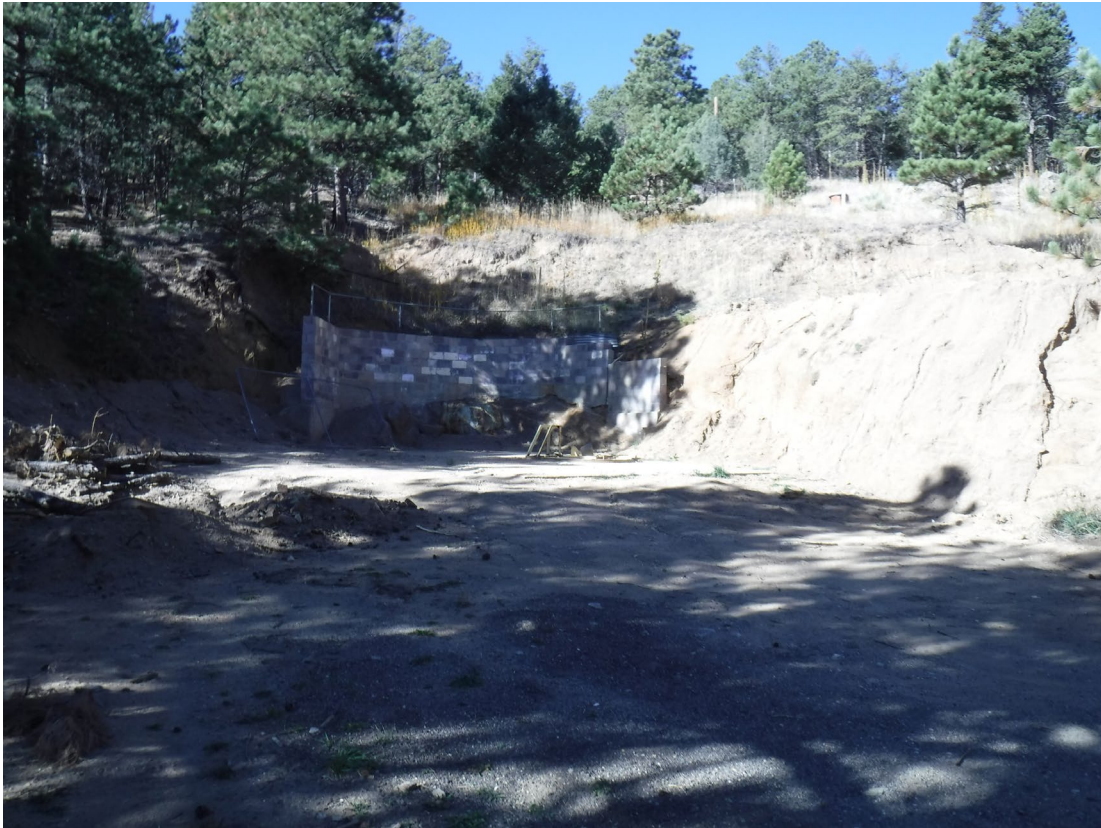
Photo 3: Looking at the location of the former winch house and headframe the highwall, center right of picture, will be scaled back (tiered) to expose the natural bedrock and provide better erosion control and overall stability

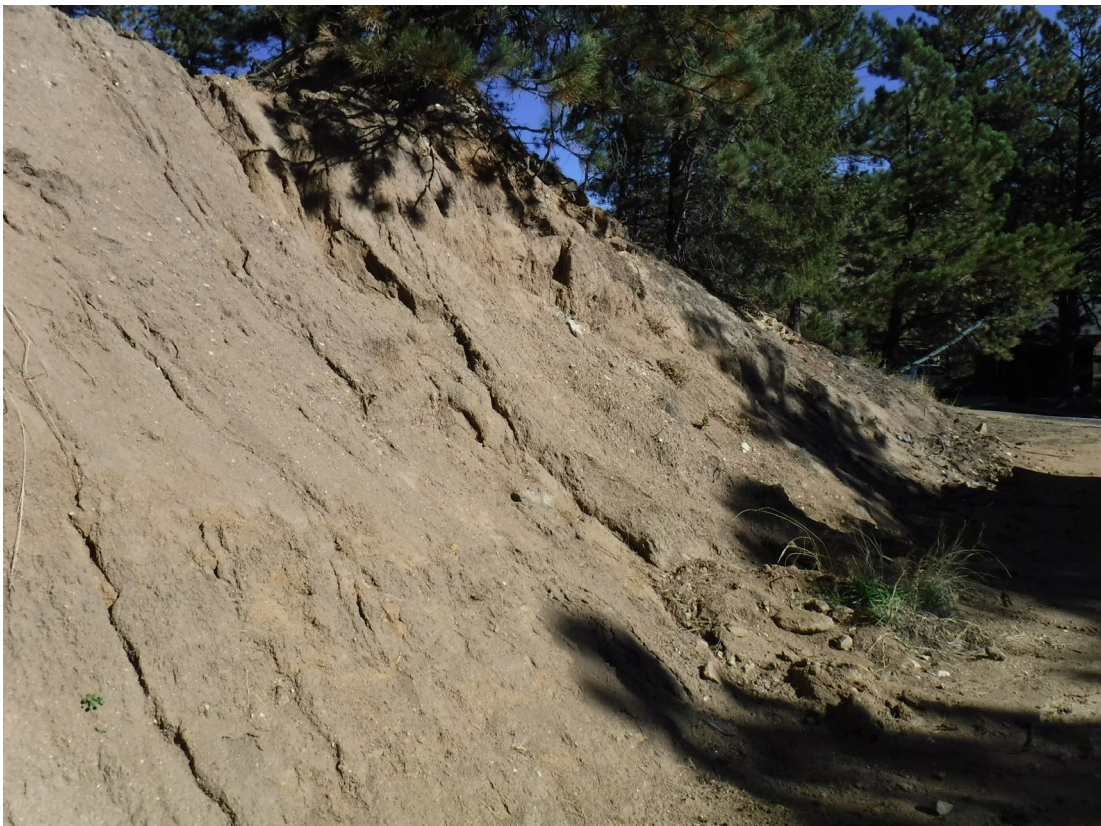
Photo 4: Highwall area to the east

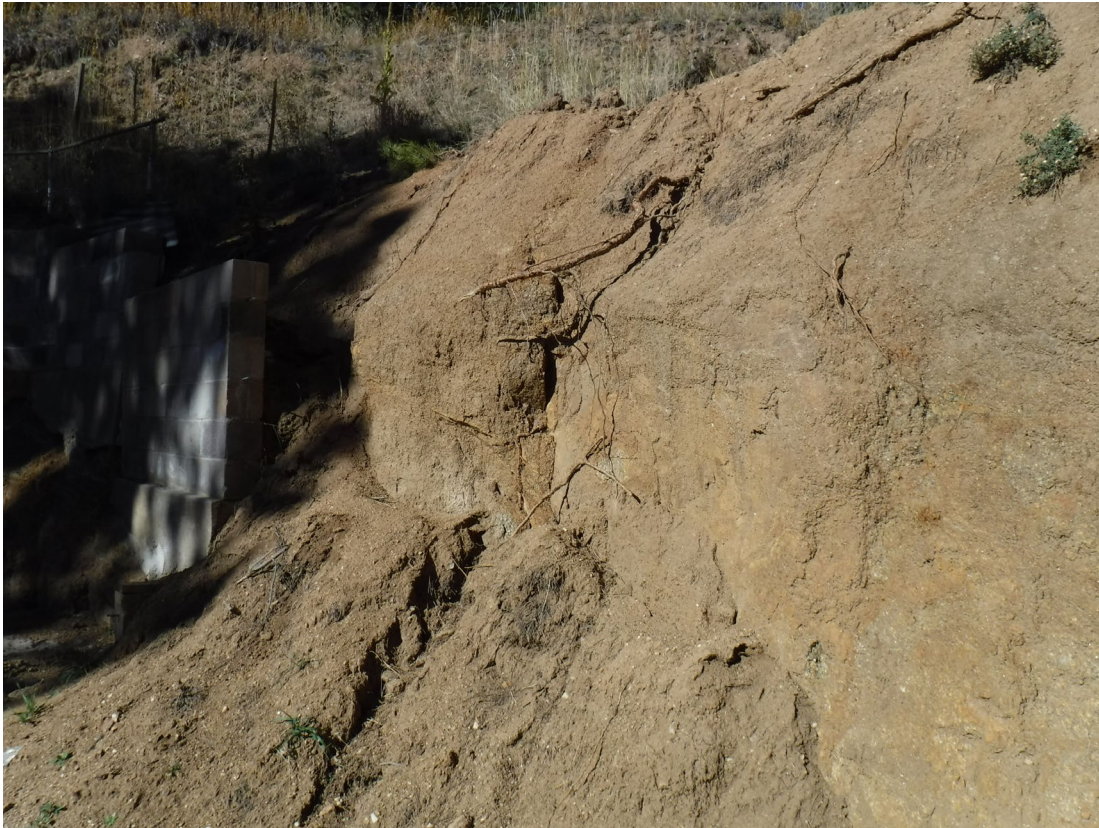
Photo 5: Close-up of highwall and exposed bedrock beneath a veneer of soil

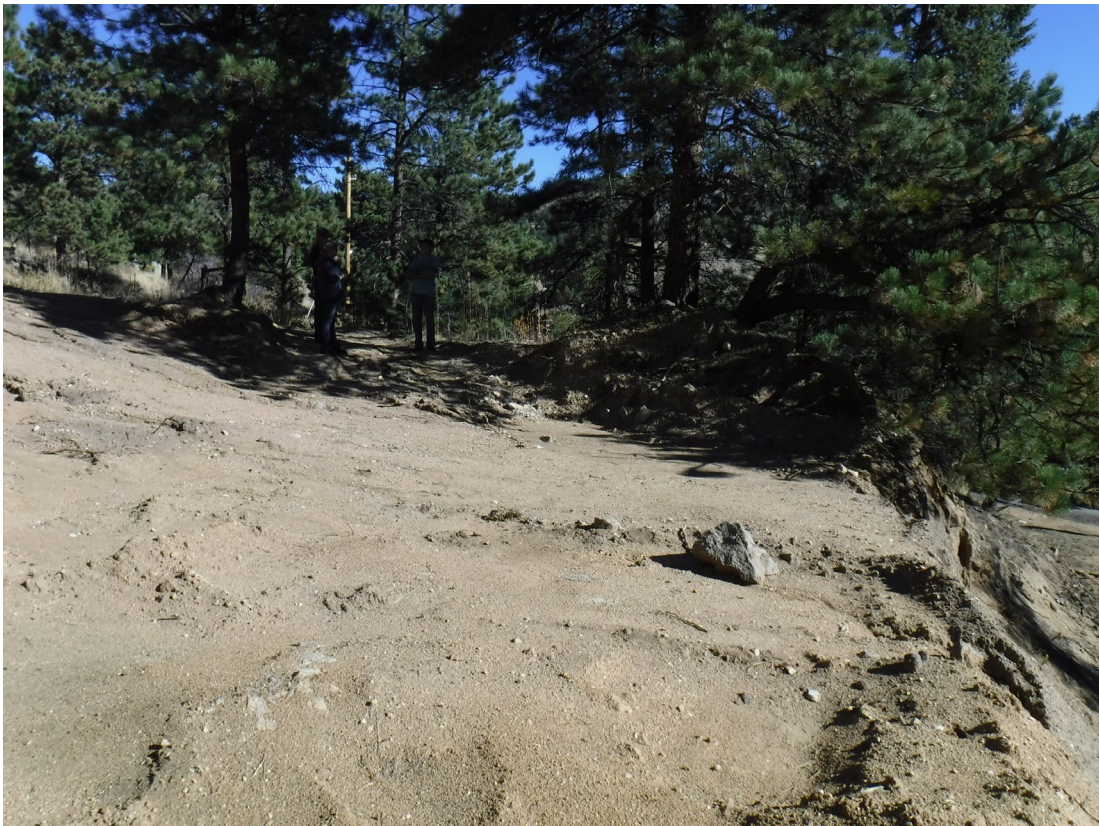
Photo 6: Area upslope from the highwall that is going to be regraded for erosion control and reseeded.
