Inspection Report, Foidel Creek Mine, C-1982-056

PERMIT INFORMATION

INSPECTION INFORMATION

This was a partial inspection of the Foidel Creek Mine; DRMS Permit No. C-1982-056, operated by Twentymile Coal, LLC. (TC). This inspection was conducted by Hunter Ridley with the Colorado Division of Reclamation, Mining, and Safety (Division) and OSMRE representatives Dan MacKinnon and Haley Hampstead. Miranda Kawcak of TC accompanied an initial the inspection. **Please address the Bold items below.**

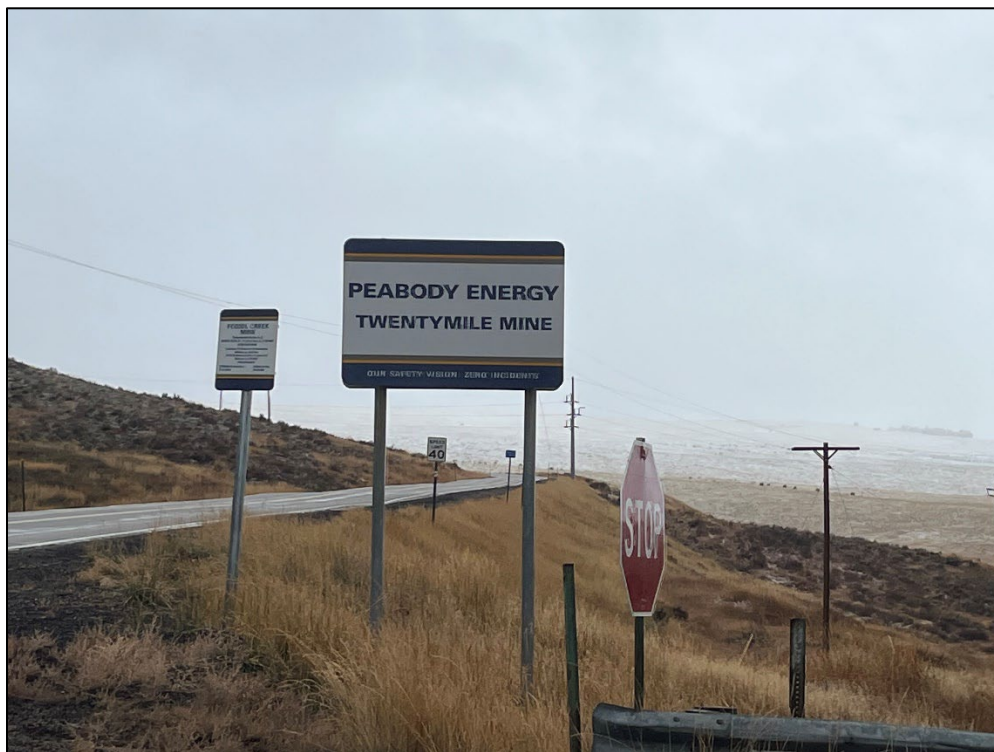
Appropriate mine identification signs were observed throughout the site (Photo 1). All information required for compliance was present on signs.

Photo 1: Mine identification signage located at the site entrance.

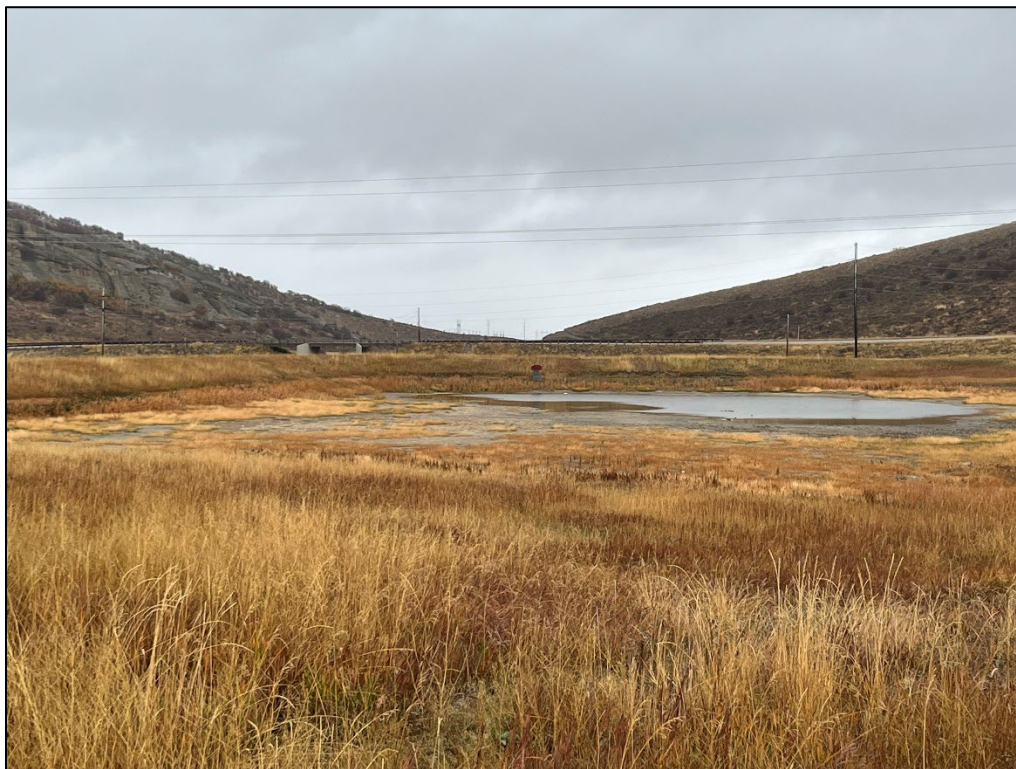
Ponds in the Main Facilities areas were checked for discharge and culverts were checked for function (Photos 2, 3, 5-9, 13, 18 - 20). Several culverts were inspected as part of the bond inspection data collection. All culverts except one at Pond E (Photo 9) were found to be free of blockages and functioning properly. All ponds across the main facilities area had been recently cleaned out. Pond T and one culvert,

Photo 2: View north of Pond G.

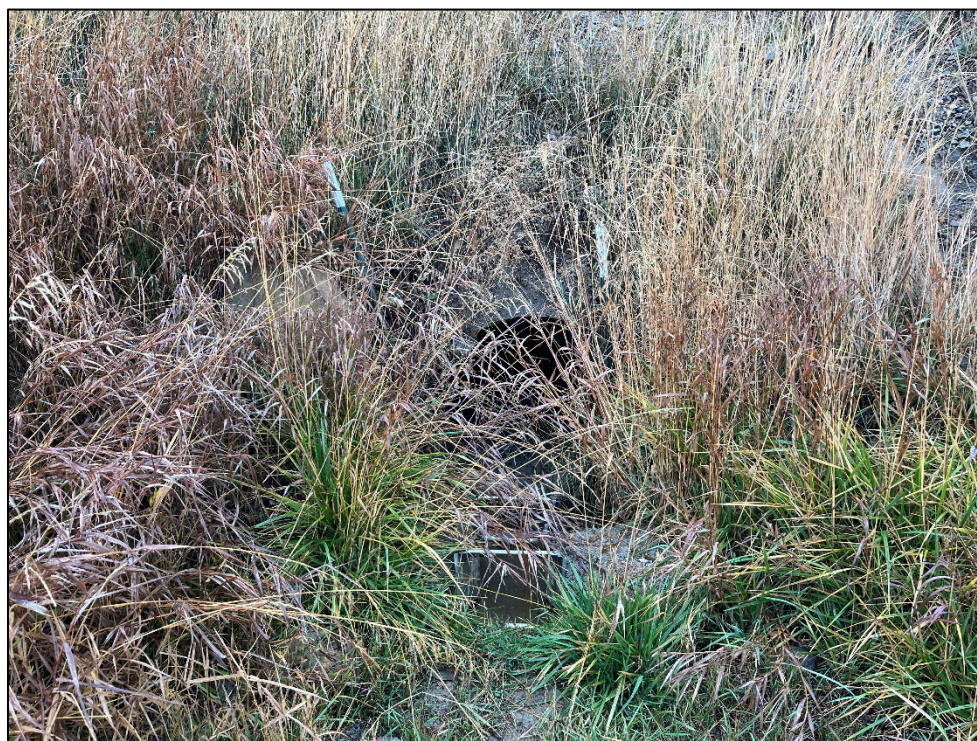
Photo 3: Unnamed 36" Culvert connected to the northwestern side of Pond F.

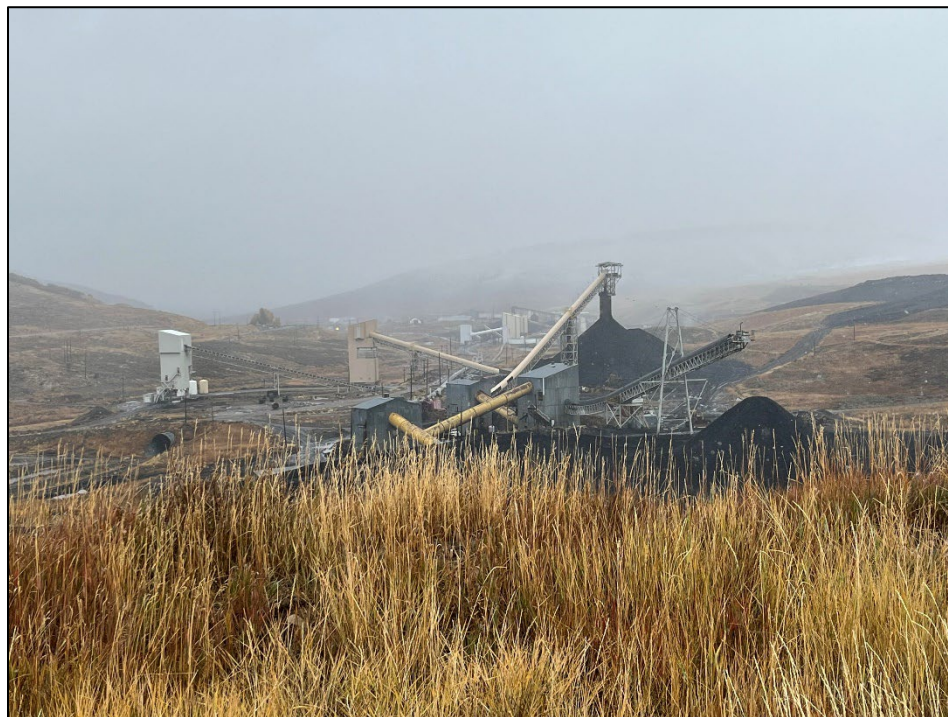
Figure 4: View north of the Main Facilities Area from xxx

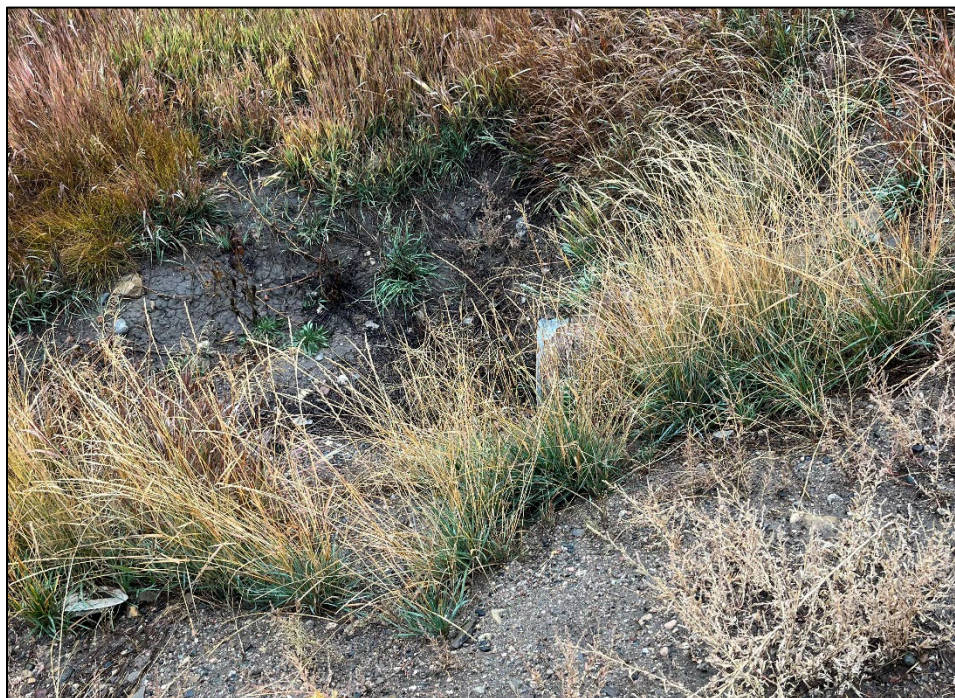
Figure 5: 24" Culvert F-2-B, located near Pond F and connects to Ditch F-2, clean and functioning.

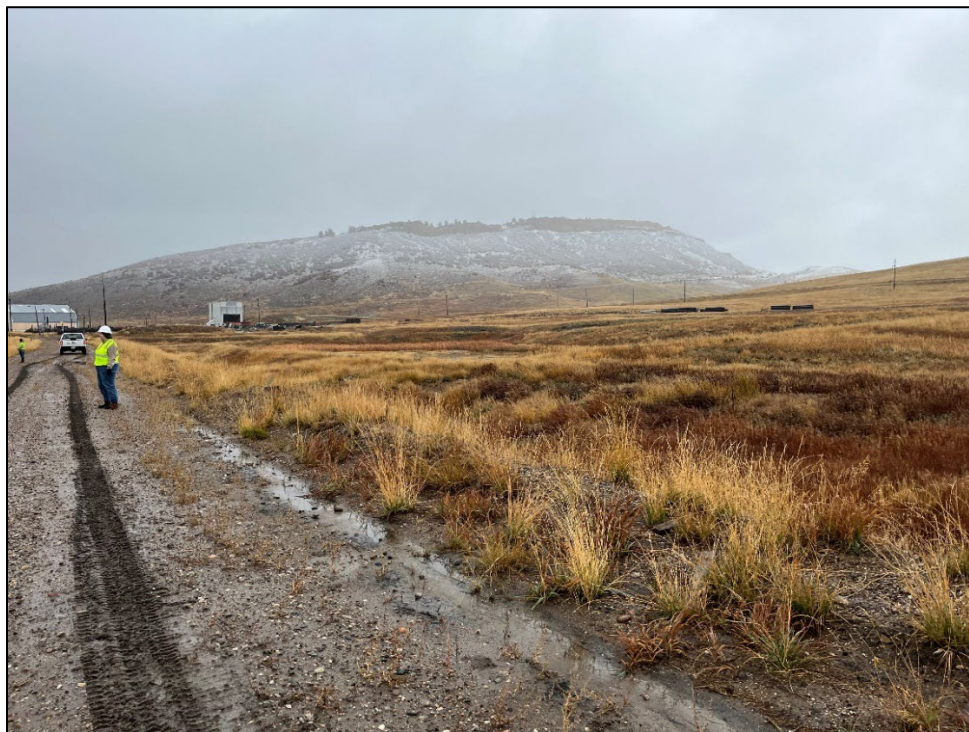
Photo 6: View east of Pond F.

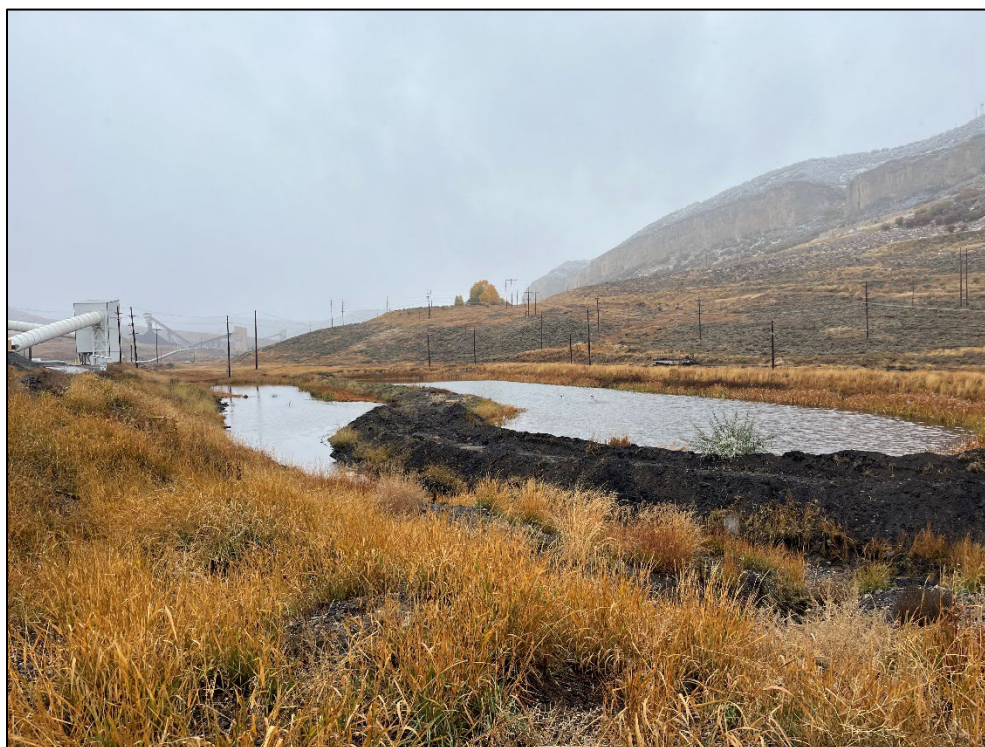
Photo 7: View southeast of Pond E, recently cleaned.

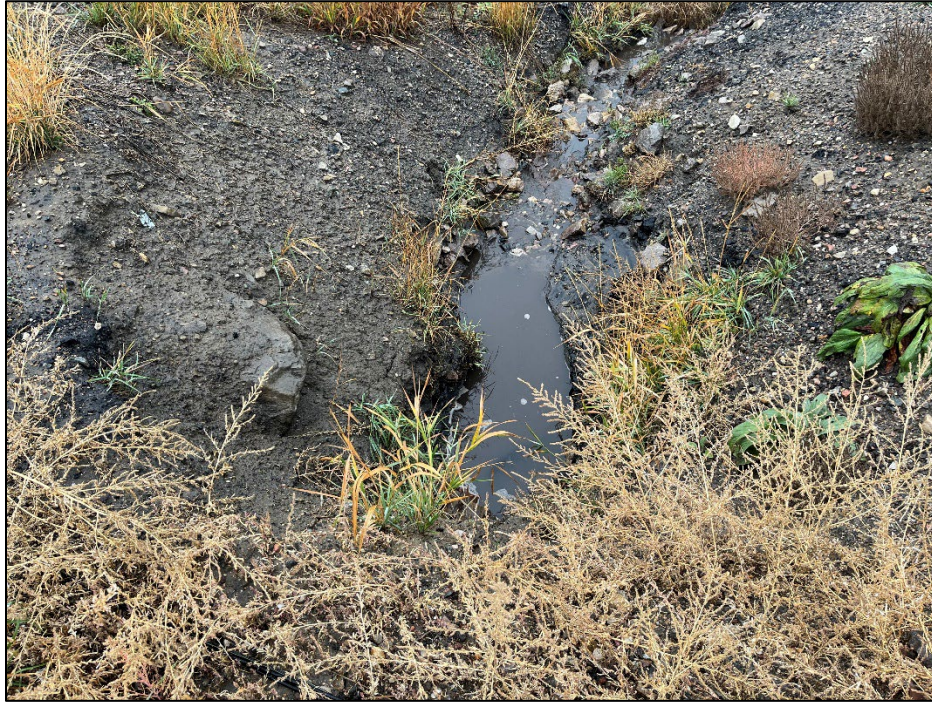
Photo 8: Culvert E2D at Pond E, clean and functioning.

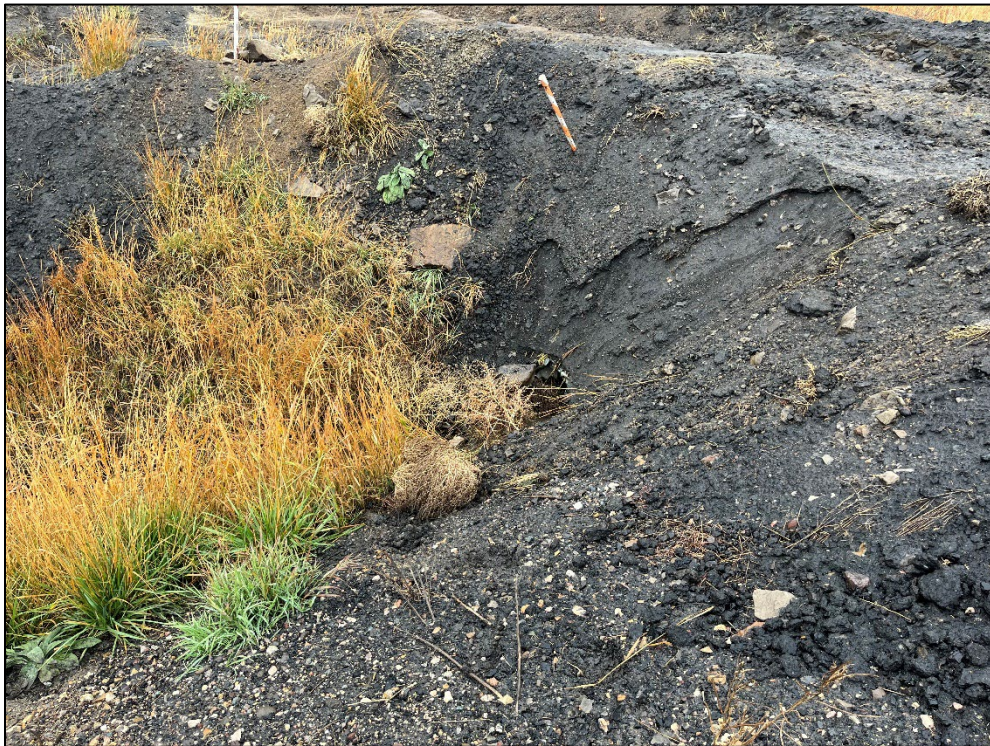
Photo 9: Unnamed culvert located on the northeastern side of Pond E is in need of cleanout, a rock and vegetation blocks flow.

- Repair silt fence located behind the stoker loadout building
- Protect topsoil piles along the 6MN road during maintenance and snow plowing activities during the winter months
- Clean out the unnamed culvert at Pond E as shown in Photo 9

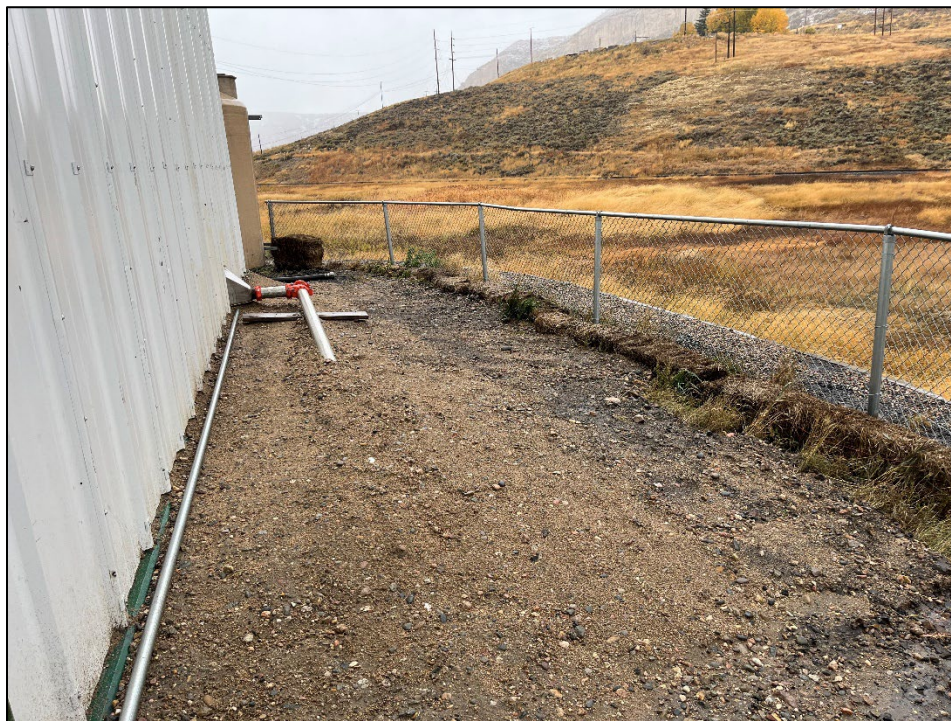
The stoker coal loadout facility has been sealed with an inner waterproof liner. This was done in an effort to control any potential water leakage from this wash plant facility from travelling offsite and depositing sediment into nearby Foidel Creek. Photo documentation of this was provided to the Division on September 29, 2023. A pipe which run from the back of the facility towards a pump house was also installed to collect any water that pools in the stoker loadout building (Photo 10). As per the Division's request, several BMPs were also installed around the stoker loadout building to control any excess erosion. These improvements include a silt fence, which is in need of repair (Photo 12), and an additional sediment fence located on the western side of the stoker building to protect Foidel Creek from eroding sediment and from coal spills from the loadout (Photo 11). Hay bales have also been maintained at the back of the stoker building to control erosion (Photo 10).

Photo 10: Repaired plumbing behind the stoker loadout building.

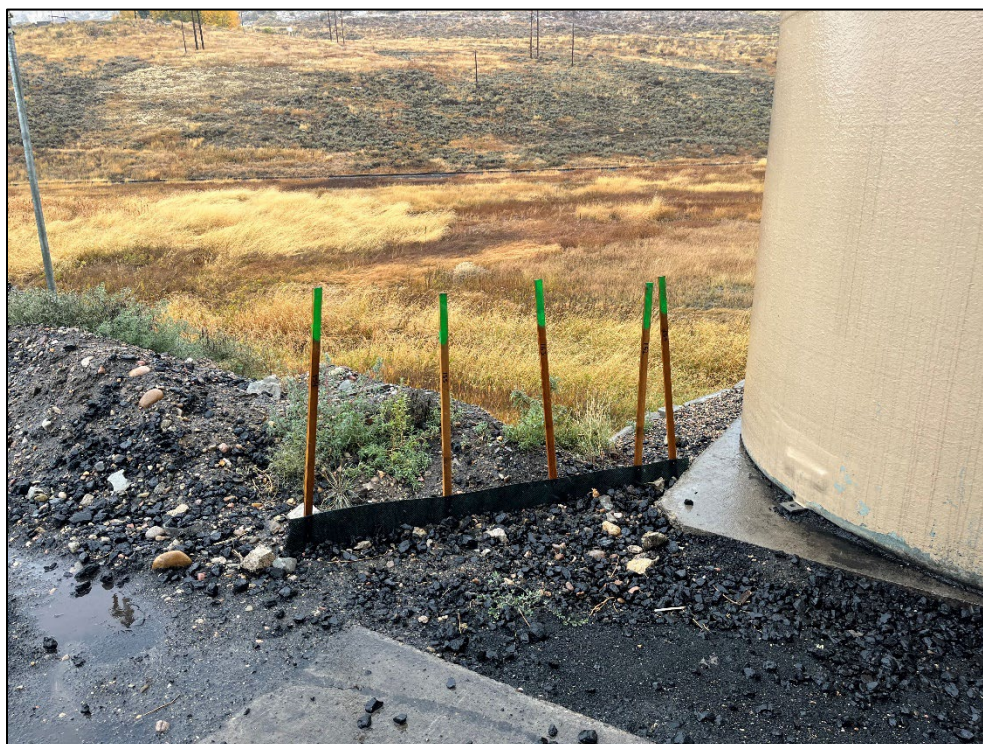
Figure 11: Additional BMP located on the south eastern side of the stoker loadout building.

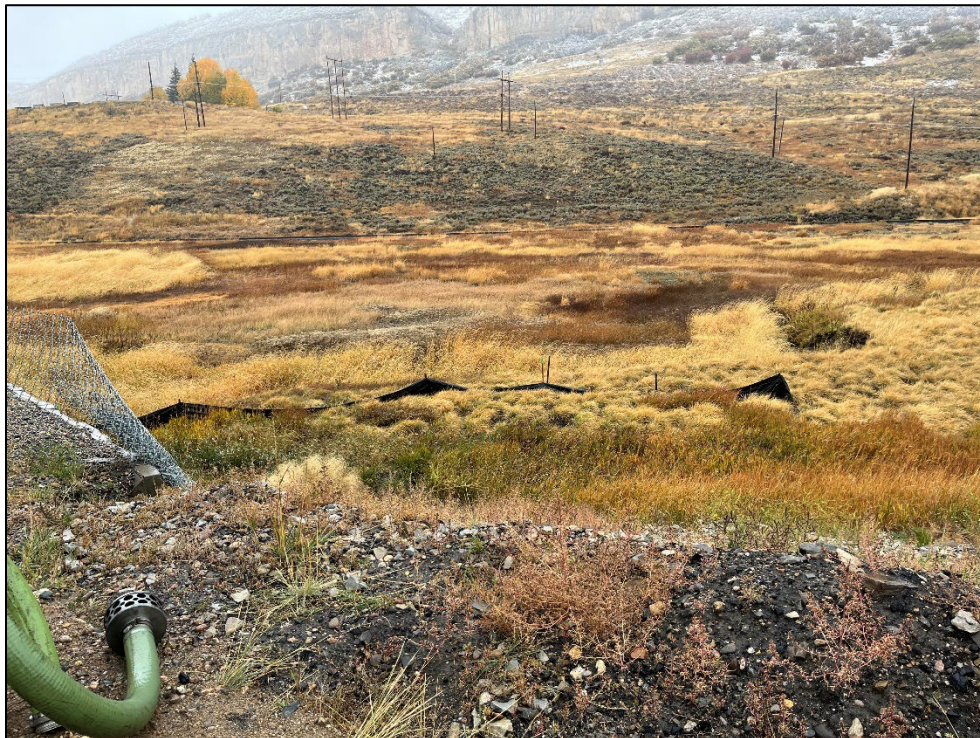
Photo 12: Silt fence below the stoker loadout building in need of repair.

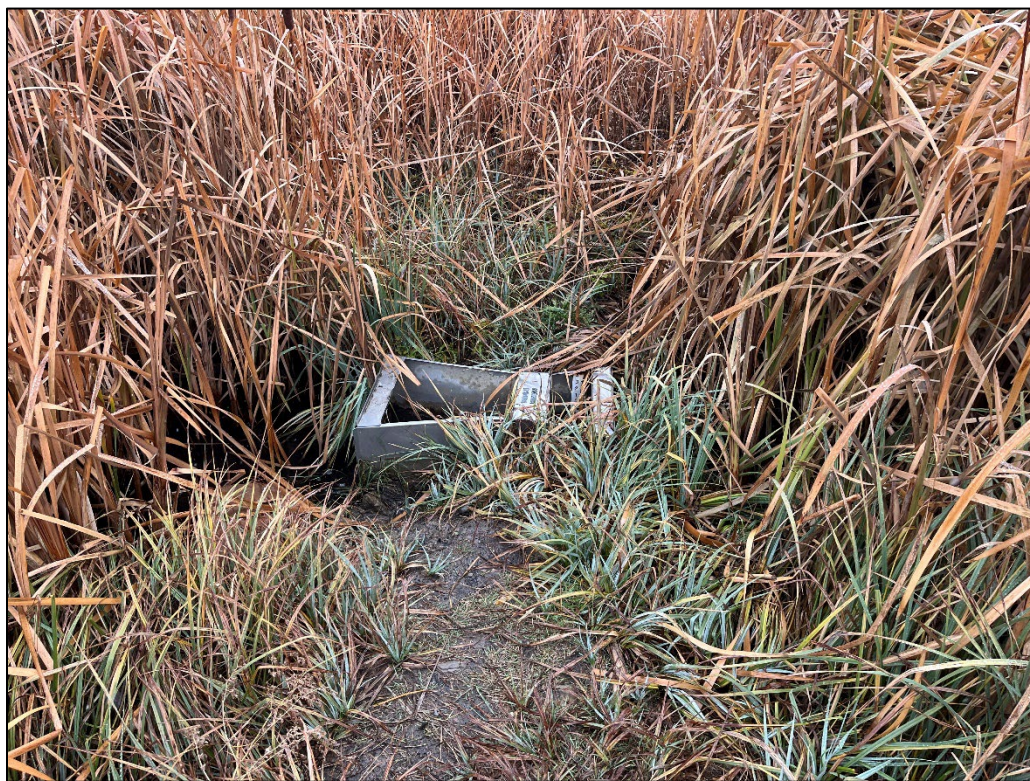
Photo 13: Weir located at the discharge point for Pond D.

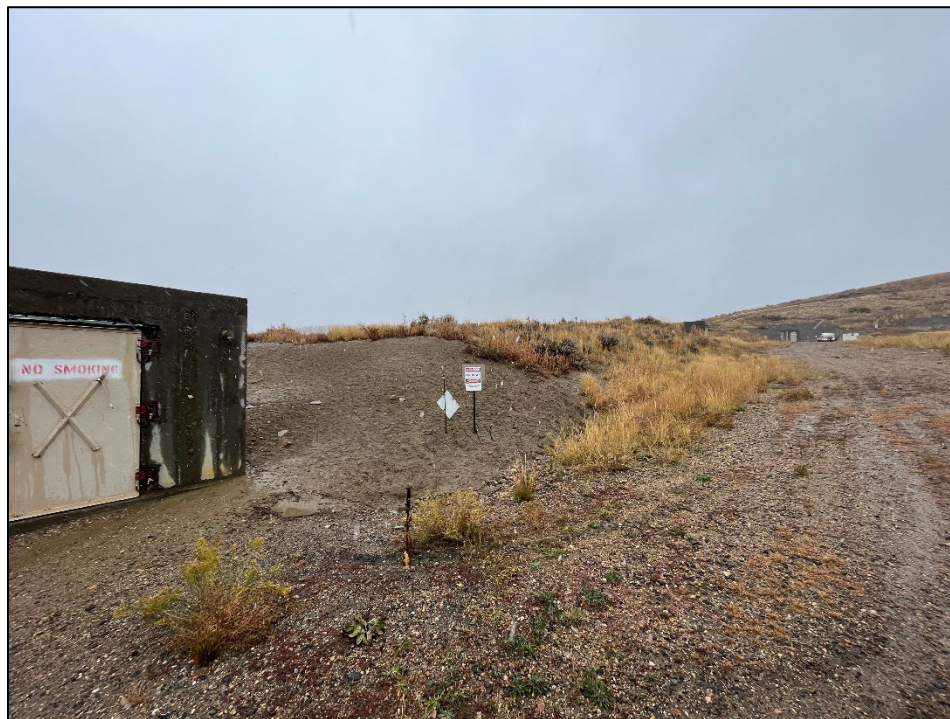
Three explosives storage bunkers are located on the far southwestern side of the main facilities area (Photo 14). Explosives are kept on site for general blasting, and would be mostly in contexts of maintaining safety underground. The storage bunkers are inventoried monthly. A storage lot for excess equipment and vehicles is also located in this same area (Photo 16).

Photo 14: One of three storage bunkers for explosives at the Foidel site.

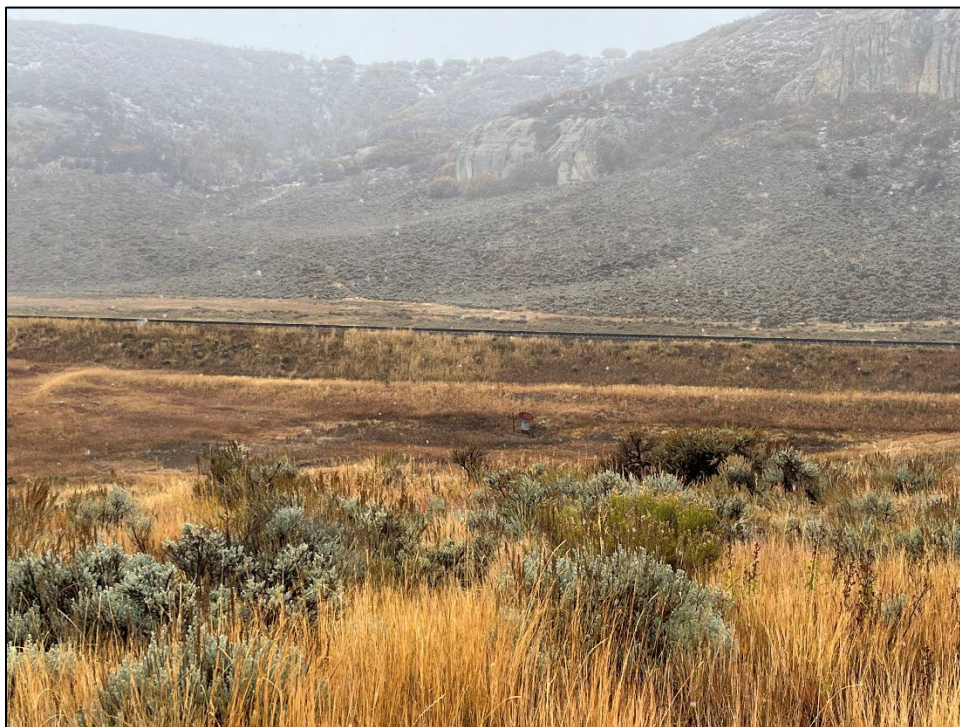
located on the far western side of the main facilities area, were also inspected (Photos 15 and 17). Pond T has not discharged in many years and remains dry year round aside from small amounts of storm water and snowmelt capture.

Photo 15: Pond T, has not discharged in many years.

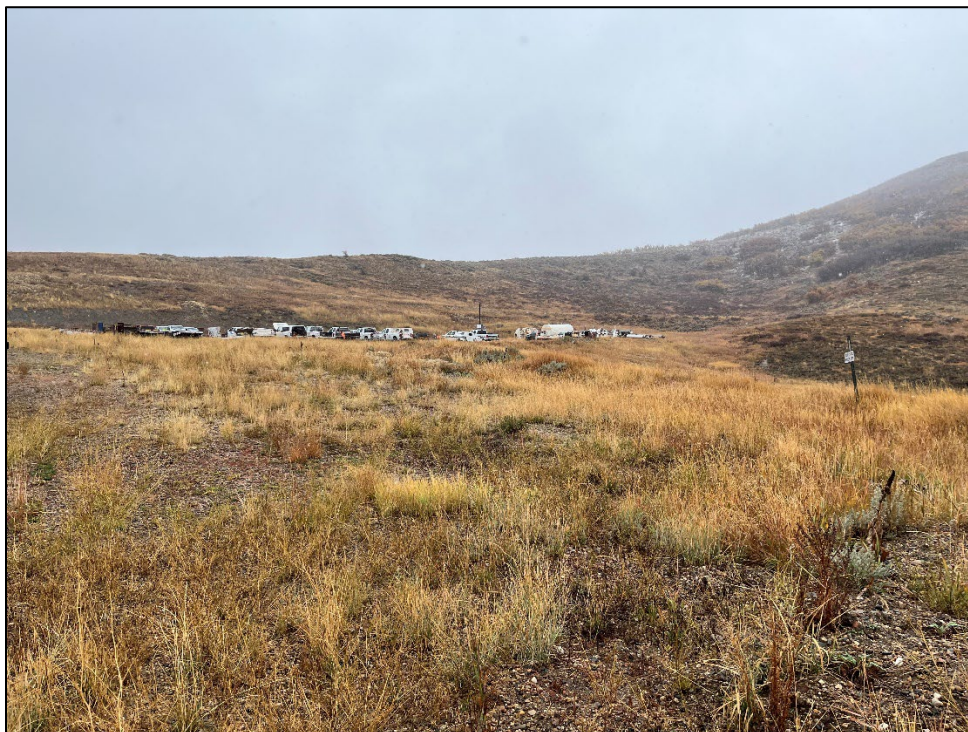
Photo 16: View northeast of a vehicle storage area southwest of the main facilities area.

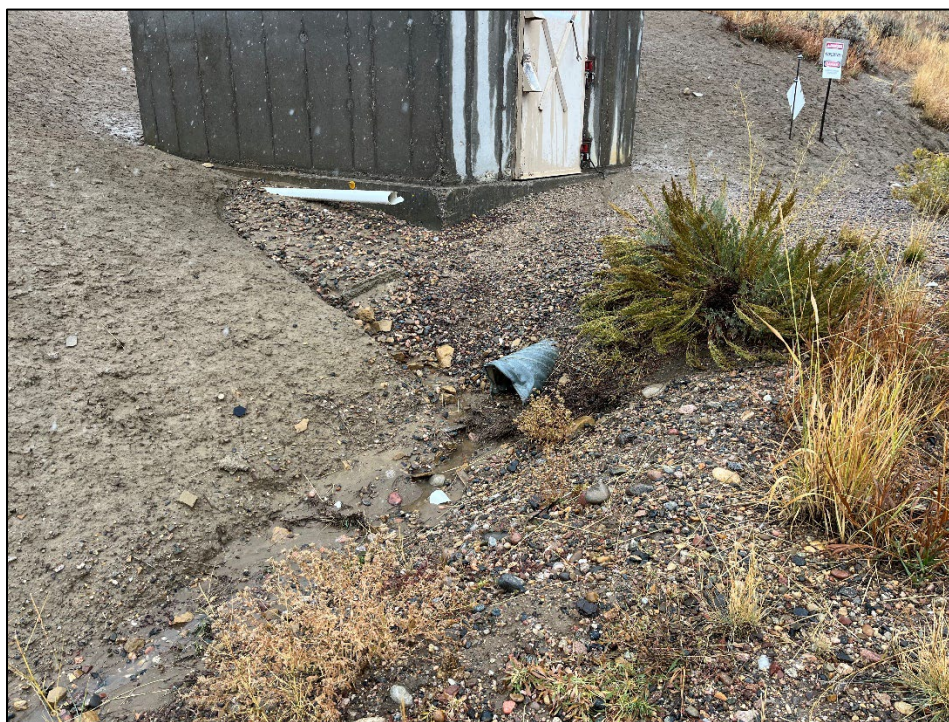
Photo 17: One of two 12" culverts located in the western facility area near the explosives storage bunkers.

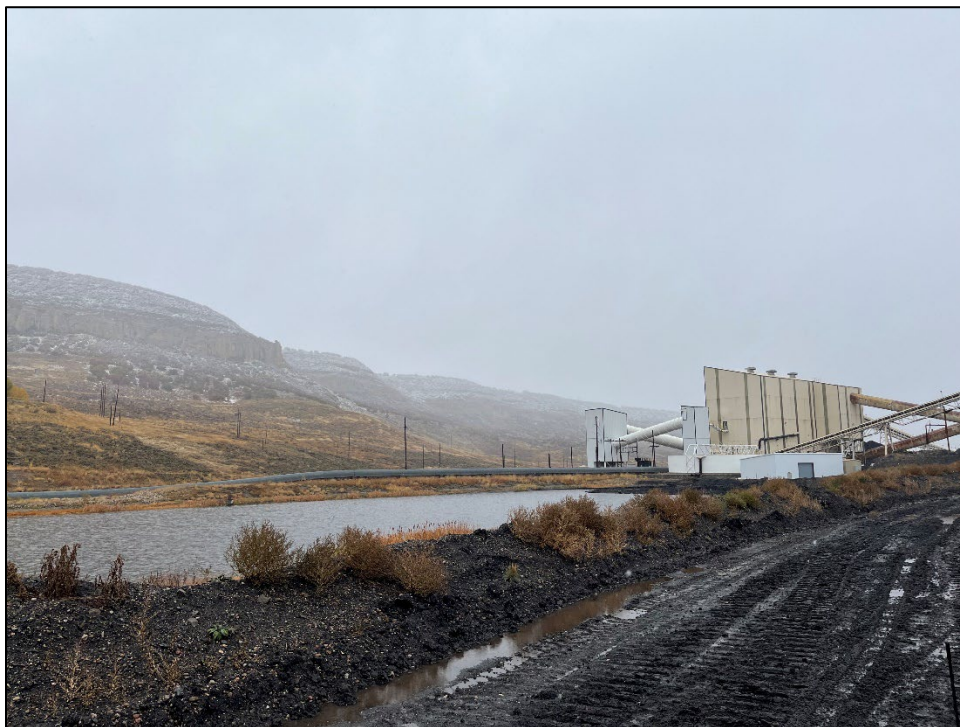
Photo 18: View north of Pond D, the overland belt conveyor, and the stoker loadout facility.

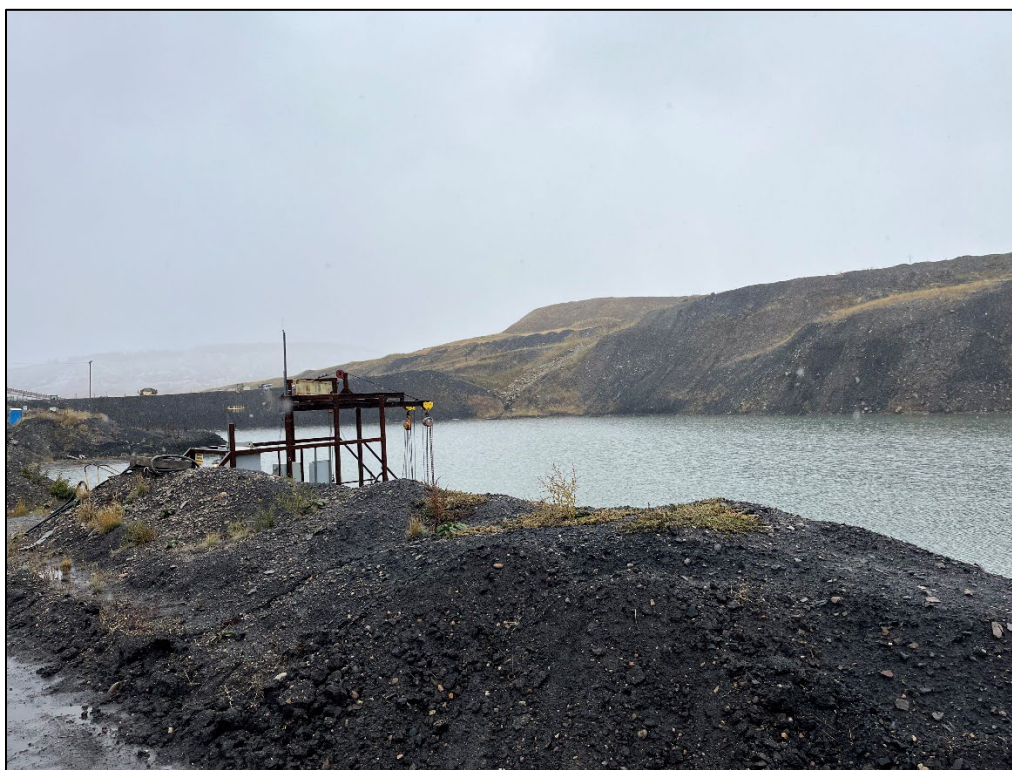
Photo 19: View southeast of the Pit Pond.

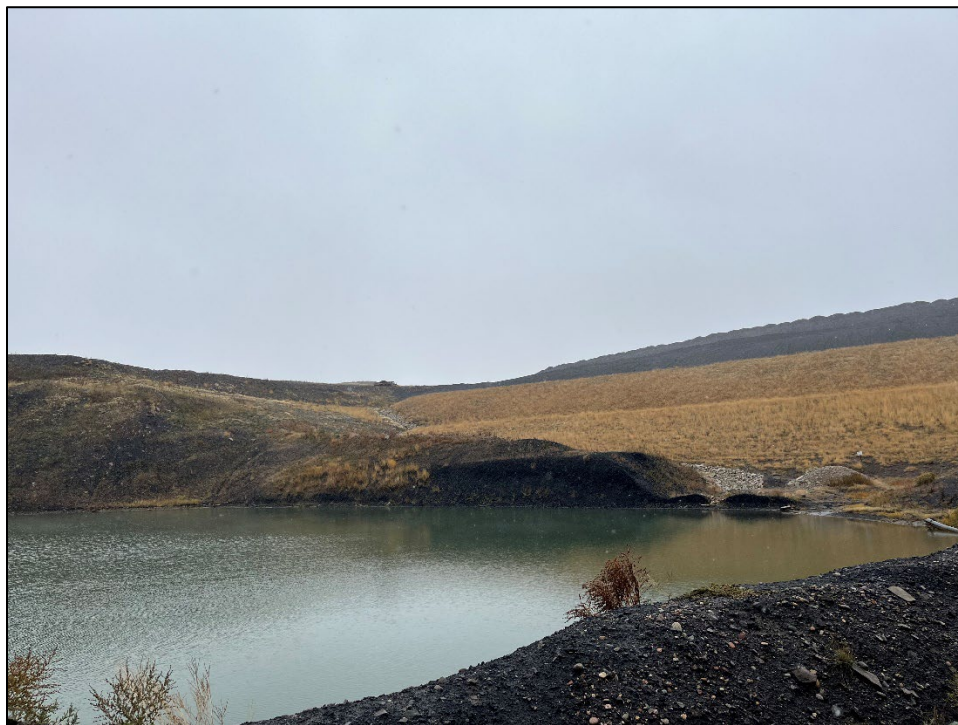
The refuse pile was inspected from below (Photo 20) and from atop the pile (Photo 21). Trucks were actively hauling material at the time of inspection. The pile appeared to be stable and free of any standing water. Construction of lift three is currently underway and will continue throughout the winter season as weather allows. Eventually, this refuse face will be built up to meet the ridge of the adjacent, older refuse pile (Photo 21).

Photo 20: View south of the Pit Pond and refuse pile.

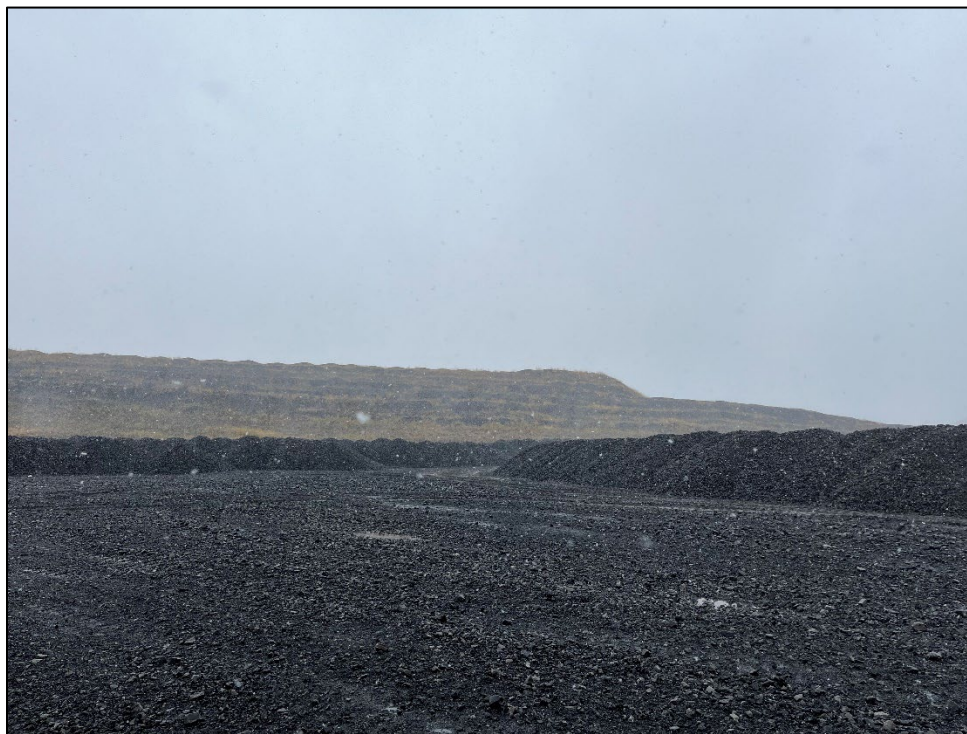
Photo 21: View west from atop the refuse pile, looking towards the older refuse pile ridge which the currently active pile will eventually meet with.

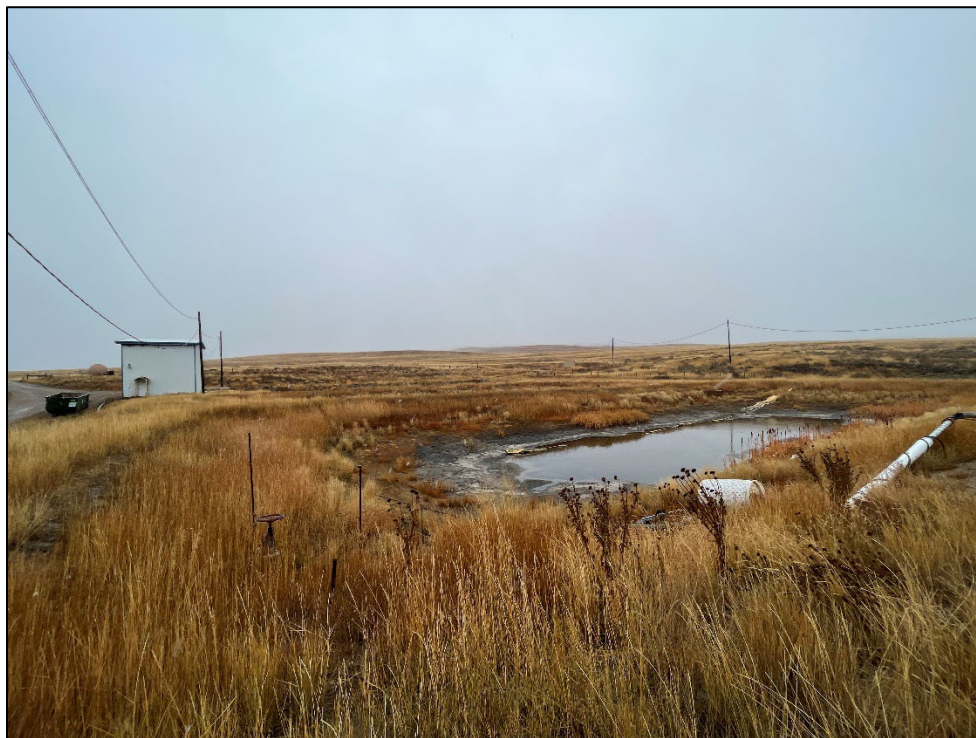
The Fish Creek Borehole area, located northwest of the main facilities area, is a water treatment borehole with three retention ponds. The ponds were inspected for stability and found to be free of erosional features (Photo 22). Water from this area is discharged to Foidel Creek infrequently as water quality is low due to high amounts of iron. The Operator stated that an updated treatment system would need to be installed in this area before water is discharged regularly.

Photo 22: View east of the Fish Creek Borehole, three ponds are used to store and filter water before it is discharged to nearby Foidel Creek.
