MINERALS PROGRAM INSPECTION REPORT
PHONE: (303) 866-3567

MINE NAME: Kues Gravel Pit	MINE/PROSPECTING ID#: M-1983-187	MINERAL: Sand and gravel	COUNTY: Logan
INSPECTION TYPE: Monitoring	WEATHER: Clear	INSP. DATE: August 29, 2023	INSP. TIME: 12:00
OPERATOR: Logan County	OPERATOR REPRESENTATIVE: Jeff Reeves	TYPE OF OPERATION: 112c - Construction Regular Operation	
REASON FOR INSPECTION: Normal I&E Program	BOND CALCULATION TYPE: None	BOND AMOUNT: N/A	
DATE OF COMPLAINT: NA	POST INSP. CONTACTS: None	JOINT INSP. AGENCY: None	
INSPECTOR(S): Nikie Gagnon	INSPECTOR'S SIGNATURE:

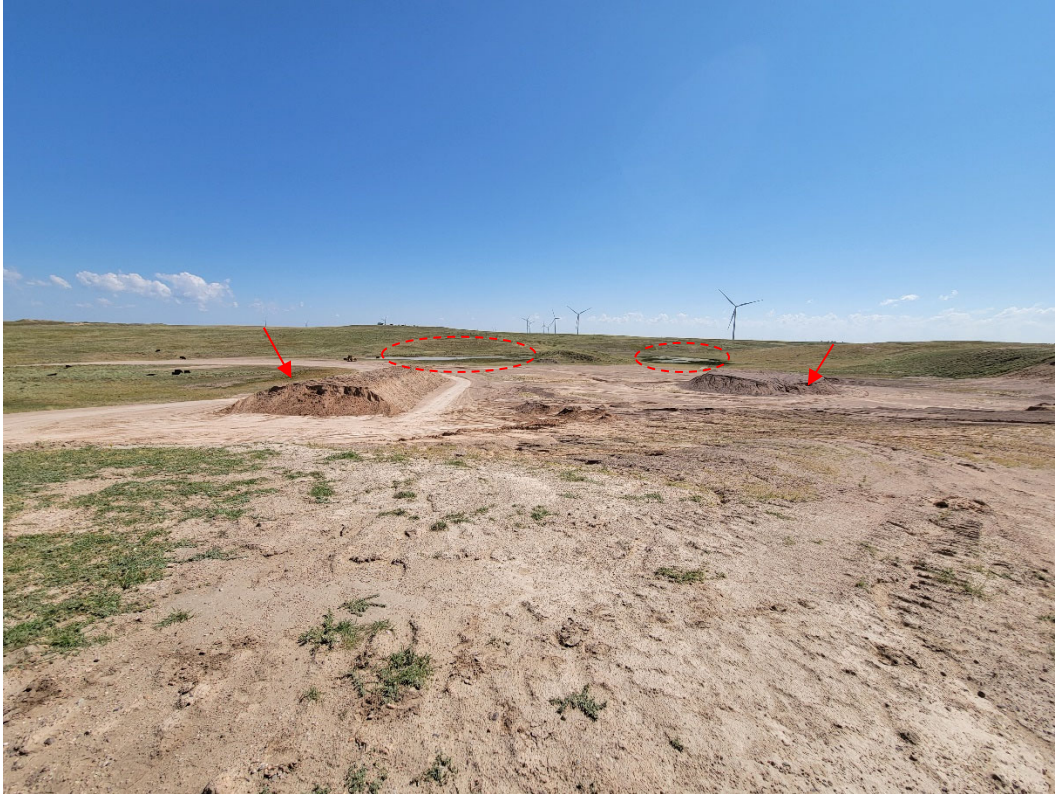
Photo 1: Looking east into the pit from the western highwall. Slopes are 3H:1V and vegetated on the east side of the permit area. Stockpiles of material are located on the pit floor (arrows). Stormwater collection areas circled in background.

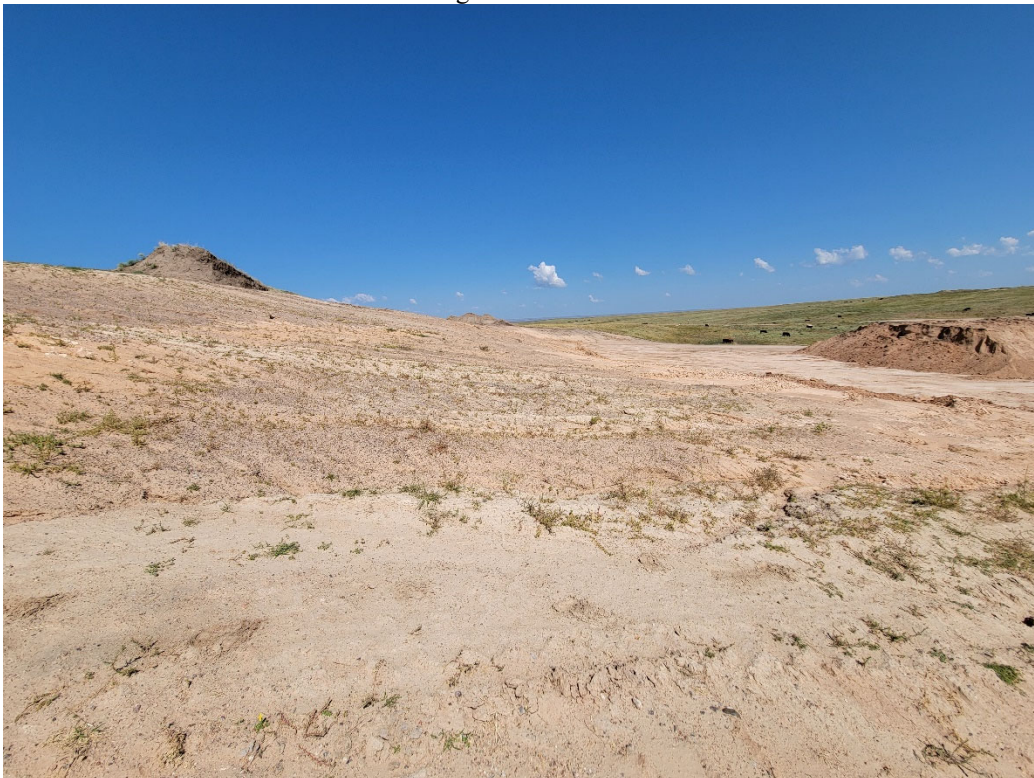
Photo 2: Looking northwest across the slope on the active mine face.

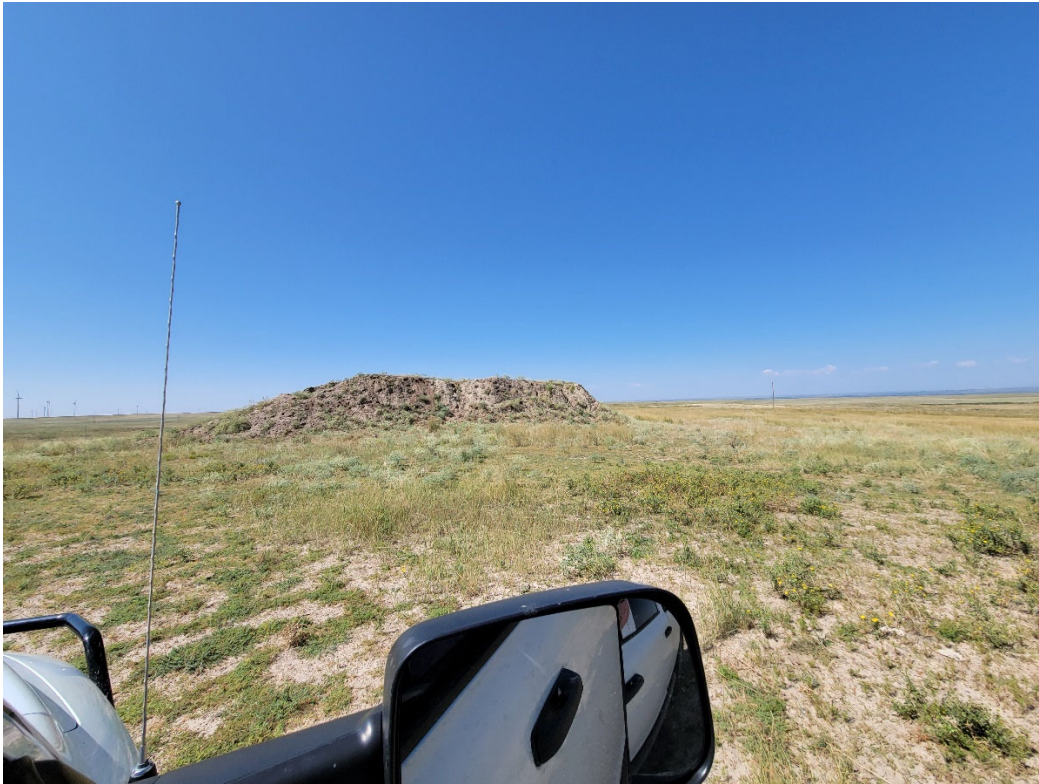
Photo 3: Topsoil stored on the western side of the permit area, above the active mining area.

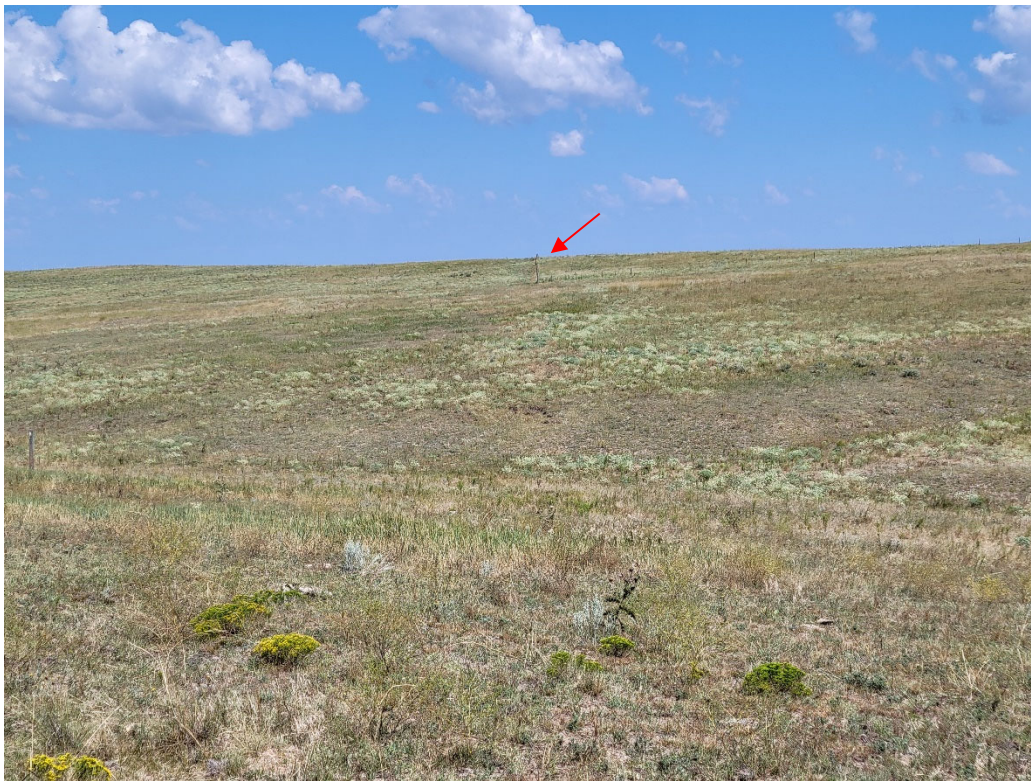
A mine sign was posted in accordance with Rule 3.1.12(1) at the entrance to the pit and the boundaries are marked in the corners with wood and metal posts. A barbed wire fence runs along the eastern and northern boundaries.

Photo 4: Looking north across eastern side of the permit area. Red arrow points to boundary marker.

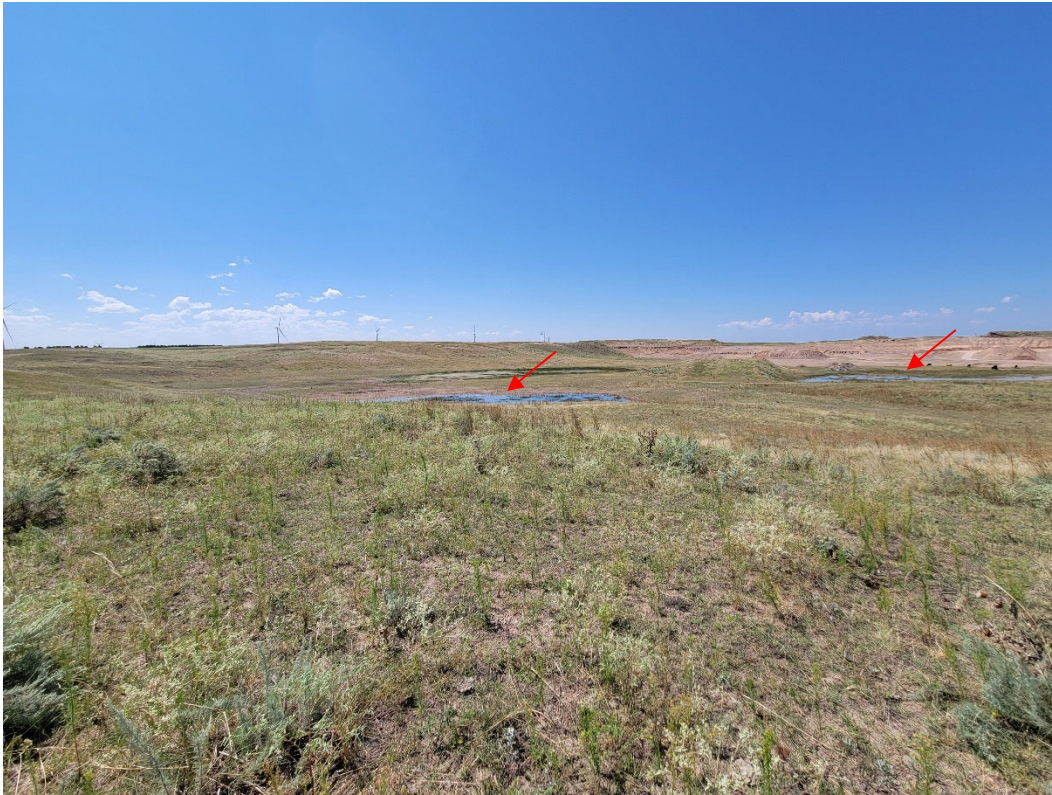
This site was last inspected by DRMS on June 5, 2019. At that time, the inspector noted the pit floor contained several areas of ponding water due to recent rain events. During this inspection, ponded water was observed in a depression in a previously mined area on the east side of the active pit, and in an unmined area on the north side of the permit area. Cattle was observed around the pond on the north side, which is where the ephemeral drainage flows through the parcel. The Division and the Operator discussed options for reworking the site grading or installing stormwater management structures to prevent water accumulation. The Operator should be aware that Rule 3.1.6(1)(a) states "Disturbances to the prevailing hydrologic balance of the affected land and of the surrounding area and to the quantity or quality of water in surface and groundwater systems both during and after the mining operation and during reclamation shall be minimized by measures, including, but not limited to compliance with applicable Colorado water laws and regulations governing injury to existing water rights." The Division of Water Resources (DWR) requires that any stormwater runoff intercepted by this operation that is not diverted or captured in priority must infiltrate into

Photo 5: Looking west from the eastern side of the permit area. Stormwater observed in two areas noted by arrows.

If the Operator decides to install any stormwater management structures, the County will need to submit a Technical Revision to change the mine plan for the site. Otherwise, the Division recommends regrading to prevent future ponding of water, as stated in the approved Mine Plan.

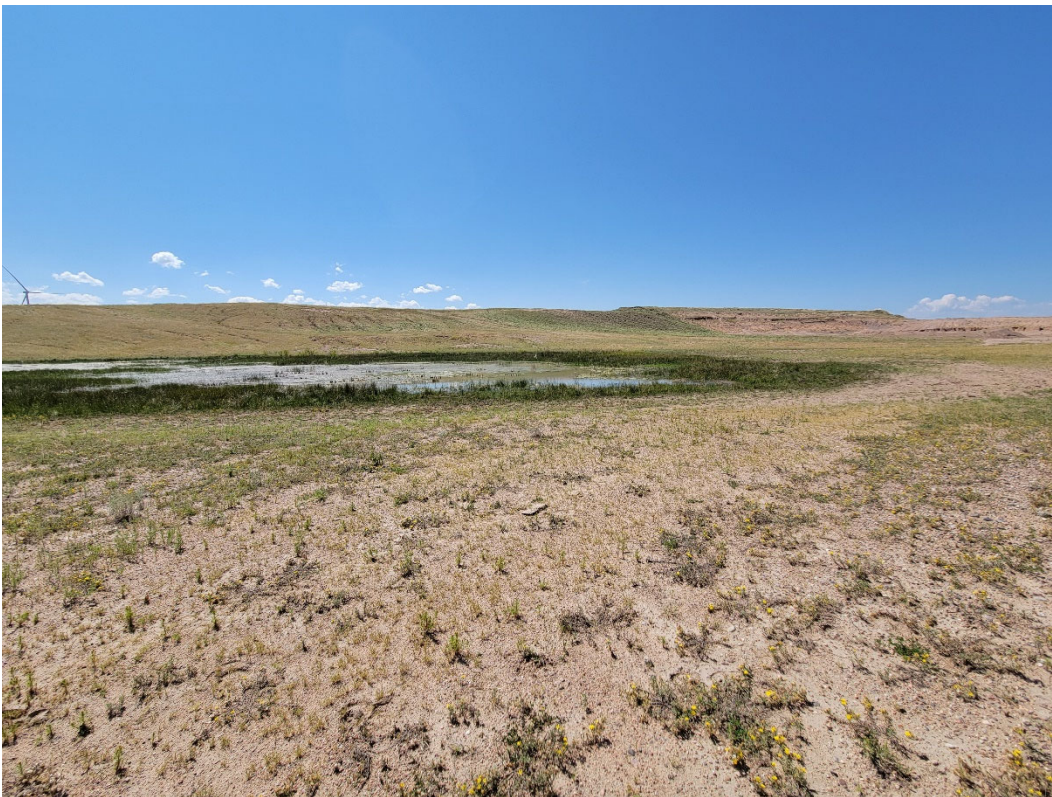
Photo 6: Close-up view of water in depression on the east side of the active pit area.

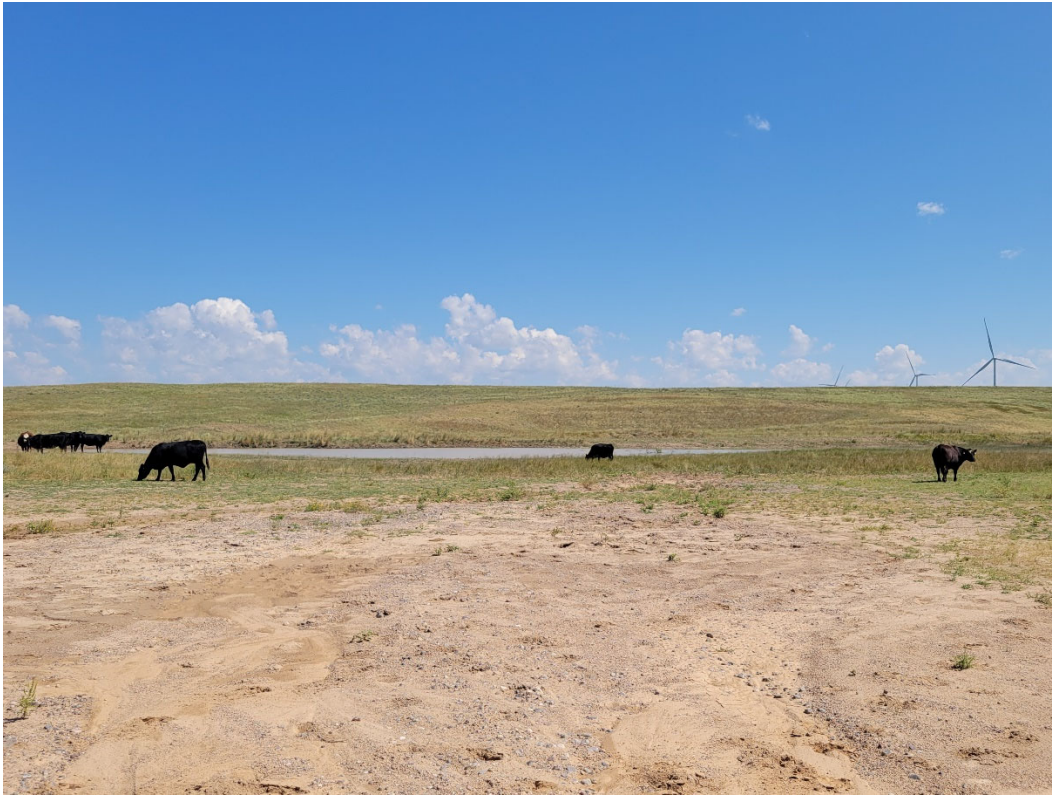
Photo 7: Looking north at pond in an unmined area along the unnamed drainage on the north side of the permit.
