MINERALS PROGRAM INSPECTION REPORT
PHONE: (303) 866-3567

| MINE NAME: Hillyer Pit | MINE/PROSPECTING ID#: M-1982-011 | MINERAL: Sand and gravel | COUNTY: San Juan |
| INSPECTION TYPE: Surety Release Inspection | WEATHER: Clear | INSP. DATE: October 19, 2023 | INSP. TIME: 09:45 |

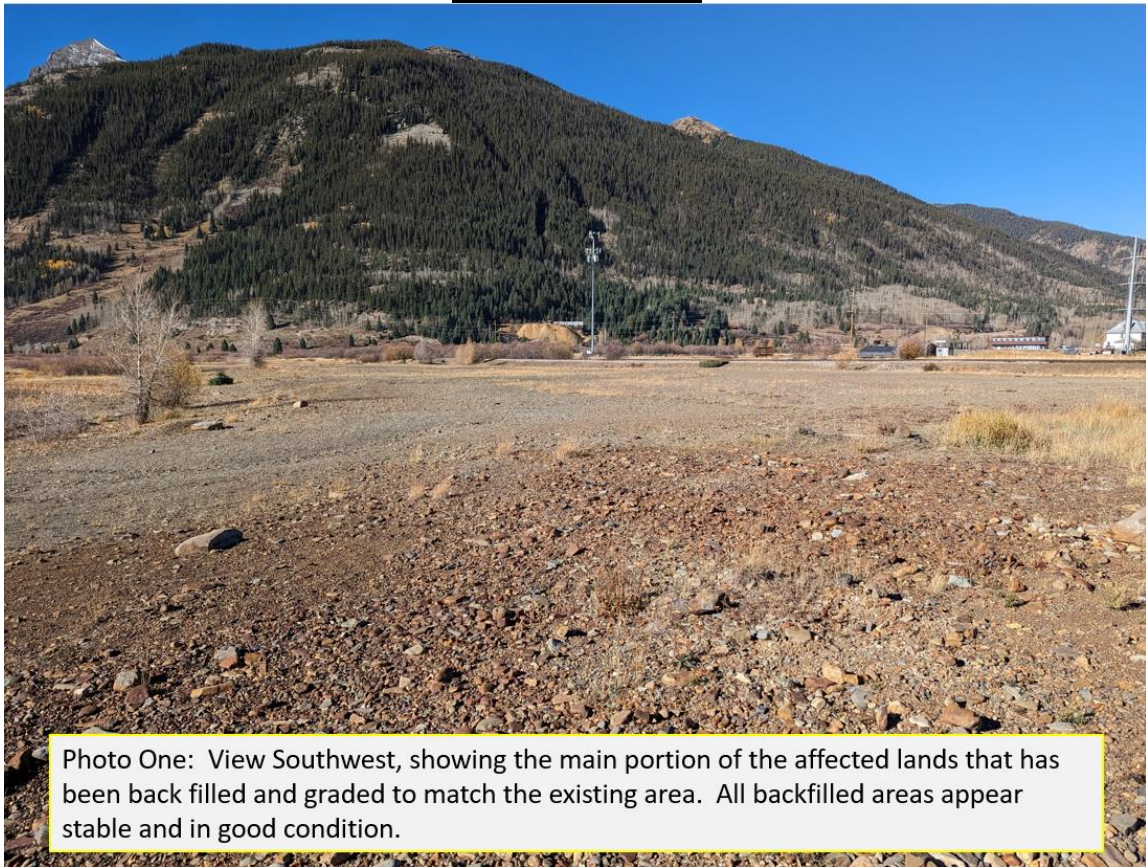
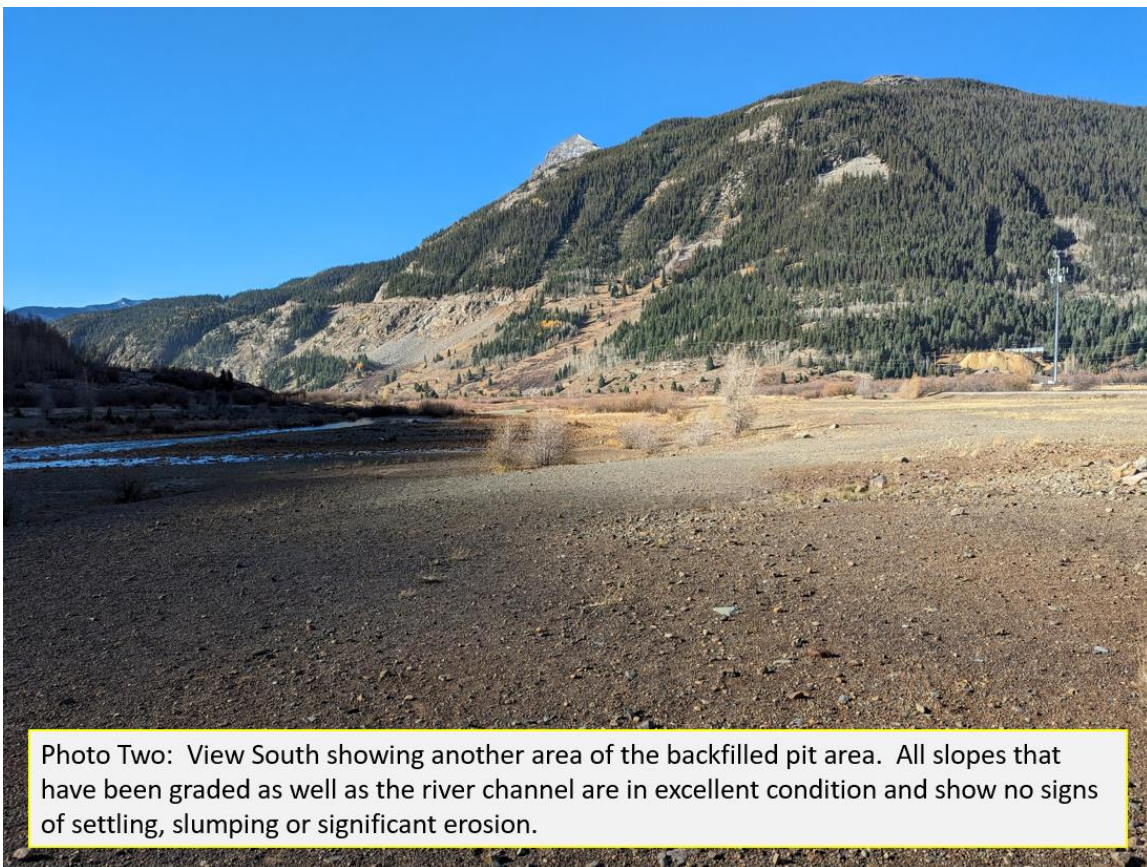
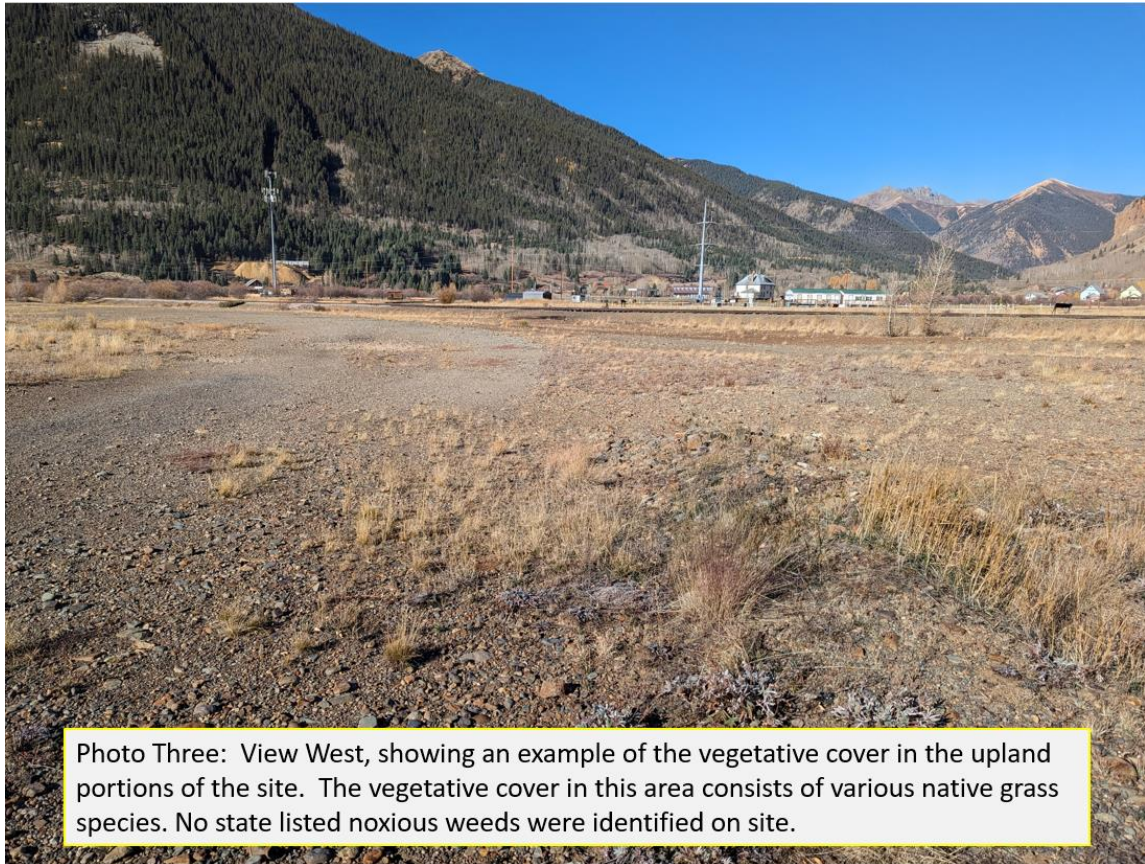
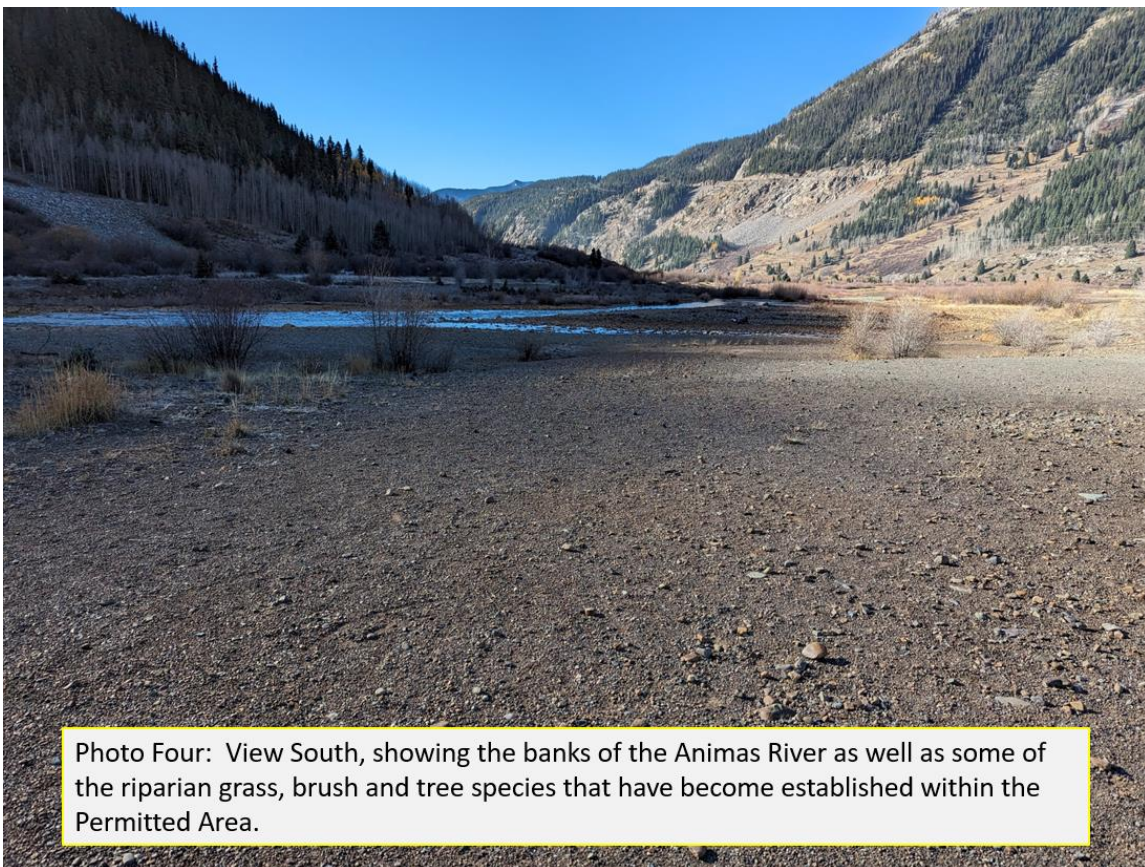
PHOTOGRAPHS

This inspection was conducted in response to the Operator's request for Full and Final Release of the entire permitted area by the Colorado Division of Reclamation, Mining and Safety's Active Mines Program. The Hillyer pit is listed as an active 110(c) operation that has had final reclamation completed for some time. The site is located just south of Silverton at approximately 9260 Feet in Elevation. The site is accessed from 10th street, and is adjacent to the Animas River. No operator representative was present during the inspection and no mining or reclamation related equipment was on site at the time of the inspection. The Division currently holds \$4,280.56 in Financial Warranty for the site. Four Photos accompany this report to illustrate the current site conditions.

The site consists of 7.5 acres that lies along the West banks of the Animas River. Mining was conducted by way of allowing the river to flow into the pit, depositing bedload before waters receded after the runoff. Material would then be removed from the pit and exported from the site. All areas associated with this activity have been backfilled and graded to blend with the existing flood plain. Photos One and Two show the main excavation areas that are backfilled, showing no signs of settling, slumping or erosion. The grading and reclamation work was so successful, that the disturbed areas are almost indiscernible from the surrounding flood plain. According to records kept by the Division, there was no topsoil present on site prior to mining, therefore none was salvaged for reclamation use. Most of the disturbed area consists of various sized gravel and cobble material with some vegetation having taken hold. Areas of native grasses and some riparian species were noted, examples of which can be seen in Photos Three and Four. Areas of riparian brush species including willows and tree saplings were also noted. The vegetative cover is as good as, or better than adjacent undisturbed lands. The banks of the Animas River appear to be behaving in a manner that is consistent with normal river morphology and no evidence of mining activity having an effect on that morphology was noted.
