## MINERALS PROGRAM INSPECTION REPORT

<b>MINE NAME:</b> Stephens Pit	<b>MINE/PROSPECTING ID#:</b> M-1978-146	<b>MINERAL:</b> Sand and gravel	<b>COUNTY:</b> Logan
<b>INSPECTION TYPE:</b> Monitoring	<b>WEATHER:</b> Clear	<b>INSP. DATE:</b> August 29, 2023	<b>INSP. TIME:</b> 10:00
<b>OPERATOR:</b> Logan County	<b>OPERATOR REPRESENTATIVE:</b> Rob Kasper	<b>TYPE OF OPERATION:</b> 112c - Construction Regular Operation	
<b>REASON FOR INSPECTION:</b> Normal I&E Program	<b>BOND CALCULATION TYPE:</b> None	<b>BOND AMOUNT:</b> N/A	
<b>DATE OF COMPLAINT:</b> NA	<b>POST INSP. CONTACTS:</b> None	<b>JOINT INSP. AGENCY:</b> None	
<b>INSPECTOR(S):</b> Nikie Gagnon	<b>INSPECTOR'S SIGNATURE:</b>

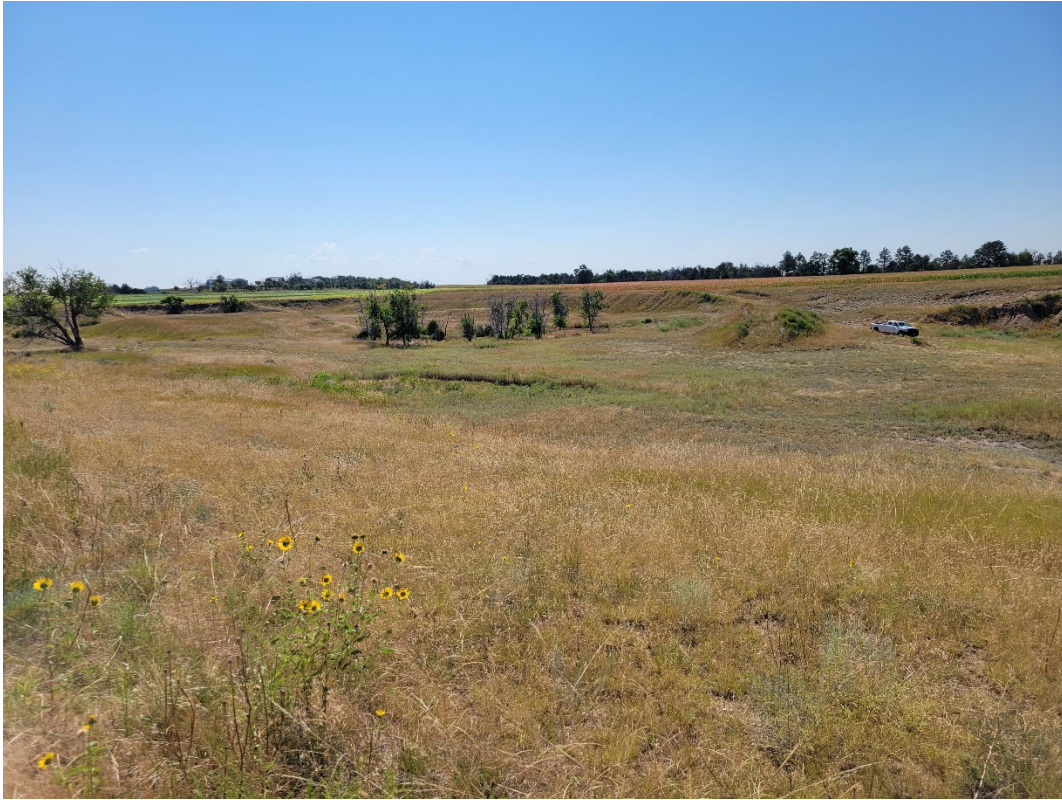
Photo 1: Looking southeast across the excavated pit from the northwestern boundary.

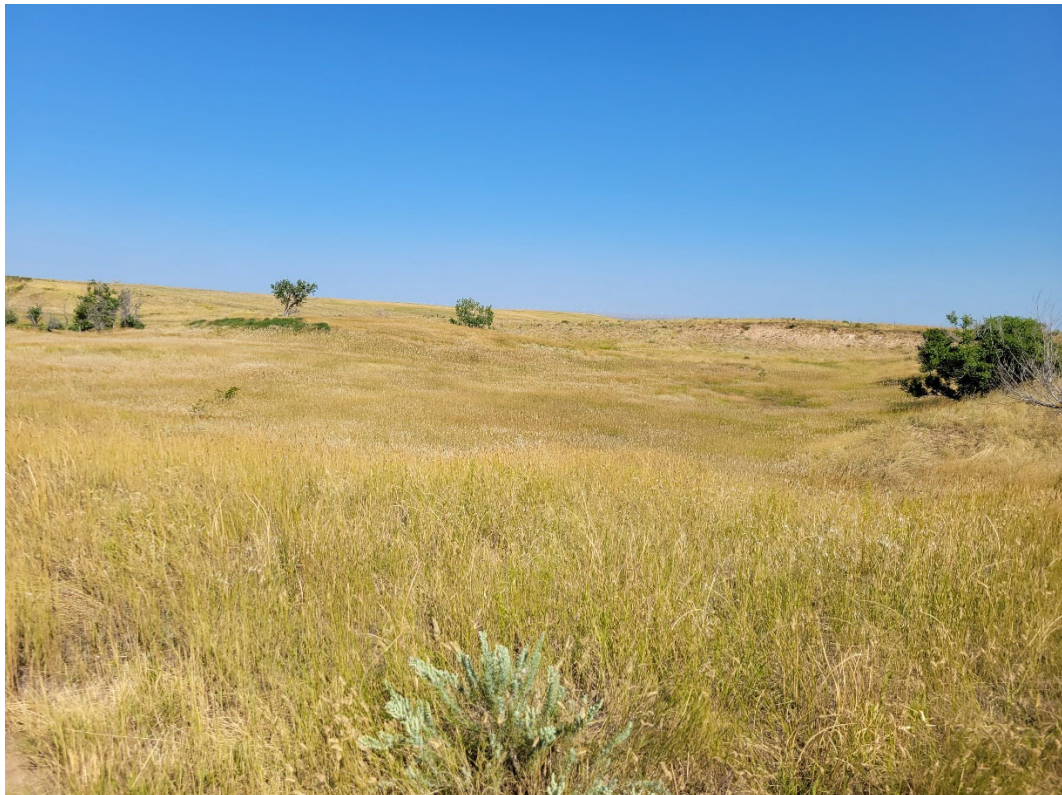
Photo 2: Looking north across the east side of the pit area.

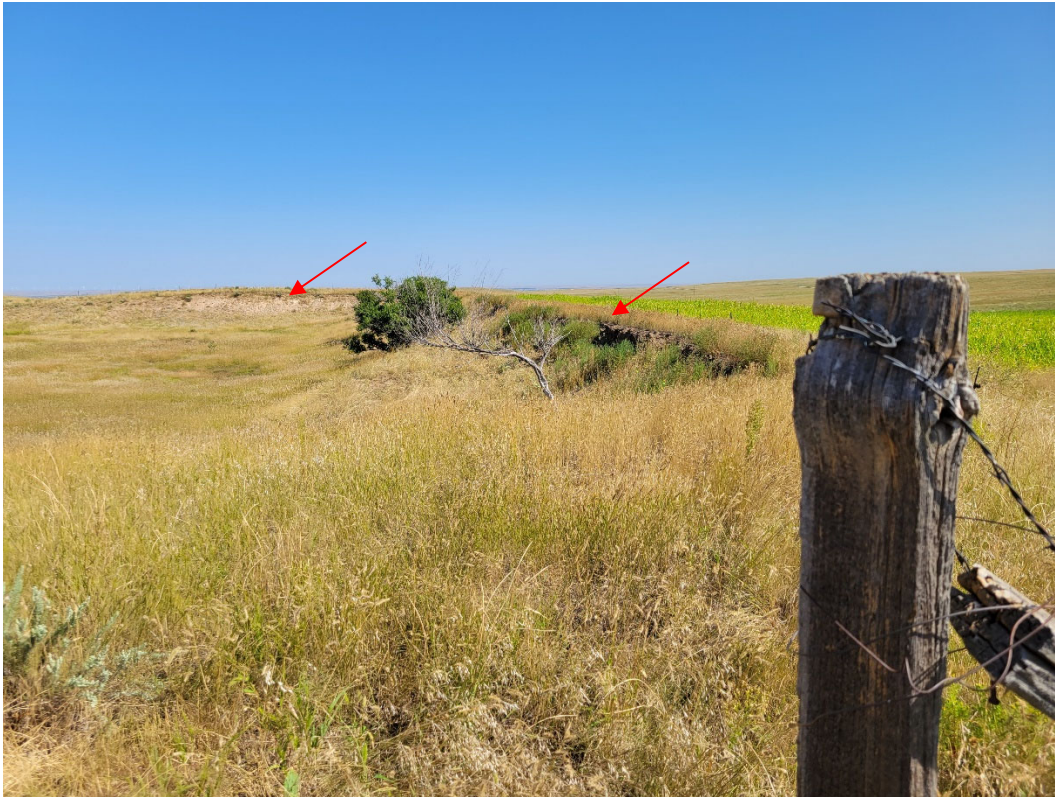
Photo 3: Looking down the eastern boundary. Arrows indicate areas where slopes are steeper than 3H:1V.

The approved Reclamation Plan includes grading all slopes to a maximum gradient of 3H:1V, replacing 5-8 inches of topsoil, drill seeding with the recommended seed mixture, and mulching the site with 2 tons per acre of straw. The approved seed mixture includes the following species in pounds Pure Live Seed (PLS) per acre: side-oats grama (1.8), little bluestem (1.4), prairie sandreed (1.3), yellow sweetclover (0.9), and blue grama (0.6).

Based on review of previous inspection and annual reports, and observations made during this inspection, it appears that neither mining nor reclamation work has occurred recently at this site. The Division reminds Logan County that reclamation must be completed with all reasonable diligence within five (5) years from the date that mining activities ceased as required by C.R.S. 34-32.5-116(4)(q)(I) and Rule 3.1.3.

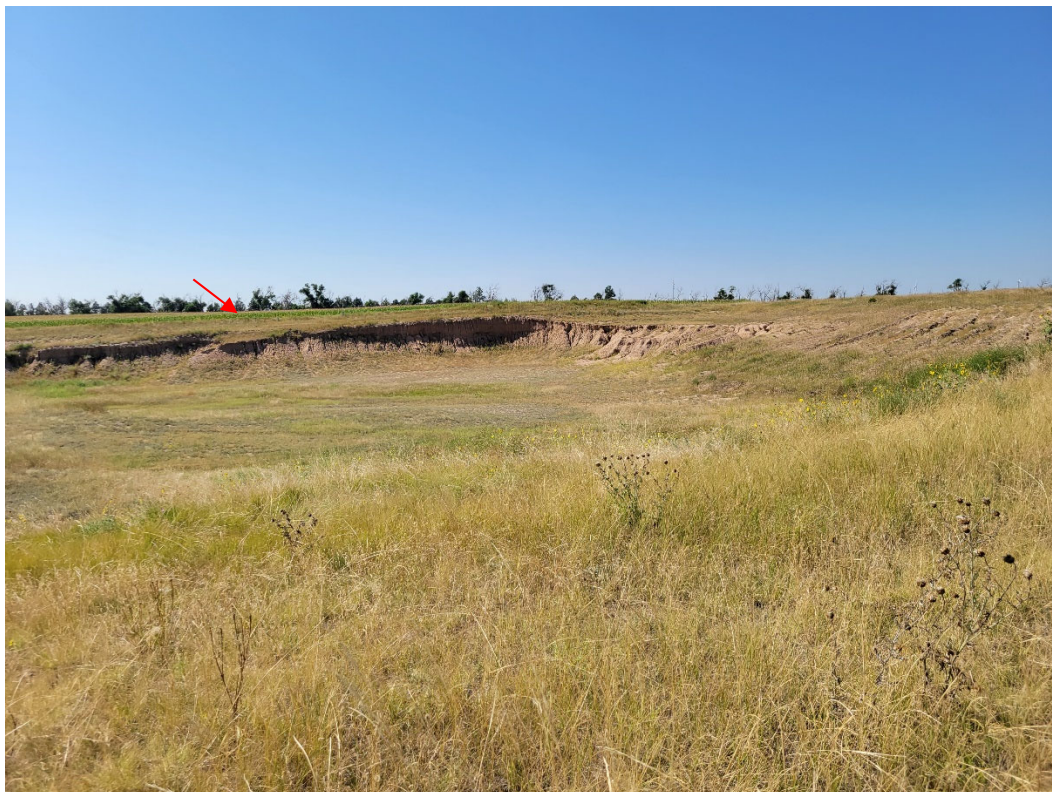
Photo 4: Looking southwest at the highwall in the west side. Undisturbed area within the permit boundary is above the highwall in the background (red arrow).

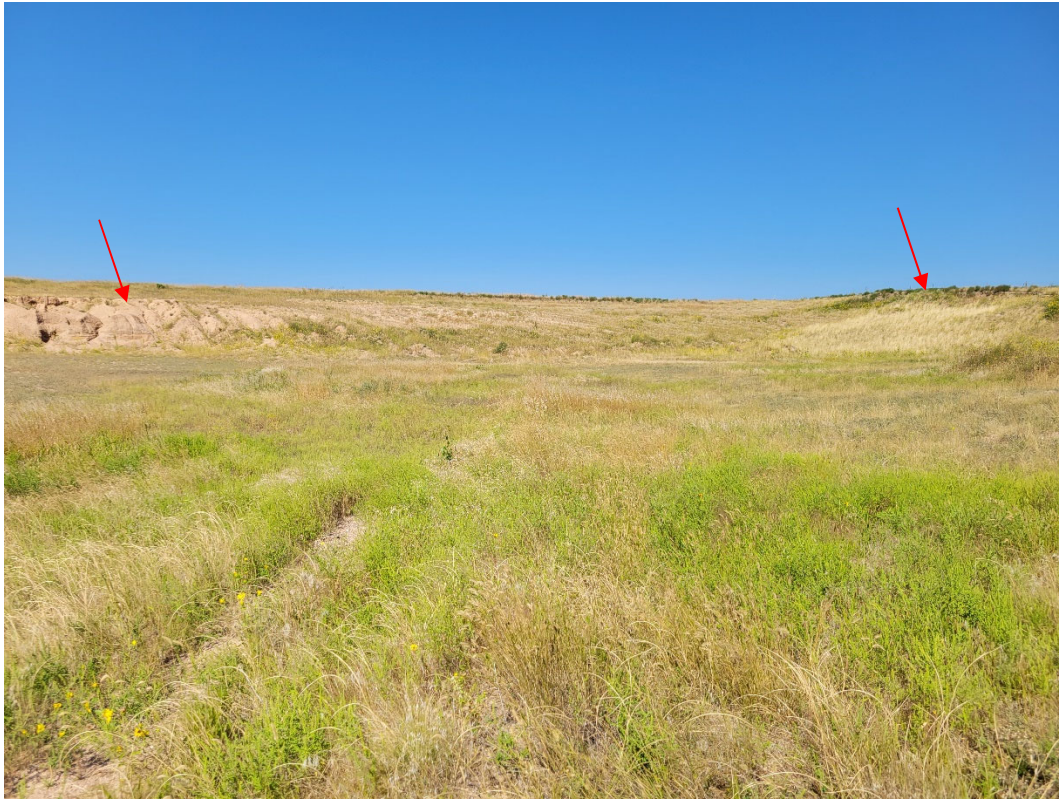
Photo 5: Looking west at the partially graded slope in the west pit. Steeper slopes are on either side of the graded area (red arrows).

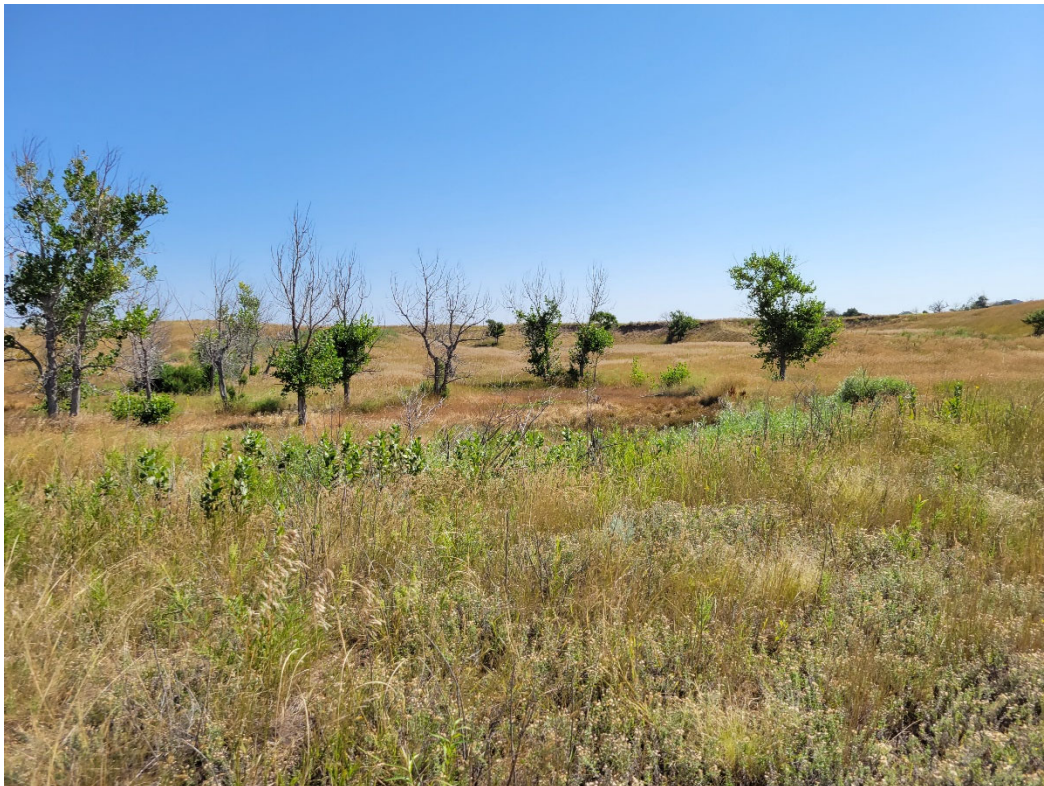
Photo 6: Volunteer cottonwood trees growing in the middle of the excavation.

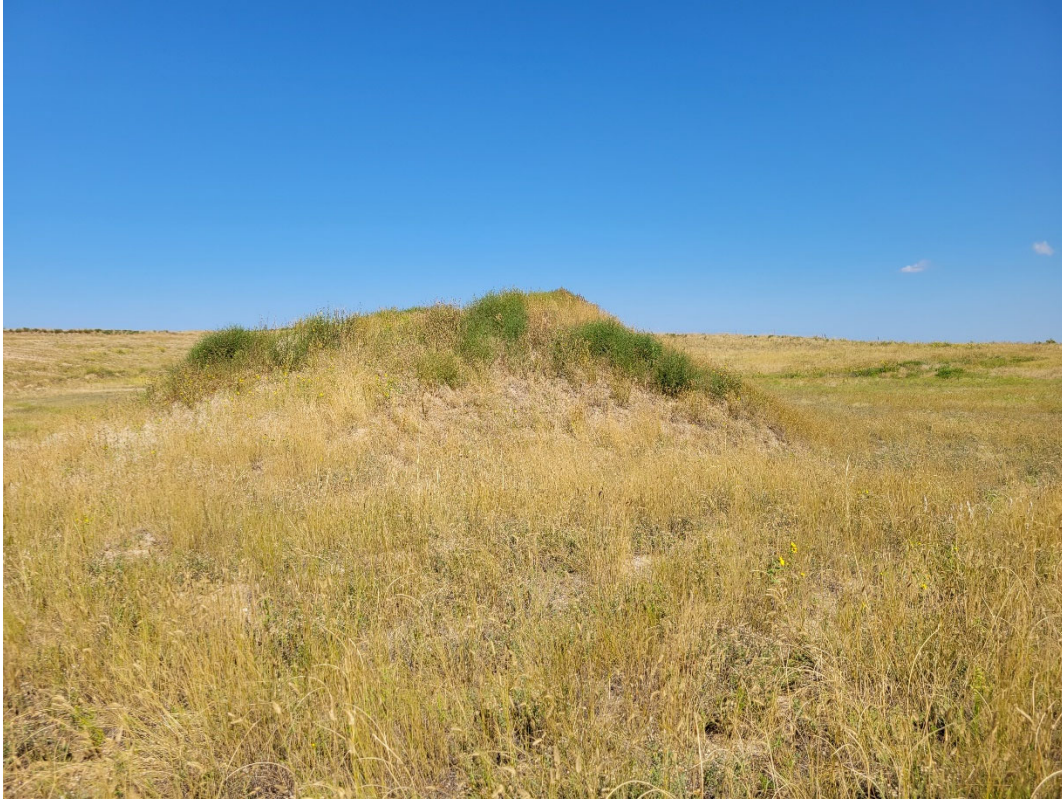
The Division observed two vegetated and stable topsoil stockpiles located on the pit floor.

Photo 7: Looking northwest at topsoil storage on the pit floor.

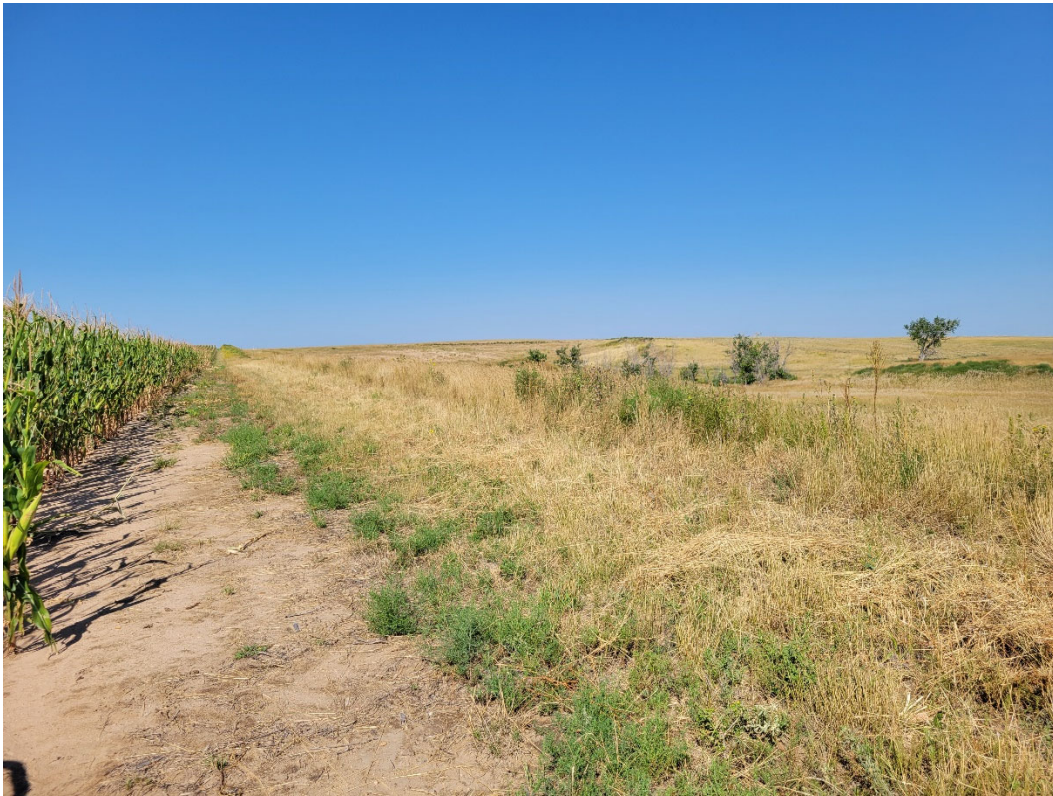
Photo 8: Looking west down the edge of the cornfield that splits the disturbed mining area on the right from the unmined area on the left.

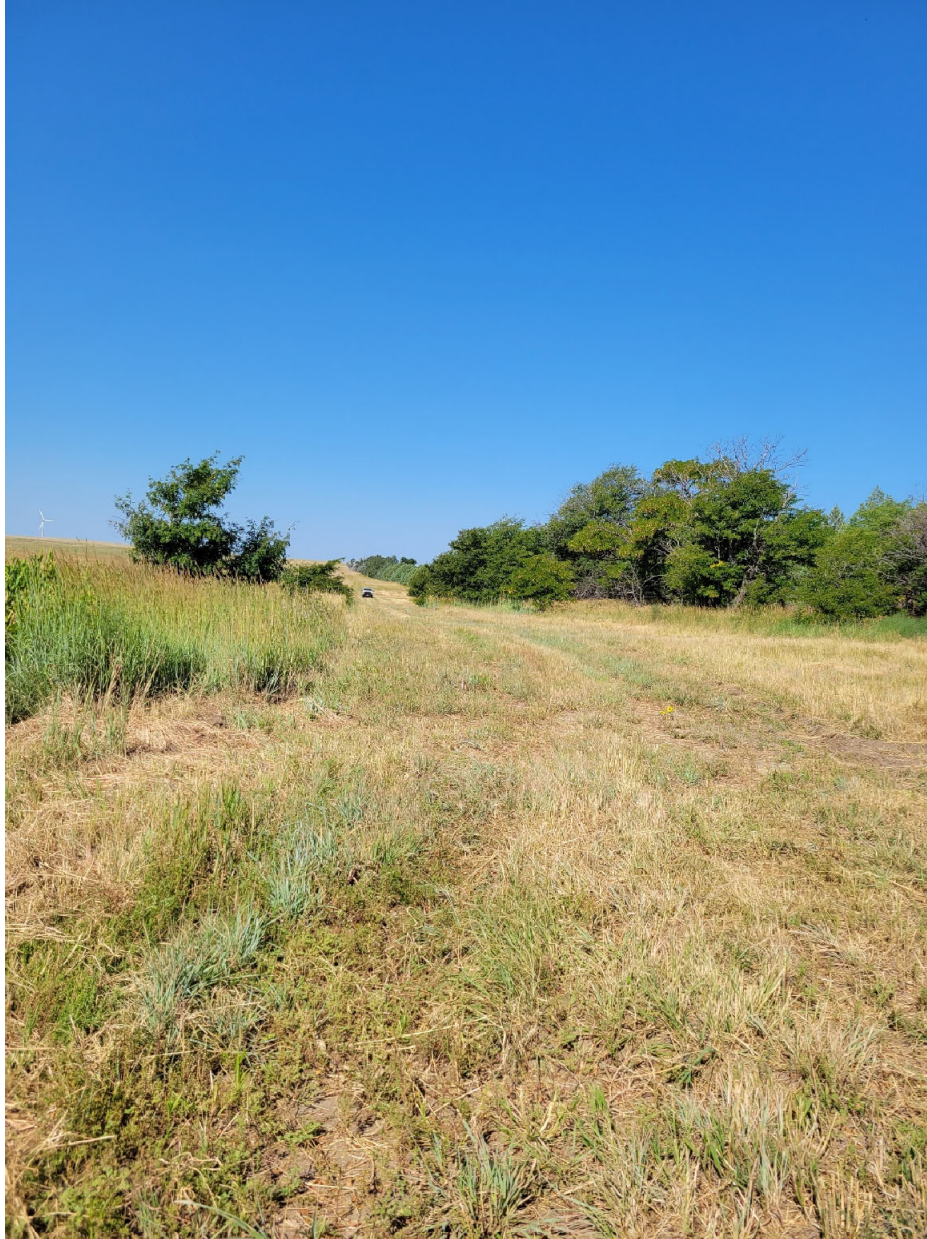
This mine was last inspected on June 5, 2019. At that time, the County informed the Division that they lost access to the State Leased Land on the north side of the mine used for the original access road. The landowner granted Logan County access to the site through the agricultural fields south and east of the pit and, as of this inspection, the County is still using the road to the south to access the mine. The Division reminds the County that if mining starts up again at this site, they will need to submit an amendment application to the Division to widen and upgrade the road to handle truck traffic and add the acreage to the permit area.

Photo 9: Access road from CR93 leading to the mine, outside permit area.

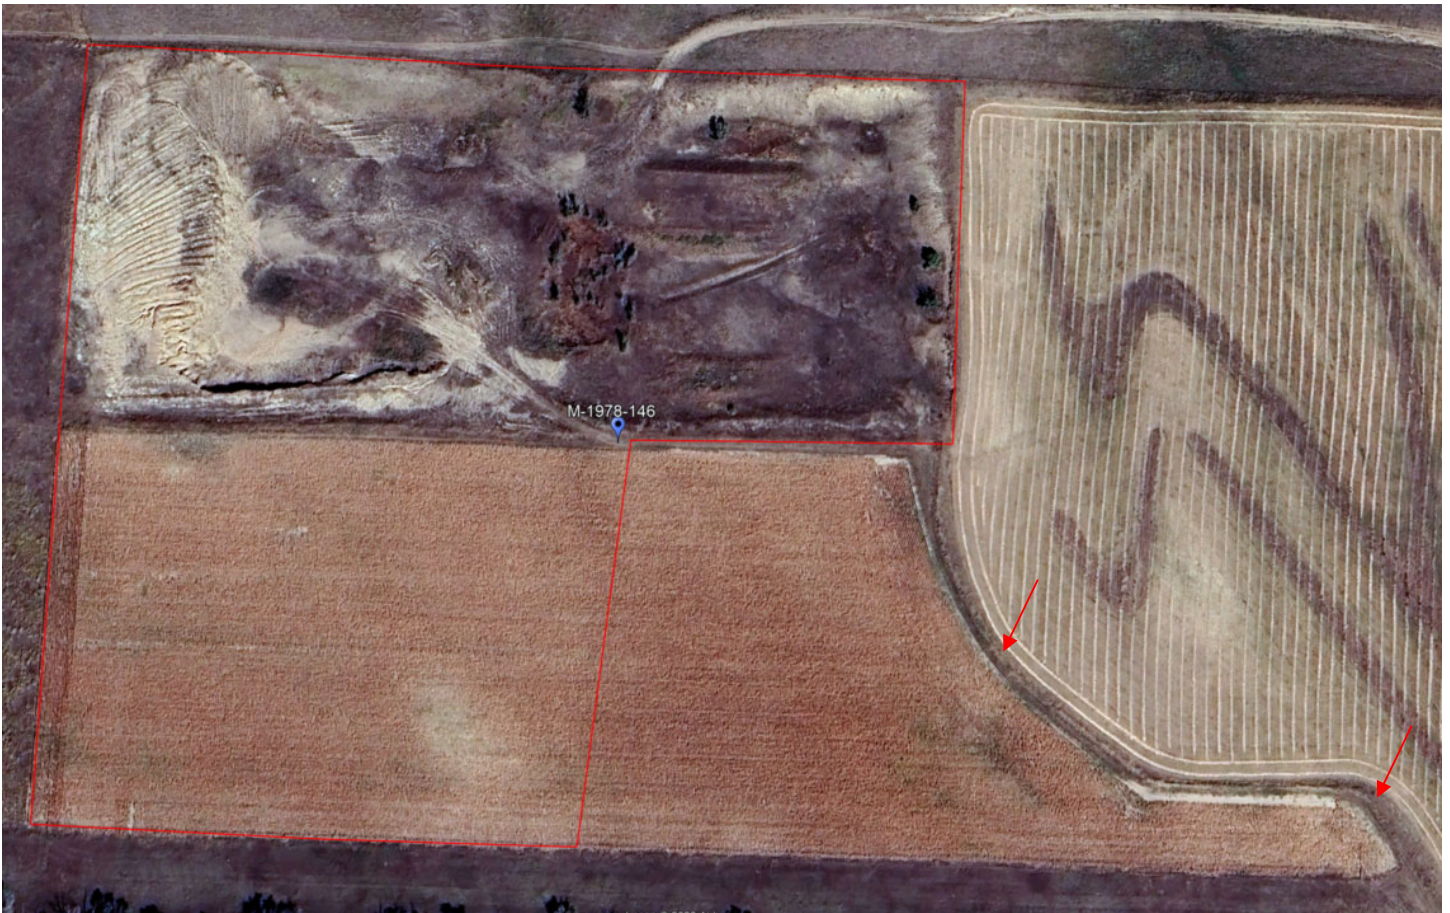
Image 1: Red outline is the approximate permit boundary area. Arrows point to two-track access road to CR93 Google Earth image dated 9/2020.
