**MINERALS PROGRAM INSPECTION REPORT**  
**PHONE: (303) 866-3567**

<b>MINE NAME:</b> Bob Terrill Clay Pit	<b>MINE/PROSPECTING ID#:</b> M-1999-029	<b>MINERAL:</b> Clay (general)	<b>COUNTY:</b> Logan
<b>INSPECTION TYPE:</b> Monitoring	<b>WEATHER:</b> Cloudy	<b>INSP. DATE:</b> August 29, 2023	<b>INSP. TIME:</b> 11:00
<b>OPERATOR:</b> Logan County	<b>OPERATOR REPRESENTATIVE:</b> Jeff Reeves	<b>TYPE OF OPERATION:</b> 110c - Construction Limited Impact	
<b>REASON FOR INSPECTION:</b> Normal I&E Program	<b>BOND CALCULATION TYPE:</b> None	<b>BOND AMOUNT:</b> N/A	
<b>DATE OF COMPLAINT:</b> NA	<b>POST INSP. CONTACTS:</b> None	<b>JOINT INSP. AGENCY:</b> None	
<b>INSPECTOR(S):</b> Nikie Gagnon	<b>INSPECTOR'S SIGNATURE:</b>

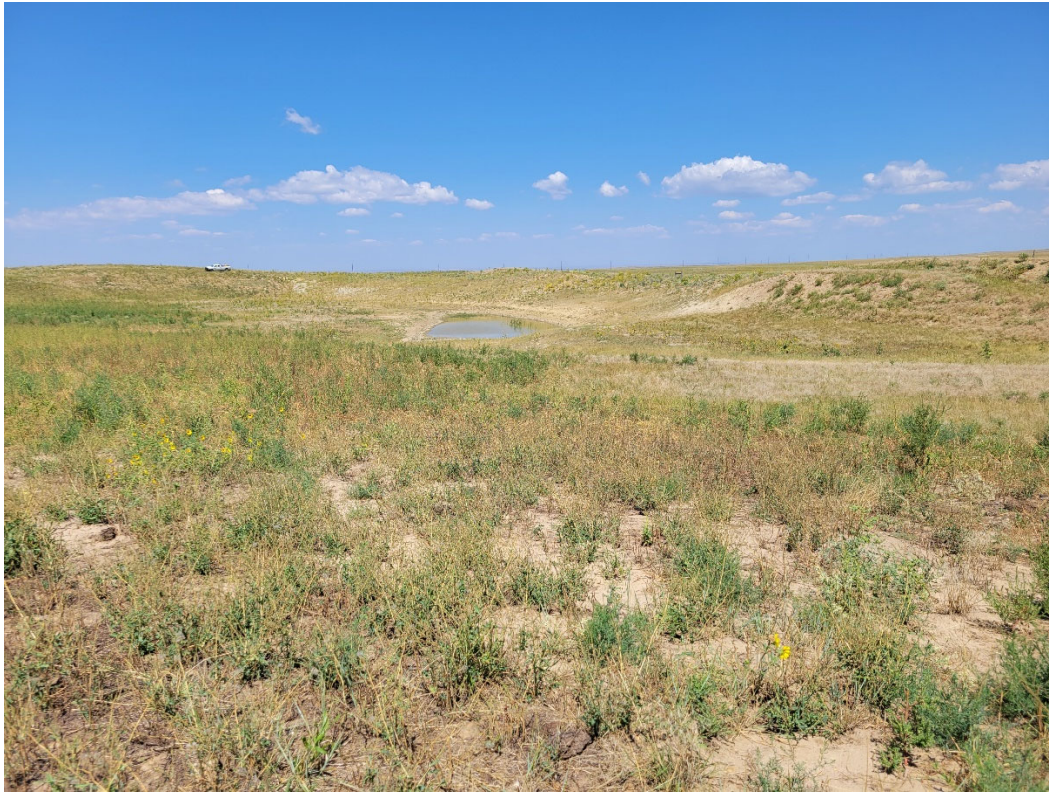
Photo 1: Looking northwest at the excavated pit from the entrance.

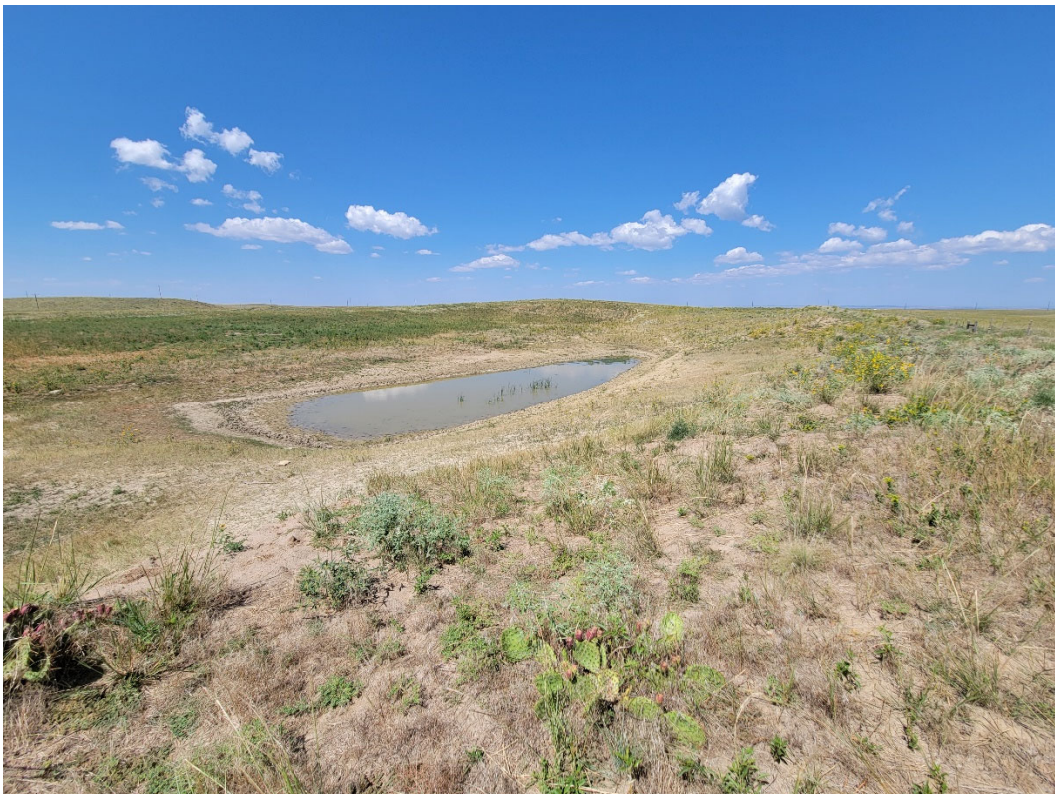
Photo 2: Looking west across the excavated pit from the eastern pit wall.

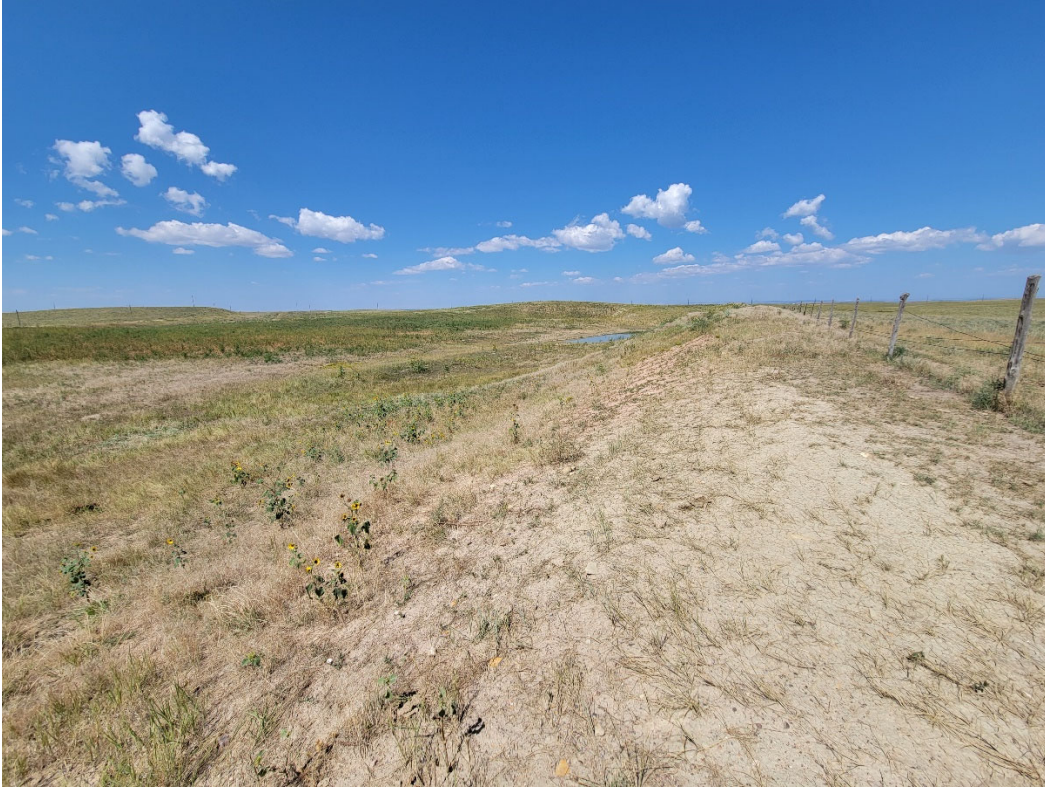
During the last inspection on February 12, 2019, the Operator stated the County planned to reclaim the mine that year. Based on observations during this inspection, reclamation is not complete. According to the approved reclamation plan, all slopes will be graded to 3H:1V, and 18 inches of overburden and 5 inches of topsoil will be replaced, and the site will be seeded with a rangeland seed mixture. The Division observed slopes steeper than 3H:1 around the excavated pit and overburden is still stockpiled on the northwestern side. Mr. Reeves indicated they planned to bring in the 5 inches of topsoil after grading is complete. The Division reminds Logan County that reclamation must be completed with all reasonable diligence within five (5) years from the date that mining activities ceased as required by C.R.S. 34-32.5-116(4)(q)(I) and Rule 3.1.3.

Photo 3: Looking north along the pit wall that is close to the permit boundary on the east side of the permit area. The slopes are steeper than 3H:1H here.

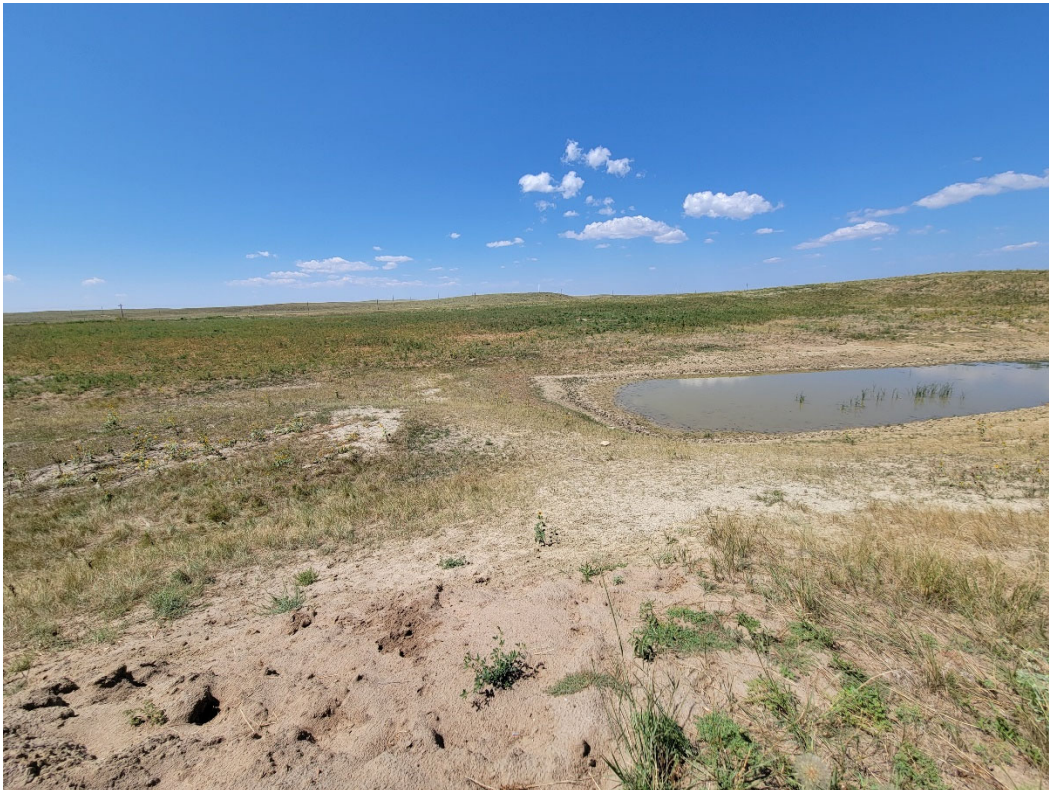
Additionally, ponded stormwater was observed in the middle of the pit floor. Mr. Reeves stated that this pit is typically dry however, Logan County received higher than average precipitation this year. The County plans to regrade the pit and side slopes to create positive drainage away from the center. The Division reminds the Operator that the Division of Water Resources (DWR) requires that any stormwater runoff intercepted by this operation that is not diverted or captured in priority must infiltrate into the ground or be released to the stream system within 72 hours; otherwise the operator will need to make replacements for evaporation through a substitute water supply plan approved by DWR or a plan for augmentation decreed by the water court.

Photo 4: Stormwater ponded in a depression in the center of the excavated pit.

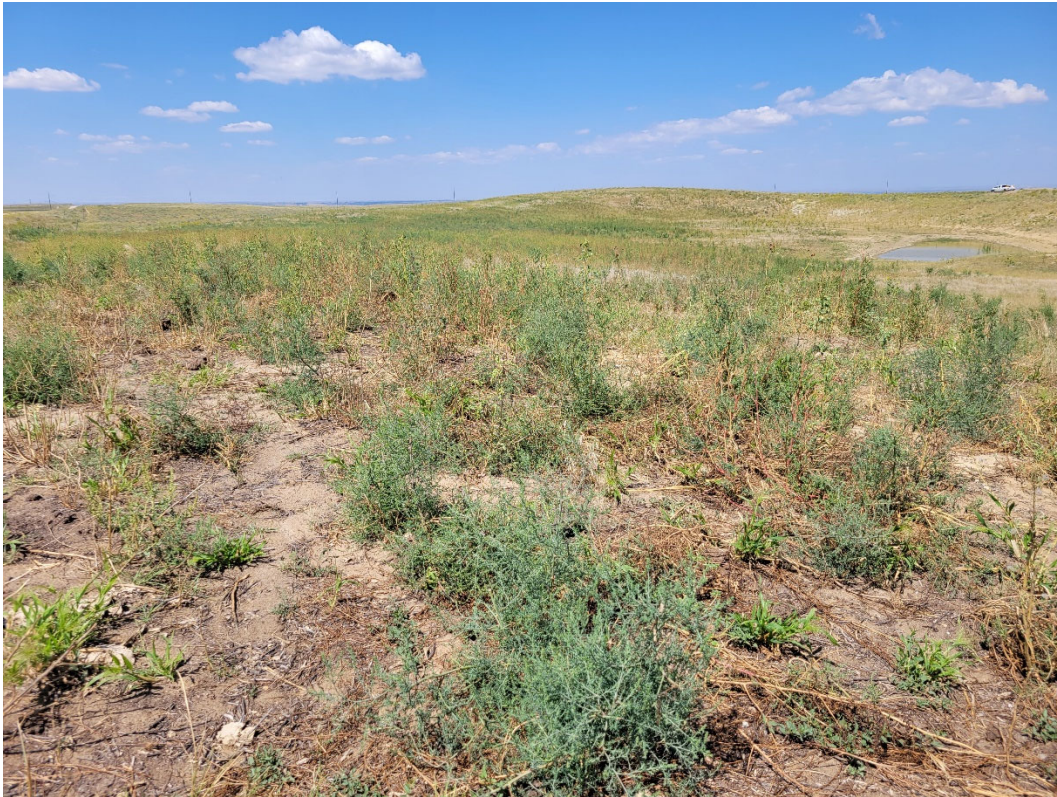
Annual and perennial weeds, primarily Russian thistle and field bindweed (a class C listed species) were observed at the site. Mr. Reeves stated during this inspection that the County planned to conduct weed control across the site this month. The Division reminds the Operator that per Rule 3.1.10(6), "methods of weed control shall be employed for all prohibited noxious weed species, and whenever invasion of a reclaimed area by other weed species seriously threatens the continued development of the desired vegetation. Weed control methods shall also be used whenever the inhabitation of the reclaimed area by weeds threaten further spread of serious weed pests to nearby areas."

Photo 5: Russian thistle noted on the south and west sides of the excavated pit.

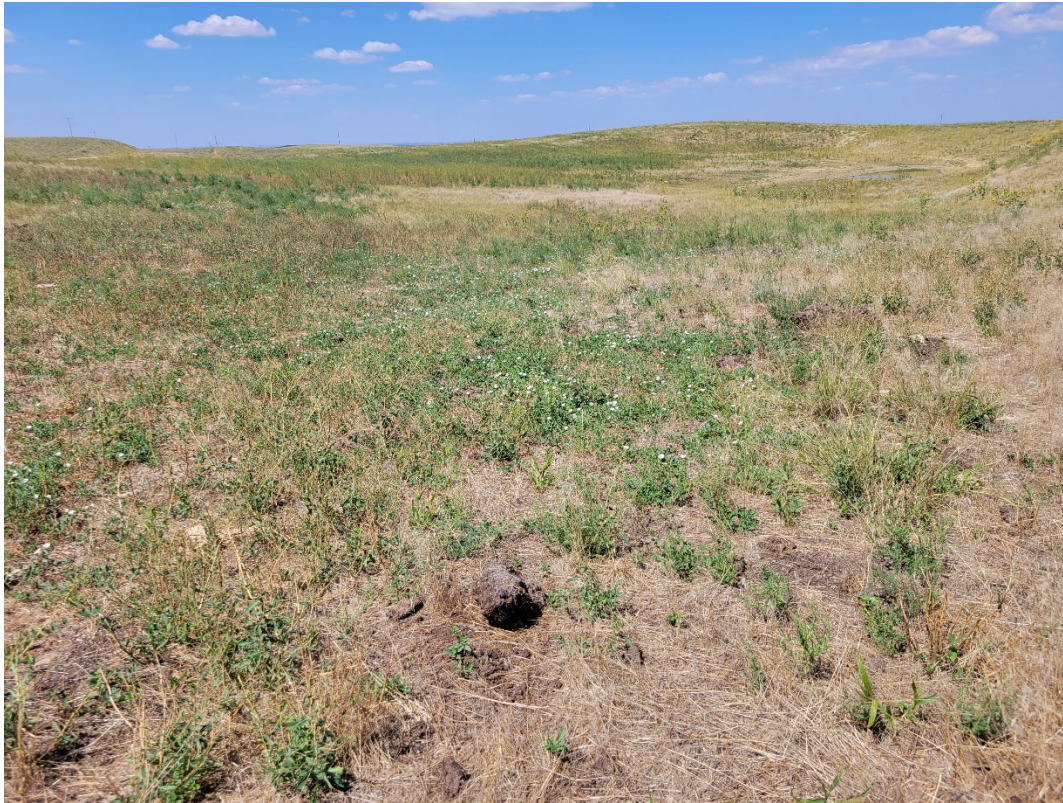
Photo 6: Field bindweed observed south of the excavated pit and near the entrance.

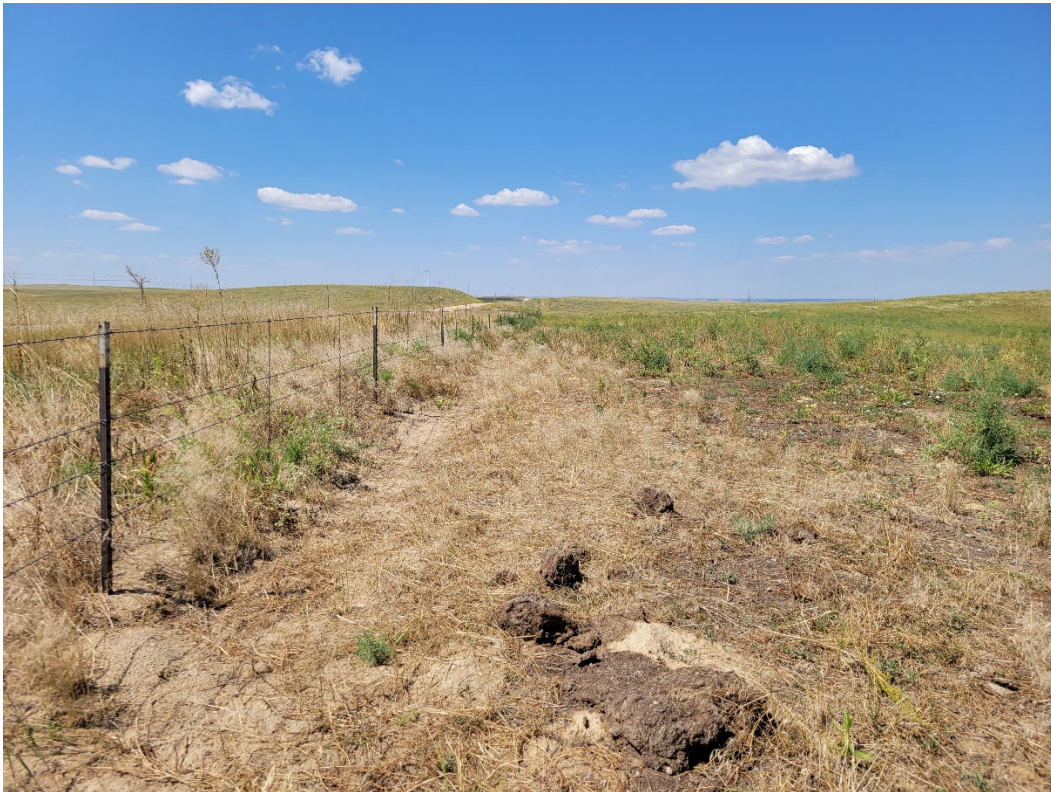
A mine sign was posted in accordance with Rule 3.1.12(1) at the entrance to the pit and the boundaries are marked in the corners with wood and metal posts. A barbed wire fence runs around the boundary of the permit area.

Photo 6: Looking west along the southern permit boundary. A barbed wire fence marks the perimeter of the permit area.

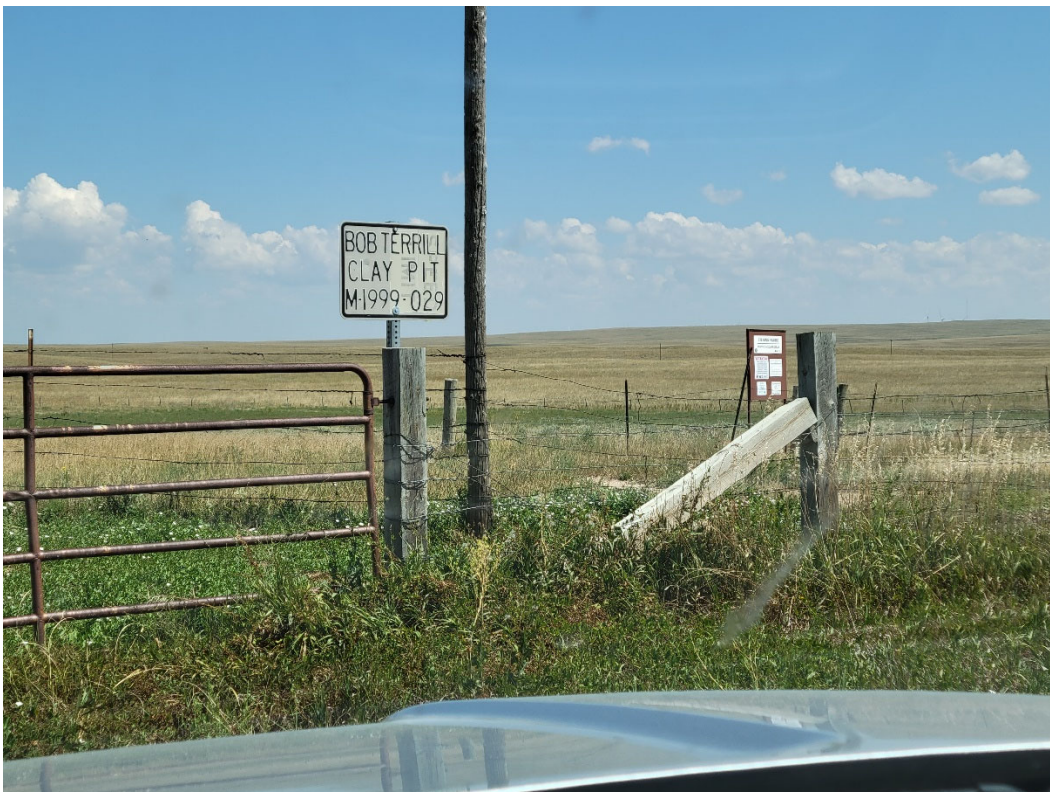
Photo 6: Mine sign and gate at the entrance to the pit.
