Bond Release Inspection Report, SL-03, Hayden Gulch Loadout, C-1992-081

PERMIT INFORMATION

INSPECTION INFORMATION

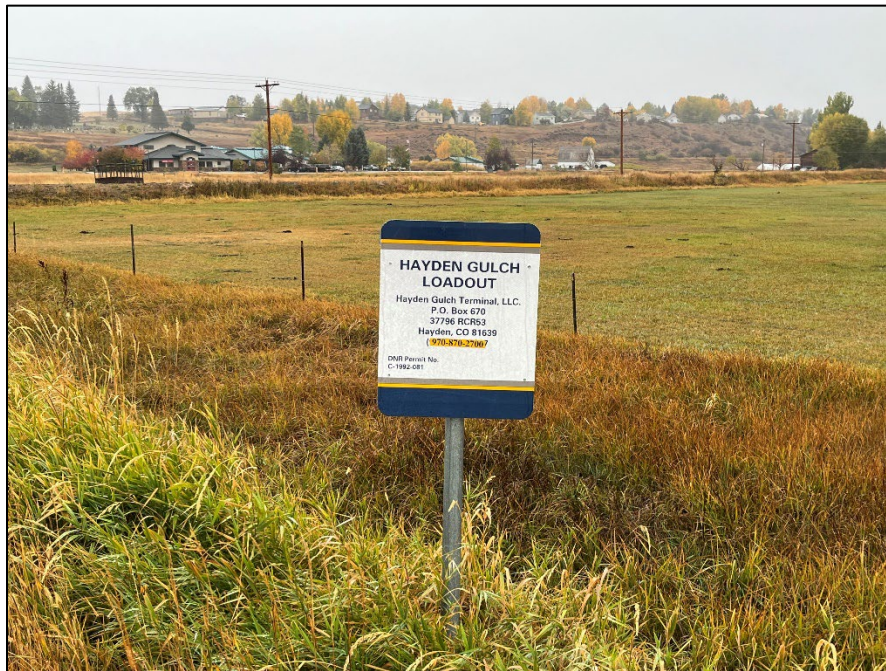
Mine identification markers were observed at the western entrance to the unreleased TAHR and adjacent to the unreleased agricultural section north and south of Hwy 40 (Photos 1 and 5). All topsoil piles, except for Topsoil Pile 2 (Photo 8), had appropriate signage denoting the piles as topsoil piles. This signage was in the form of either a metal sign or a plastic, red marker.

Photo 1: Mine sign located just off Highway 40.

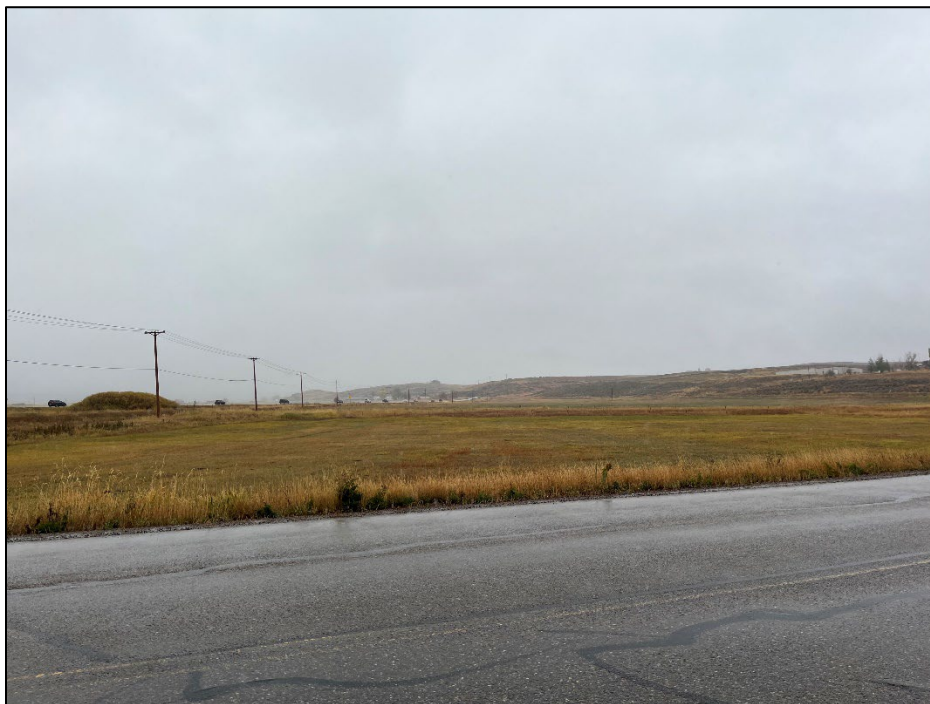
If SL-3 is approved, the only remaining unreleased area at HGLO will be 6.8 acres, 2.3 of which are disturbed. This disturbed area consists of a vegetated hay field (Photo 2).

Photo 2: View east of unreleased hay fields area.

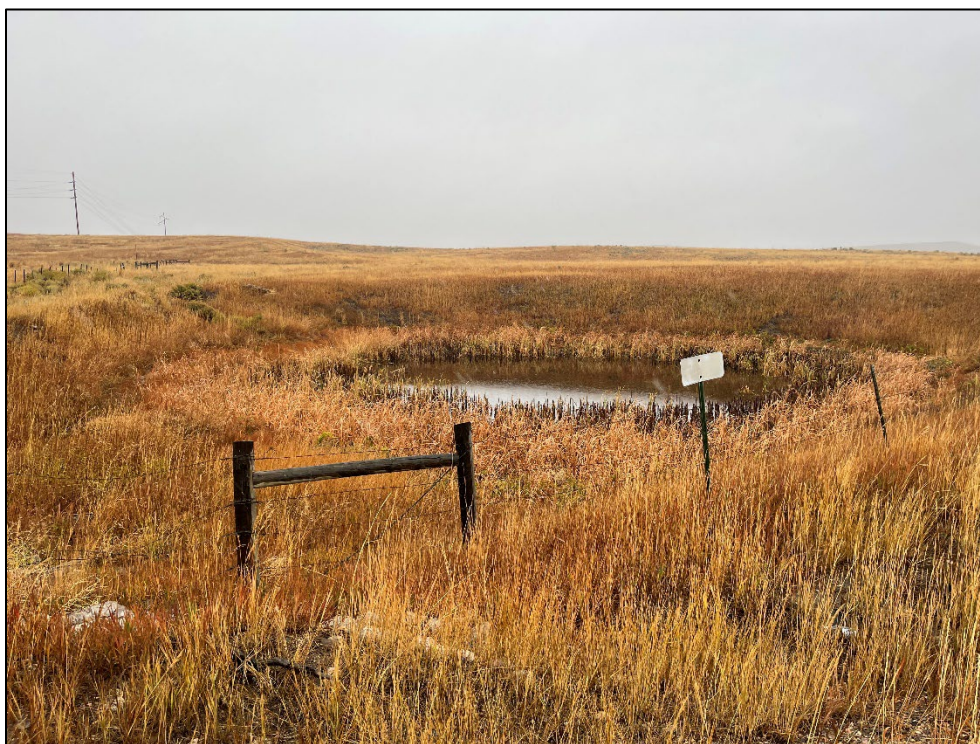
Truck Loop Pond 001, accessed from the northern side of the unreleased TAHR, was partially full and functioning properly (Photo 3). The banks were well vegetated and stable.

Photo 3: View north of Truck Loop Pond 001.

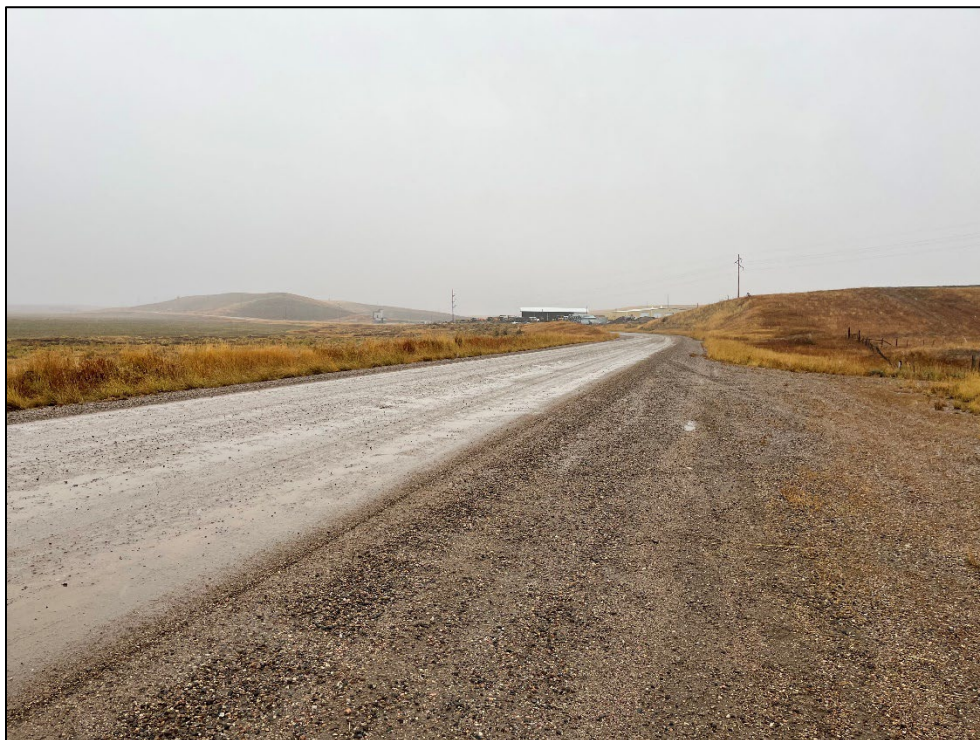
The TAHR (Photo 4) was well maintained and no erosional features of concern were noted. According to the Operator, Routt County has been maintaining the TAHR since late 2022 and has conducted any required grading, plowing, or general maintenance.

Photo 4: View west of western end of the TAHR release area.

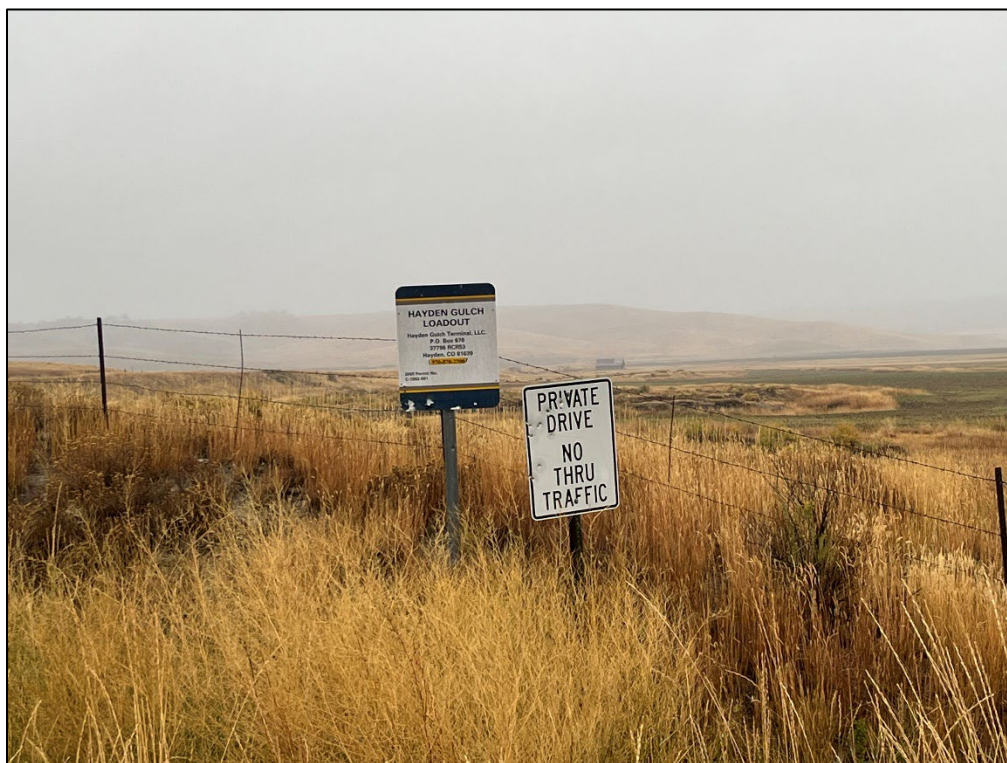
Photo 5: Mine sign located at the southwestern end of the TAHR, connecting to CR 53.

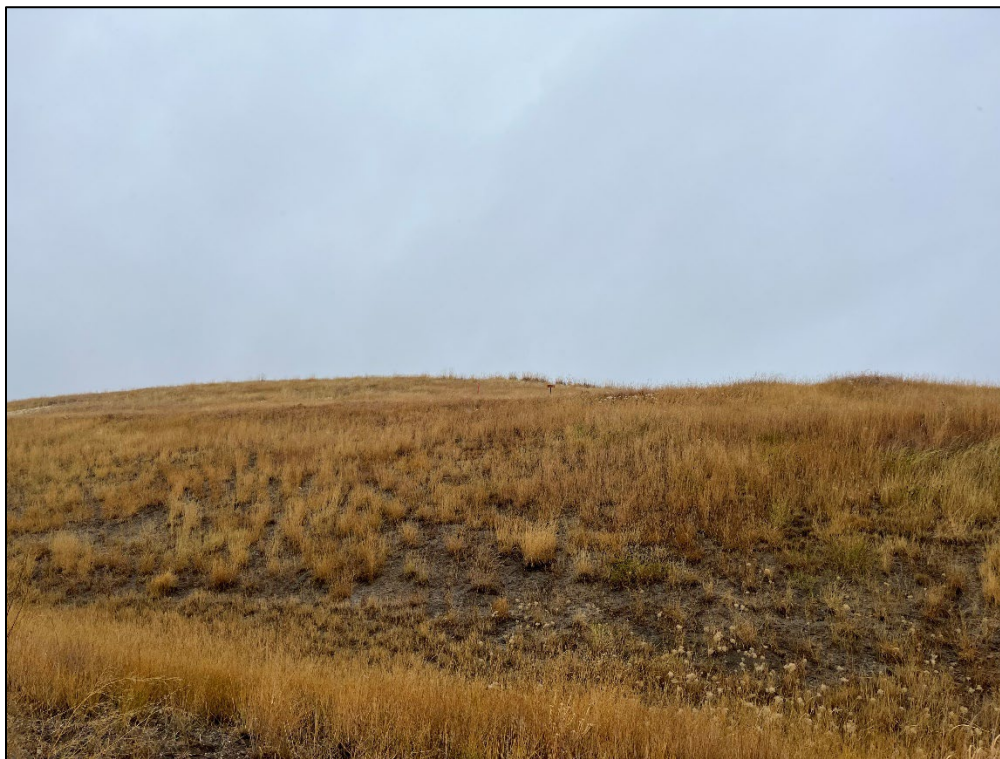
Photo 6: View north of Topsoil Pile 1 located in the TAHR corridor.

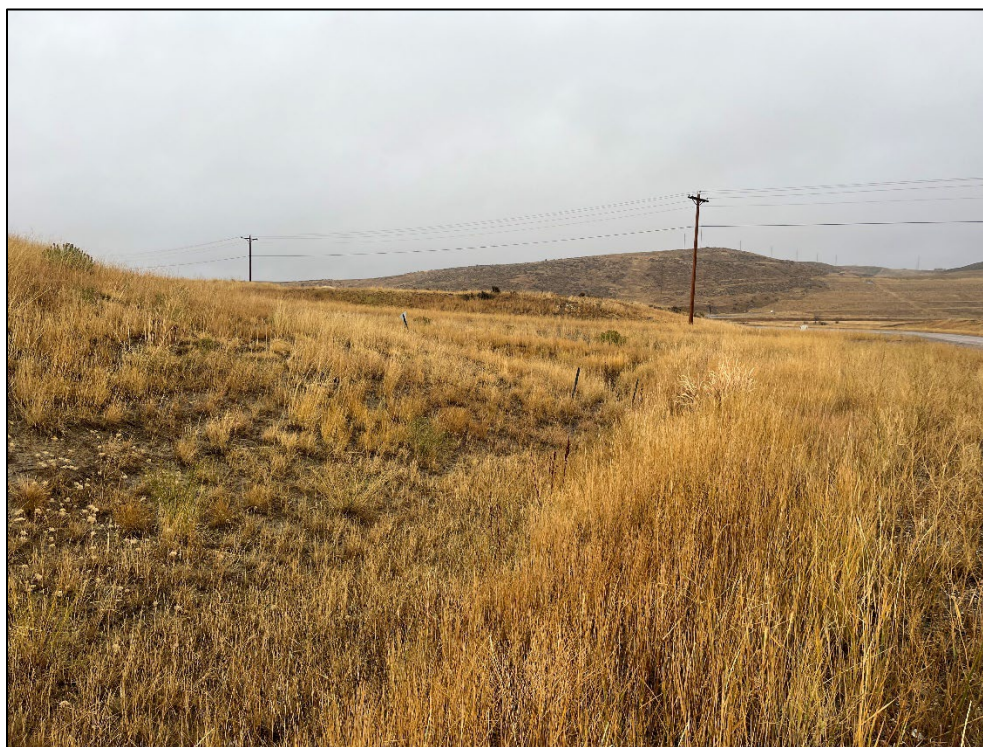
Photo 7: Drainage around Topsoil Pile 1 was well maintained.

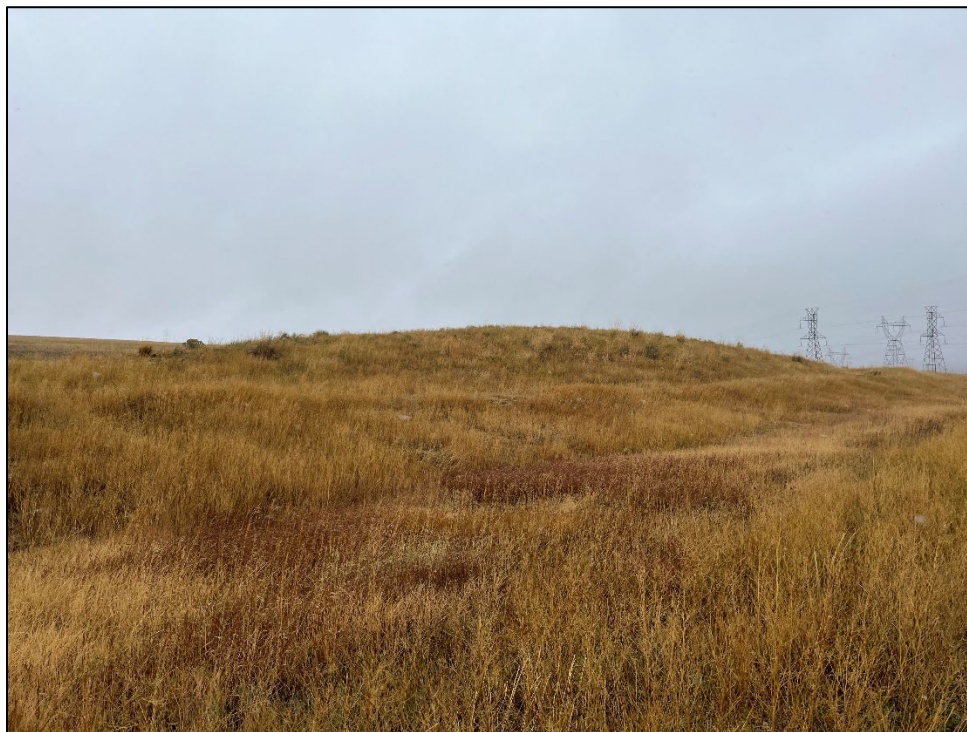
Photo 8: View north of Topsoil Pile 2.

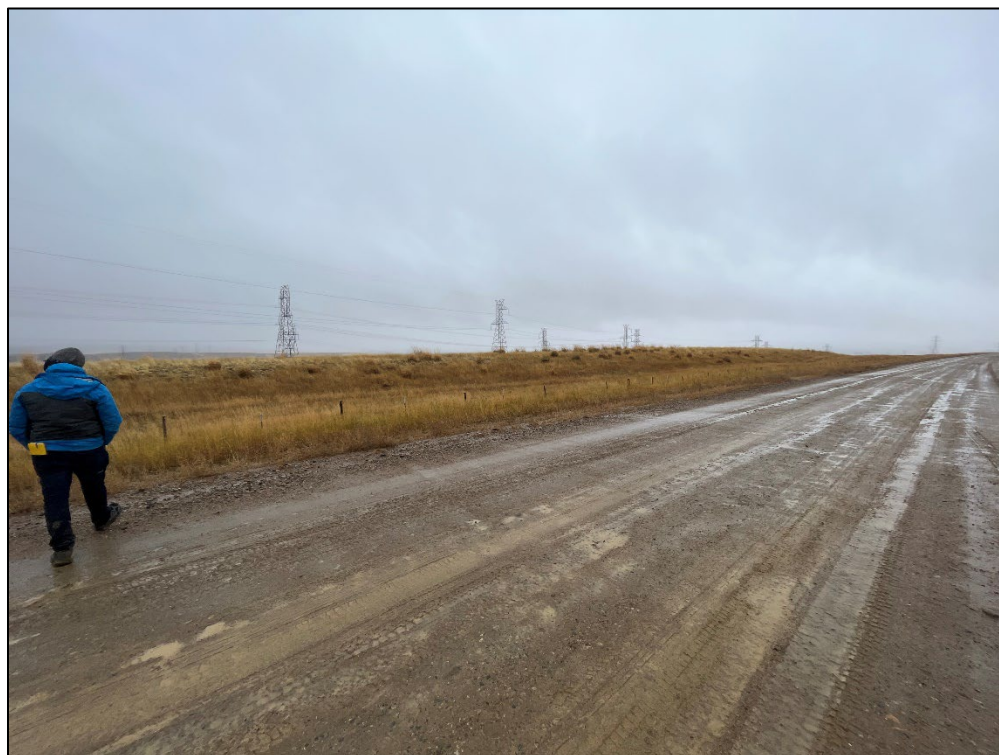
Photo 9: View south of Topsoil Pile 3.

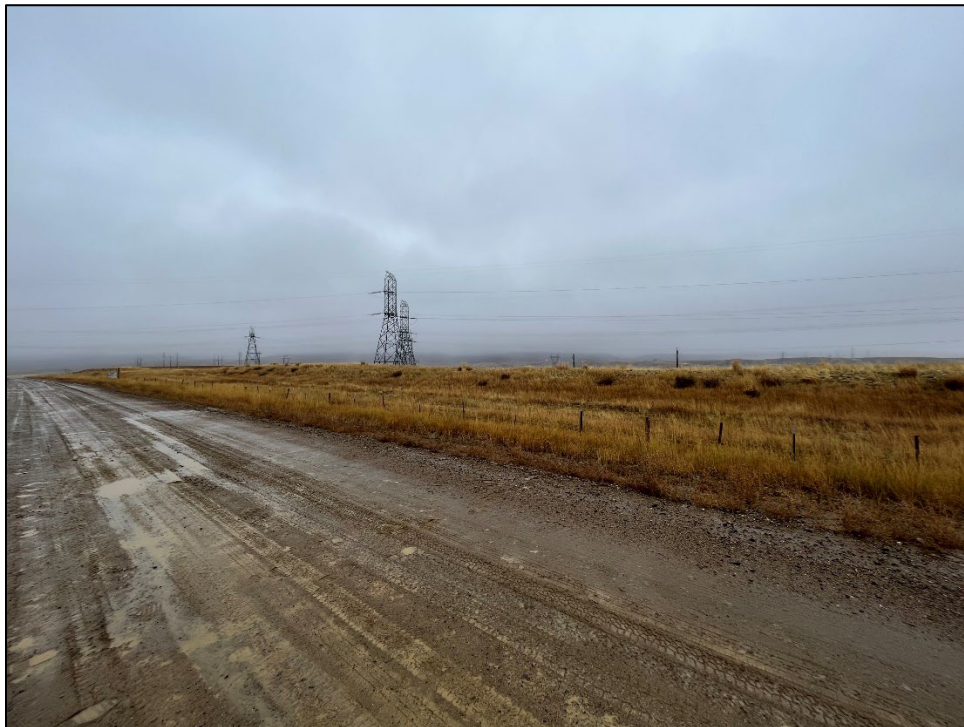
Photo 10: View southeast of Topsoil Pile 3 and the TAHR.

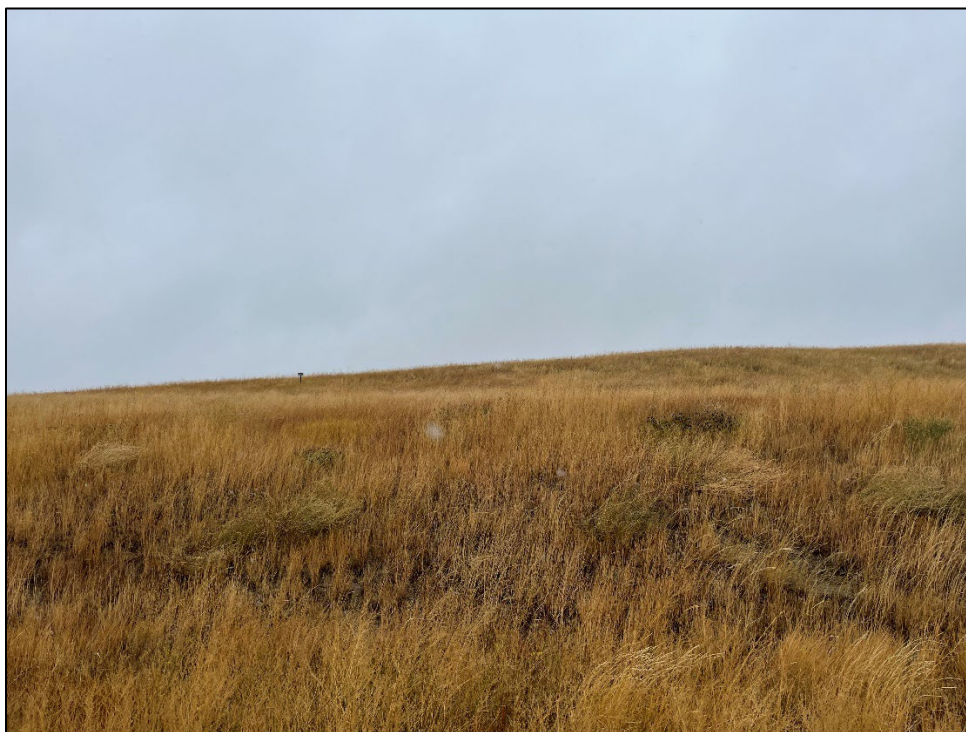
Photo 11: View north of Topsoil Pile 4.

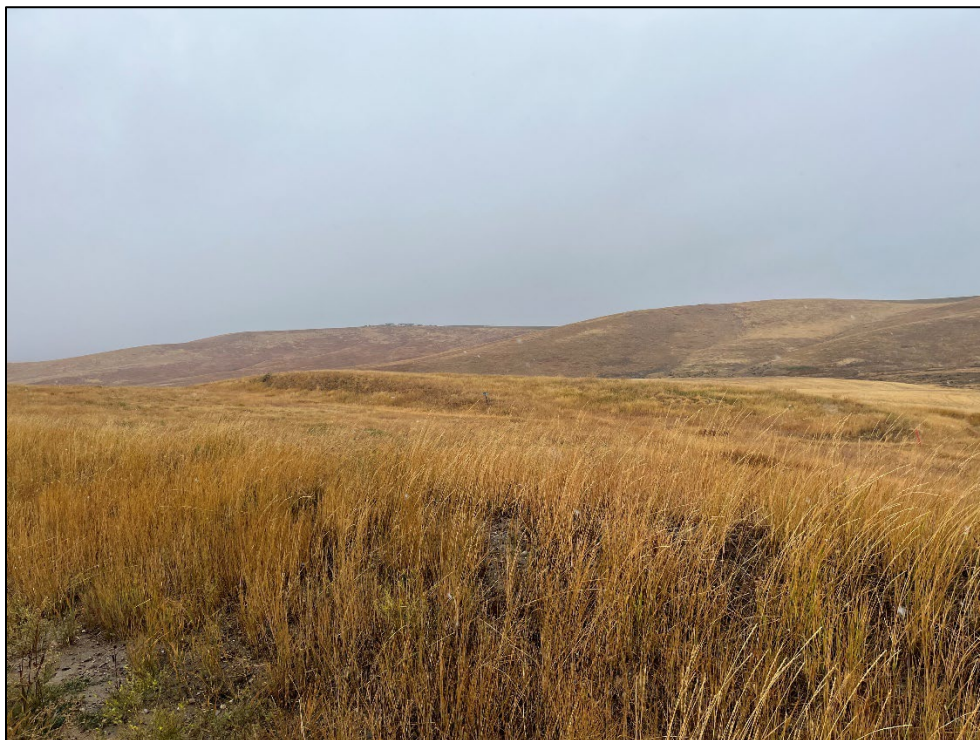
Photo 12: View north of Topsoil Pile 5.

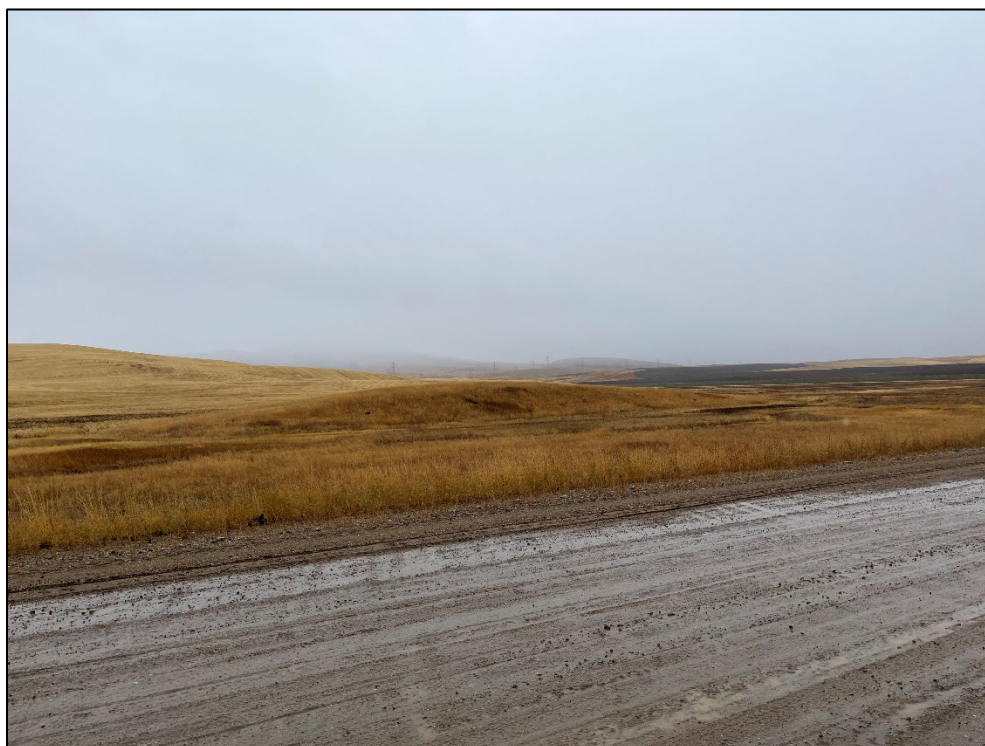
Photo 13: View south of Topsoil Pile 6.

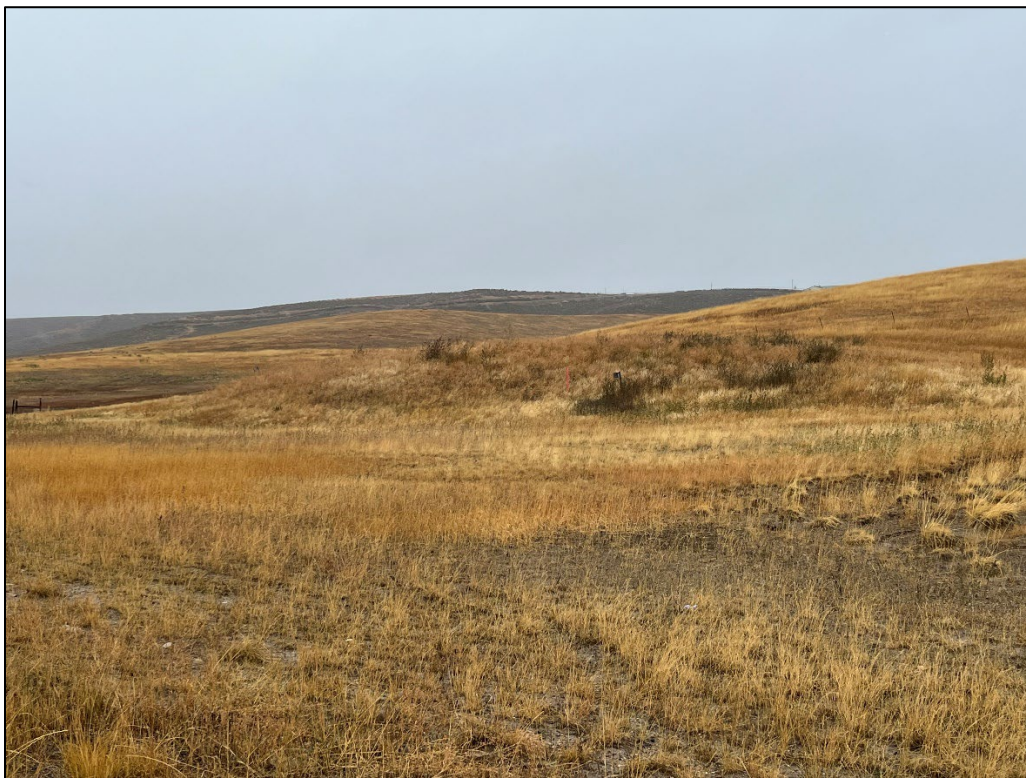
Photo 14: View north of Topsoil Pile 7.

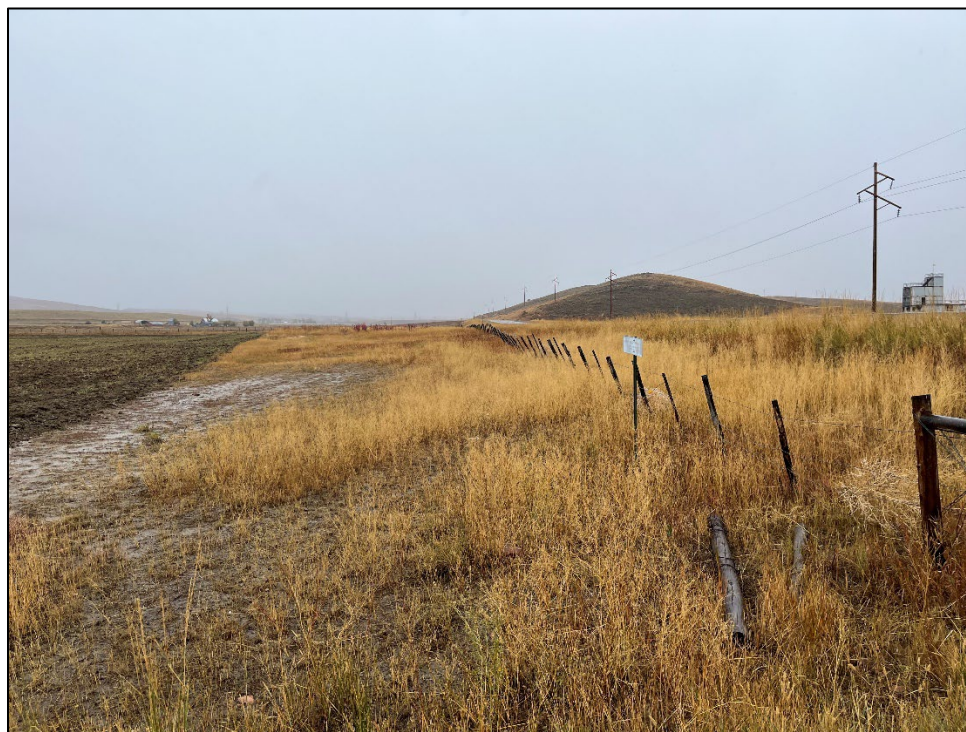
Photo 15: View west of a mapped location of a topsoil pile, no pile is located in this area.
