MINERALS PROGRAM INSPECTION REPORT
PHONE: (303) 866-3567

MINE NAME: Climax Mine	MINE/PROSPECTING ID#: M-1977-493	MINERAL: Molybdenum	COUNTY: Lake, Summit
INSPECTION TYPE: Monitoring	WEATHER: Clear	INSP. DATE: October 18, 2023	INSP. TIME: 12:00
OPERATOR: Climax Molybdenum Company	OPERATOR REPRESENTATIVE: Eric Detmer	TYPE OF OPERATION: 112d-3 - Designated Mining Operation	
REASON FOR INSPECTION: Normal I&E Program	BOND CALCULATION TYPE: None	BOND AMOUNT: \$91,011,850.00	
DATE OF COMPLAINT: NA	POST INSP. CONTACTS: None	JOINT INSP. AGENCY: None	
INSPECTOR(S): Dustin Czapla	INSPECTOR'S SIGNATURE:

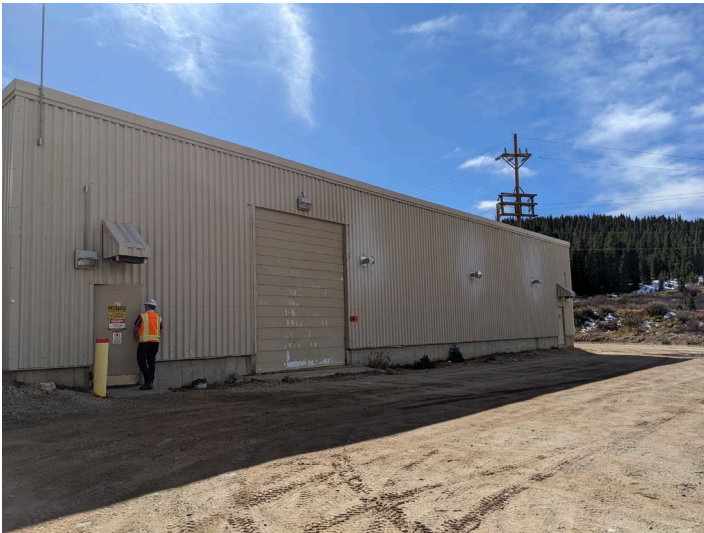
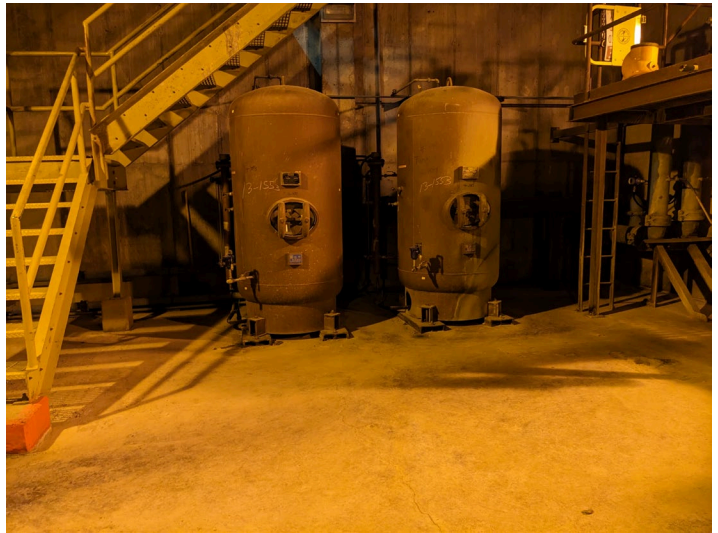
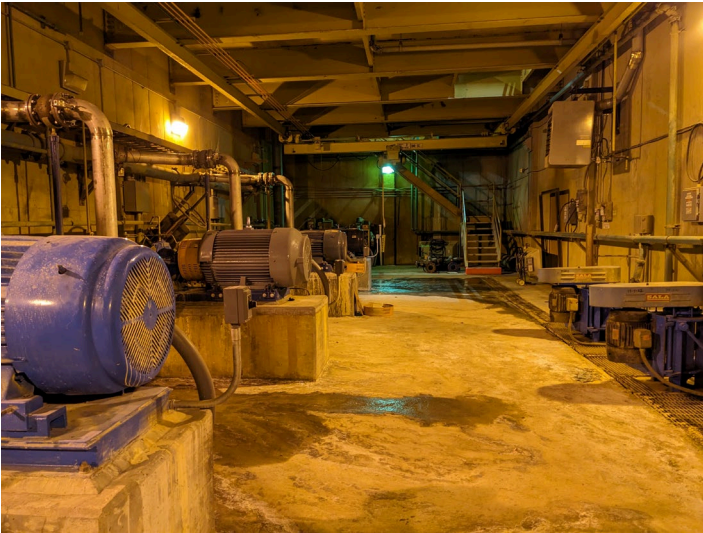
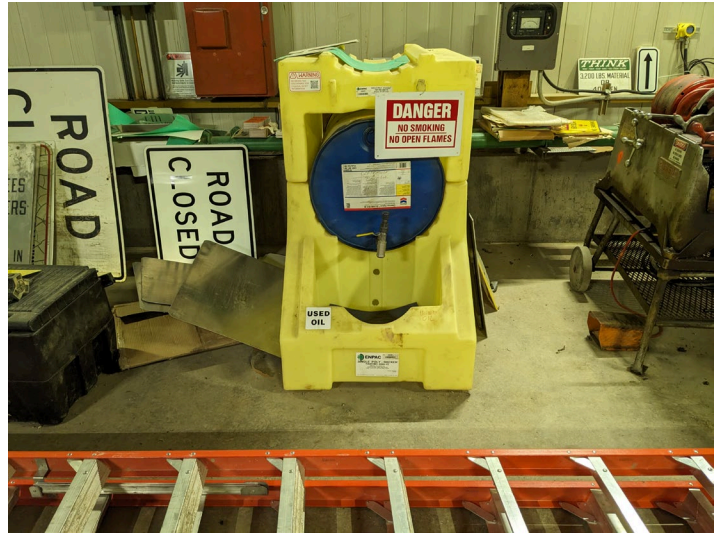
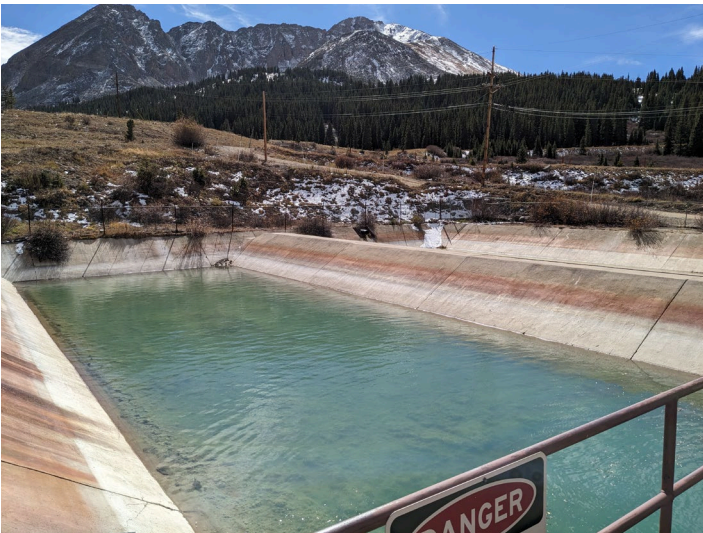
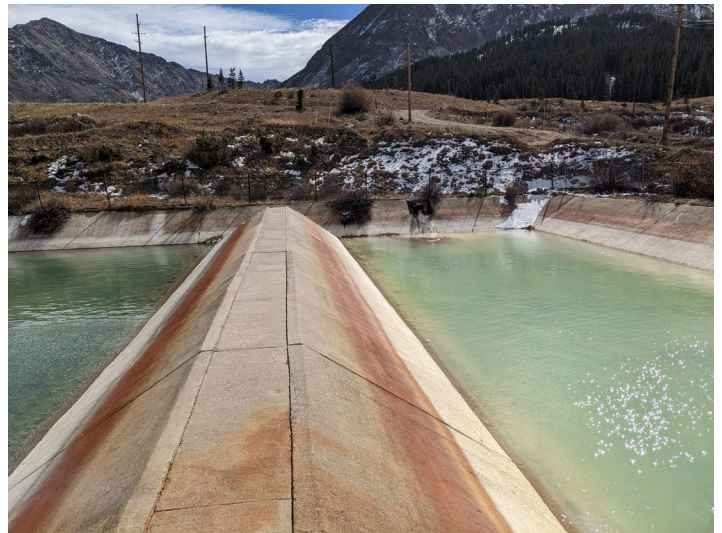
The Storke Wastewater Pump Station is located just below the Storke Yard and acts as a seepage and storm water collection and return system where collected impacted water is pumped to the water treatment/process water circuit in the Tenmile Creek drainage. Two concrete lined ponds serve to collect seepage and storm water/snowmelt run-off from the yard area and it is pumped to the ETDL where it mixes with other mine water prior to treatment. The Storke Wastewater Pump System appeared to be functioning as designed. A minor water leak from a pump seal was observed at one of the pumps within the pump station. Mr. Detmer made note of the leak and stated it would be repaired right away. No other problems were noted.

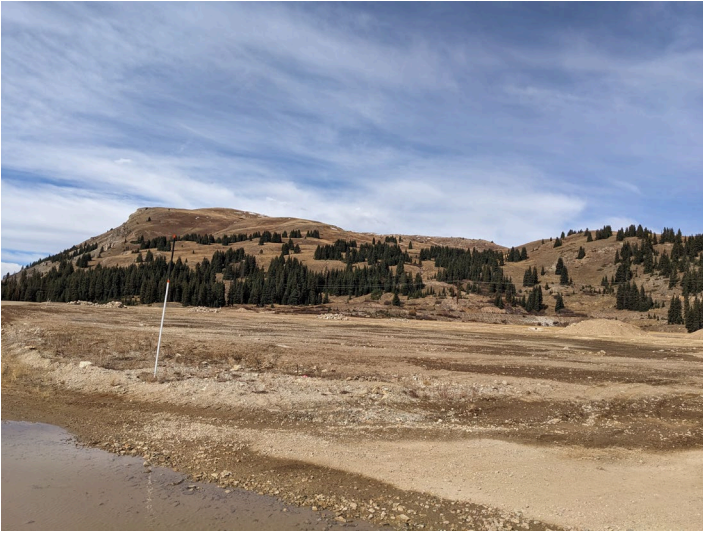
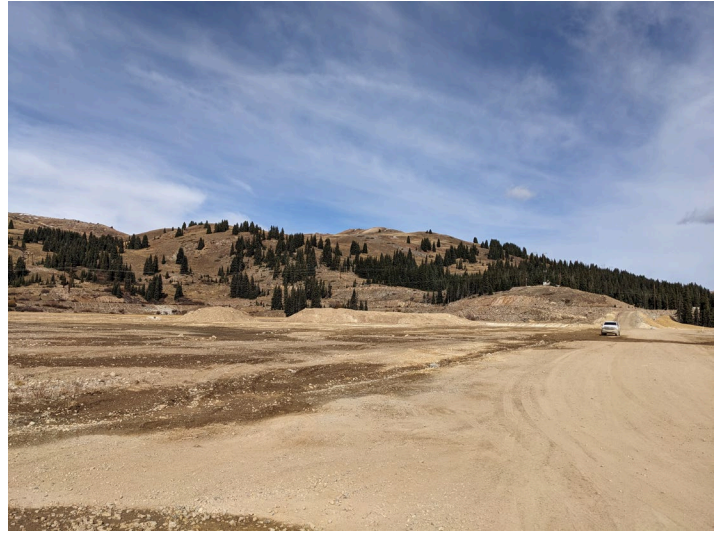
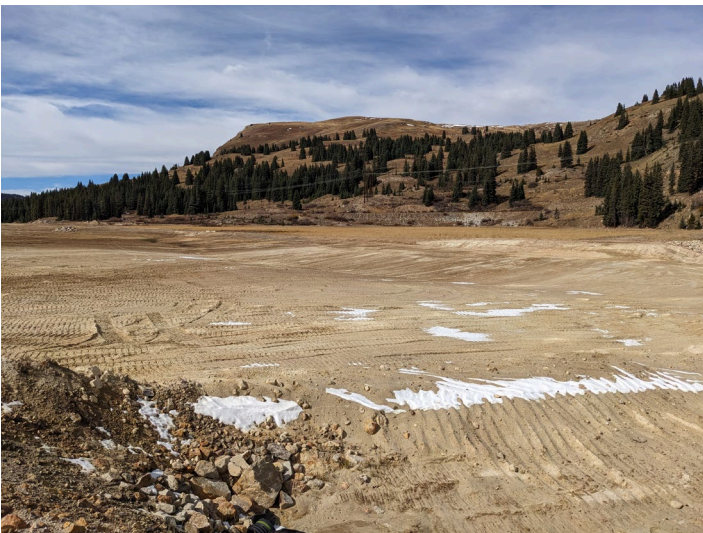
The final plan for the Lake Irwin area was reconfigured through TR35. Phases II and III of the wetlands mitigation plan will no longer be constructed, and the outlet in the Phase I area was redesigned. Much of the grading is complete in this area and the Phase I channel and outlet have been constructed. No problems were noted in this area.

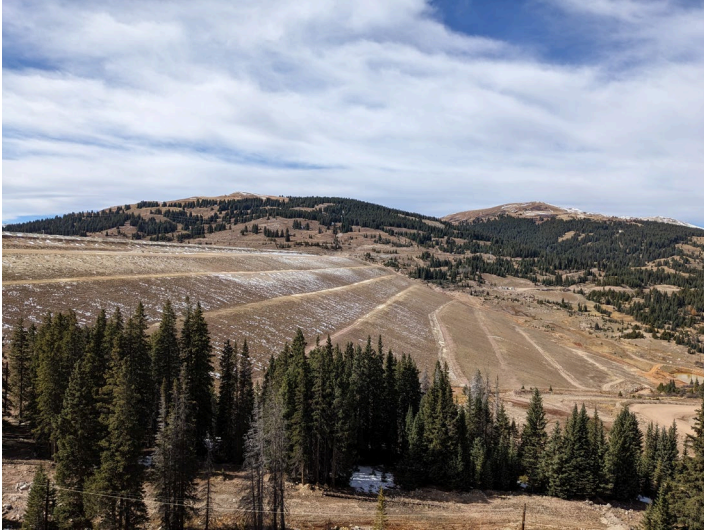
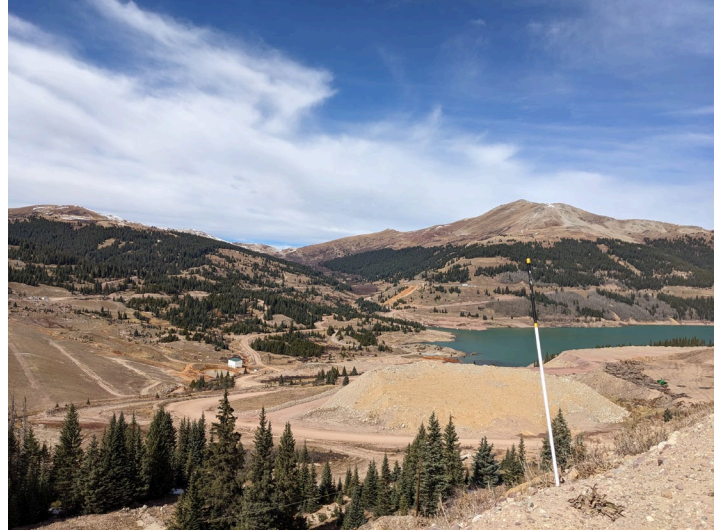
The Tenmile TSF and 3 Dam are an EPF. The TSF contains acid-generating material. Mill tailing is delivered to the TSF through the tailings delivery line. A water pool is maintained at the upstream end of the Tenmile TSF for process water storage, storm water management, and as the first stage in the water treatment system. Seepage from 3 Dam is routed to a collection pond and pumped back by vertical turbine pumps to the Sludge Densification Plant or diverted to the water pool on the Mayflower TSF. The pumping system is located within the 3 Dam Pump Station below the Tenmile TSF. No problems were noted in this area.

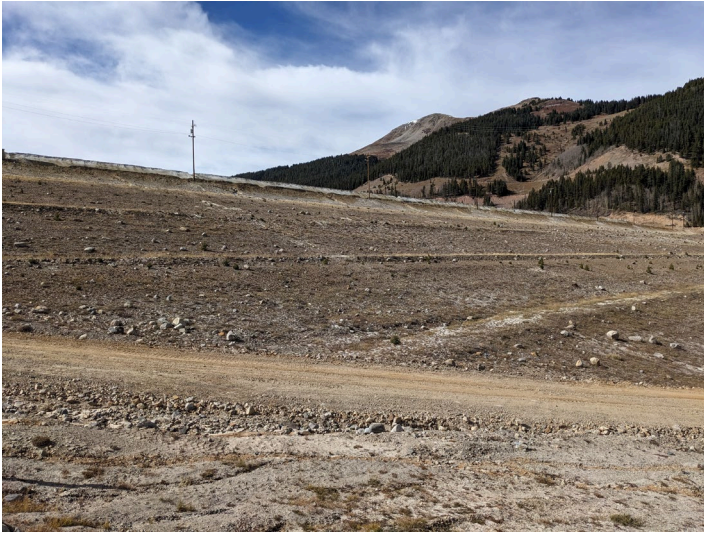
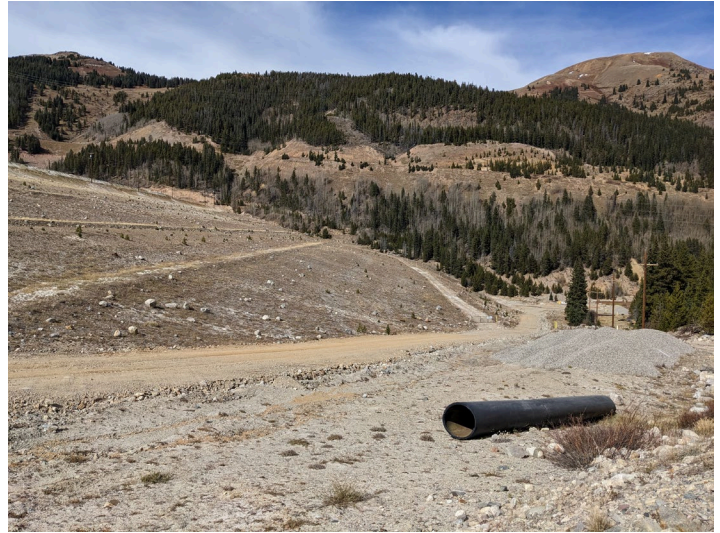
The Mayflower TSF and 5 Dam are the last downstream TSF in the Tenmile Creek Watershed. The TSF contains acid-generating material. To prevent dam failure, the Mayflower TSF includes an emergency flood bypass tunnel. Along with tailings storage, the Mayflower TSF also provides containment of contaminated materials or designated chemicals that might be accidentally released up-gradient of the TSF. Seepage from 5 Dam is routed to concrete ponds. Collected seepage is pumped back by vertical turbine pumps to the 3 Dam Pump Station or the water pool on the Mayflower TSF. The 5 Dam seepwater pumping system is located within the Mayflower Pump Station below the TSF. No problems were noted in this area.

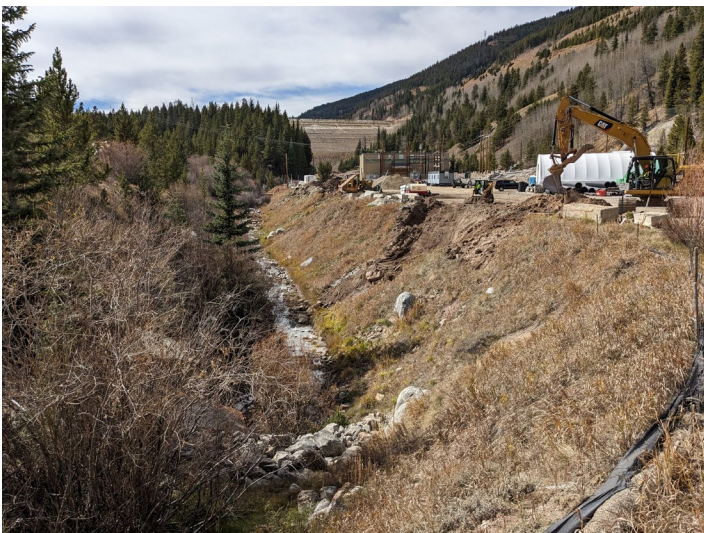
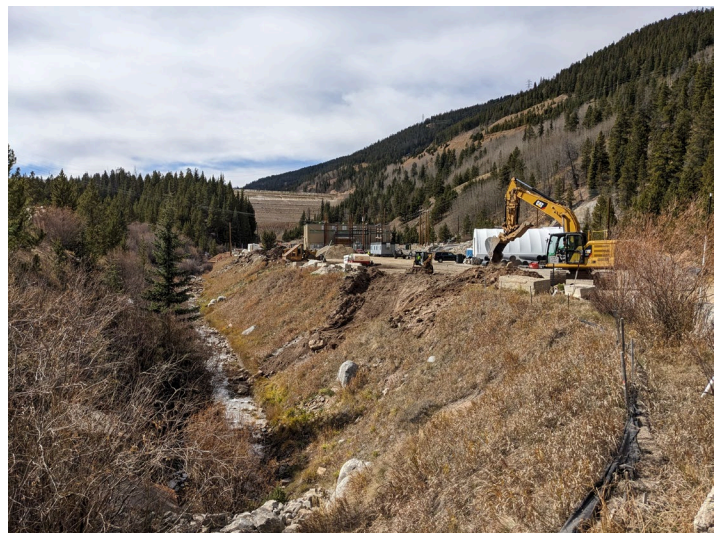
Construction of the 5-Dam Seepwater Collection Area - Secondary Containment System that was approved through TR36 is underway. The project involves constructing a cutoff wall, collection sump, and pumping infrastructure downstream of the Mayflower Clear Pond. Any water collected in the sump would be conveyed back to the Mayflower Clear Pond.
