MINERALS PROGRAM INSPECTION REPORT
PHONE: (303) 866-3567

MINE NAME: Hawkeye Mine	MINE/PROSPECTING ID#: M-1978-311	MINERAL: Uranium and vanadium	COUNTY: San Miguel
INSPECTION TYPE: Multi Person Inspection	WEATHER: Clear	INSP. DATE: October 5, 2023	INSP. TIME: 09:00
OPERATOR: Gold Eagle Mining, Inc.	OPERATOR REPRESENTATIVE: Don Coram	TYPE OF OPERATION: 110d - Designated Limited Impact	
REASON FOR INSPECTION: Normal I&E Program	BOND CALCULATION TYPE:	BOND AMOUNT: \$100.00	
DATE OF COMPLAINT: NA	POST INSP. CONTACTS: None	JOINT INSP. AGENCY: None	
INSPECTOR(S): Lucas West, Travis Marshall	INSPECTOR'S SIGNATURE:

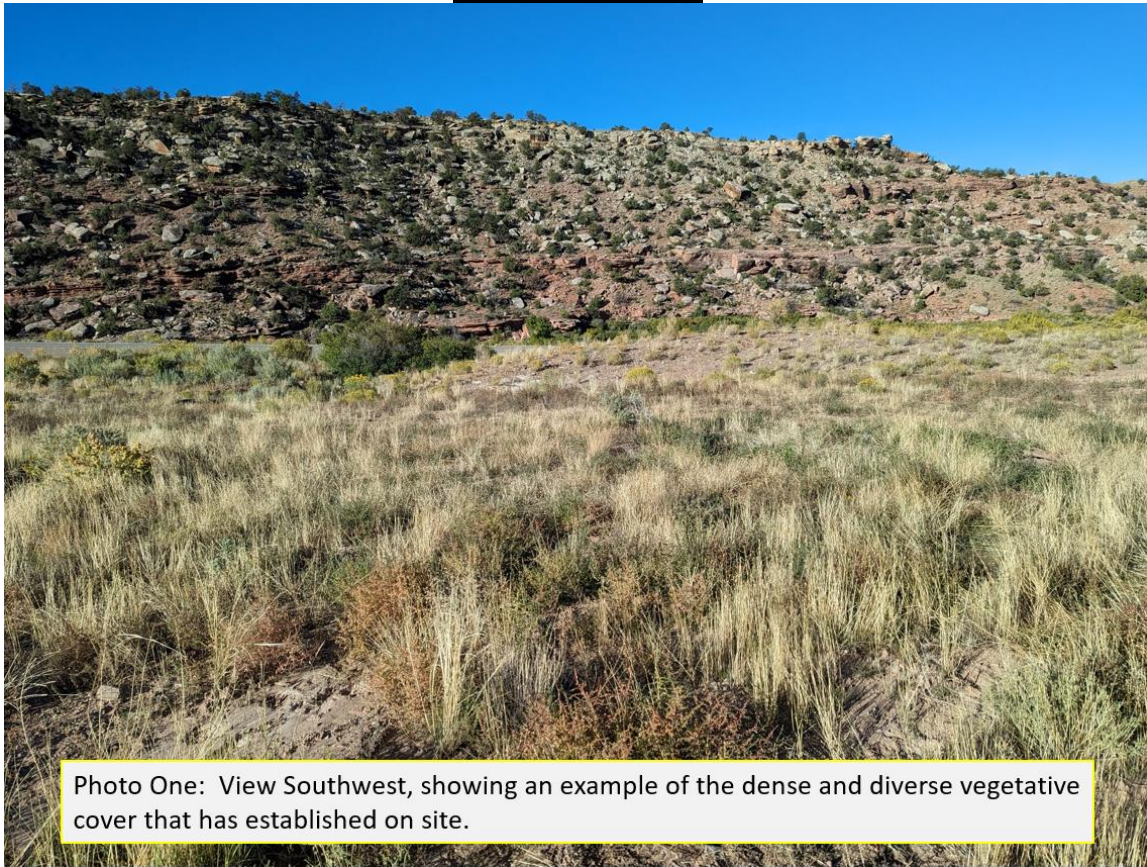
Final reclamation of the site has been completed, and the site remains in the same condition as the previous inspection. During previous inspections it was identified that the vegetative cover was not yet established enough to recommend full and final release. However, during this inspection it was observed that the vegetation is well established and appears to be healthy. The vegetative cover across the site is well established and in good condition. Multiple year's growth was noted indicating the vegetation is self-sufficient and capable of self-regeneration. The vegetation is currently as good as or better than adjacent undisturbed lands. Examples of the vegetative establishment can be seen in Photos One and Two.

Photo One: View Southwest, showing an example of the dense and diverse vegetative cover that has established on site.

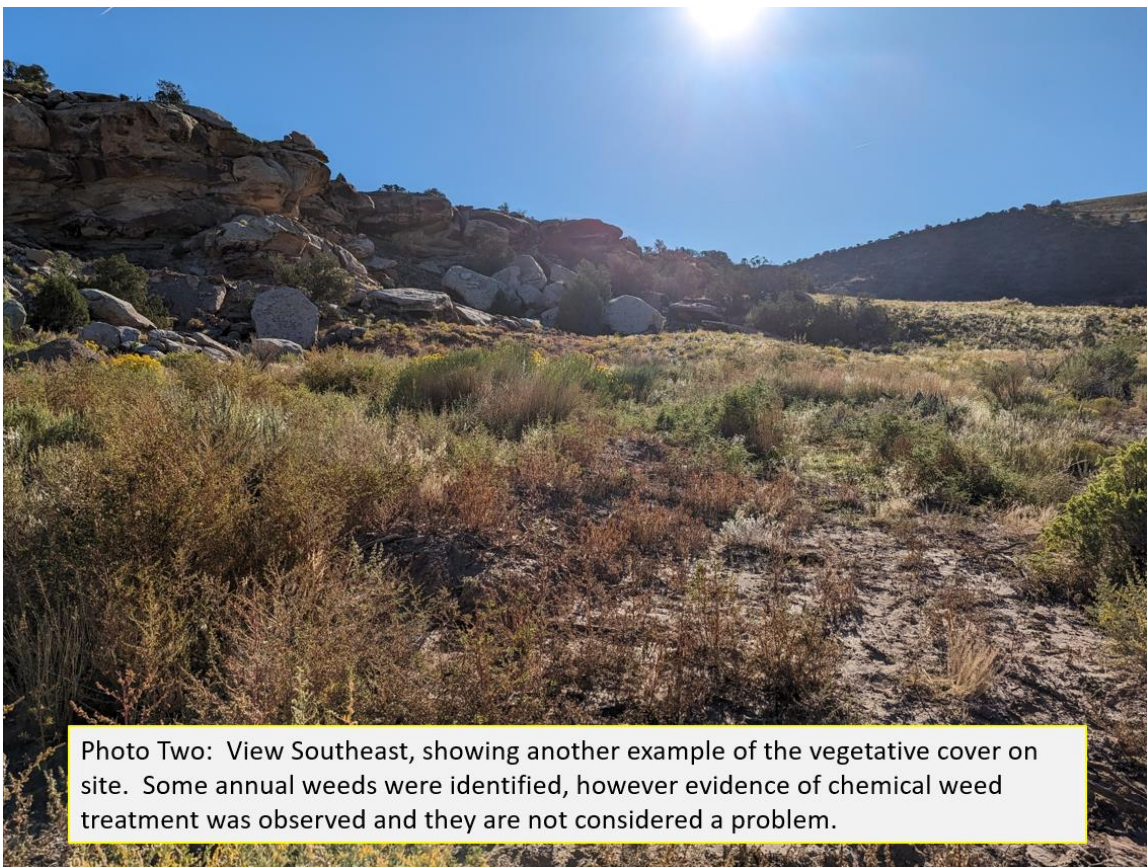
Photo Two: View Southeast, showing another example of the vegetative cover on site. Some annual weeds were identified, however evidence of chemical weed treatment was observed and they are not considered a problem.

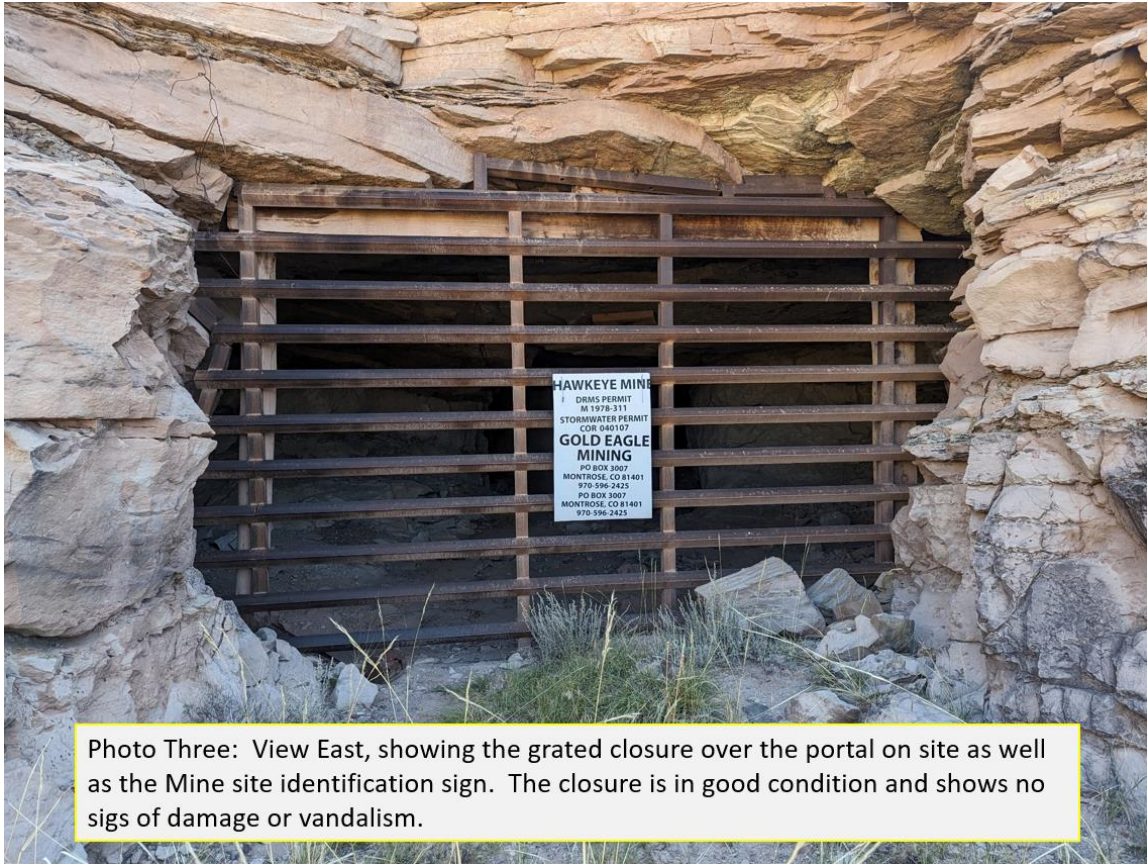
The site contains a secured portal onsite leading to the underground workings that is closed with a welded steel closure. The portal closure, seen in Photo Three, is stable and in good condition. The proper Mine Identification signage is secured to the portal closure. It shows no signs of vandalism or attempted unauthorized entry. The access road leading to the portal is equipped with various storm water control structures and appears to be stable. The access road can be seen in Photo Four. Adjacent to the portal is a natural drainage leading down toward the county road. The storm water controls lead through the site, down the natural drainage to a small "sediment pond" near the County Road. The sediment pond is well vegetated to dissipate flows and was in good condition. The waste rock pile was observed and appeared to be stable at the time of the inspection.

Photo Three: View East, showing the grated closure over the portal on site as well as the Mine site identification sign. The closure is in good condition and shows no signs of damage or vandalism.

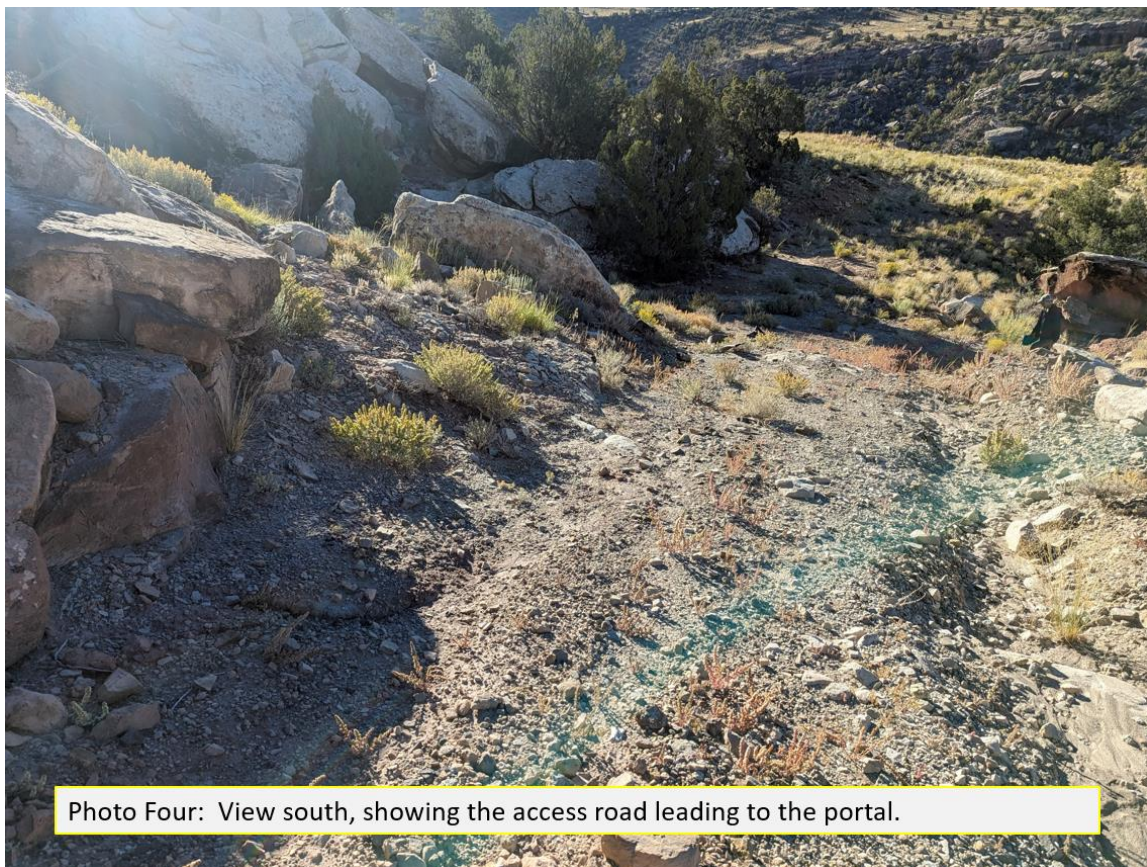
Photo Four: View south, showing the access road leading to the portal.
