**MINERALS PROGRAM INSPECTION REPORT**  
**PHONE: (303) 866-3567**

<b>MINE NAME:</b> Ellison Mine	<b>MINE/PROSPECTING ID#:</b> M-1978-342	<b>MINERAL:</b> Uranium and vanadium	<b>COUNTY:</b> San Miguel
<b>INSPECTION TYPE:</b> Multi Person Inspection	<b>WEATHER:</b> Clear	<b>INSP. DATE:</b> October 5, 2023	<b>INSP. TIME:</b> 09:29
<b>OPERATOR:</b> Gold Eagle Mining, Inc.	<b>OPERATOR REPRESENTATIVE:</b> Don Coram	<b>TYPE OF OPERATION:</b> 110d - Designated Limited Impact	
<b>REASON FOR INSPECTION:</b> Normal I&E Program	<b>BOND CALCULATION TYPE:</b>	<b>BOND AMOUNT:</b> \$100.00	
<b>DATE OF COMPLAINT:</b> NA	<b>POST INSP. CONTACTS:</b> None	<b>JOINT INSP. AGENCY:</b> None	
<b>INSPECTOR(S):</b> Lucas West	<b>INSPECTOR'S SIGNATURE:</b>

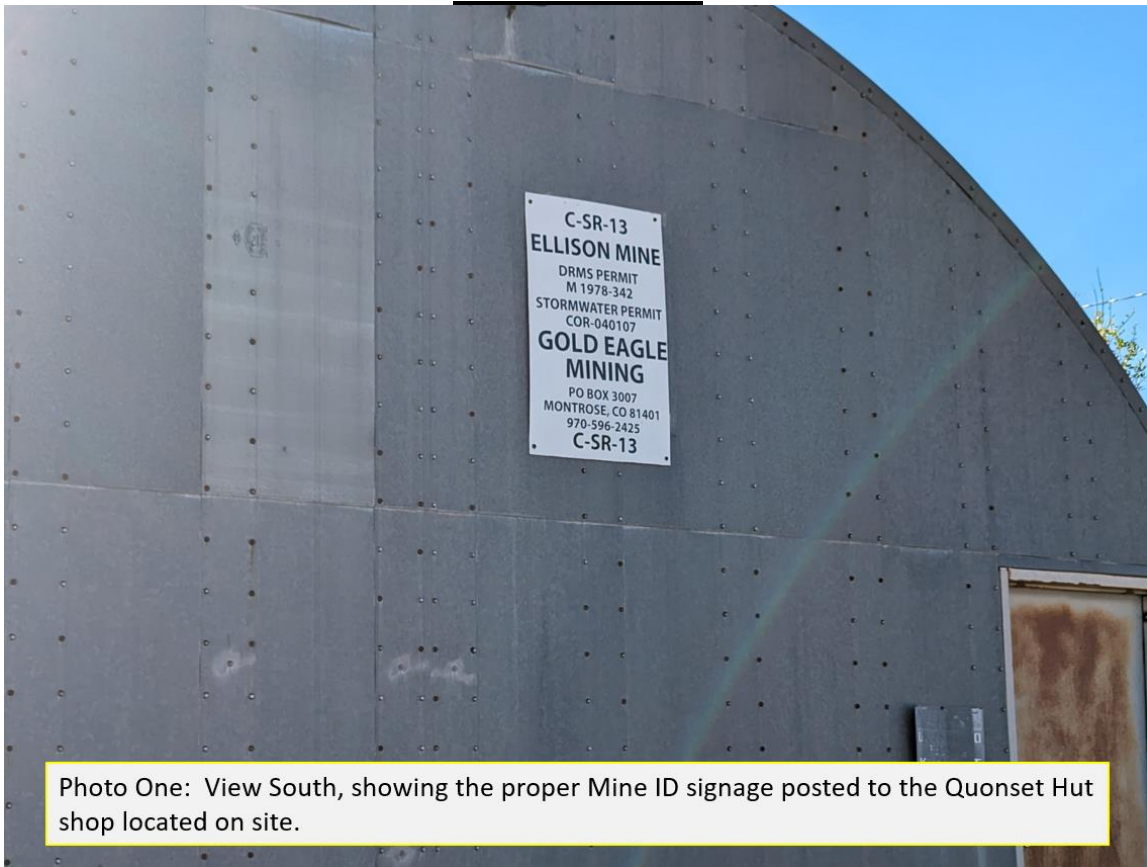
The proper Mine Identification sign was posted near the entrance to the site on the Quonset Hut shown in Photo One. Permit boundary markers were observed, and all disturbance was inside the permitted area. The majority of the disturbance on site is focused on the main pad area. The pad, shown in Photo Two, is in good condition and appeared stable at the time of the inspection. No evidence of settling, slumping or erosion was noted. The storm water controls were also observed and appeared to be functioning as designed. Evidence of storm water control device maintenance was observed. The maintenance work is approved and supervised by the DOE. No erosional issues were observed during this inspection. The main pad and work area that the Quonset Hut, container and portal are located on was in good condition and well vegetated with native grasses and shrubs. The slopes of the main pad and work area were all well vegetated and appear to be stable.

Photo One: View South, showing the proper Mine ID signage posted to the Quonset Hut shop located on site.

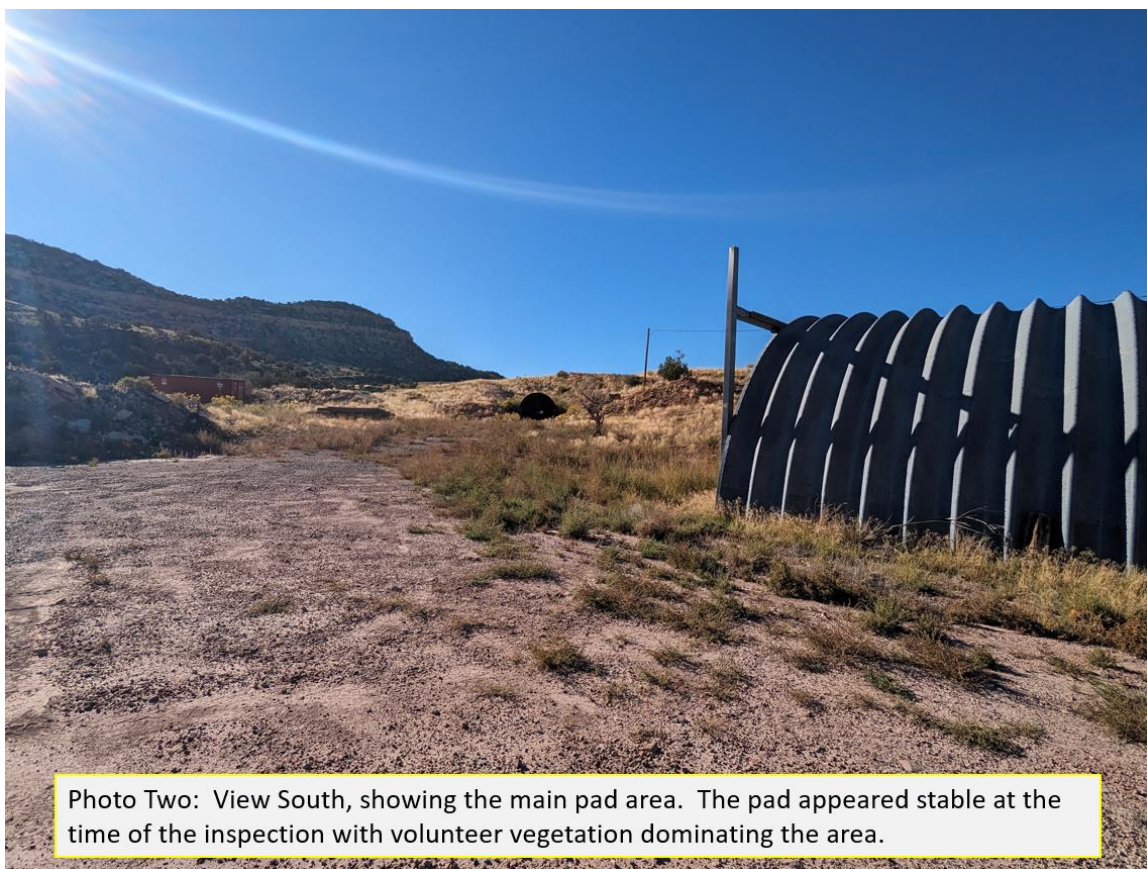
Photo Two: View South, showing the main pad area. The pad appeared stable at the time of the inspection with volunteer vegetation dominating the area.

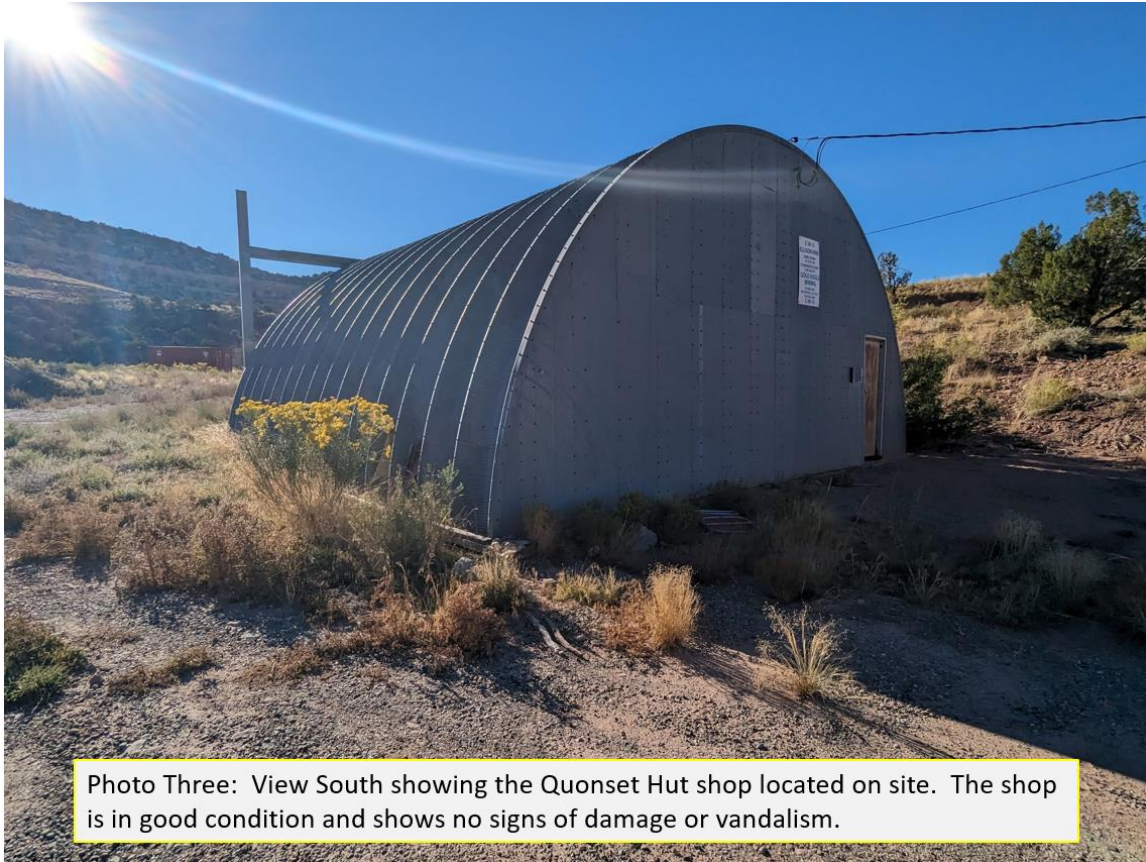
The Quonset hut style structure was secure and in good condition at the time of this inspection as seen in Photo Three. Also located on is a shipping container used for storage that was also secured and in good condition. The shipping container can be seen in Photo Four. The portal, shown in Photo Five is enforced with a Quonset style structure leading underground, and secured with a locked, welded steel grate. All components associated with the portal are in good condition and show no signs of attempted unauthorized entry.
