MINERALS PROGRAM INSPECTION REPORT
PHONE: (303) 866-3567

MINE NAME: Burros Mine	MINE/PROSPECTING ID#: M-1977-297	MINERAL: Uranium and vanadium	COUNTY: San Miguel
INSPECTION TYPE: Multi Person Inspection	WEATHER: Clear	INSP. DATE: October 5, 2023	INSP. TIME: 09:58
OPERATOR: Gold Eagle Mining, Inc.	OPERATOR REPRESENTATIVE: Don Coram	TYPE OF OPERATION: 110d - Designated Limited Impact	
REASON FOR INSPECTION: Normal I&E Program	BOND CALCULATION TYPE:	BOND AMOUNT: \$100.00	
DATE OF COMPLAINT: NA	POST INSP. CONTACTS: None	JOINT INSP. AGENCY: None	
INSPECTOR(S): Lucas West Travis Marshall	INSPECTOR'S SIGNATURE:

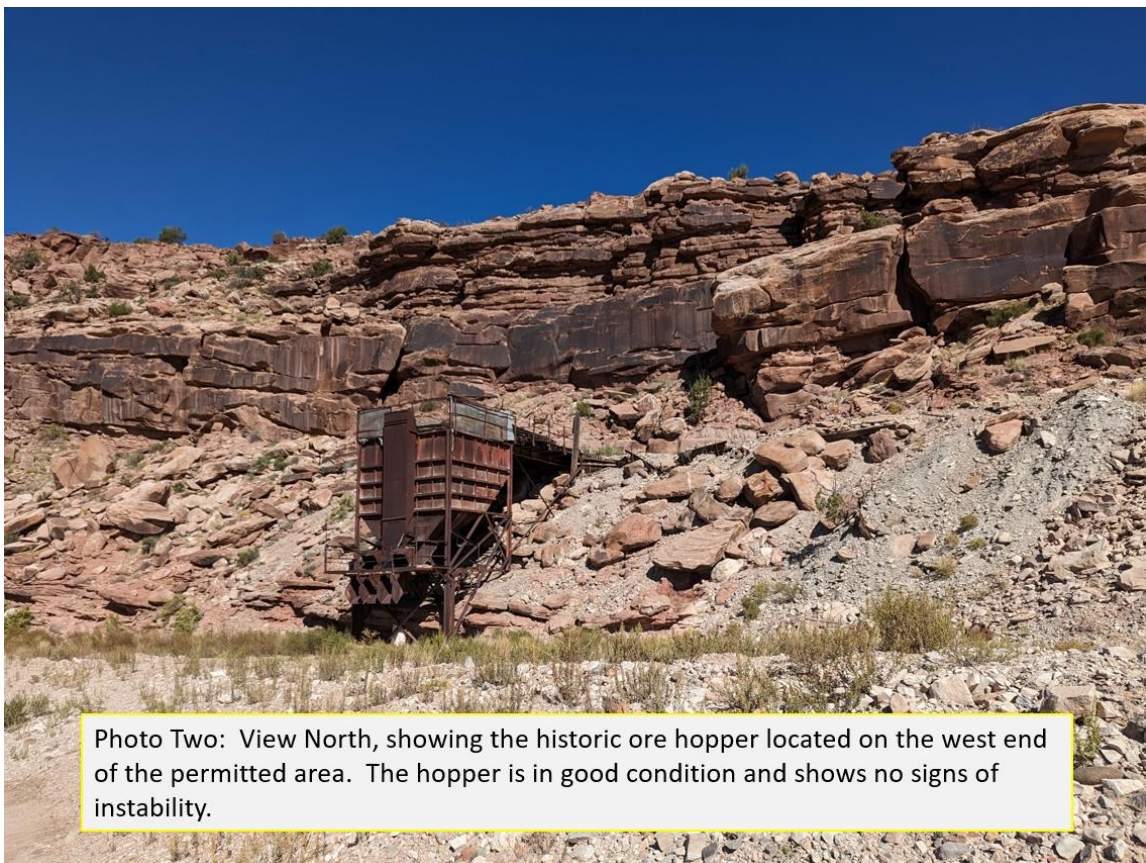
The 9.9 acres of this site includes the areas referred to as the Burro 3, 5 and 7 as well as the area surrounding the portal, main pad area and ore hopper area. Included in this are the roads leading from the Burro tunnel to the 5 and on to the 7. All of these areas are still included in the DRMS permit Boundary but fall under varying land management jurisdictions between DOE and BLM. The portal of the Burro Tunnel was observed, and verified to be secure as seen in Photo One. The portal is closed with a locking metal gate closure and shows no signs of vandalism or attempted unauthorized entry. Various items including historic air lines and other items surround the portal. The storm water control features across the site to divert storm water flow from the affected lands to a sediment basin near the county road, adjacent to a historic ore hopper located on site were all in good condition and appear to be functioning as designed. The ore hopper was stable at the time of the inspection and in good condition and can be seen in Photo Two.

On site discussions centered on the completion of reclamation by the March 18, 2023 final reclamation deadline. The only remaining task to have reclamation completed is securing the area surrounding the ore hopper to prevent trespassing. The reclamation of all other disturbed areas is considered complete, and agreed upon by all other agencies present during this inspection. Once the fencing surrounding the ore hopper is complete, a full and final release request can be pursued.

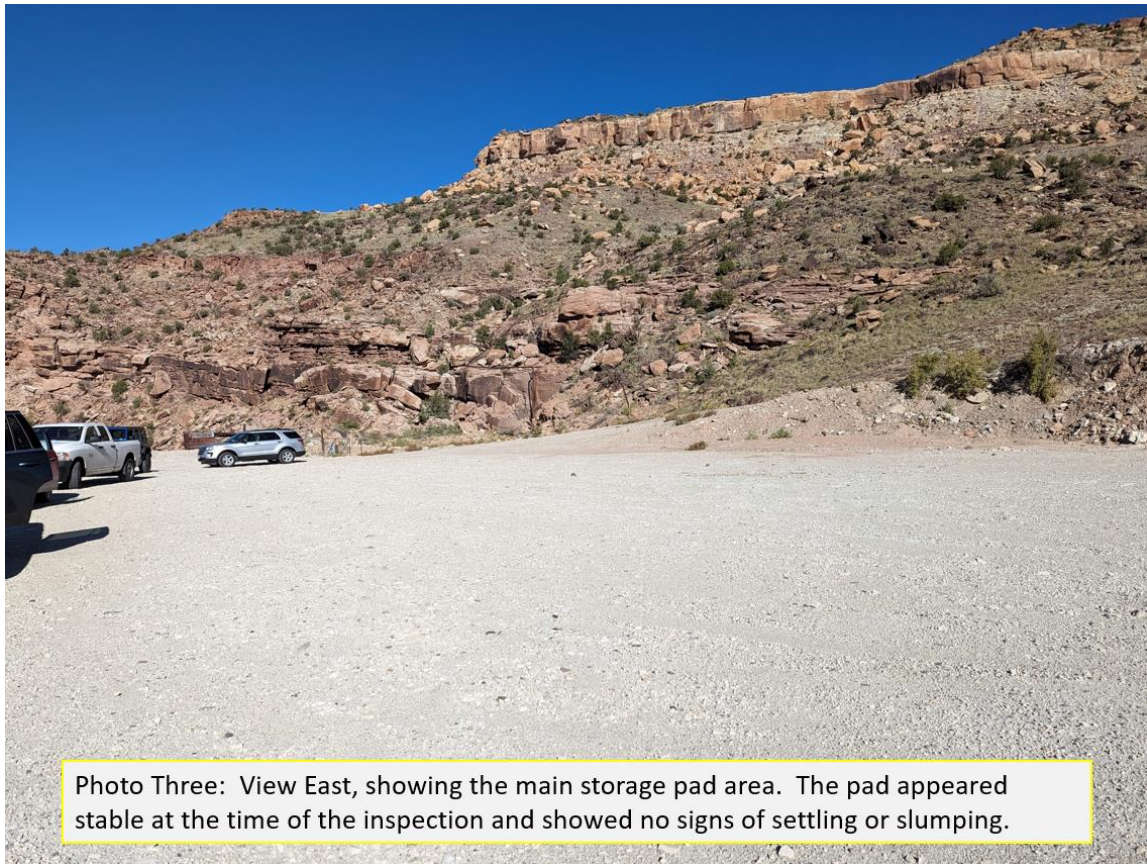
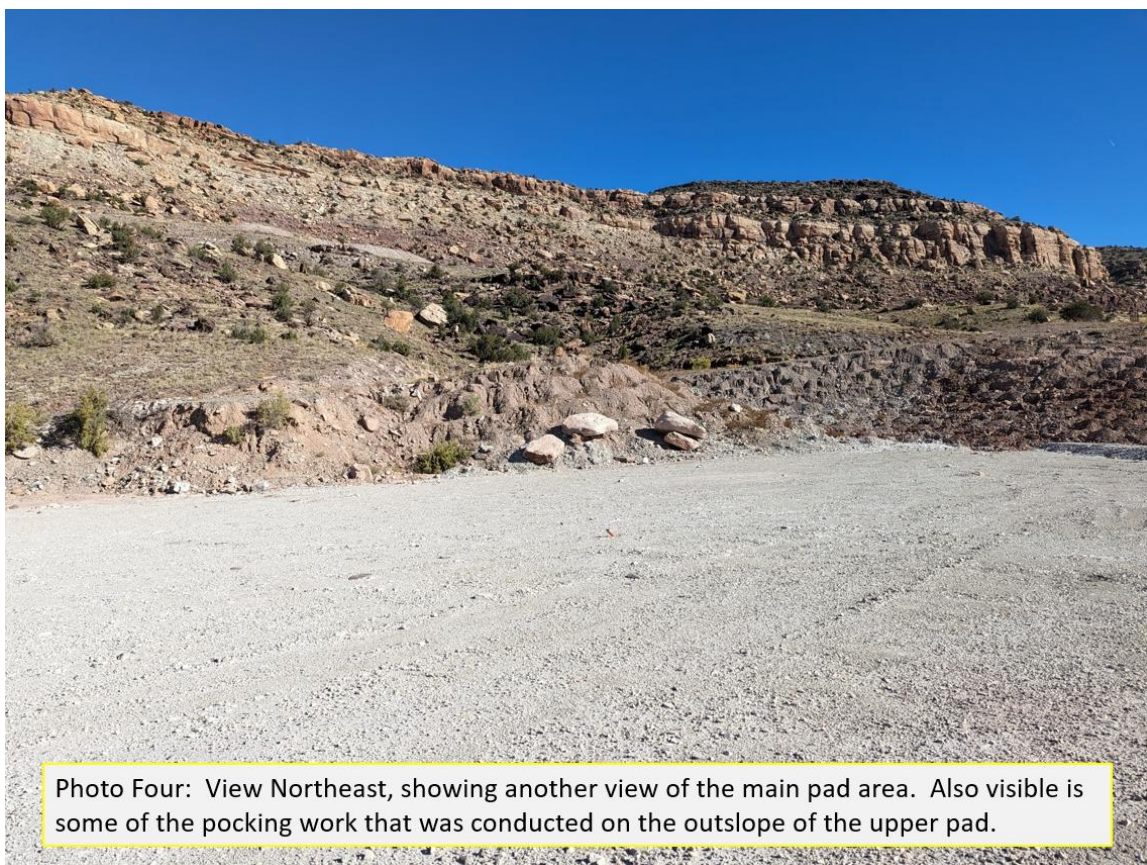
The main storage pad where the stockpiles were located can be seen in Photos Three and Four. The top of the pad was stable at the time of the inspection and clear of all materials. The out slopes have been regraded to pull the toe away from the dry creek bed of Burro Creek to prevent sediment from entering the creek. A portion of the slopes have been pocked for stability, and all out slopes observed appeared to be stable at the time of the inspection. Examples of the pocking and out slopes can be seen in Photos Five. The pad and its out slopes appeared stable at the time of the inspection, no signs of settling, slumping or erosion was noted during this inspection.
