MINERALS PROGRAM INSPECTION REPORT
PHONE: (303) 866-3567

MINE NAME: SR-11 Mine	MINE/PROSPECTING ID#: M-1977-451	MINERAL: Uranium and vanadium	COUNTY: San Miguel
INSPECTION TYPE: Multi Person Inspection	WEATHER: Clear	INSP. DATE: October 5, 2023	INSP. TIME: 11:53
OPERATOR: Highbury Resources Inc.	OPERATOR REPRESENTATIVE: Scott Pottorff	TYPE OF OPERATION: 112d-1 - Designated Mining Operation	
REASON FOR INSPECTION: Normal I&E Program	BOND CALCULATION TYPE:	BOND AMOUNT: \$43,000.00	
DATE OF COMPLAINT: NA	POST INSP. CONTACTS: None	JOINT INSP. AGENCY: None	
INSPECTOR(S): Lucas West Travis Marshall	INSPECTOR'S SIGNATURE:

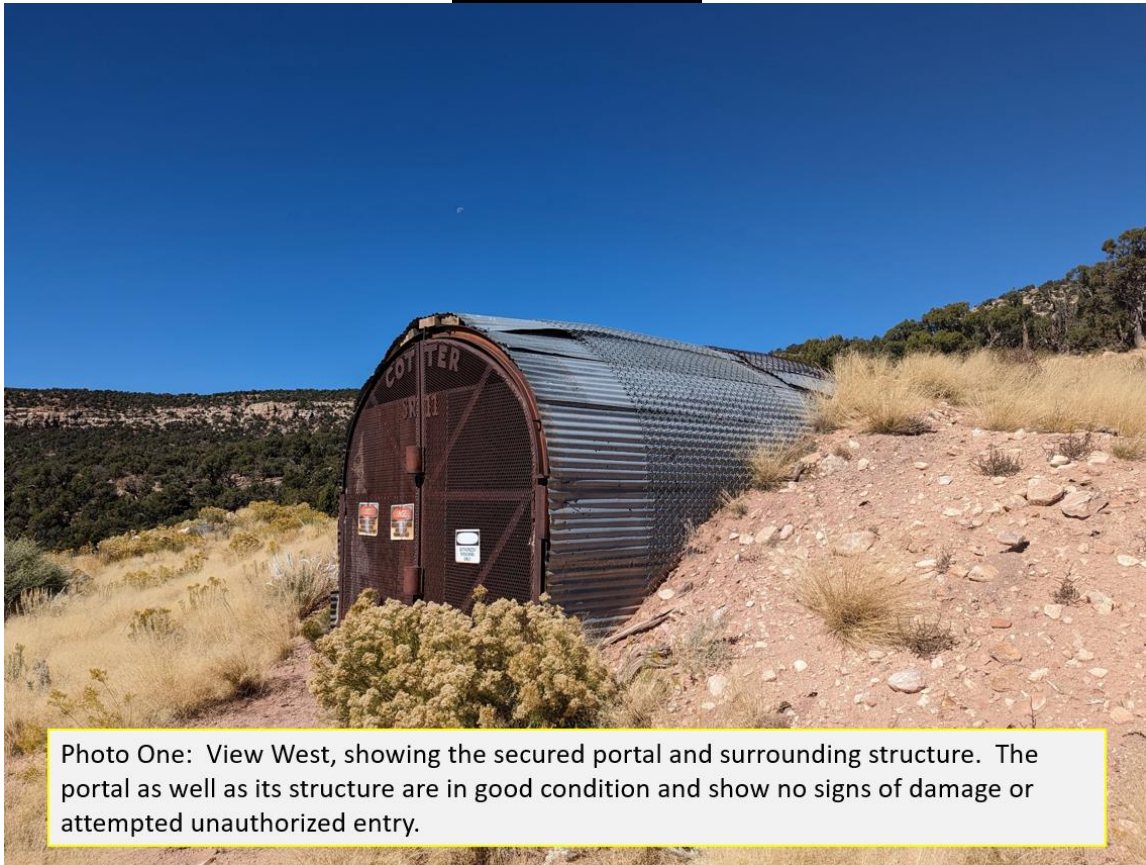
The proper mine identification signage was posted at the entrance to the site, and the permit boundaries are clearly marked. There was no equipment on site during the inspection. This inspection was limited to the surface facilities. The portal has been secured by a locked gate shown in Photo One. The portal closure is in good condition and shows no signs of attempted unauthorized entry. The main reclamation item that has been accomplished since the Division's previous inspection is the removal of the office trailer located on site. Photo Two shows the location that the trailer, used to be. Remaining tasks associated with this area is the removal of the on-site septic system.

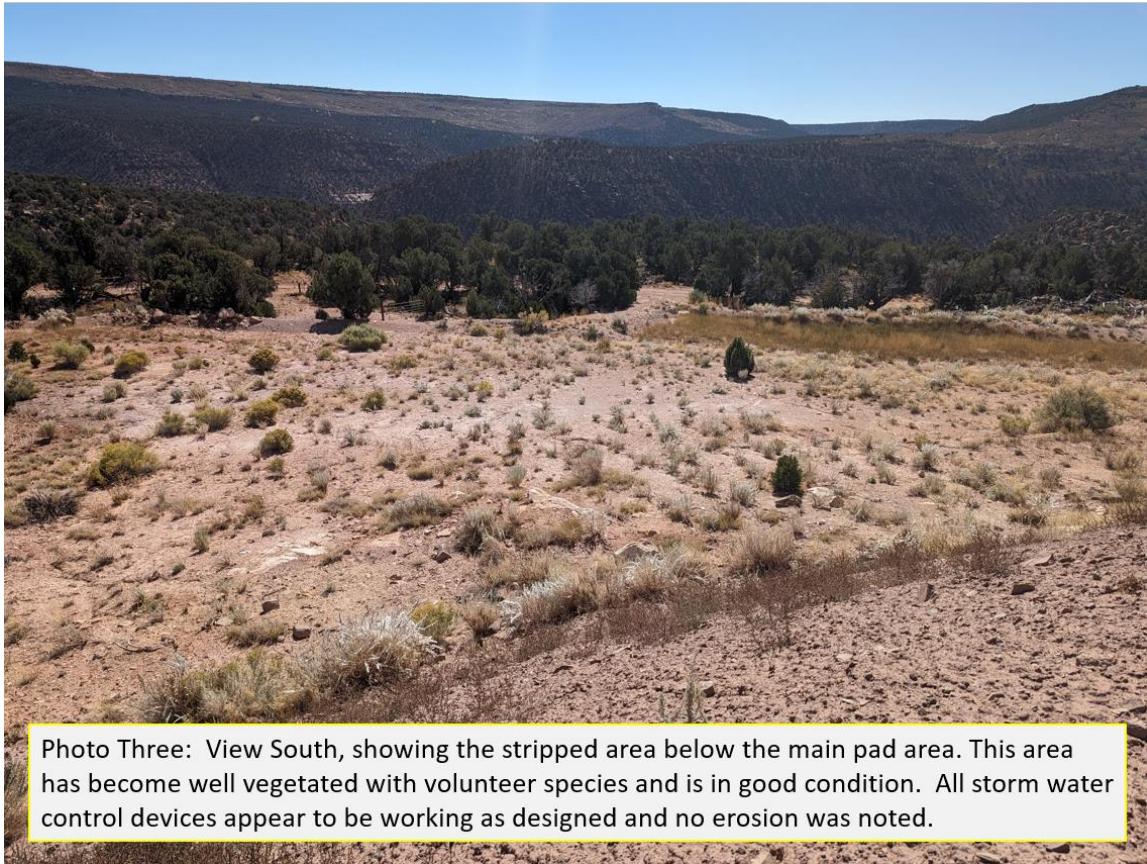
The portal pad and waste dump area consists of only development waste as the mine was never in production. The slopes of the waste dump are approximately at a 2H: 1V configuration and appear to be stable. The slopes show no evidence of erosion but it has been stabilized by the vegetation and is in good condition. At the toe of the waste dump is the stripped area that has been prepped to expand the dump when the mine reactivates. A sediment ditch runs along the base of the waste dump conveying any storm water and sedimentation to the storm water collection basin. The stripped area and out slopes of the pad can be seen in Photos Three and Four. Throughout the site, the vegetation has become well established and self-sustaining. The vegetation can be seen in all of the photos included in this report. Evidence of chemical treatment of small populations of noxious weeds was observed during the inspection.
