MINERALS PROGRAM INSPECTION REPORT
PHONE: (303) 866-3567

MINE NAME: Timnath Pit	MINE/PROSPECTING ID#: M-1989-056	MINERAL: Sand and gravel	COUNTY: Larimer
INSPECTION TYPE: Surety-Related Inspection	WEATHER: Clear	INSP. DATE: August 24, 2023	INSP. TIME: 09:45
OPERATOR: McAtee Construction Company	OPERATOR REPRESENTATIVE: Rodney Havens Joshua Kruchten	TYPE OF OPERATION: 112c - Construction Regular Operation

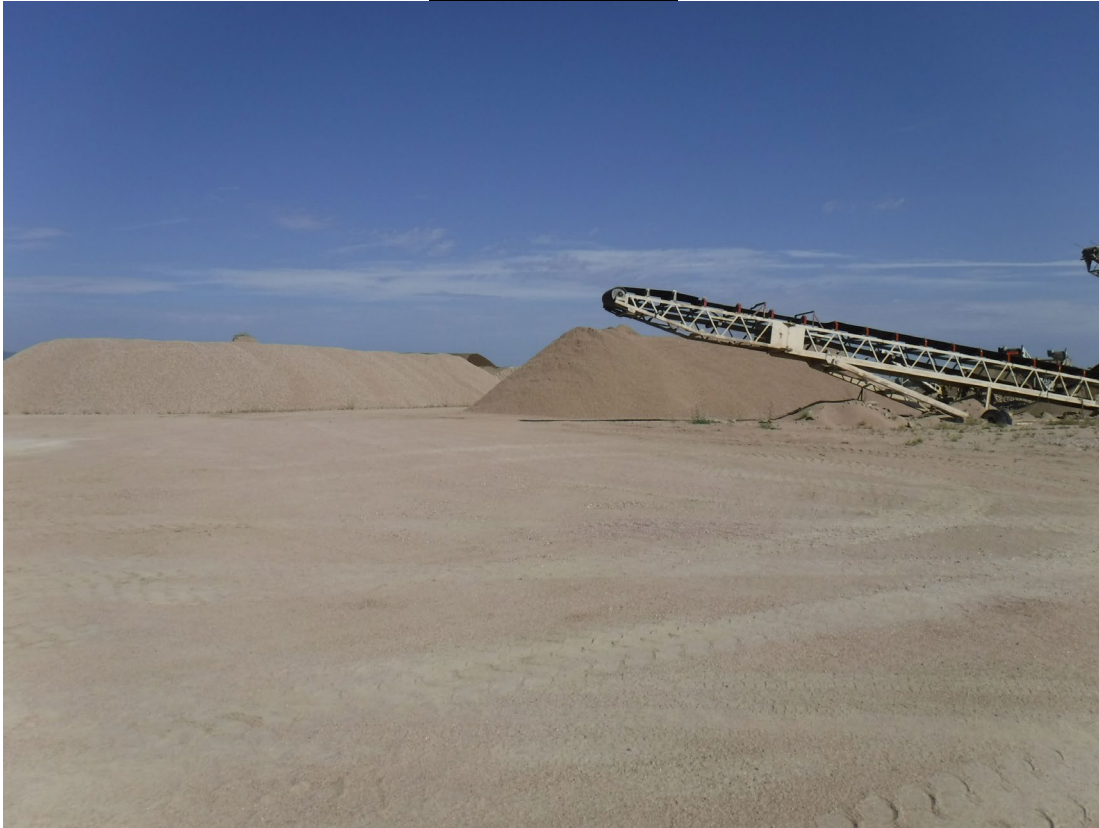
Photo 1: Processing stockpiles and equipment south end of Phase 2

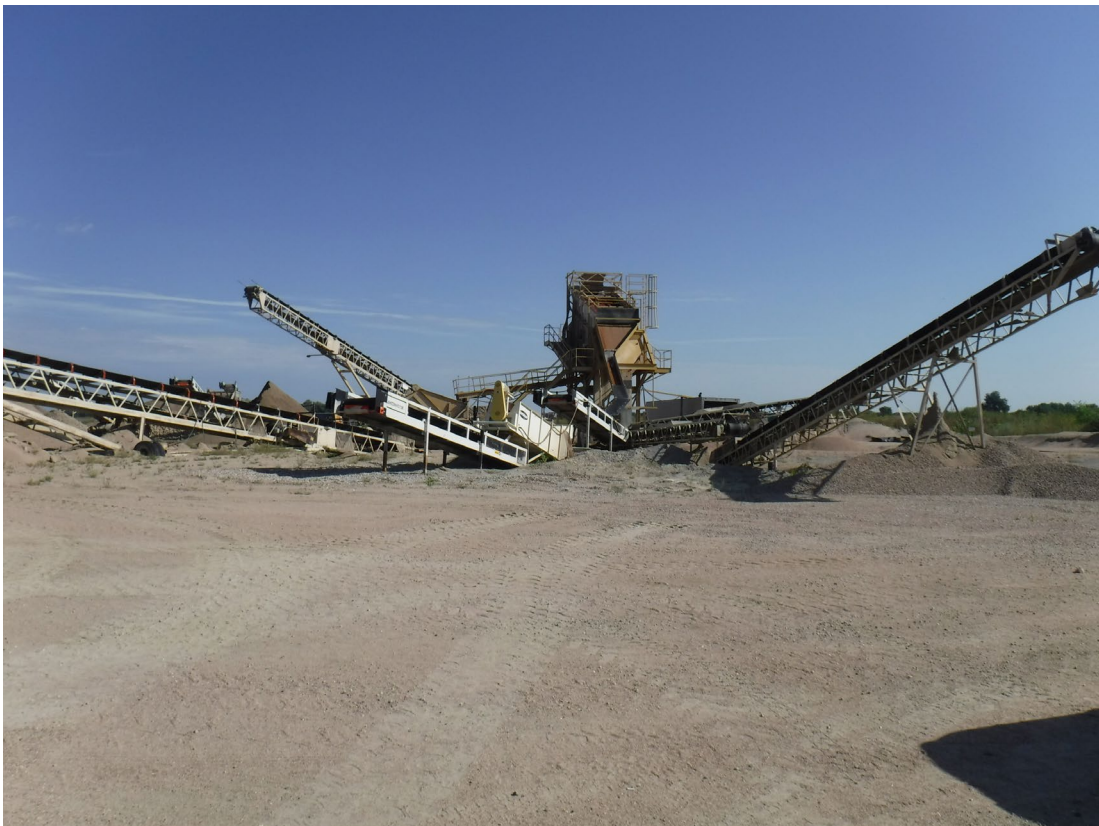
Photo 2: Processing plant, south end of Phase 2

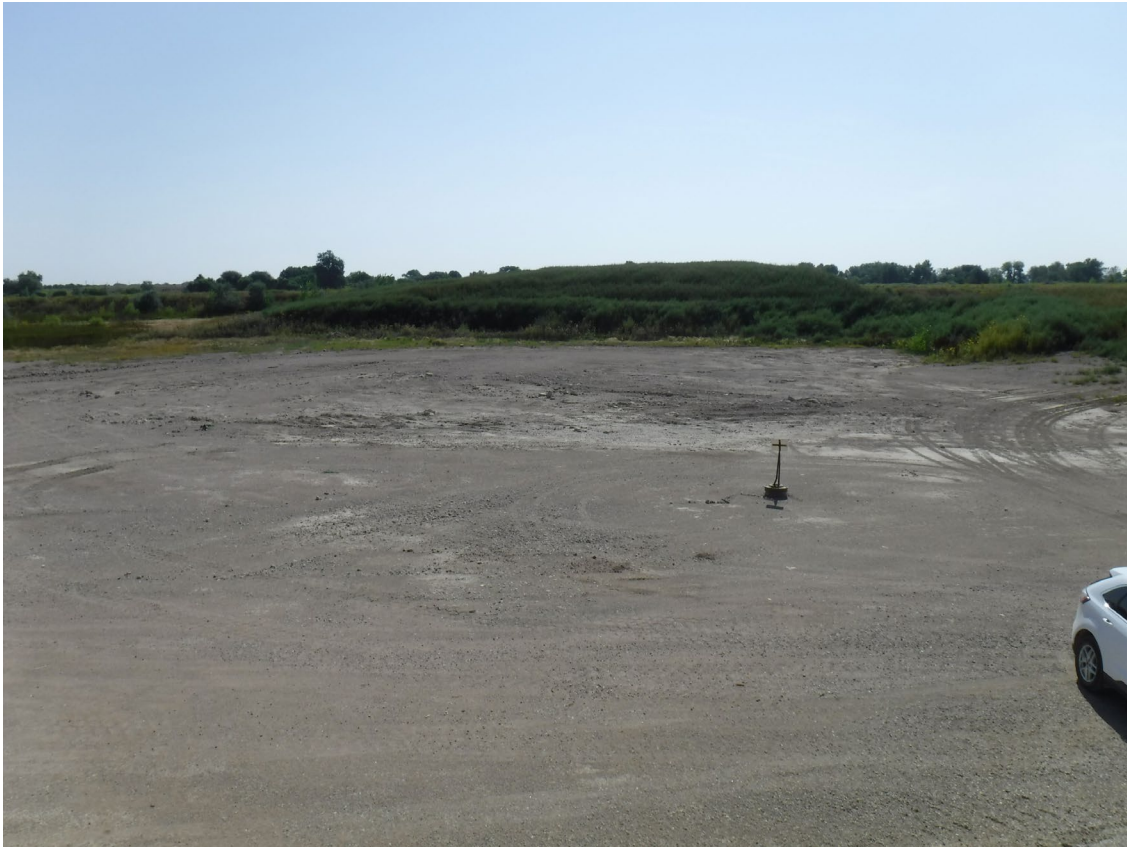
Photo 3: Topsoil stockpile, midpoint area of Phase 2 looking east

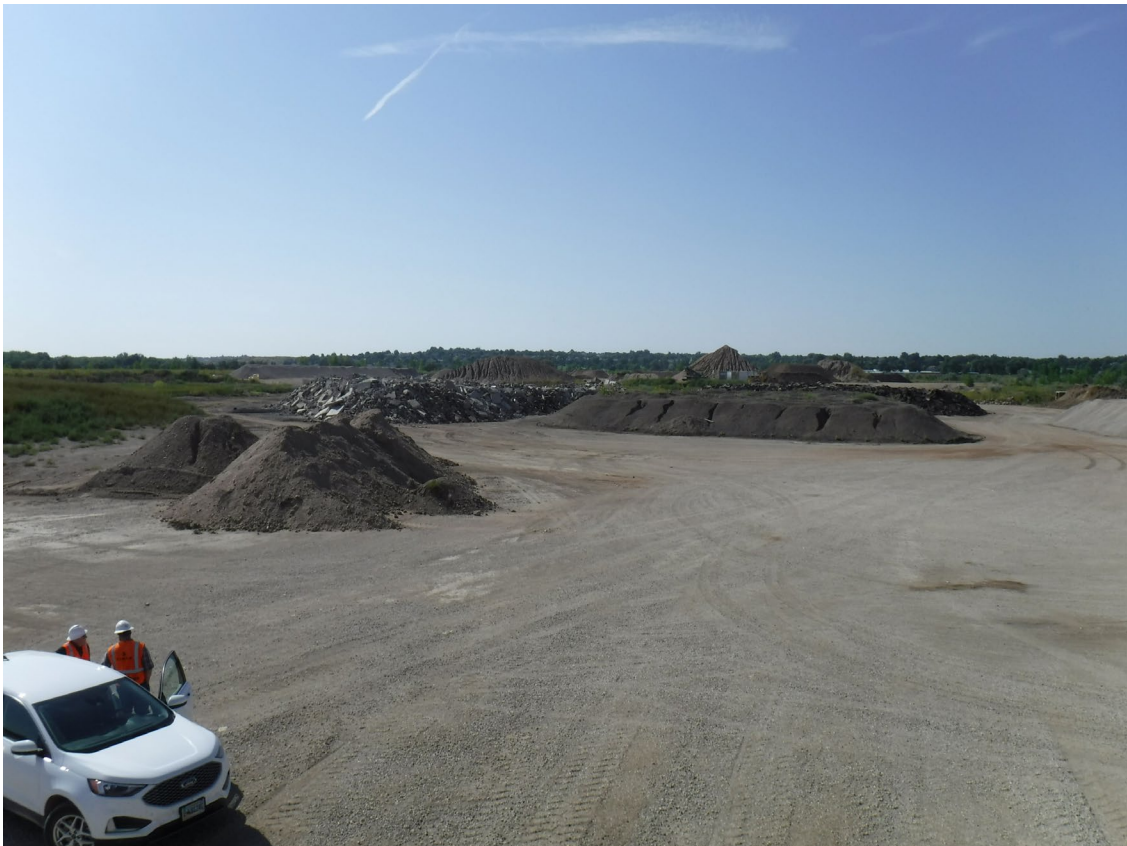
Photo 4: Looking south from a stockpile located at the midpoint of Phase2

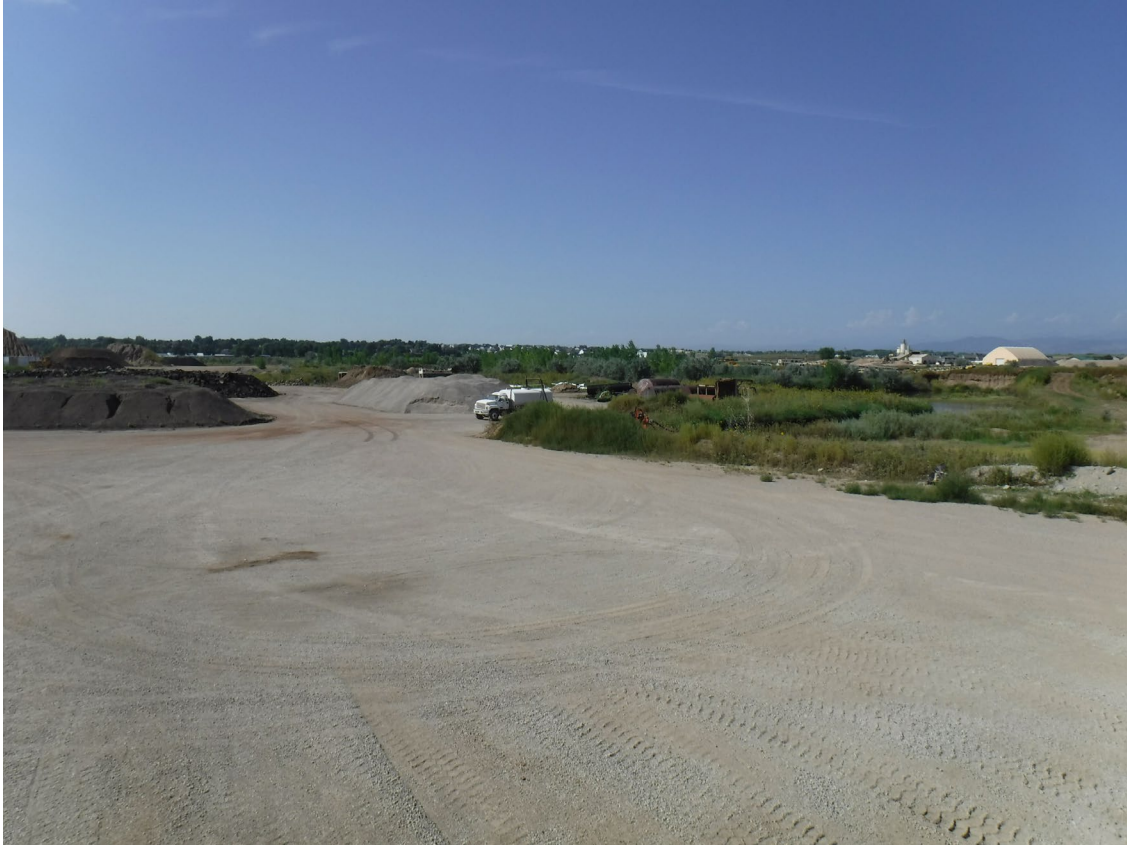
Photo 5: Concrete batch plant center right of photo, looking to southwest

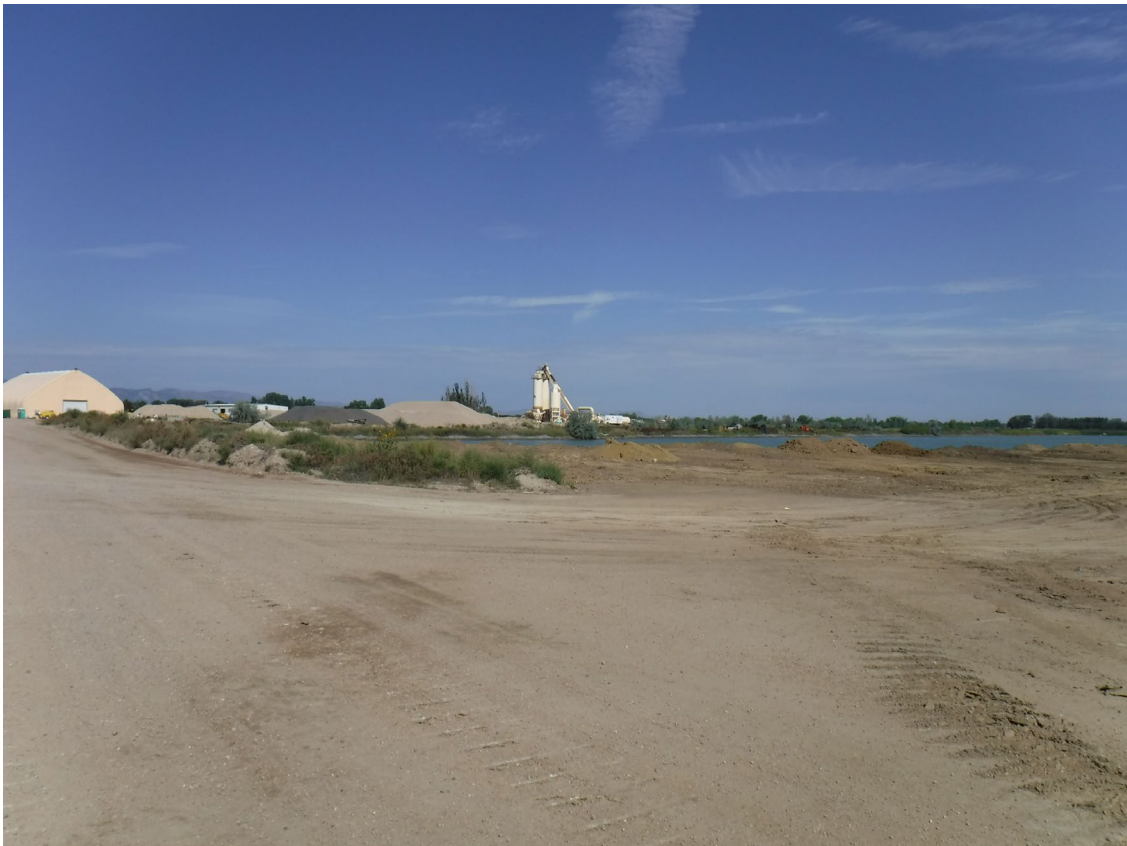
Photo 6: Asphalt batch plant center of photo, open water in foreground is Phase3

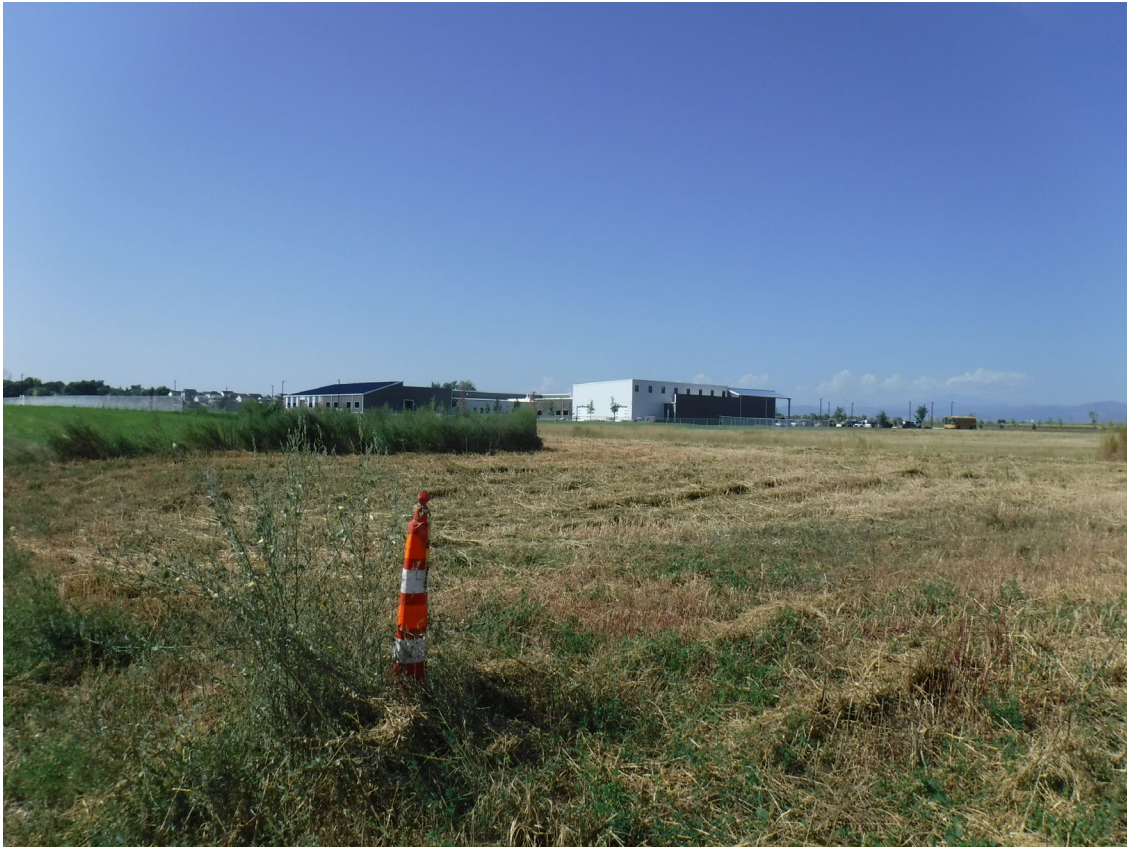
In the southwestern portion of the permit boundary there is a school that was recently built. The school occupies approximately 13.9 acres of land that was never affected by mining. During the inspection it was discussed with the new Operators that they would like to release this area from the permit boundary. The Division agrees that it should be released from the permit area and will approve a release request of the area once an Acreage Release request is submitted.

Photo 7: School located within permit boundary

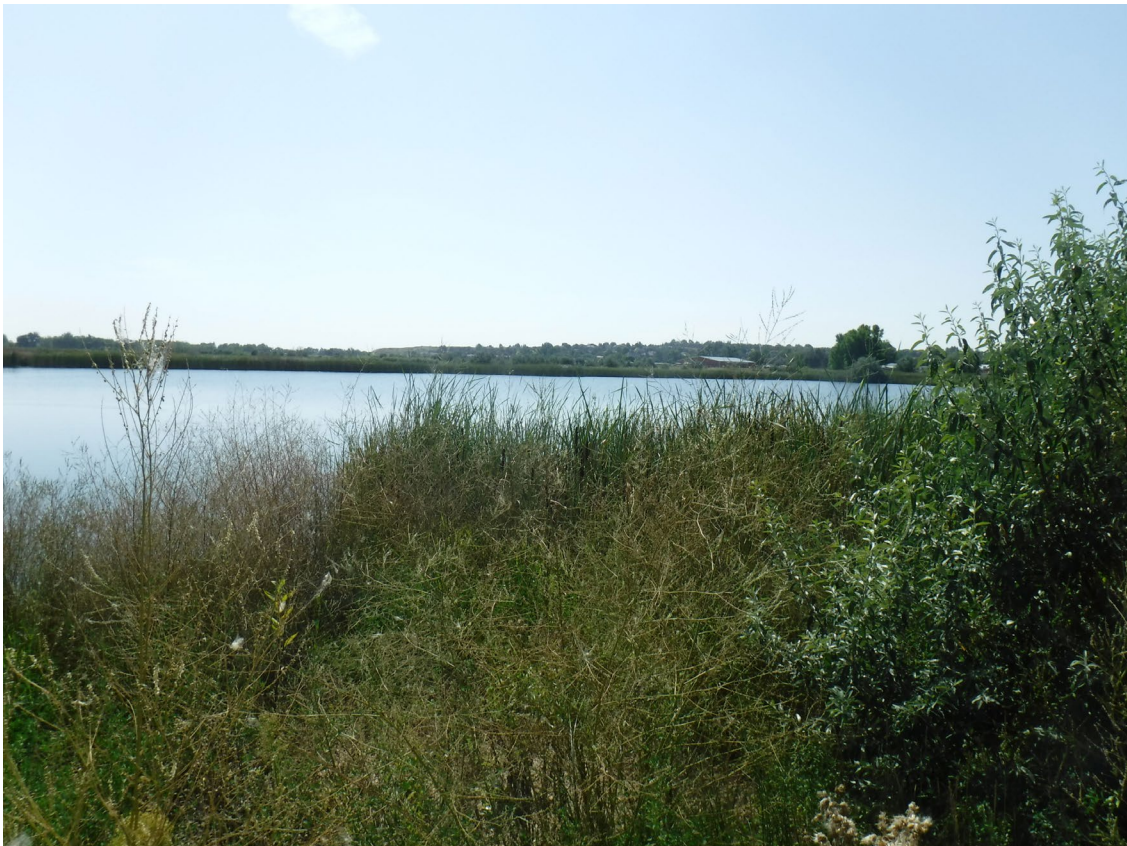
Photo 8: Open water area located to the east of the school

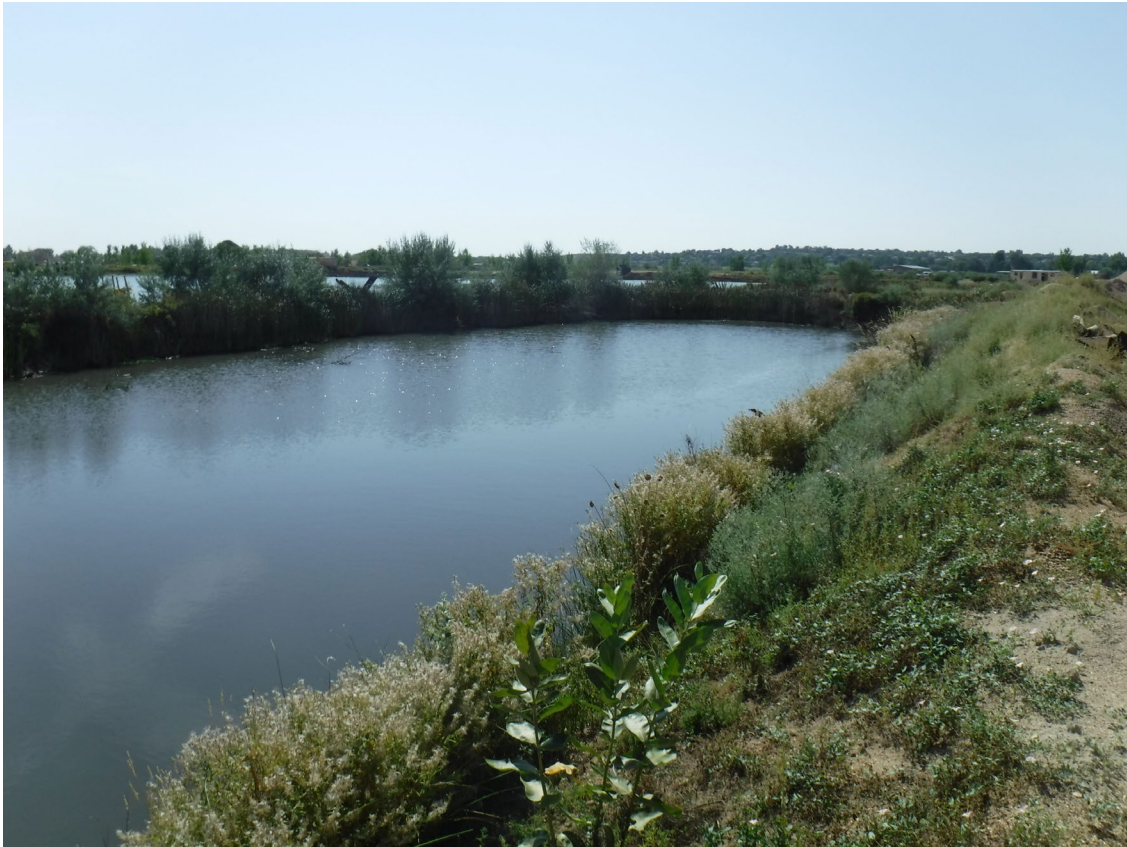
Photo 9: Mallard Creek in foreground adjacent to asphalt plant and open water of Phase 3 in background

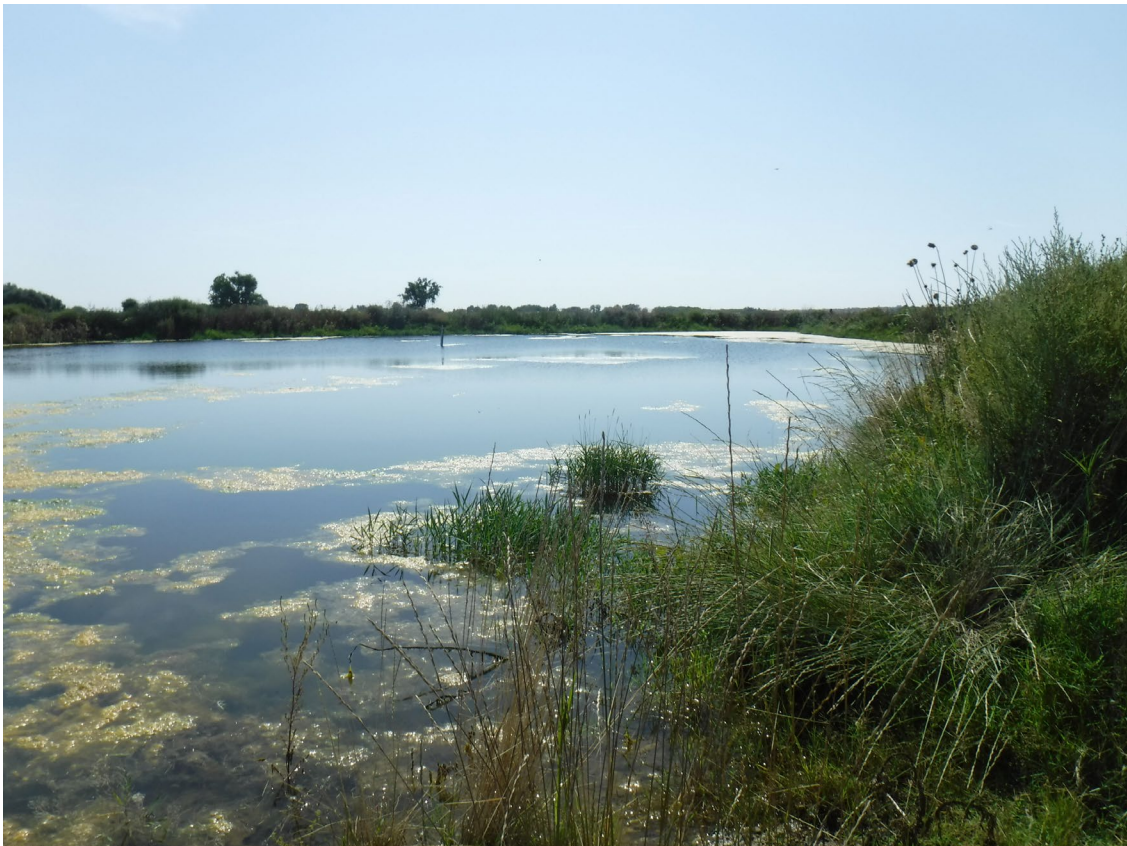
Photo 10: Recharge pond in the north of the permit area.
