C1983059, Terror Creek Loadout, October Inspection Report

PERMIT INFORMATION

Permit Number: C-1983-059 Mine Name: Terror Creek Loadout Operator: Oxbow Mining, LLC Operator Address: Mr Doug Smith PO Box 535 Paonia, CO 81434	County: Delta Operation Type: Loadout Permit Status: Active Ownership: Private
	Operator Representative Present: Doug Smith
Operator Representative Signature: (Field Issuance Only)

Inspection Start Date: October 26, 2023 Inspection Start Time: 08:30 Inspection End Date: Inspection End Time:	Inspection Type: Coal Partial Inspection Inspection Reason: Normal I&E Program Weather: Clear
Joint Inspection Agency: None	Joint Inspection Contacts:
Post Inspection Agency: None	Post Inspection Contacts:
Inspector(s): Leigh Simmons	Inspector's Signature:

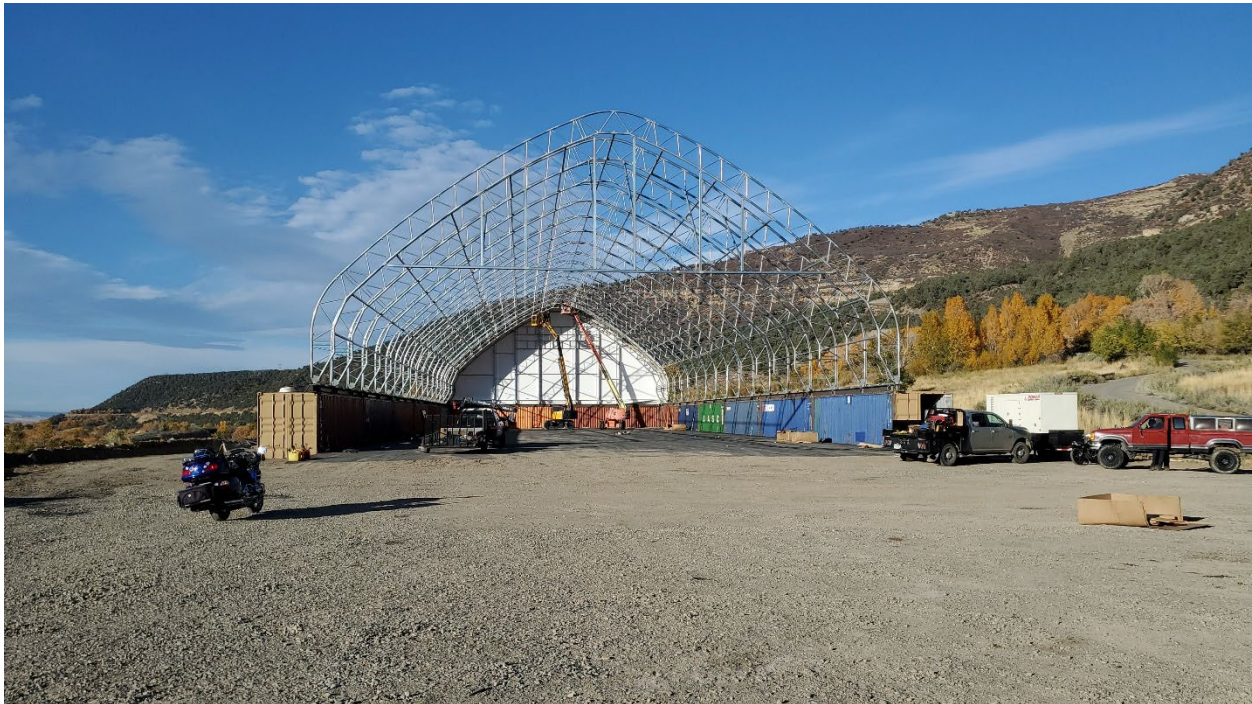
The lower pad had been leveled and compacted. Gravel had been spread and the placement of the shipping containers was complete. Asphalt had been placed inside the space contained by the shipping containers, and the erection of the temporary building on top of them had begun.

Figure 1: Construction of temporary building in progress

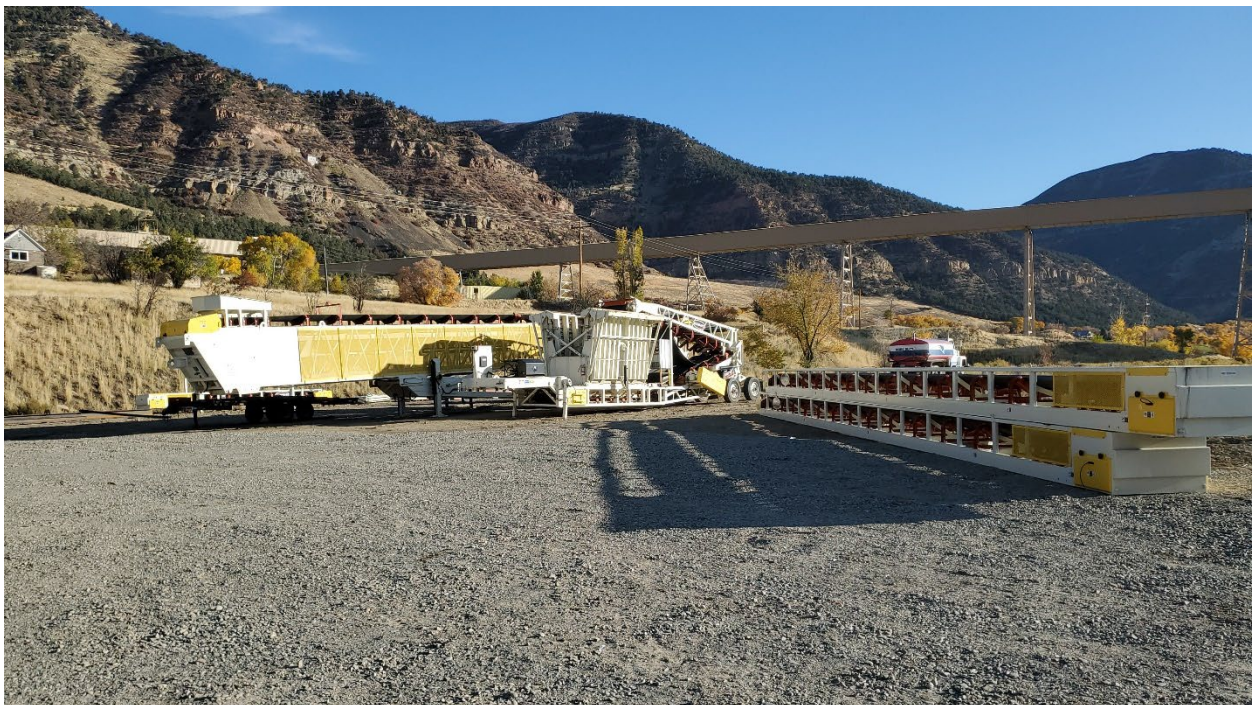
The Terror Creek site had been leased to Gunnison Energy and is expected to be used to store materials and equipment for their oil and gas activities through summer 2024. Several mobile conveyors had been brought to the site (some of which are to help with the construction of the building and one of which will remain on site to help with loading and unloading sand). The mobile conveyors are considered “heavy equipment”, the storage of which is discussed in section 2.05.5 of the Permit Application Packet; they are the property of Gunnison Energy and are not bonded for under Oxbow’s mining permit.

Figure 2: Mobile conveyors on site

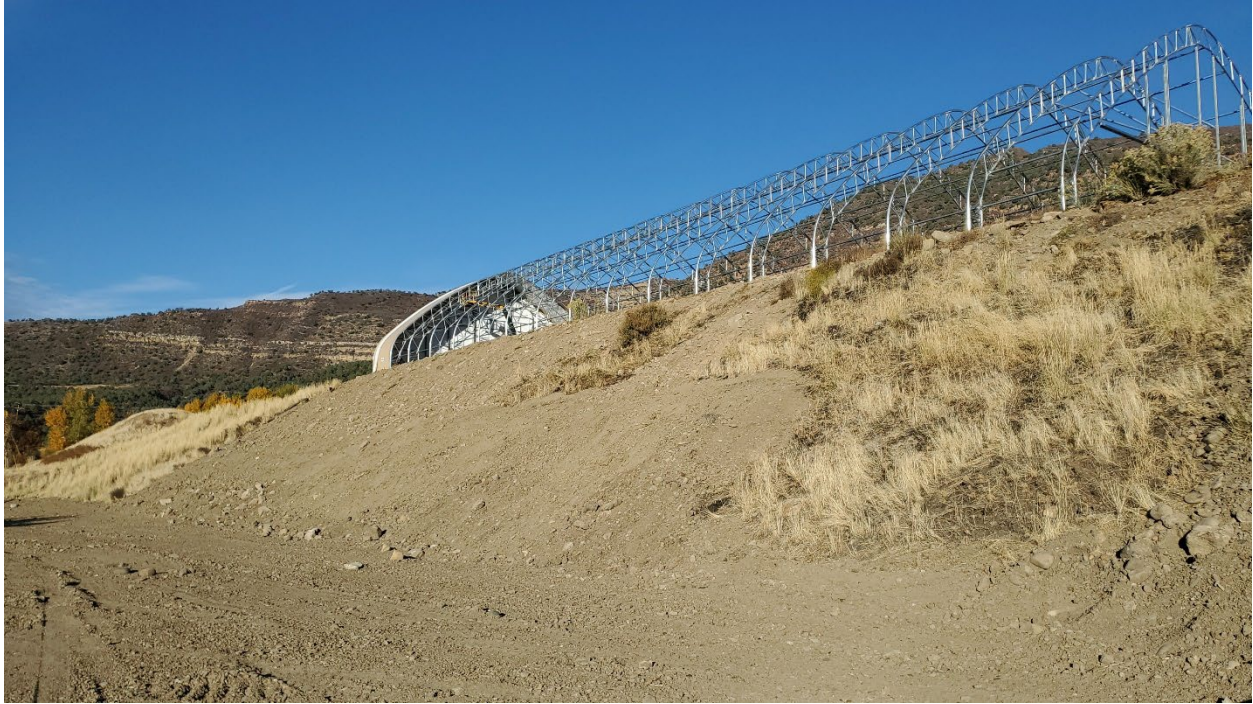
The remaining concrete foundations and coal waste had been demolished and covered with soil. The disturbance had been seeded.

Figure 3: Railroad embankment showing demolition of remaining concrete foundations

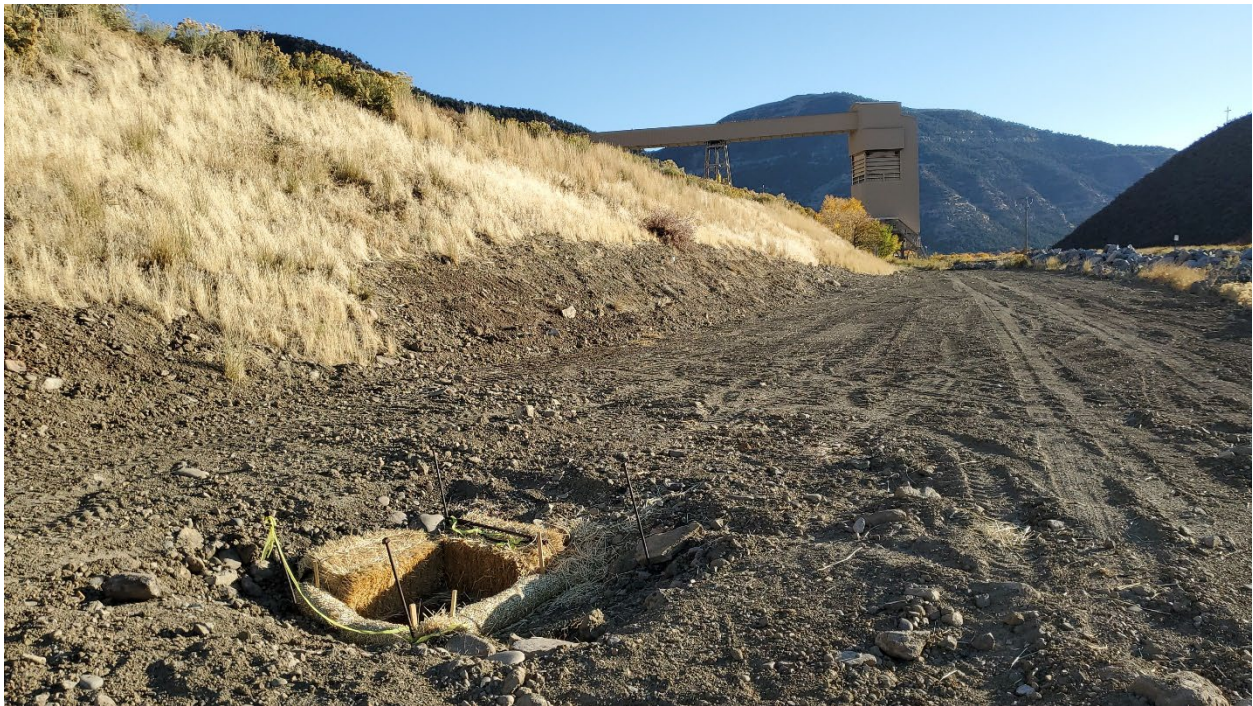
The inlet to the culvert under the railway tracks had been cleaned and protected with straw bales.

Figure 4: Inlet to culvert under the railroad
