PERMIT INFORMATION

Permit Number: C1981033 Mine Name: Bear Mine Operator: N/A Operator Address: N/A	County: Gunnison Operation Type: Underground Permit Status: Revoked Ownership: Private
	Operator Representative Present: N/A
Operator Representative Signature: (Field Issuance Only)

INSPECTION INFORMATION

Inspection Start Date: October 26, 2023 Inspection Start Time: 09:00 Inspection End Date: Inspection End Time:	Inspection Type: Coal Complete Inspection Inspection Reason: Normal I&E Program Weather: Clear
Joint Inspection Agency: None	Joint Inspection Contacts:
Post Inspection Agency: None	Post Inspection Contacts:
Inspector(s): Leigh Simmons	Inspector's Signature:

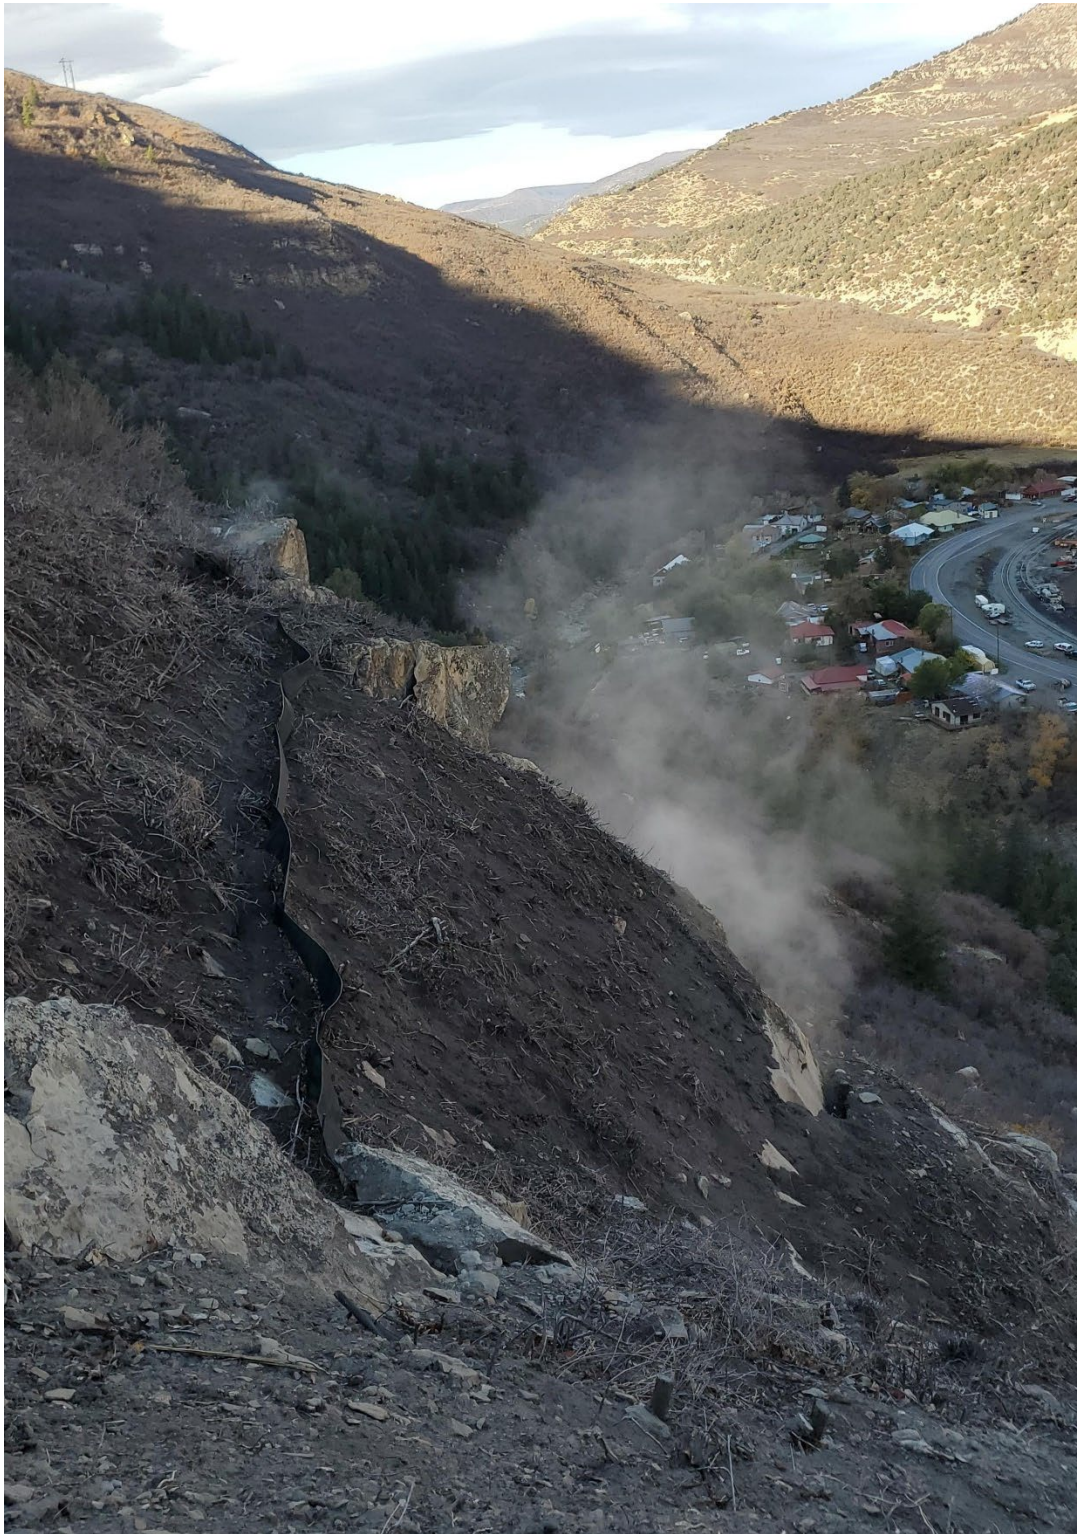
Figure 1: Active vent at west end of bench

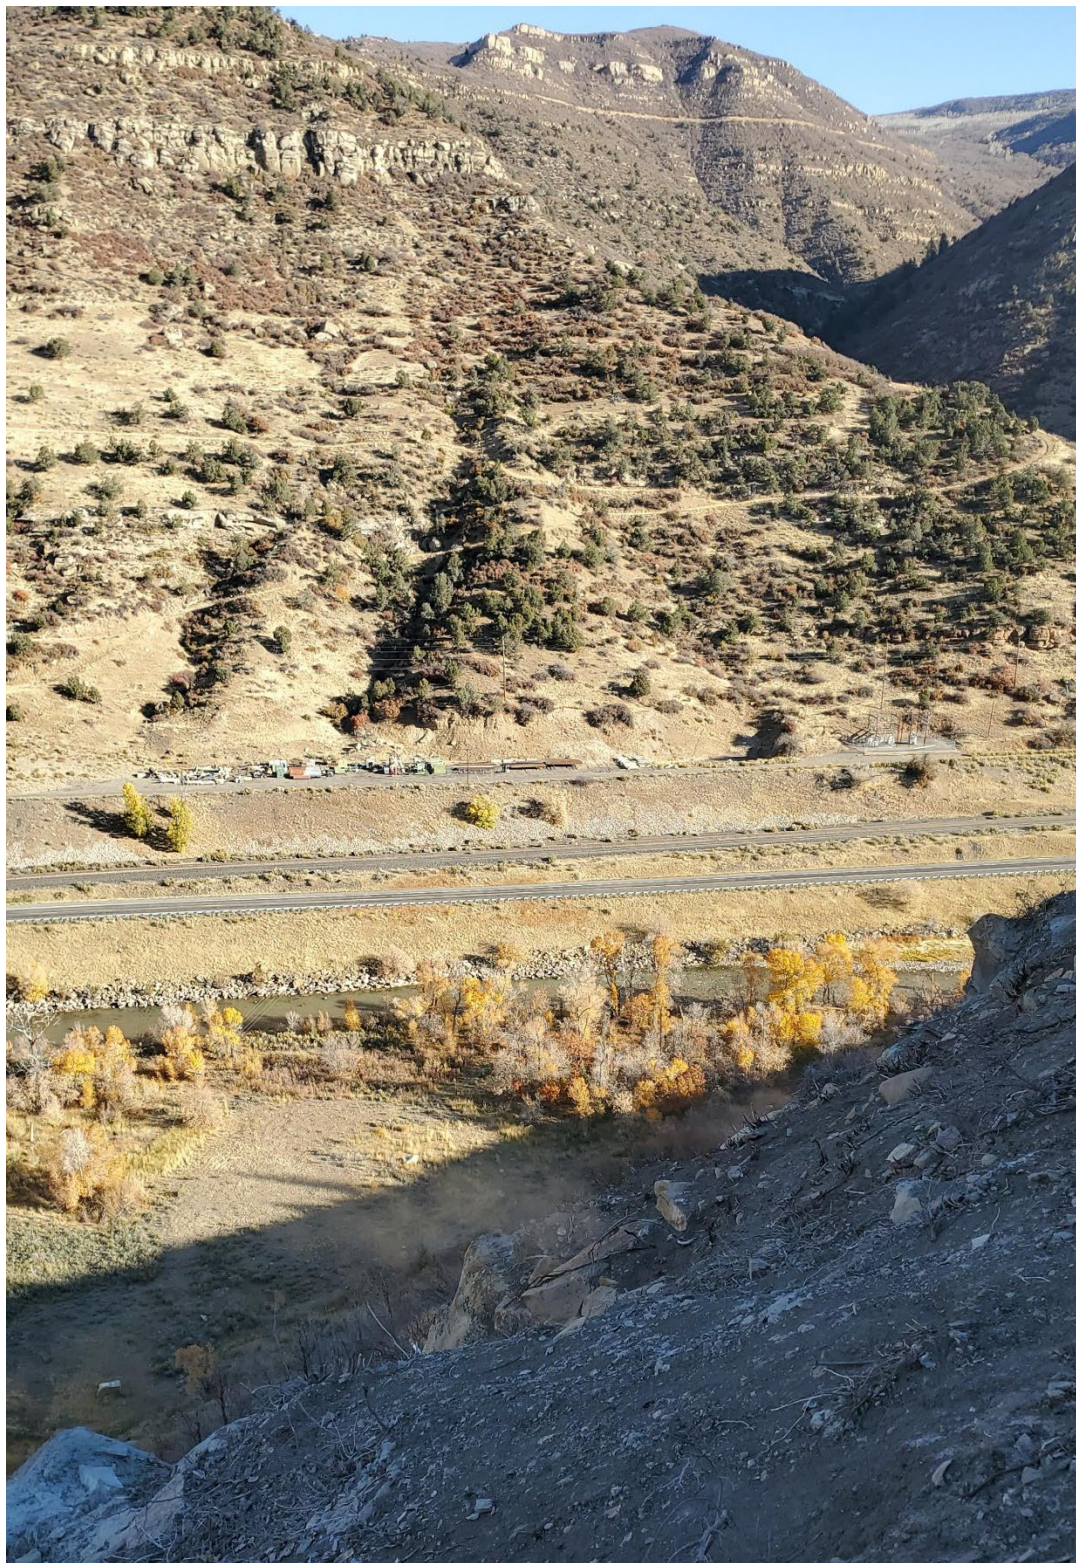
Figure 2: More vents a few yards further east

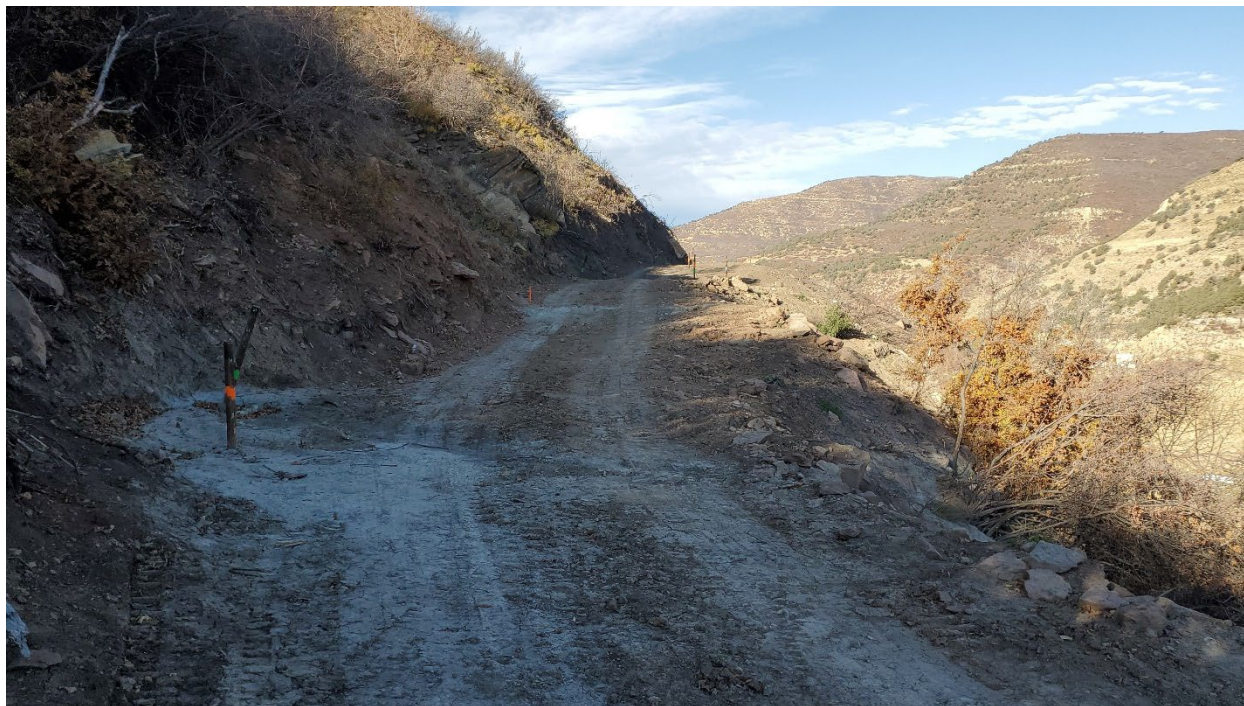
Figure 3: New holes along bench

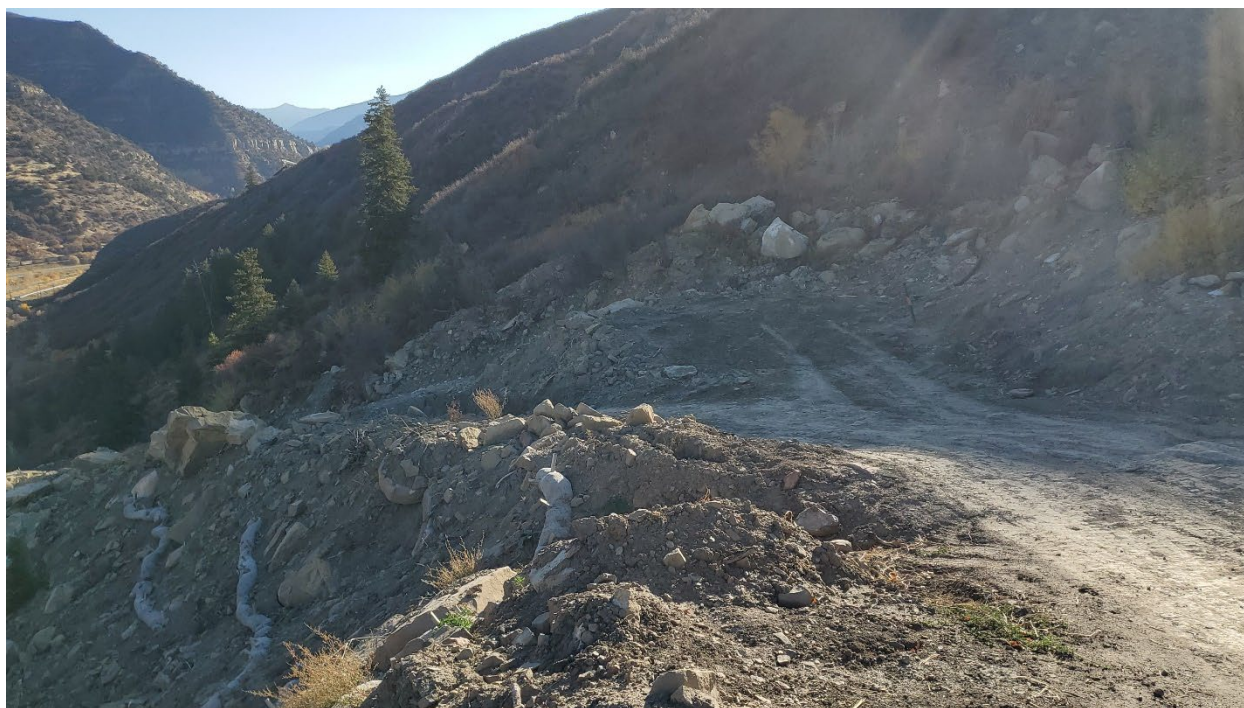
Figure 4: Existing sediment control, to be improved in early November

Contractors with Hayduke Environmental were expected to spend around five days at the site in early November to create water bars and/or rolled dips on the temporary road, with rock armoring on the downslope side; the inside ditch on the road will be cleaned and defined; and silt fence will be installed as necessary across the hillside (straw wattles are not expected to be used).

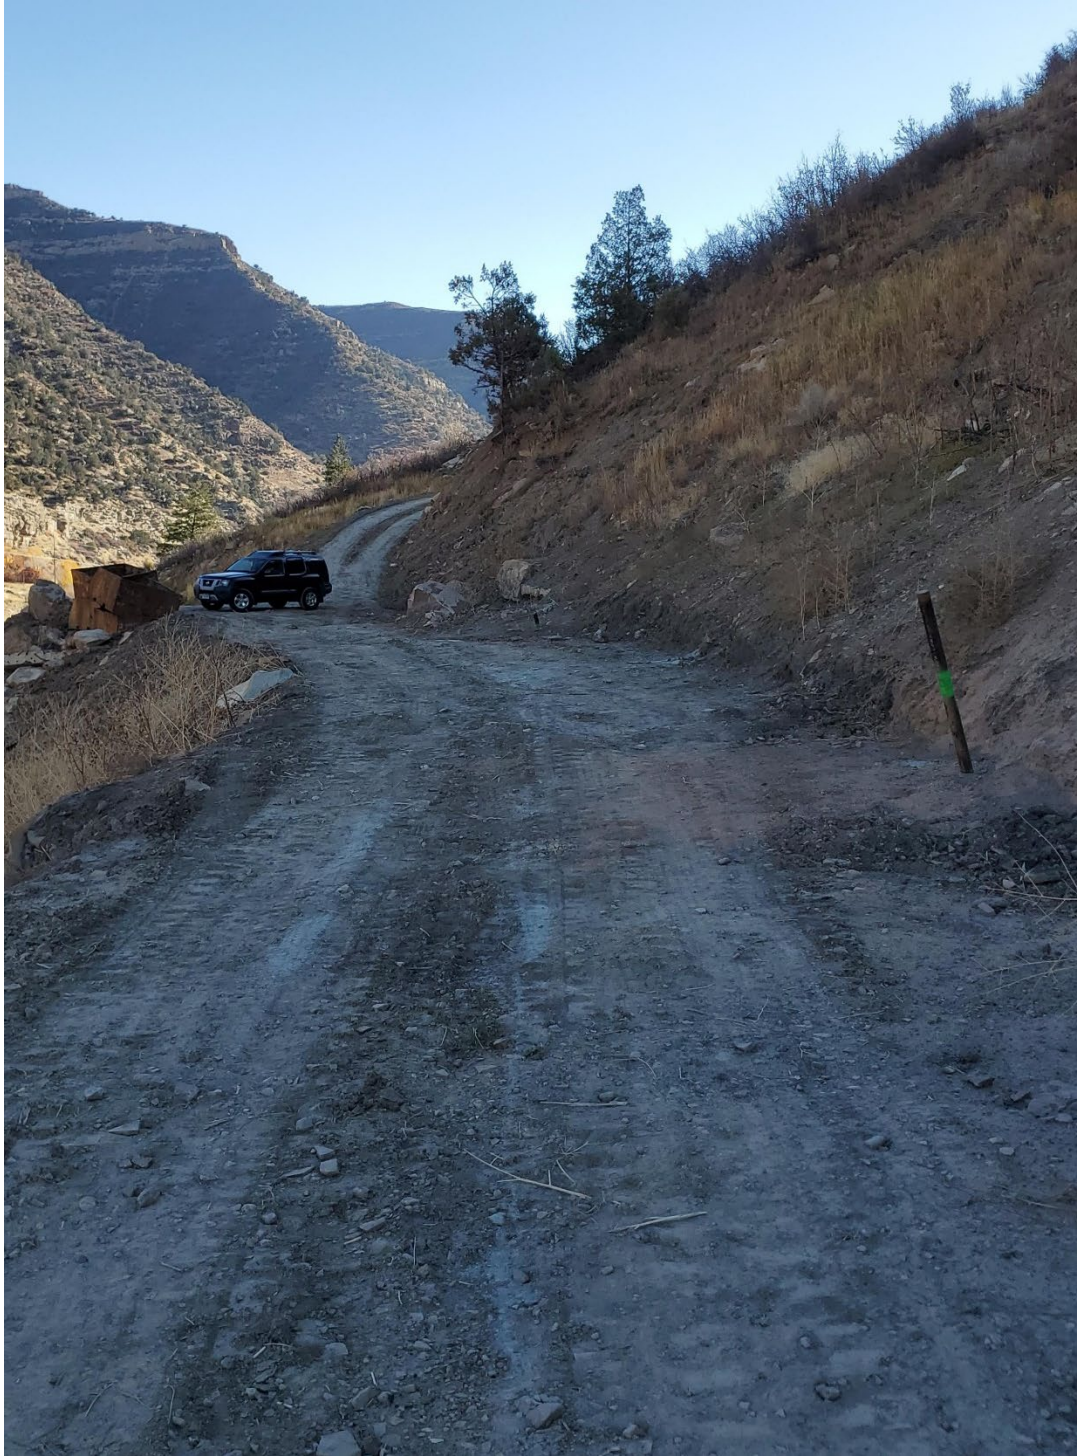
Figure 5: Eastern end of bench

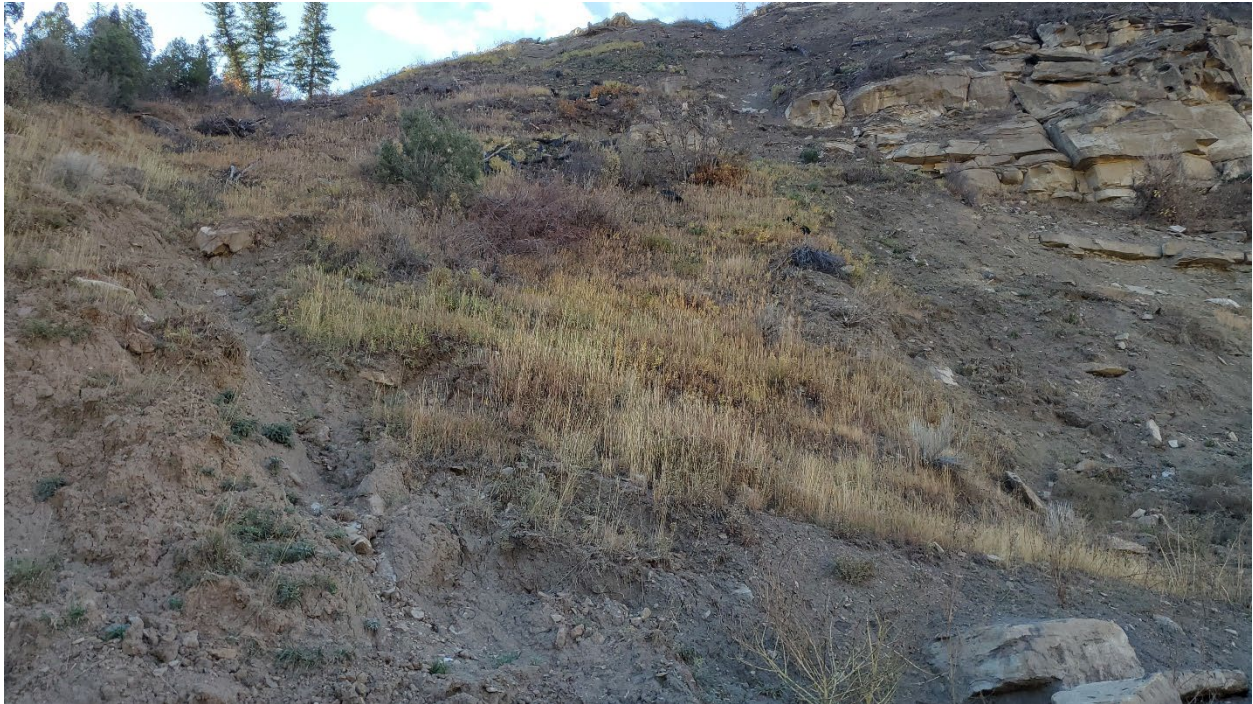
Figure 6: Current state of hillside below bench

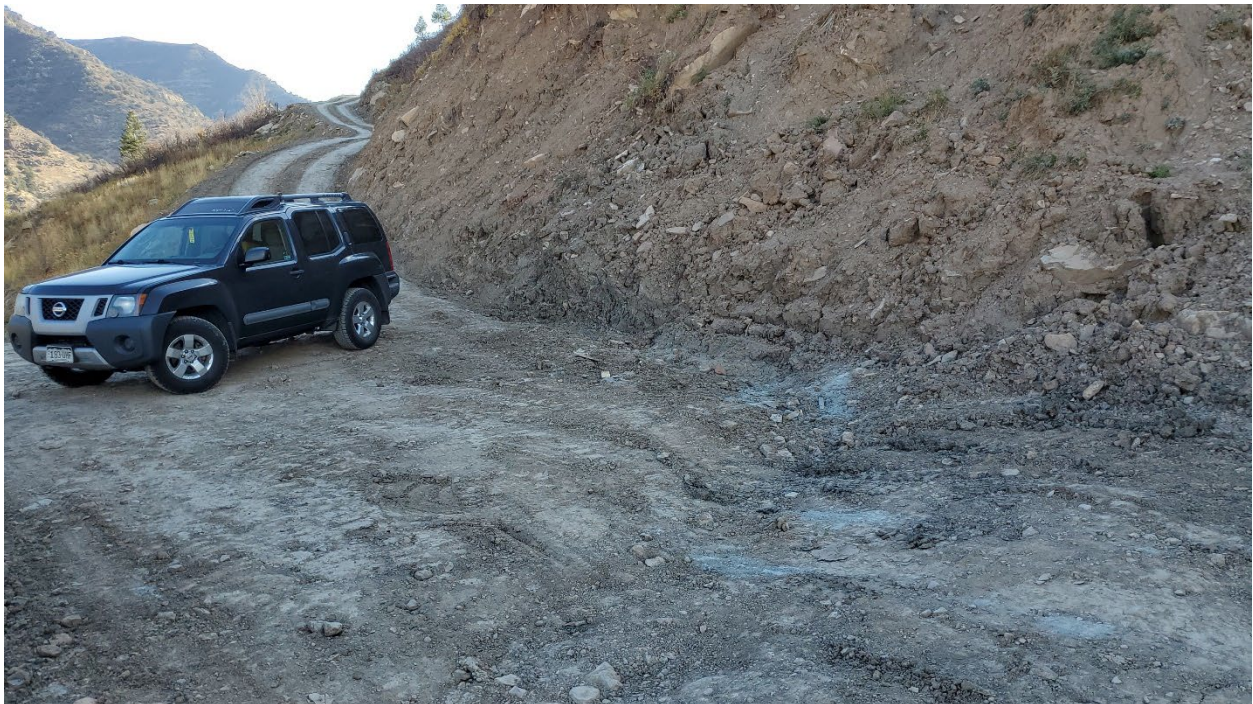
Figure 7: Indistinct road ditch at eastern end of lower road
