MINERALS PROGRAM INSPECTION REPORT

MINE NAME: Stage Stop Pit	MINE/PROSPECTING ID#: M-1984-025	MINERAL: Sand and gravel	COUNTY: Saguache
INSPECTION TYPE: Surety Release Inspection	WEATHER: Clear	INSP. DATE: October 24, 2023	INSP. TIME: 13:00
OPERATOR: Southway Construction Company, Inc.	OPERATOR REPRESENTATIVE: Paul Bottini	TYPE OF OPERATION: 112c - Construction Regular Operation	
REASON FOR INSPECTION: Surety Release Requested	BOND CALCULATION TYPE: None	BOND AMOUNT: \$55,081.00	
DATE OF COMPLAINT: NA	POST INSP. CONTACTS: None	JOINT INSP. AGENCY: None	
INSPECTOR(S): Todd Jesse	INSPECTOR'S SIGNATURE:

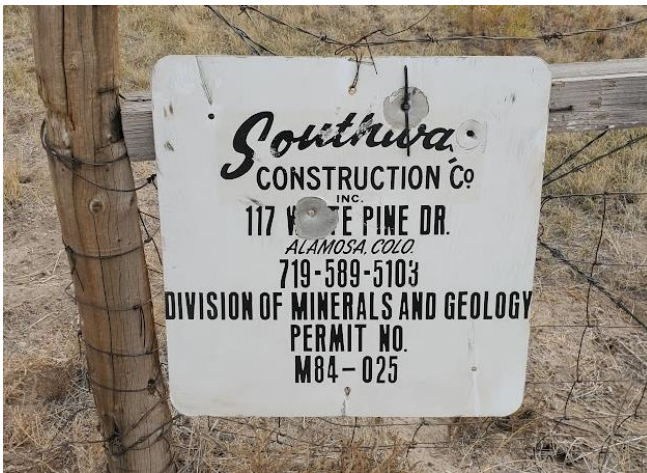
View to the south showing proper Mine ID signage posted at the entrance to the site.

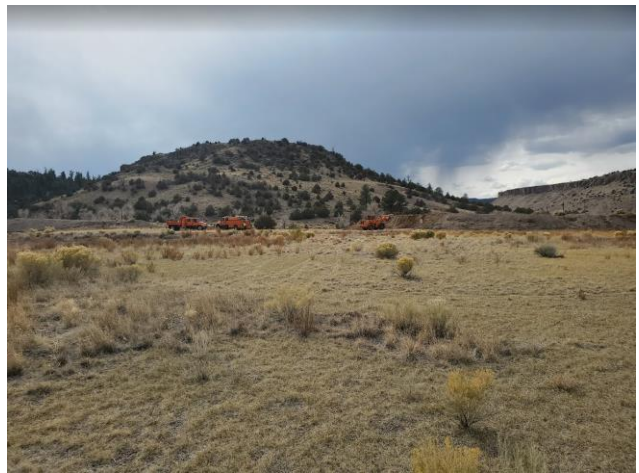
CDOT crews were actively taking stockpiled material from the permit boundary for a road project on Hwy 114 adjacent to the pit during the inspection. The permit cannot be released while material is being actively removed from the property. During the inspection the company representative stated that the stockpile was not inside the Permit Boundary, which was incorrect. The Mining Map that was submitted by Southway Construction when they assumed the permit in 1999 clearly shows this stockpile within the boundary. A copy of the Mine Plan Map is attached to this report for the operator's reference. Also attached is the Reclamation Map. As shown on the Reclamation Map, the approved Reclamation Plan calls for stockpiles to be removed from site or graded into slopes before release. Currently there are still three major stockpiles in the permit boundary – a product stockpile that CDOT crews were pulling from, an asphalt stockpile in the center of the pit and topsoil stockpile along the western side of the pit. These stockpiles will need to be removed from site or graded before release per Rule 3.1.5

View to the west showing CDOT crews pulling material from onsite stockpile.

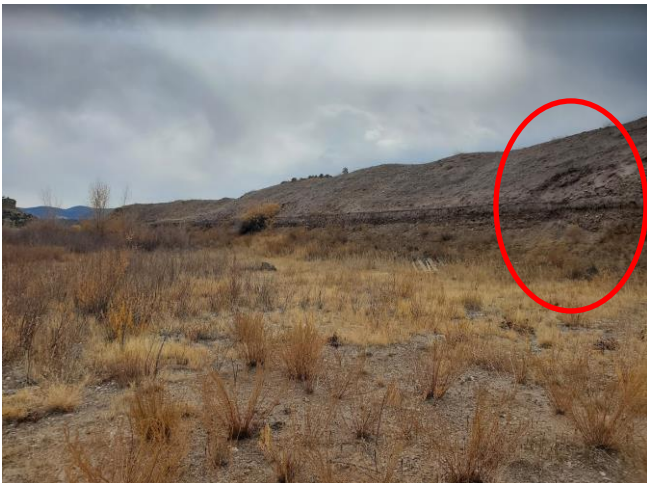
There are still two remaining highwalls on the property. The highwall along the western edge of the pit is approximately 6-8 feet tall and 300 feet long. There is also a highwall that is roughly 6 feet tall and 30 feet long located in the northeast corner of the Pit. Per Rule 3.1.5 highwalls must be eliminated or stabilized. The highwall is not stable and is sluffing as seen in Photo 3.

View to the southwest of highwall with signs of sluffing circled in red.

Additionally, once the highwalls and stockpiles are removed those areas will need to be revegetated in accordance with the Reclamation Plan requirements.

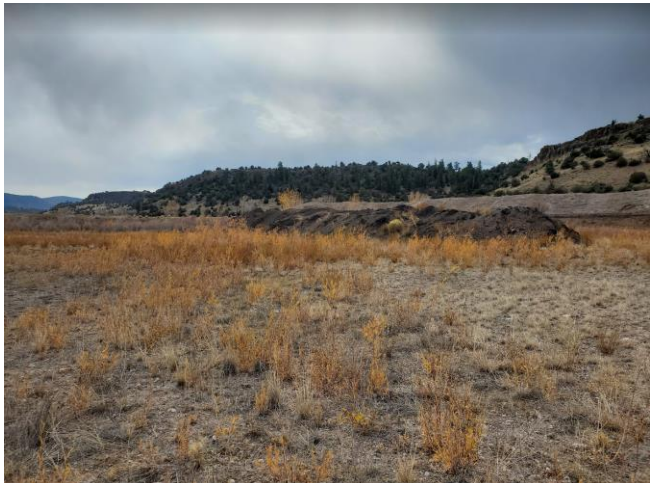
View to the southwest showing asphalt stockpile on site.

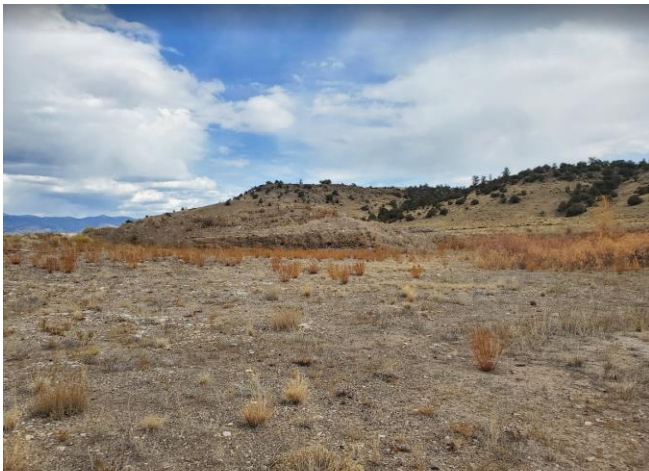
View to the east showing smaller highwall.

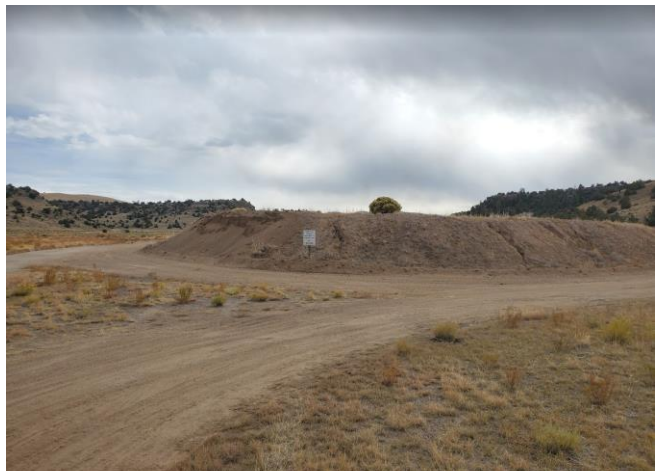
View to the south showing product stockpile in the permit boundary.
