MINERALS PROGRAM INSPECTION REPORT
PHONE: (303) 866-3567

MINE NAME: King Pit	MINE/PROSPECTING ID#: M-2004-036	MINERAL: Clay (general) and sand gravel	COUNTY: Washington
INSPECTION TYPE: Monitoring	WEATHER: Clear	INSP. DATE: September 12, 2023	INSP. TIME: 11:00
OPERATOR: Mason King	OPERATOR REPRESENTATIVE: Mason King	TYPE OF OPERATION: 110c - Construction Limited Impact	
REASON FOR INSPECTION: Normal I&E Program	BOND CALCULATION TYPE:	BOND AMOUNT: \$14,300.00	
DATE OF COMPLAINT: NA	POST INSP. CONTACTS: None	JOINT INSP. AGENCY: None	
INSPECTOR(S): Brock Bowles	INSPECTOR'S SIGNATURE:

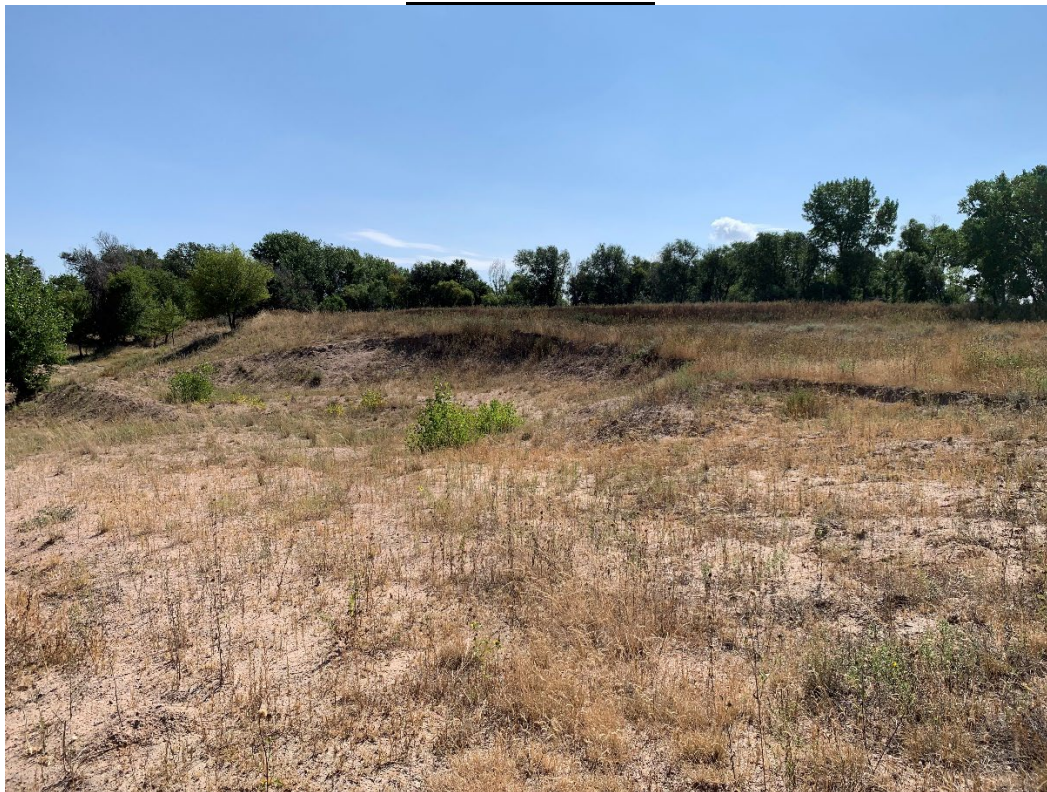
West pit- four permit boundary markers were identified. The topsoil stockpile was on the north side of the pit, was well vegetated and appeared to be stable. It did not appear that this pit had been mined recently due to the vegetation in the bottom of the pit. No signs of erosion were seen.

Photo 1 – West pit area, highwall on south side of pit

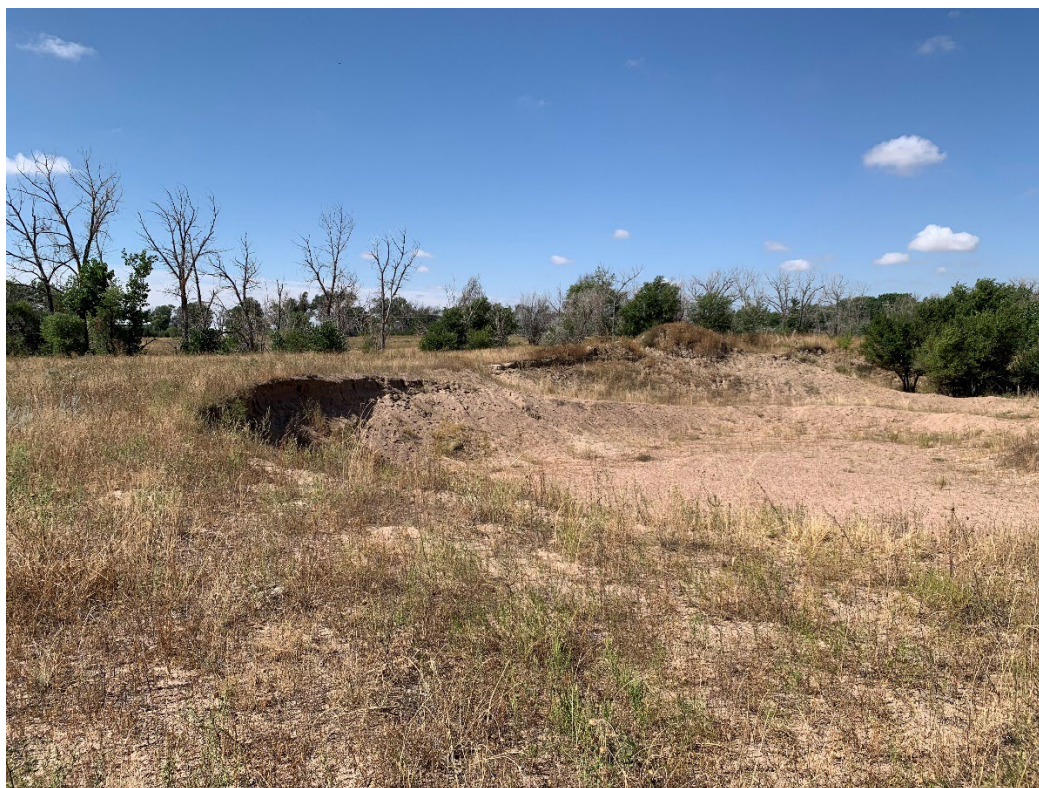
East pit- four permit boundary markers were identified. Topsoil was stockpiled on the north side of the pit, was well vegetated and appeared to be stable. The highwall on the south and east sides were 10 feet high. No signs of erosion were seen.

Photo 2 – East pit area, highwall on south side of pit
