MINERALS PROGRAM INSPECTION REPORT
PHONE: (303) 866-3567

MINE NAME: V.F. Smith Pit #5	MINE/PROSPECTING ID#: M-1981-309	MINERAL: Sand and gravel	COUNTY: Washington
INSPECTION TYPE: Monitoring	WEATHER: Clear	INSP. DATE: September 12, 2023	INSP. TIME: 10:30
OPERATOR: Mason King	OPERATOR REPRESENTATIVE: Mason King	TYPE OF OPERATION: 110c - Construction Limited Impact	
REASON FOR INSPECTION: Normal I&E Program	BOND CALCULATION TYPE: Complete Bond	BOND AMOUNT: \$7,849.00	
DATE OF COMPLAINT: NA	POST INSP. CONTACTS: None	JOINT INSP. AGENCY: None	
INSPECTOR(S): Brock Bowles	INSPECTOR'S SIGNATURE:

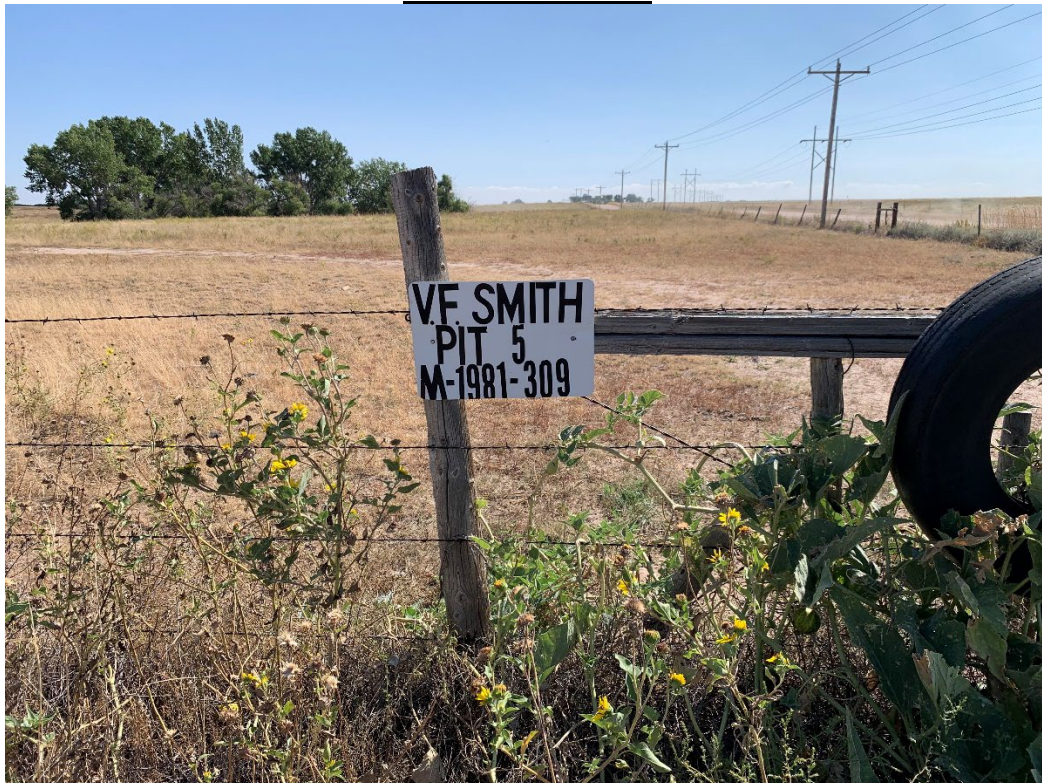
The mine entrance sign was in place with the required information and the permit boundary markers were in place. No mining was taking place.

Photo 1 – Mine entrance sign facing CR UU

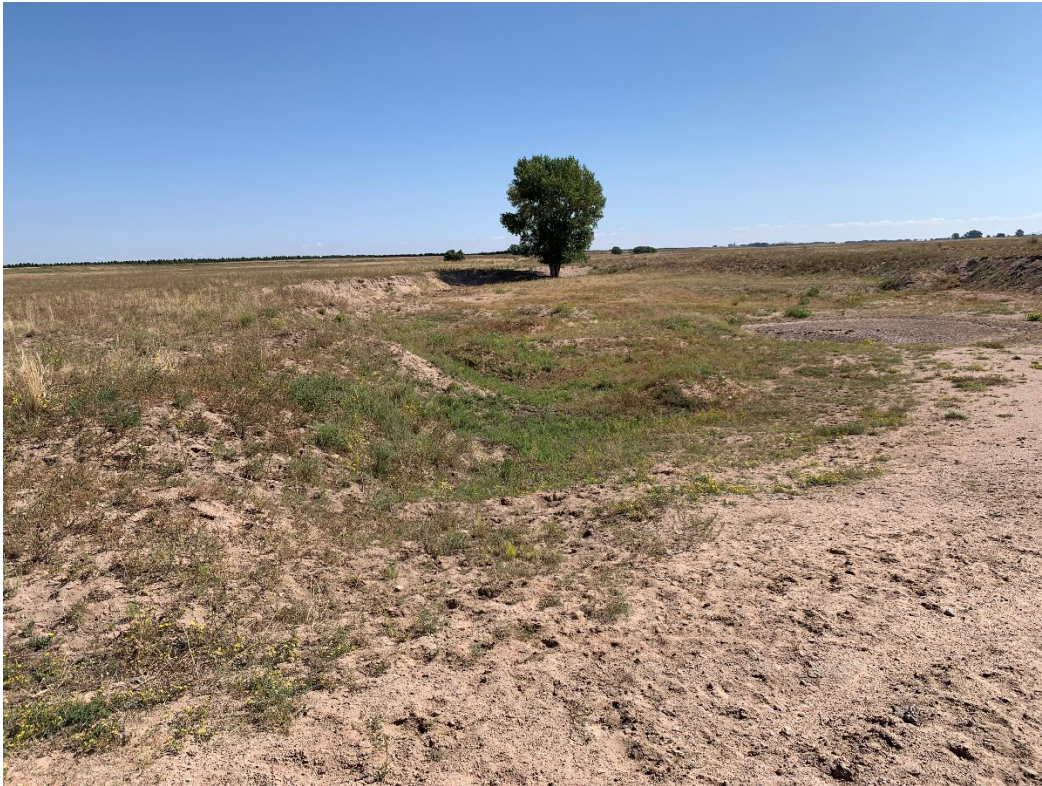
The highwall was approximately 8 feet high at the highest point and about 50 feet long. Most of the highwalls in the rest of the pit had been graded and were mostly covered in vegetation. No noxious weeds were seen in the permit area.

Photo 2 – Pit area facing north

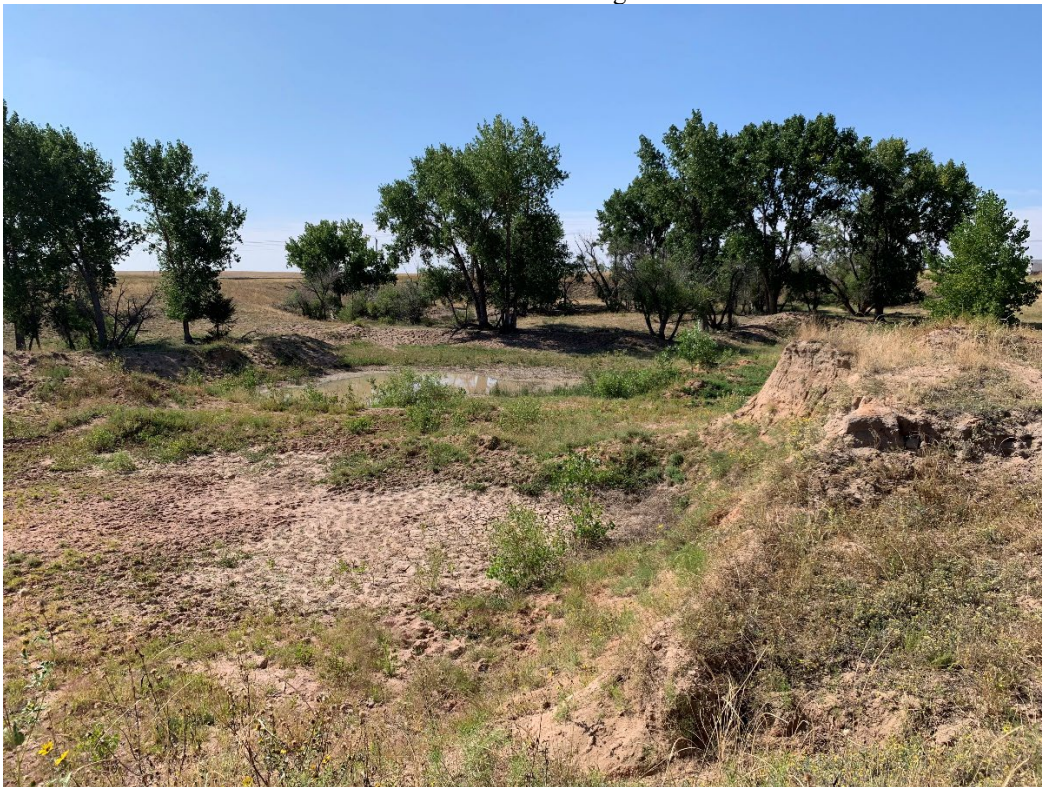
About 2 acres were disturbed as part of the active mining area. The pit is not used very often and most of the pit area has self-reclaimed. The area south of the active mining area is about 2 acres in size and is well vegetated with grasses and mature trees.

Photo 2 – Pit area facing south
