MINERALS PROGRAM INSPECTION REPORT
PHONE: (303) 866-3567

MINE NAME: Boot Jack River Rock Processing Area	MINE/PROSPECTING ID#: M-2019-016	MINERAL: Aggregate	COUNTY: Mineral
INSPECTION TYPE: Monitoring	WEATHER: Clear	INSP. DATE: October 24, 2023	INSP. TIME: 15:30
OPERATOR: Boot Jack Ranch, LLC	OPERATOR REPRESENTATIVE: Dennis Burch	TYPE OF OPERATION: 110c - Construction Limited Impact	
REASON FOR INSPECTION: Normal I&E Program	BOND CALCULATION TYPE: Complete Bond	BOND AMOUNT: \$8,894.00	
DATE OF COMPLAINT: NA	POST INSP. CONTACTS: None	JOINT INSP. AGENCY: None	
INSPECTOR(S): Todd Jesse	INSPECTOR'S SIGNATURE:

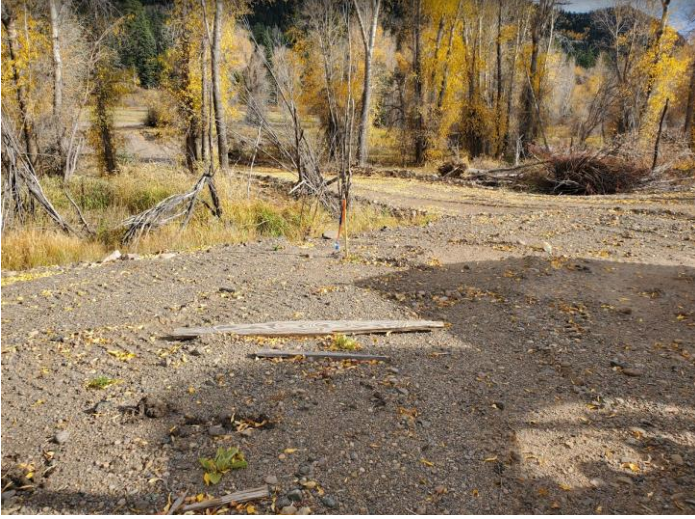
The proper mine identification signage was posted at the entrance to the site. Permit boundaries are clearly marked with flagging on posts. The site was not active at the time of the inspection, but screening and hauling equipment are on site. Hydrocarbons are stored in a support facility just outside of the permit boundary and are used to support not only the processing area, but also the rest of the ranch.

View to the southeast of post with flagging that marks the corners of the permit.

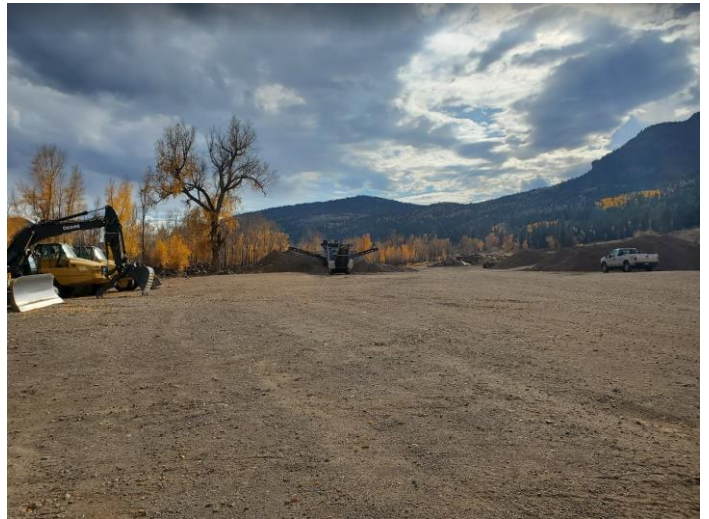
Processing has been conducted in accordance with the submitted plan within the permit boundary. Material to be processed is stockpiled in the south center of the permit area – it is estimated that there are approximately 800 cubic yards of material in the unprocessed stockpile. Processed material is stockpiled along the western boundary in stockpiles consisting of a few hundred cubic yards while awaiting use on the ranch property. No material is being exported off site at this time. The Operator states that they plan to export material at a later time, but the need for material at the ranch is currently too high to allow for exportation.

View to the south of processing area. Unprocessed stockpile is located in the center of the photo.

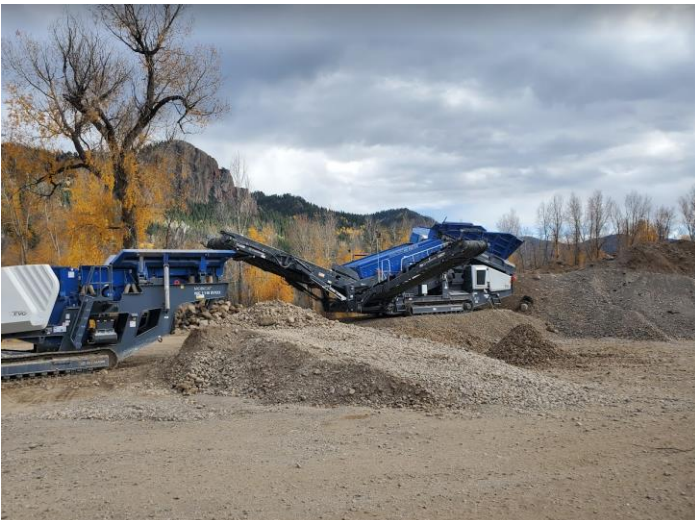
View to the east of processing equipment on site.

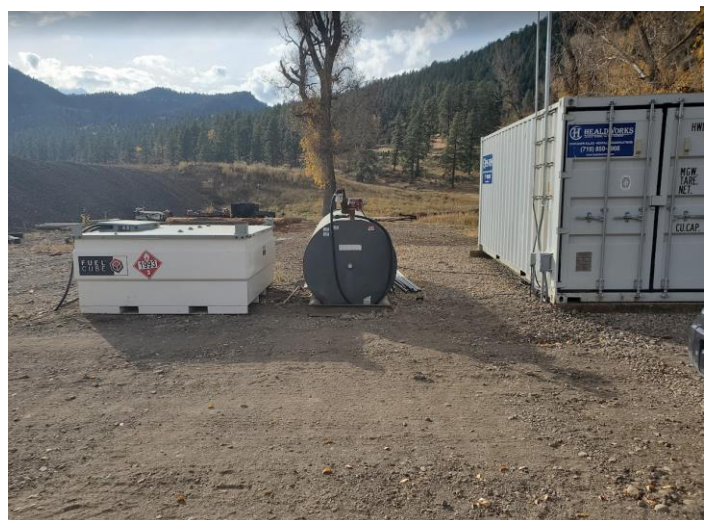
View to the west of hydrocarbon storage in off site support facility.
