**Reference: September 2023 Geotechnical Monitoring Summary Pikeview Quarry**

PIKEVIEW QUARRY SLOPE  
MONITORING

OBSERVATIONS FROM  
SEPTEMBER INSPECTION

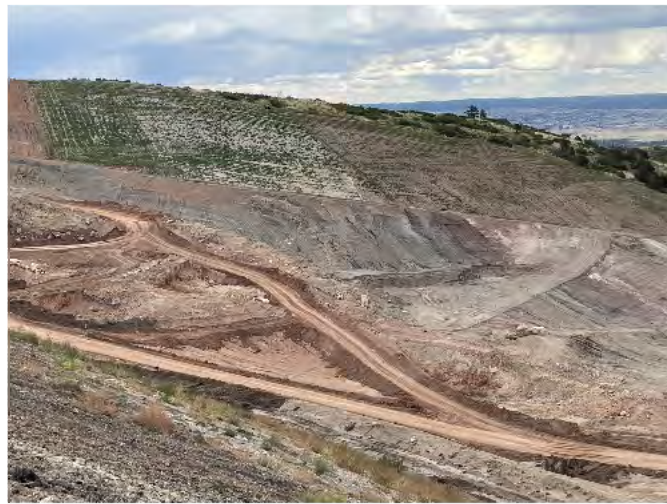
6. Vegetation growing on slopes.

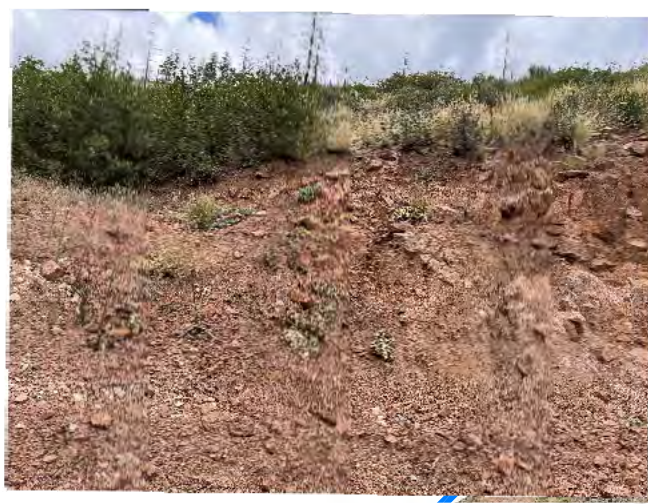
5. Weeds sprayed and/or removed.

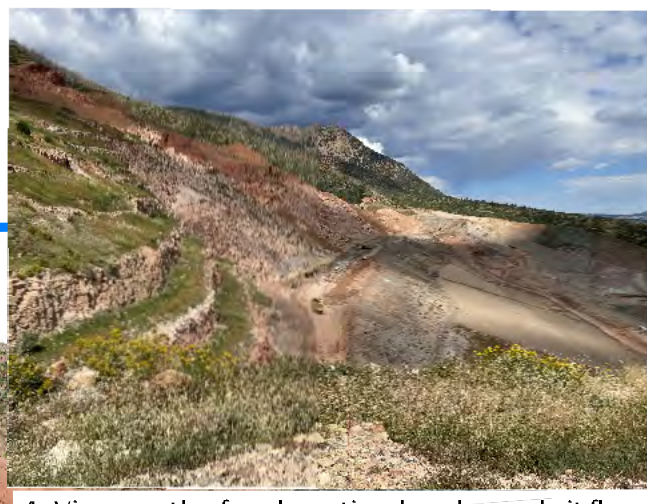
4. View north of reclamation benches and pit floor.

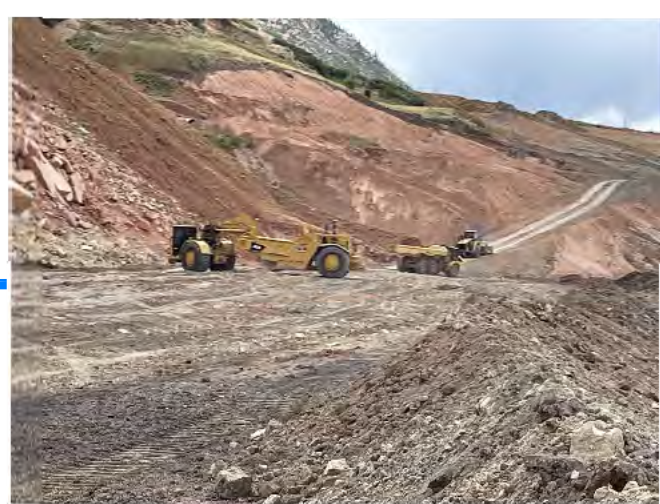
3. Scrapers and haul trucks placing fill on buttress for compaction.

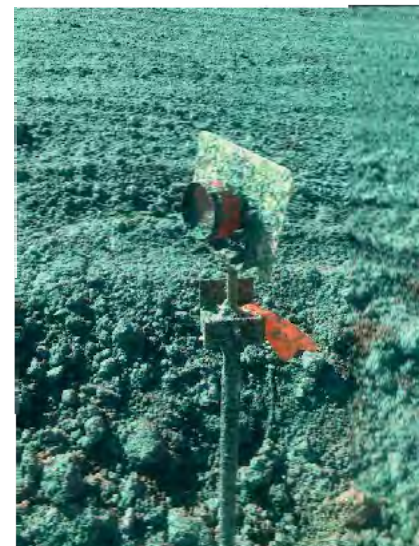
13-Sep	Points not found	Rain, and fog. No work being performed at time of alerts.	13-Sep
9-14 to 9-15	Points not found	Rain, and fog. No work being performed at time of alerts.	15-Sep
28-Sep	P69A not found	Prism removed before grading begins in this area.	28-Sep
29-Sep	P32 regression limit	P32 was replaced by P32R, and alert is a data error. Prism inspected and likely related to animal movement.	29-Sep
29-Sep	CP4 not found	Single event. Likely related to equipment operating in the area.	29-Sep
30-Sep	NP3 not found	Prism removed before grading begins in this area.	30-Sep
30-Sep	B7200-3 not found	Prism covered by hydromulching operations. Prisms were cleaned after spraying was completed.	30-Sep

7. Hydromulched slope. Prism 7200-3 before cleaning.

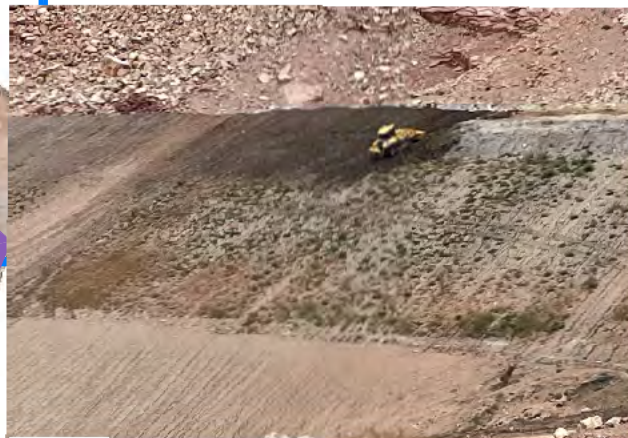
2. Repairing erosion on buttress.

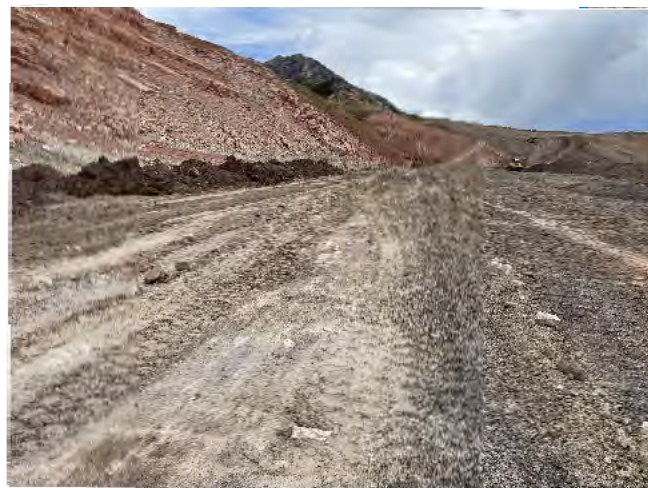
8. View north of compacted pit floor and berm.

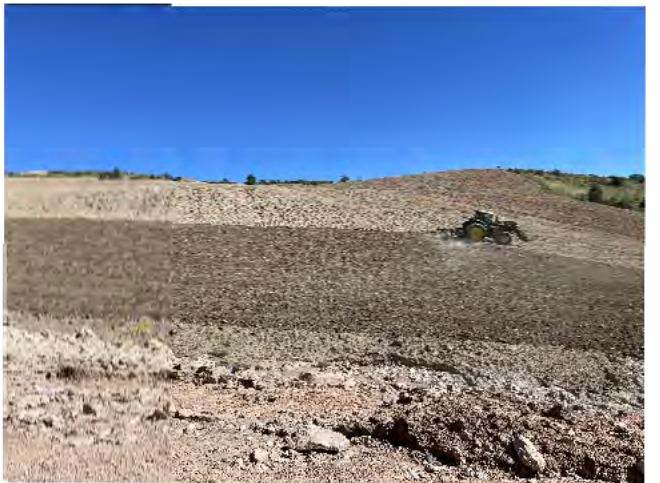
1. Grading rills before placing topsoil.

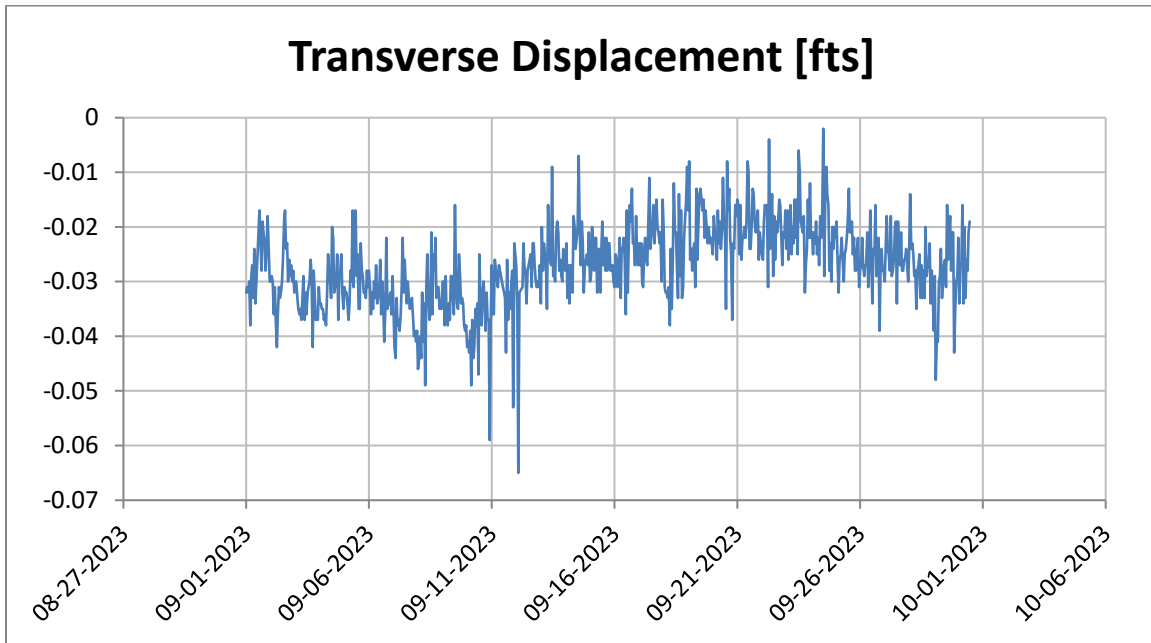
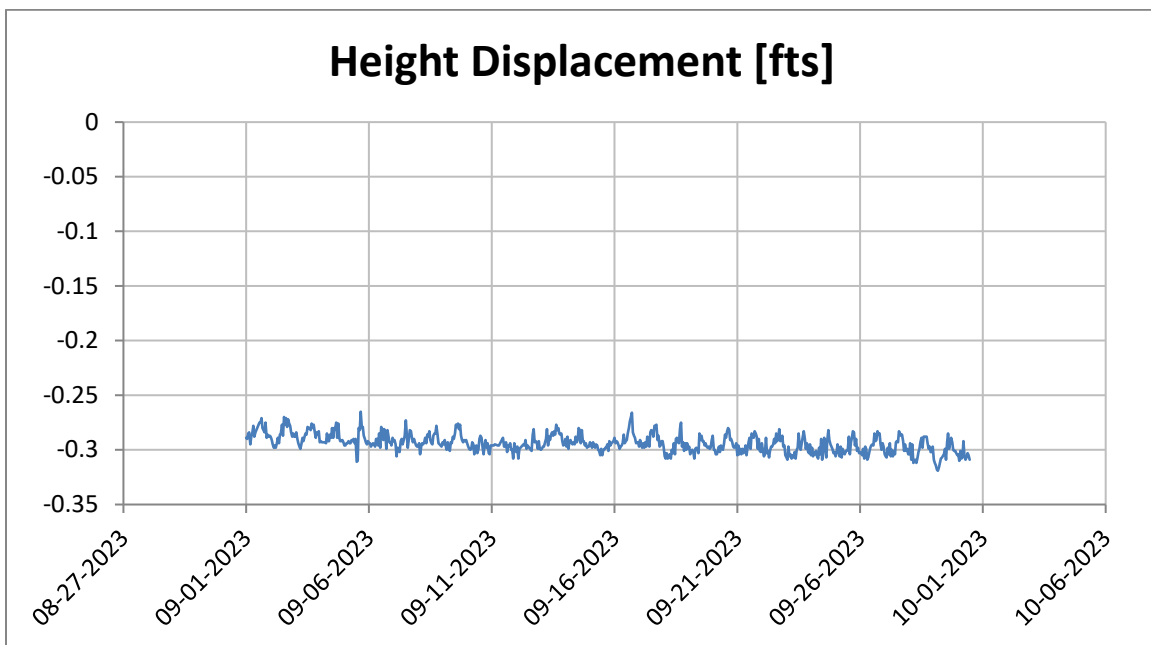
## Prism BR1

The data show stable conditions with no movements at 15 of 20 prisms with recorded displacements limited to data scatter and not actual movements. Prisms BR1, BR2 P69A, NP3 and NP66 are located above the landslide, and these prisms recorded slope creep movements at slow velocity. This settlement was likely related to loose fill or landslide material consolidating under its own weight. These prisms were placed in areas where slope creep movements are likely to occur; therefore, movements being recorded is expected. Plots of the transverse and height displacements for each prism are included in Appendix B.

1. Survey accuracy is  $\pm 0.016$  feet.
2. Alert threshold is  $\pm 0.35$  feet.
3. Transverse displacement is in the horizontal direction. Positive direction means closer to the robotic station.
4. Height displacement is in the vertical direction. Positive direction means higher in elevation.
5. Prism records slope creep movements.

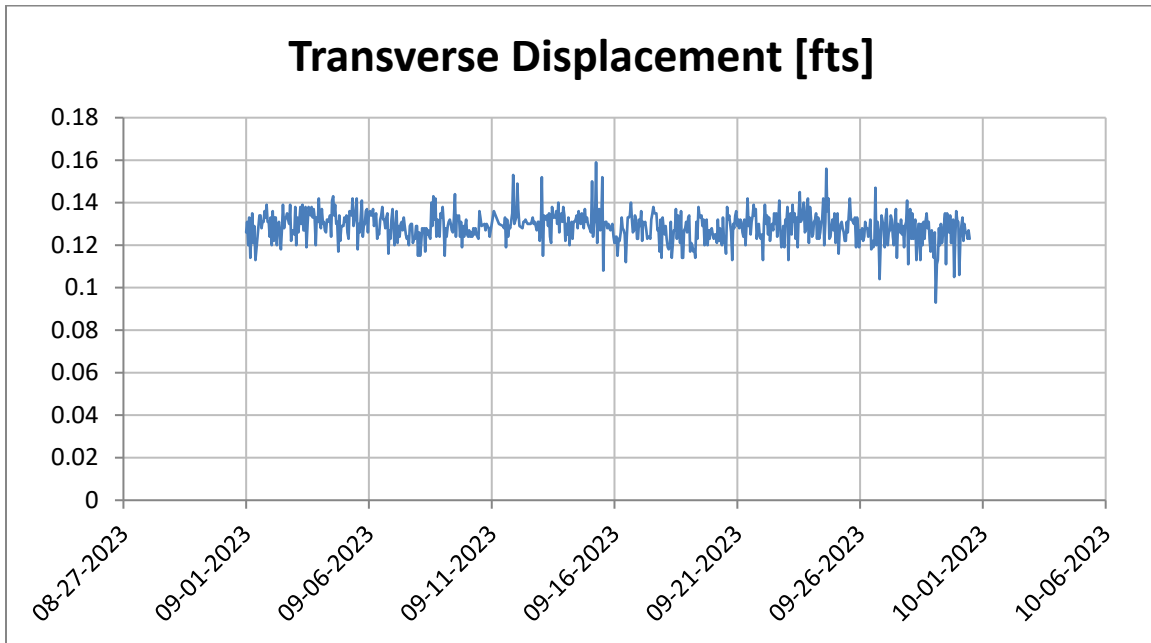
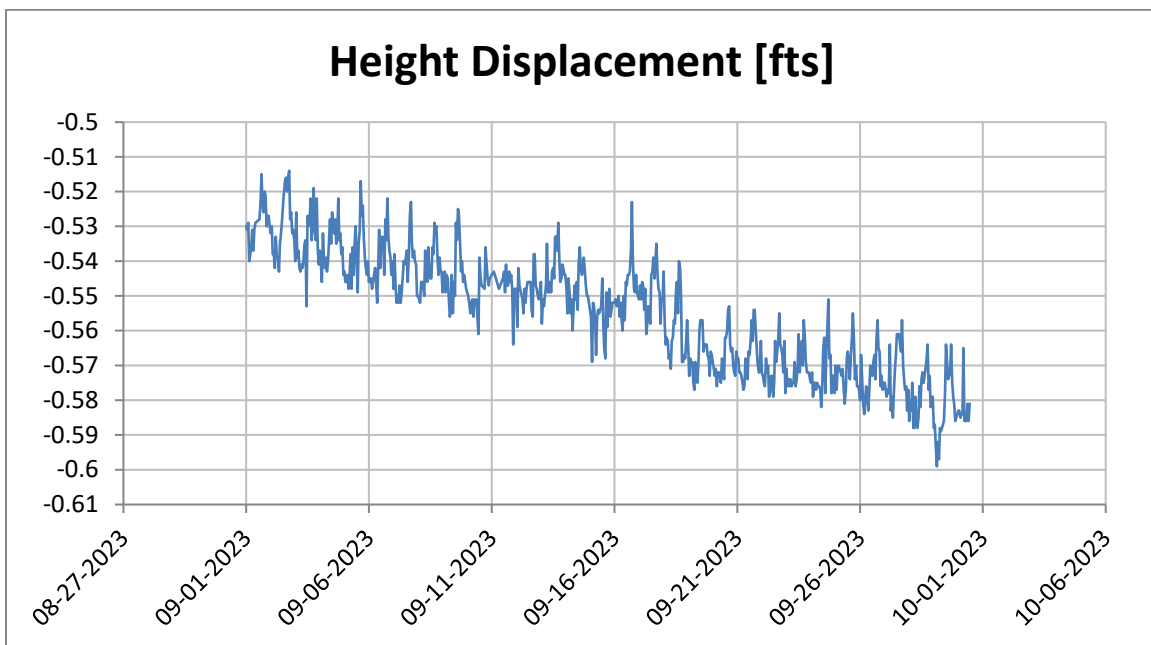
## Prism BR2

1. Survey accuracy is +/-0.016 feet.
2. Alert threshold is +/-0.35 feet.
3. Transverse displacement is in the horizontal direction. Positive direction means closer to the robotic station.
4. Height displacement is in the vertical direction. Positive direction means higher in elevation.
5. Prism records slope creep movements.

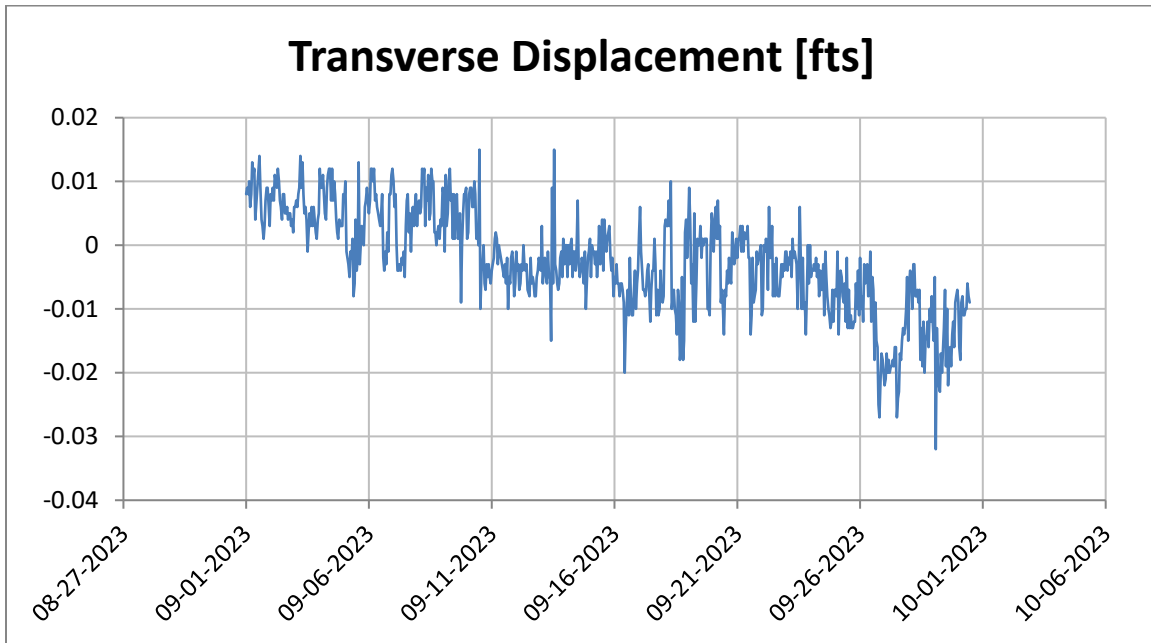
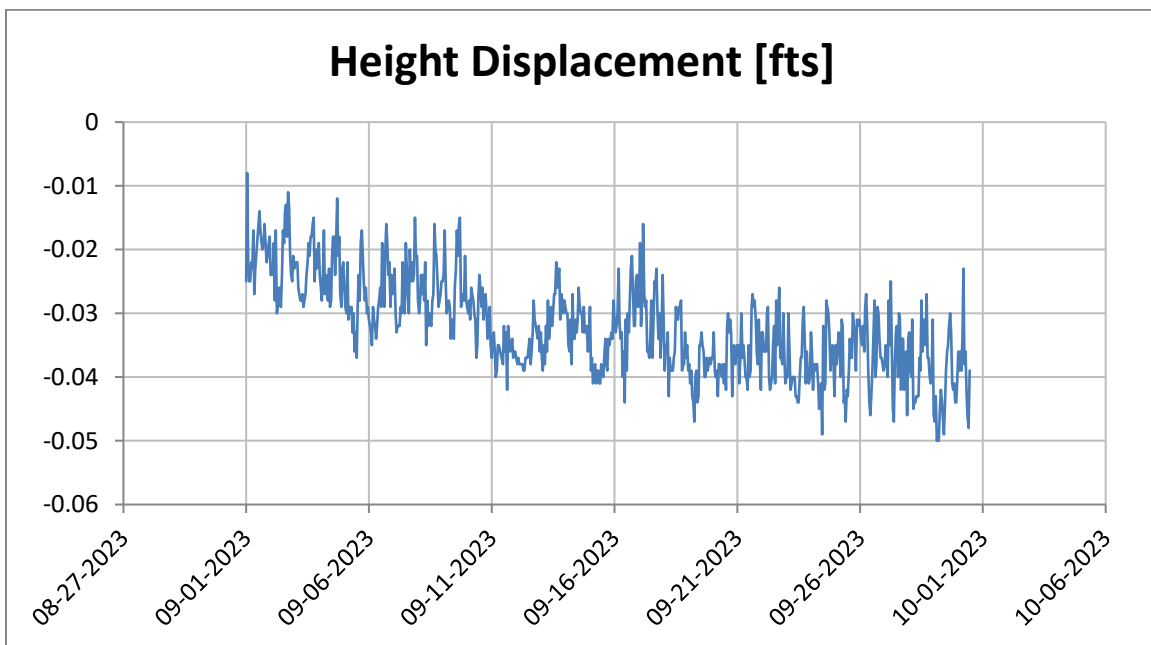
## Prism B7300-0

1. Survey accuracy is  $\pm 0.016$  feet.
2. Alert threshold is  $\pm 0.35$  feet.
3. Transverse displacement is in the horizontal direction. Positive direction means closer to the robotic station.
4. Height displacement is in the vertical direction. Positive direction means higher in elevation.
5. Apparent movements believed to be the result of topsoil placement around prism.

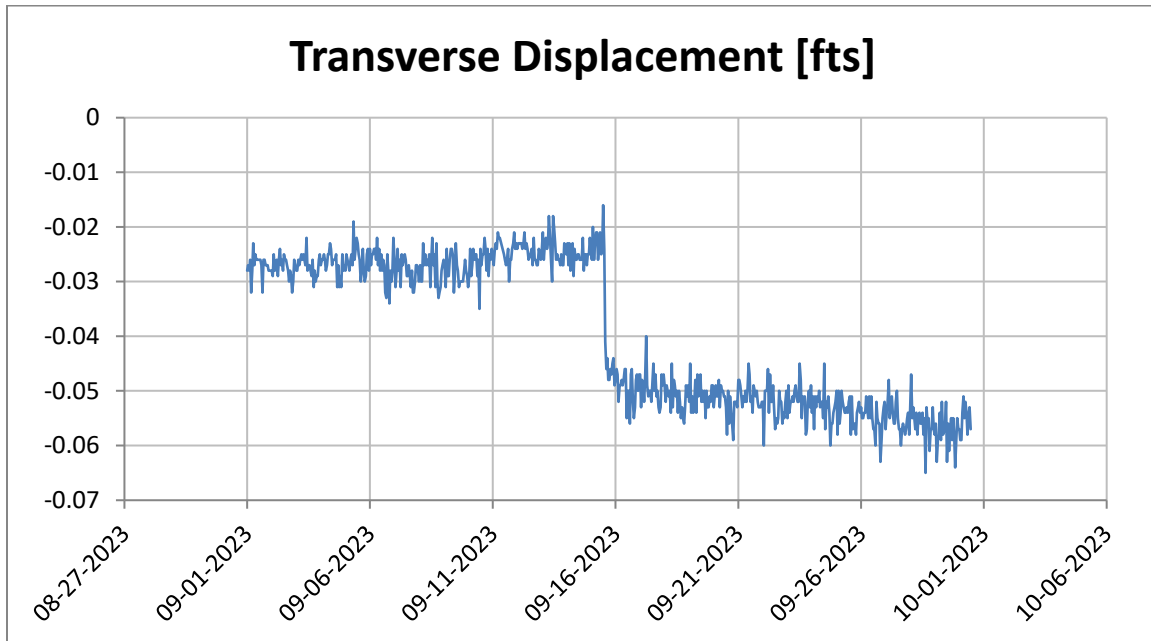
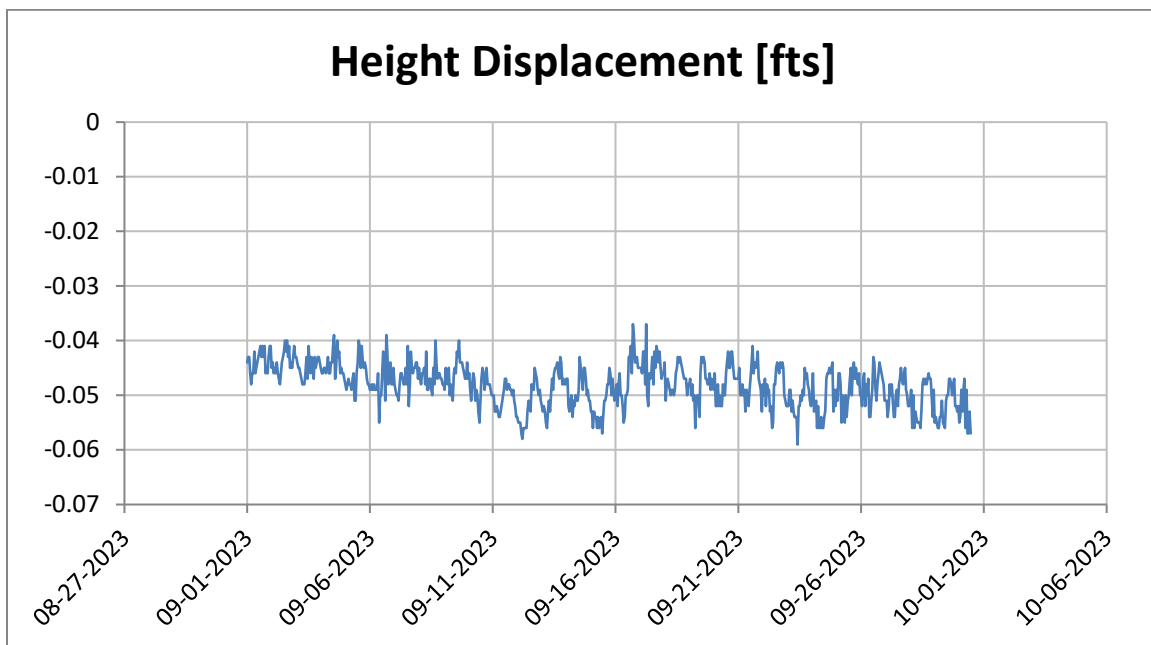
## Prism B7300-1

1. Survey accuracy is  $\pm 0.016$  feet.
2. Alert threshold is  $\pm 0.35$  feet.
3. Transverse displacement is in the horizontal direction. Positive direction means closer to the robotic station.
4. Height displacement is in the vertical direction. Positive direction means higher in elevation.
5. Apparent movements believed to be the result of topsoil placement around prism.
6. Prisms was disturbed by topsoiling operations on September 15.

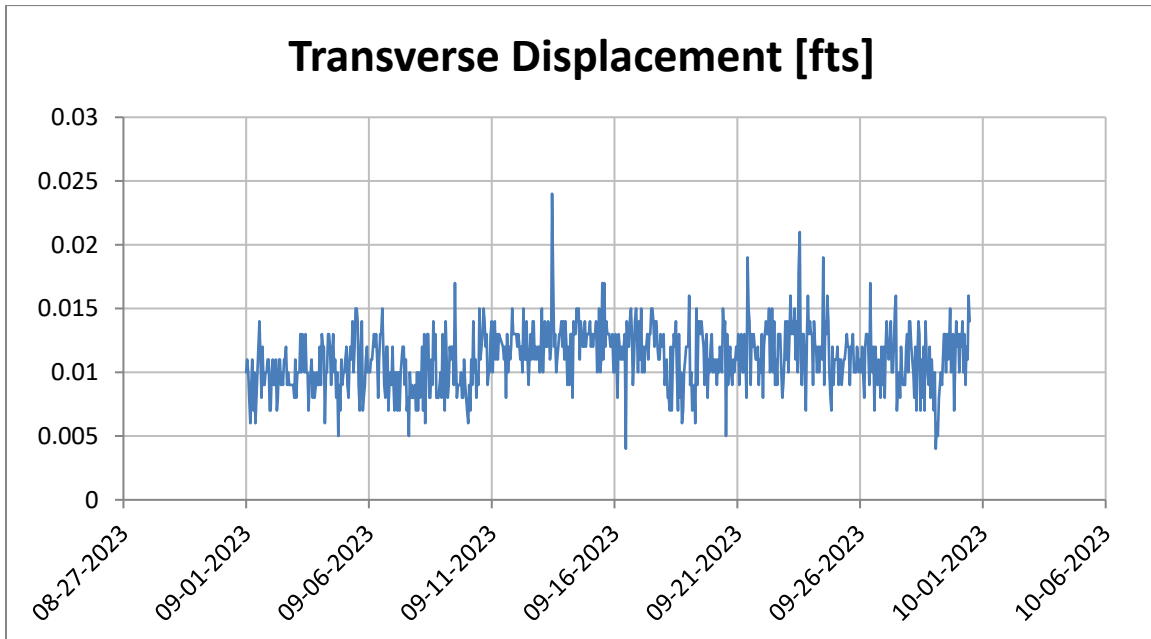
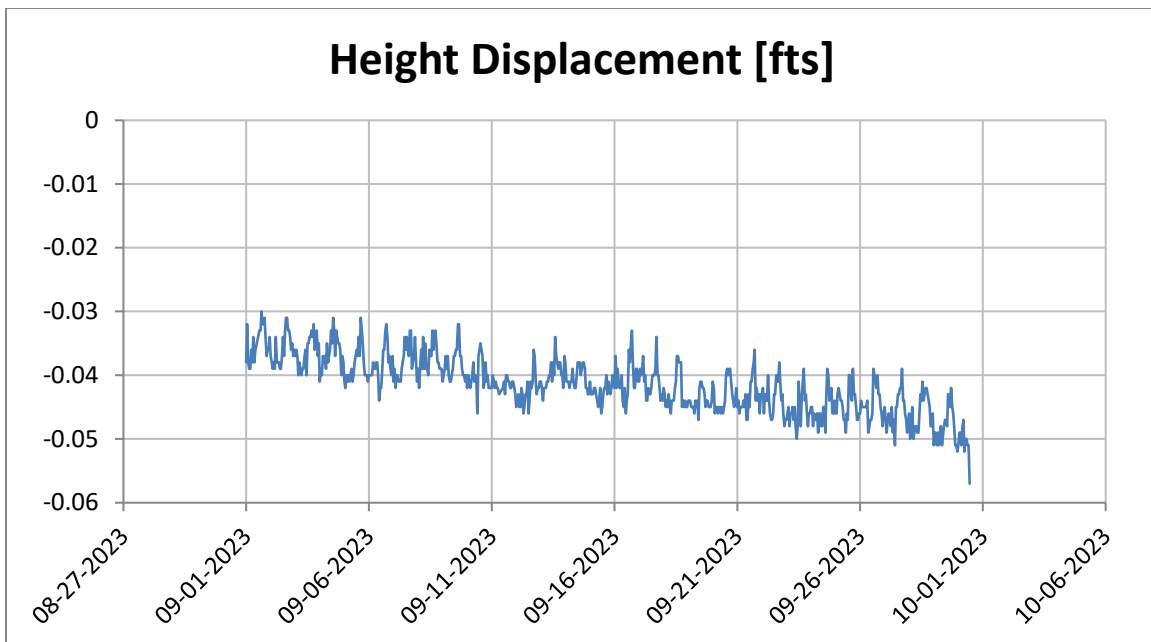
## Prism B7300-2

1. Survey accuracy is  $\pm 0.016$  feet.
2. Alert threshold is  $\pm 0.35$  feet.
3. Transverse displacement is in the horizontal direction. Positive direction means closer to the robotic station.
4. Height displacement is in the vertical direction. Positive direction means higher in elevation.
5. Apparent movements believed to be the result of topsoil placement around prism.

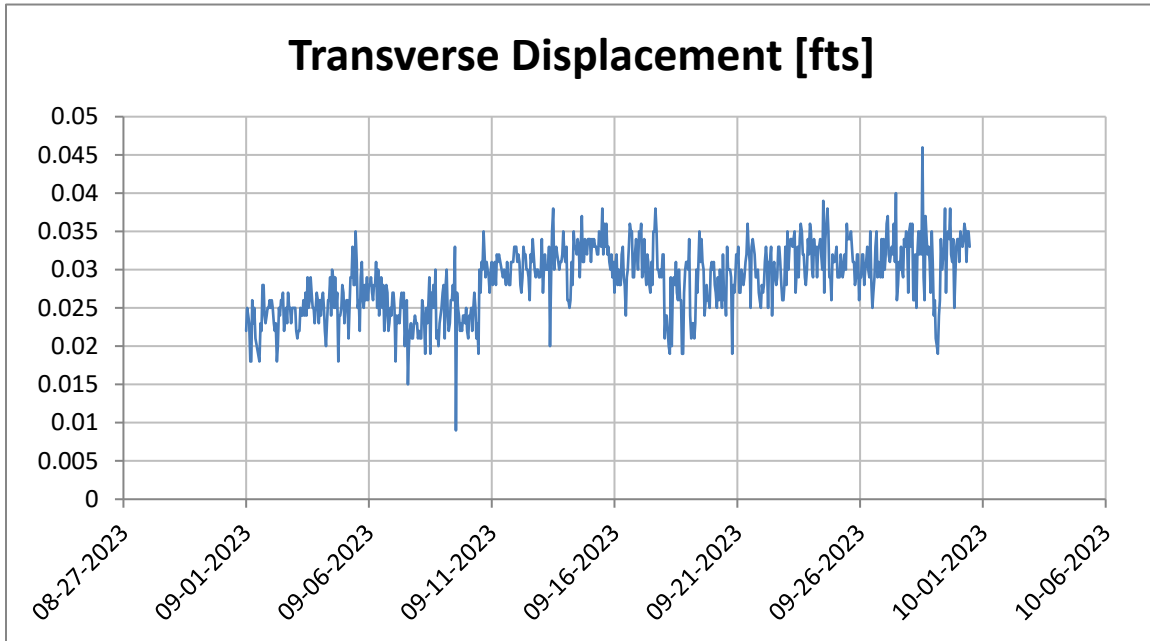
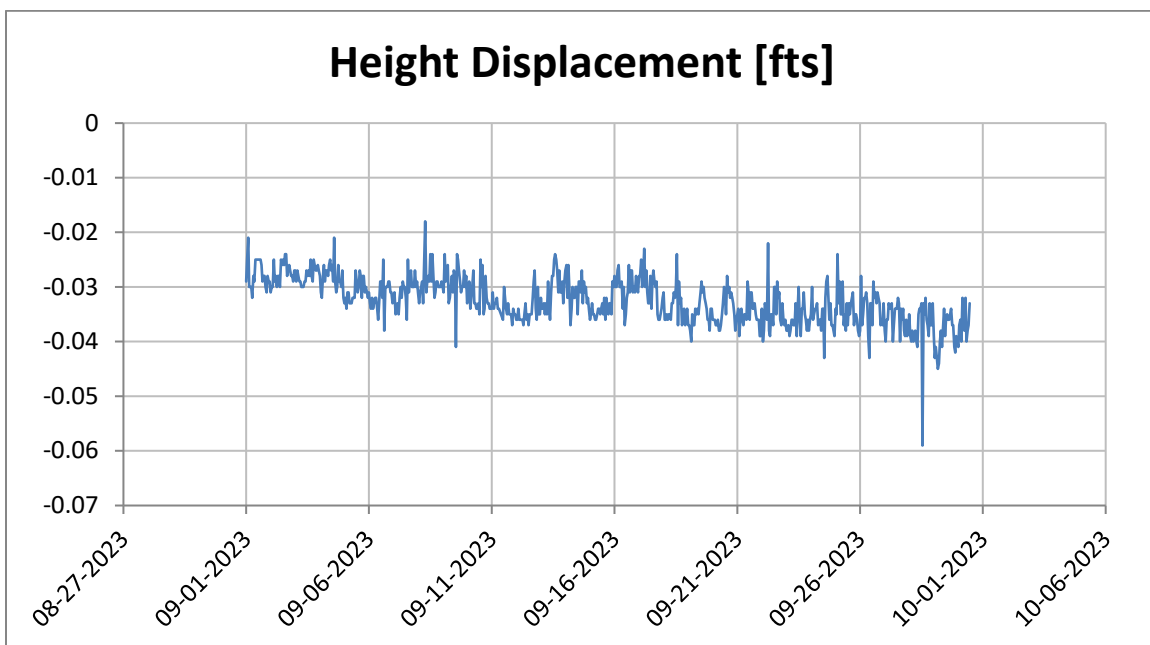
## Prism B7300-3

1. Survey accuracy is  $\pm 0.016$  feet.
2. Alert threshold is  $\pm 0.35$  feet.
3. Transverse displacement is in the horizontal direction. Positive direction means closer to the robotic station.
4. Height displacement is in the vertical direction. Positive direction means higher in elevation.
5. Apparent movements believed to be the result of topsoil placement around prism.

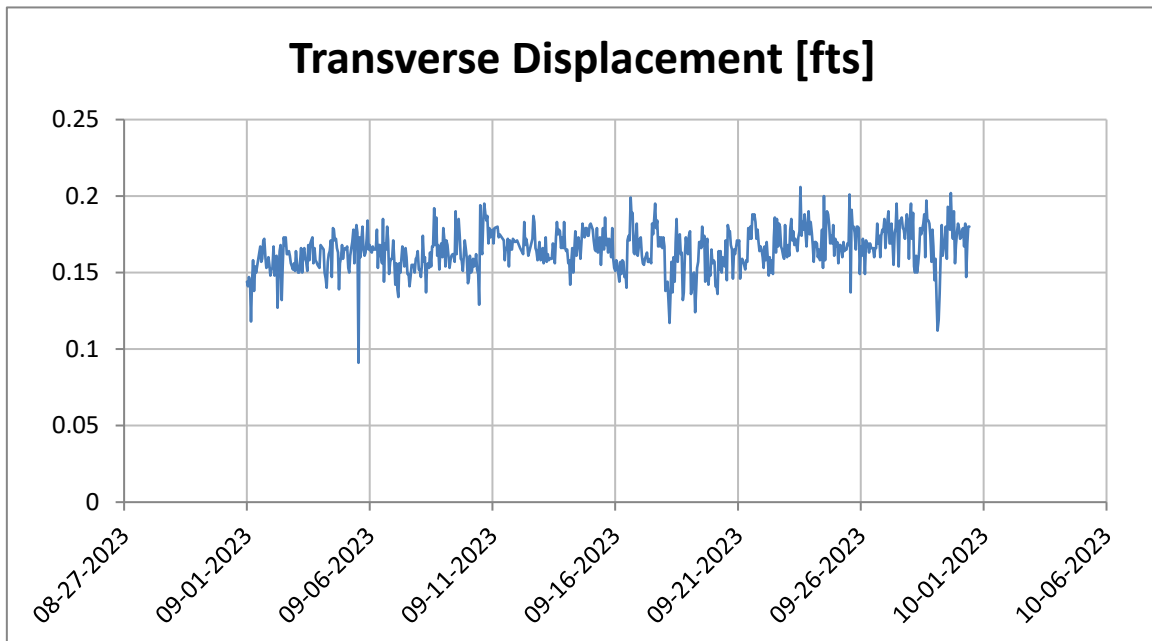
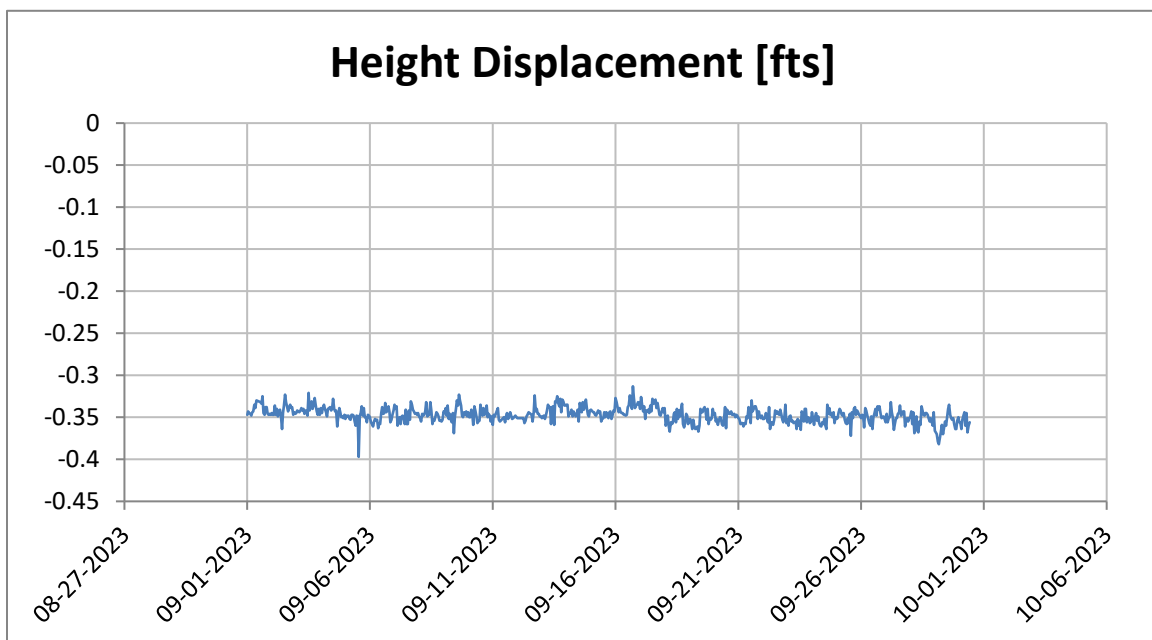
## NP3

1. Survey accuracy is  $\pm 0.016$  feet.
2. Alert threshold is  $\pm 0.35$  feet.
3. Transverse displacement is in the horizontal direction. Positive direction means closer to the robotic station.
4. Height displacement is in the vertical direction. Positive direction means higher in elevation.
5. Prism records slope creep movements.

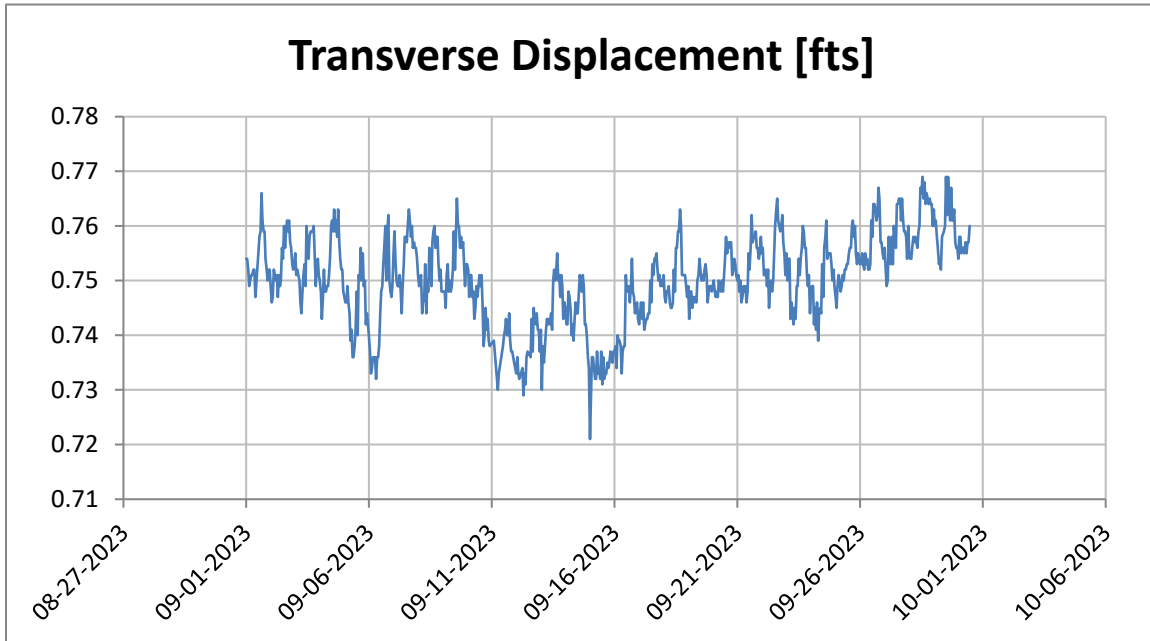
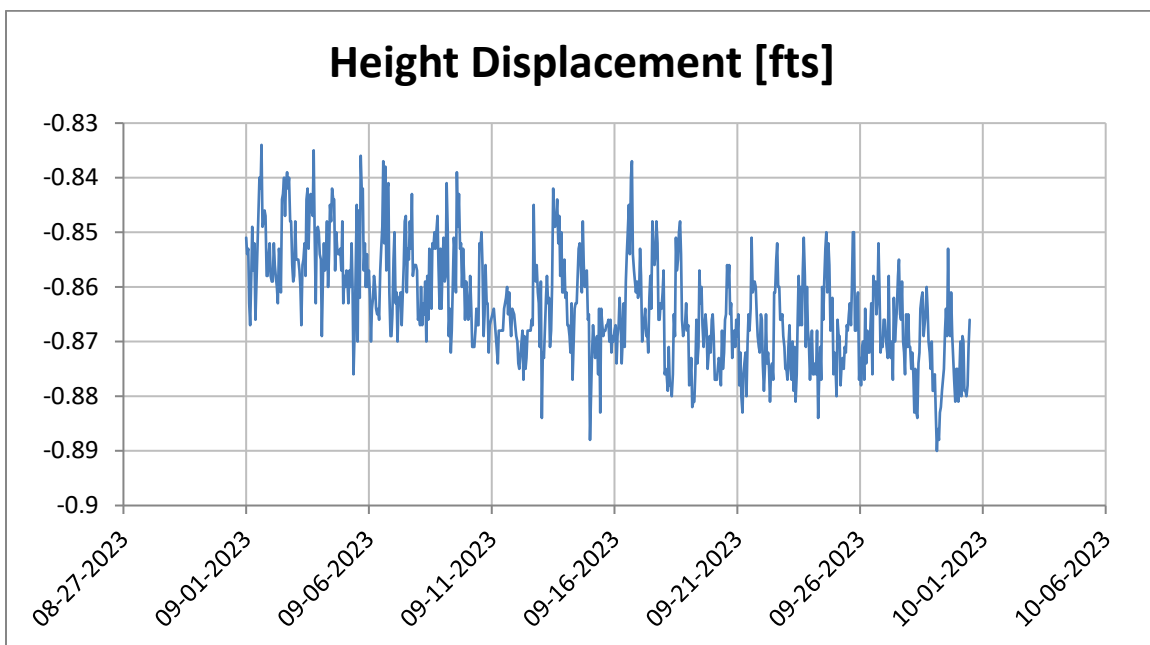
## NP66

1. Survey accuracy is  $\pm 0.016$  feet.
2. Alert threshold is  $\pm 0.35$  feet.
3. Transverse displacement is in the horizontal direction. Positive direction means closer to the robotic station.
4. Height displacement is in the vertical direction. Positive direction means higher in elevation.
5. Prism records slope creep movements.

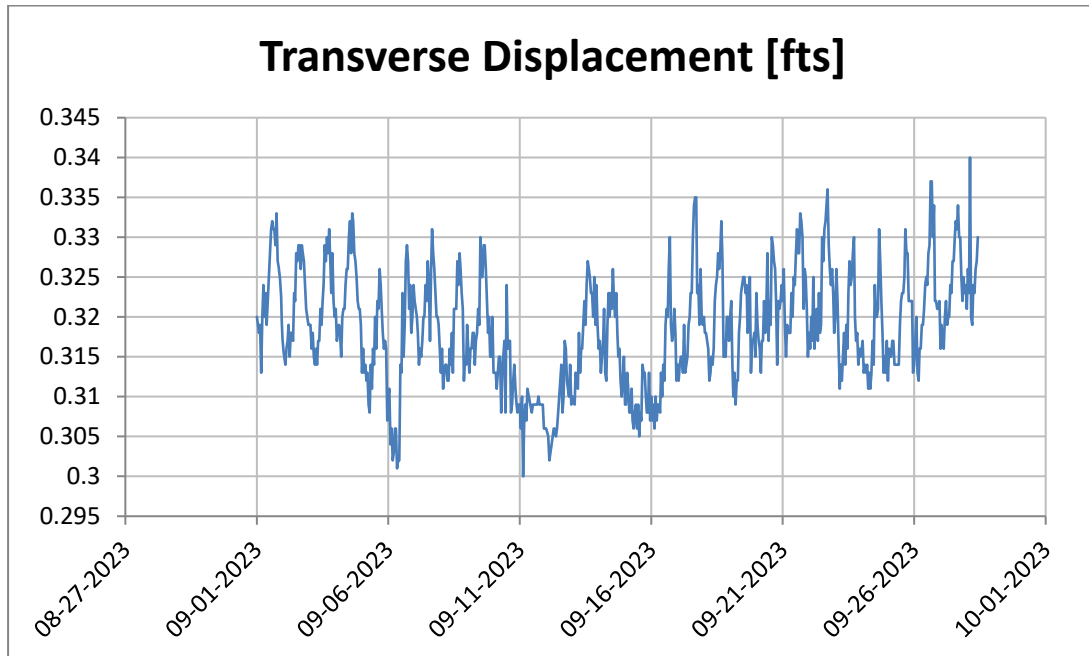
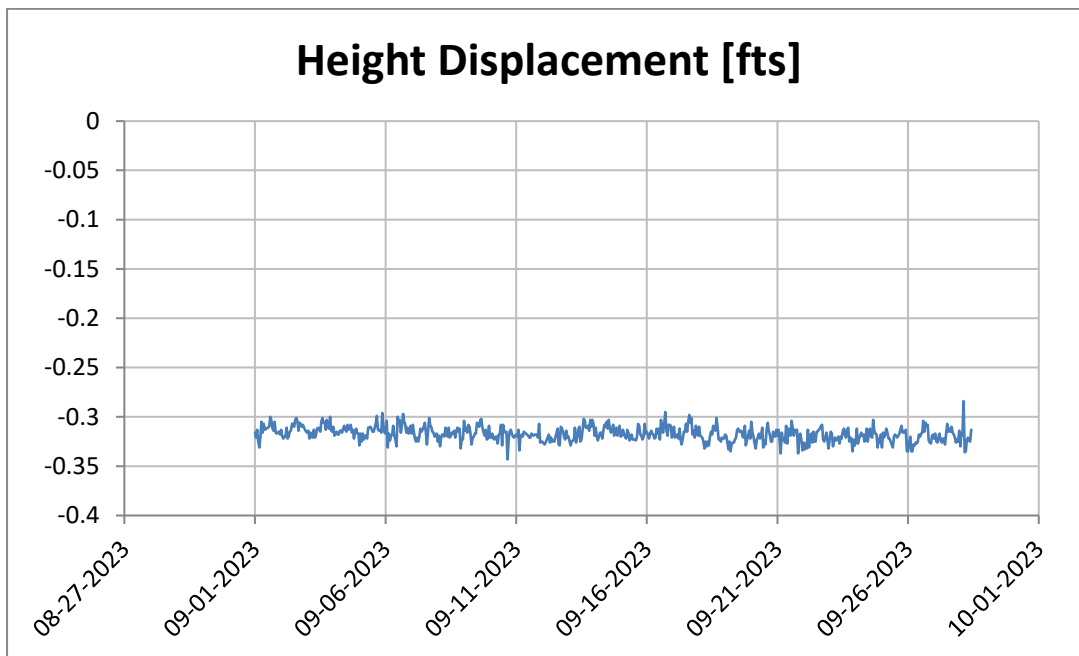
## Prism P69A

1. Survey accuracy is  $\pm 0.016$  feet.
2. Alert threshold is  $\pm 0.35$  feet.
3. Transverse displacement is in the horizontal direction. Positive direction means closer to the robotic station.
4. Height displacement is in the vertical direction. Positive direction means higher in elevation.
5. Prism records slope creep movements.

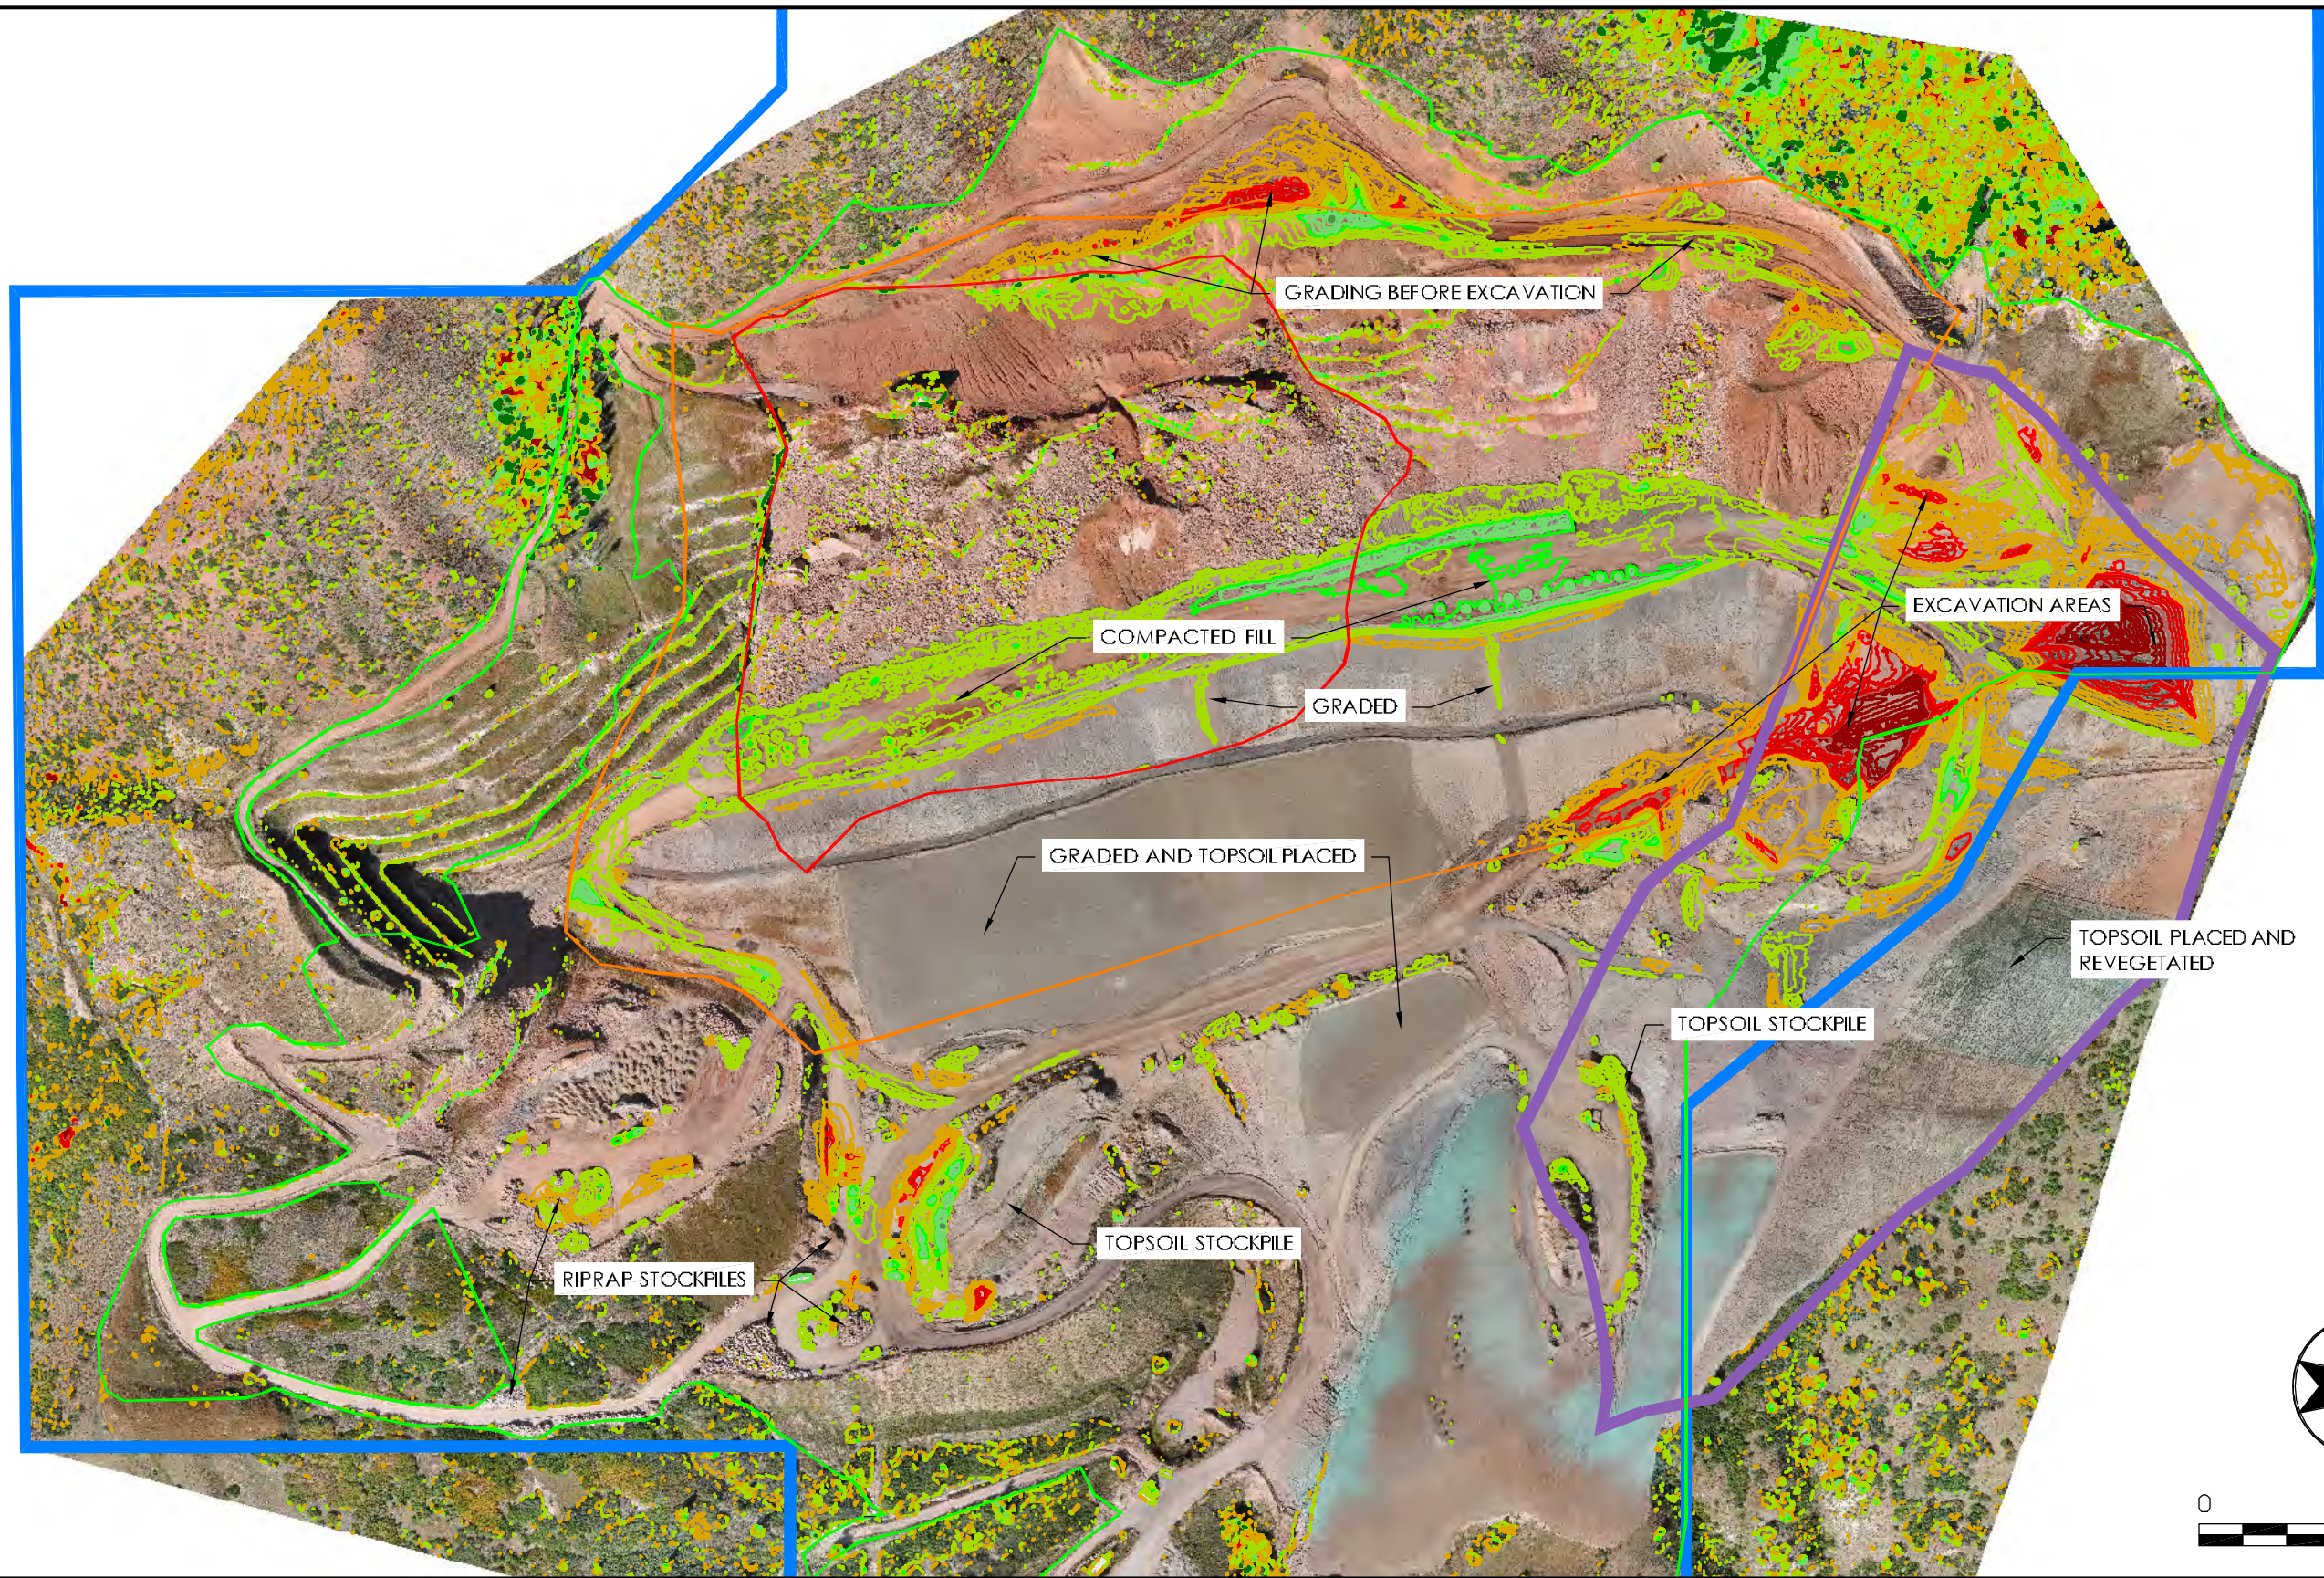
The September topography was also compared to the August topography to identify changes in the site topography. Comparison of the two surveys showed the placement of the fill material at the toe of the landslide. Fill material was excavated from the North Borrow Area and placed in the Embankment Area. No slope movements or other changes in topography were identified. The current imagery and topography are included in Figures 1 and 3, and the comparison surface is included as Figure 5 in Appendix C.

As previously reported in the September 2020 monitoring report, there are limitations with the method of comparing drone surveys from different months. The drone data indicate changes in the slopes along each of

the reclamation benches, buildings, and areas with trees or shrubs. These areas are stable, and the changes are the result of survey limitations on or near vertical slopes.
