MINERALS PROGRAM INSPECTION REPORT
PHONE: (303) 866-3567

MINE NAME: Silver Creek	MINE/PROSPECTING ID#: P-2009-001	MINERAL: Gold, silver and moly	COUNTY: Dolores
INSPECTION TYPE: Monitoring	WEATHER: Clear	INSP. DATE: October 25, 2023	INSP. TIME: 10:45
OPERATOR: Outlook Resources, Inc.	OPERATOR REPRESENTATIVE: None	TYPE OF OPERATION: MP - Mineral Prospecting	
REASON FOR INSPECTION: Normal I&E Program	BOND CALCULATION TYPE: None	BOND AMOUNT: \$5,505.00	
DATE OF COMPLAINT: NA	POST INSP. CONTACTS: None	JOINT INSP. AGENCY: None	
INSPECTOR(S): Todd Jesse	INSPECTOR'S SIGNATURE:

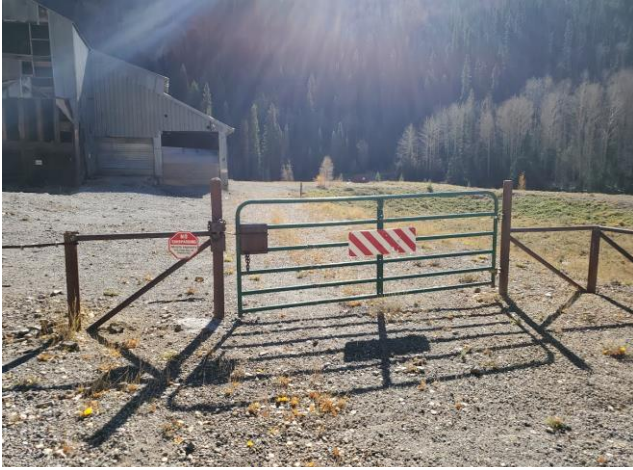
View to the south of gate that secures the property.

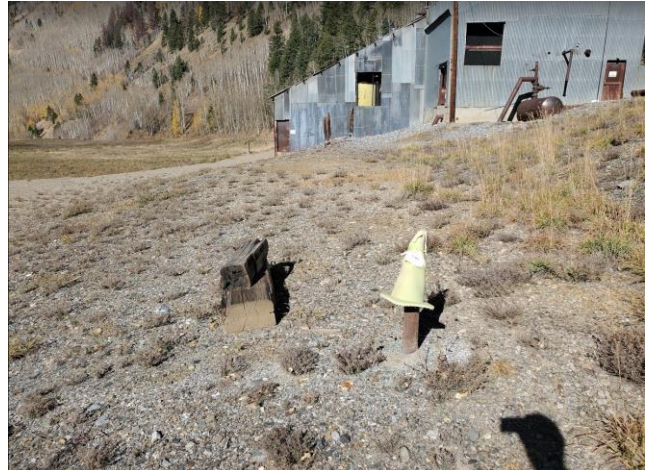
The NOI consists of 2 pads, a lower pad and upper. The lower pad is located between historic structures of the Argentine Mine. The lower pad consists of a capped pre-collar casing set to a depth of approximately 20 feet. The upper pad is located approximately ¼ mile east of the lower pad along Silver Creek. There has been no exploration work done for the NOI on the upper pad – it is currently overgrown with aspens and small conifers. The pad is located at a wide spot along the access road paralleling the creek. The road to access the pad is partially blocked by unconsolidated waste rock from historic waste dumps upslope – a dozer would be required to open the road to a drill rig.

View to the north of pre-collar casing on lower drill pad.

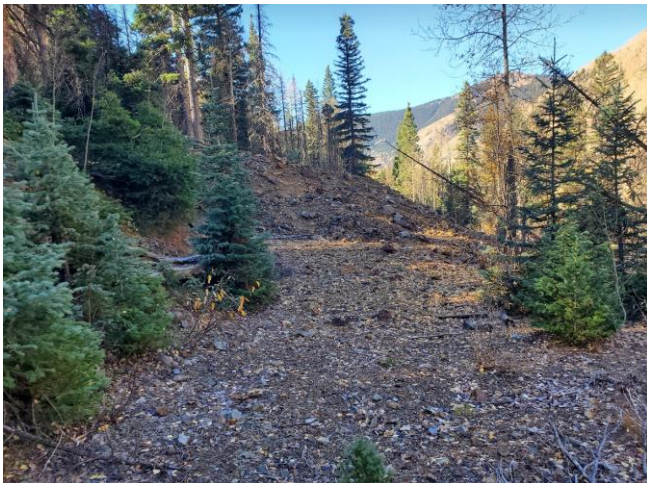
View to the east of sediment flow blocking road to upper drill pad.

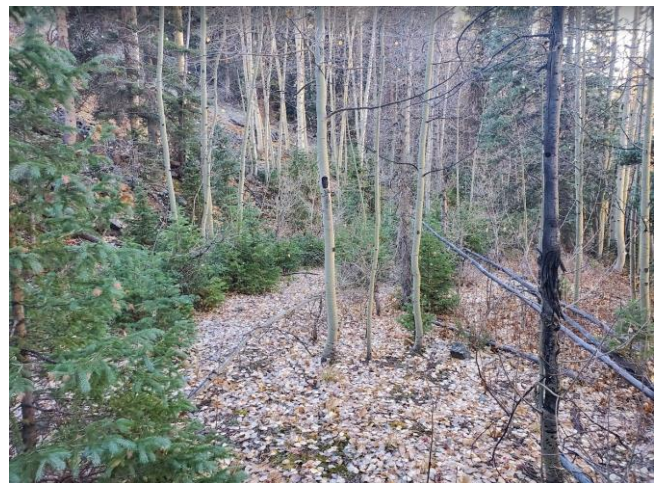
View to the southeast of upper drill pad.

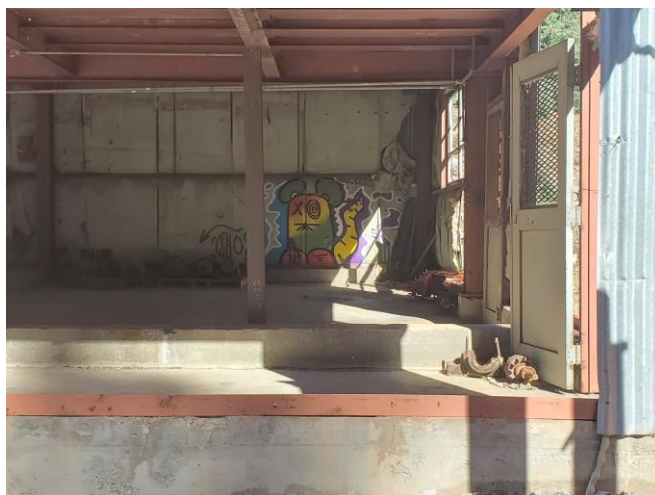
The site was not active at the time of the inspection and no exploration equipment was present. There are no onsite support facilities and no hydrocarbons or hazardous chemicals are stores on site. There were signs of unauthorized entry on the property. A number of empty alcoholic containers, bullet holes, and graffiti were observed. The Division recommends that the operator attempt to better secure the property to protect themselves from liability. No state listed invasive weed species were identified during the inspection. The operator would like to keep the NOI open for future exploration plays.

View to the north of graffiti in historic structure near lower pad.
