## Apex Lode, M-2014-011, DRMS Final Inspection Report

**MINERALS PROGRAM INSPECTION REPORT**  
**PHONE: (303) 866-3567**

<b>MINE NAME:</b> Apex Lode	<b>MINE/PROSPECTING ID#:</b> M-2014-011	<b>MINERAL:</b> Zinc and silver	<b>COUNTY:</b> Garfield
<b>INSPECTION TYPE:</b> Surety Release Inspection	<b>WEATHER:</b> Clear	<b>INSP. DATE:</b> September 19, 2023	<b>INSP. TIME:</b> 09:30
<b>OPERATOR:</b> Strong Mining Company	<b>OPERATOR REPRESENTATIVE:</b> George Strong	<b>TYPE OF OPERATION:</b> 110(1) - Hard Rock Limited Impact	
<b>REASON FOR INSPECTION:</b> Surety Release Requested	<b>BOND CALCULATION TYPE:</b>	<b>BOND AMOUNT:</b> \$34,308.00	
<b>DATE OF COMPLAINT:</b> NA	<b>POST INSP. CONTACTS:</b> U.S.Forest Service	<b>JOINT INSP. AGENCY:</b> None	
<b>INSPECTOR(S):</b> Clayton Wein	<b>INSPECTOR'S SIGNATURE:</b>

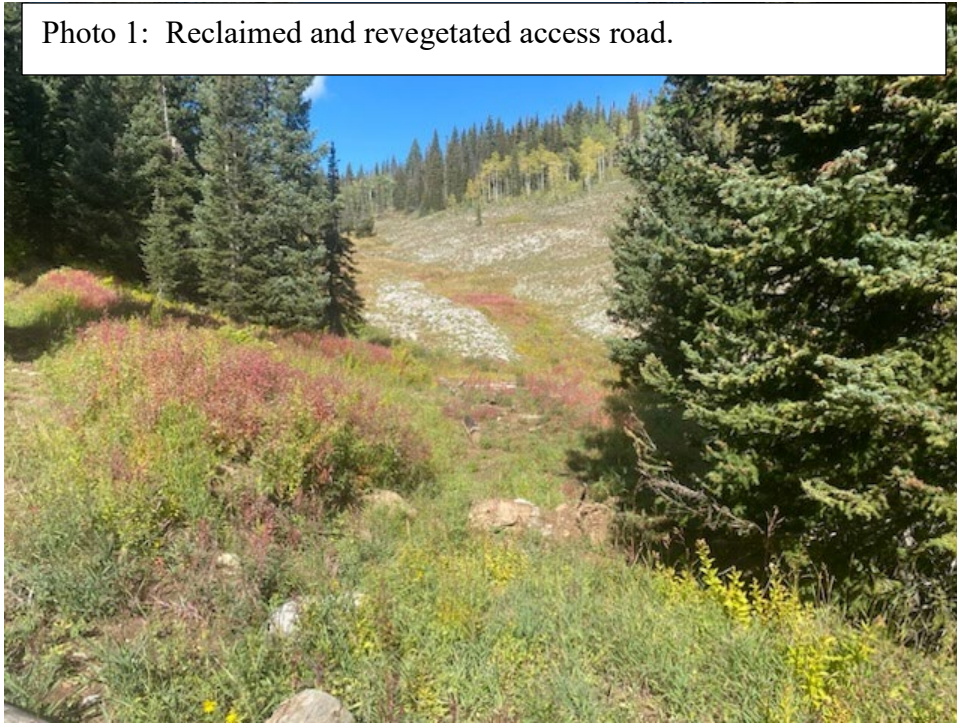
The reclaimed access road to the site was stable with vegetative cover (Photo 1). There were no indications of erosional features. The vegetation on the reclaimed road was similar to the surrounding areas.

Photo 1: Reclaimed and revegetated access road.

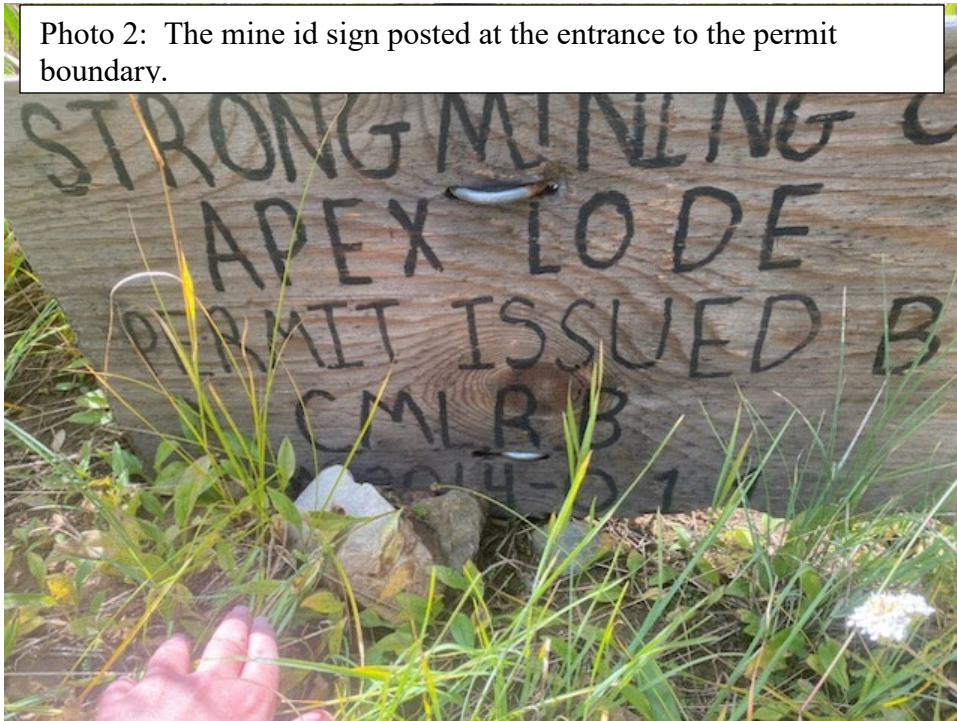
As per Rule 3.1.12, the mine identification sign was posted at the entrance to the permit boundary (Photo 2). The permit boundary was observed to be marked by T-posts painted red. All the markers were placed in easy to spot locations and visible from one marker to the next.

Photo 2: The mine id sign posted at the entrance to the permit boundary.

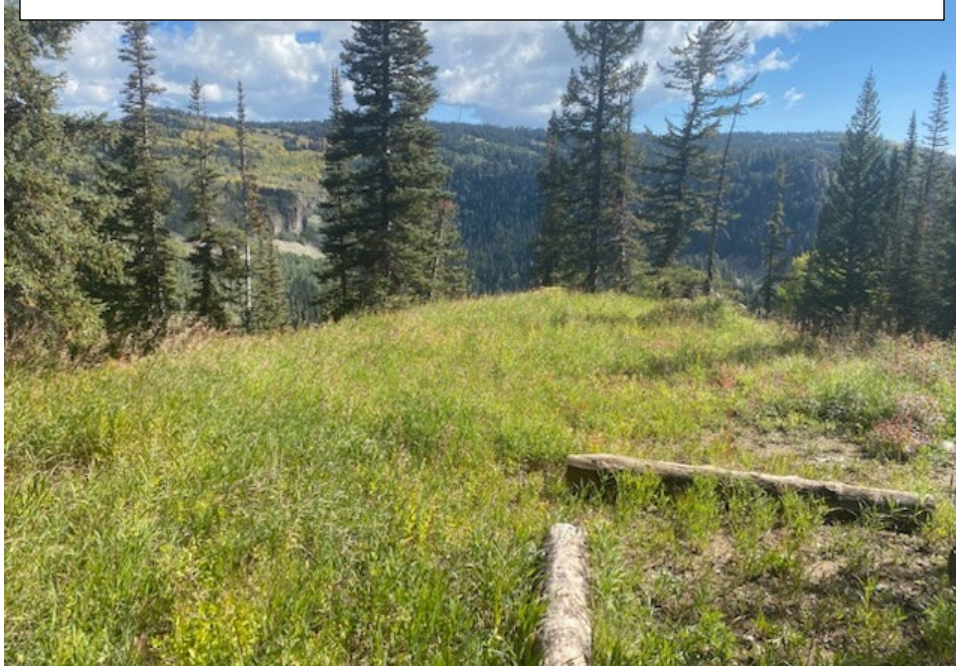
The pad where the cabin used to be located was vegetated and stable (Photo 3 and 4). The reclaimed area showed no indications of erosional features. Vegetation on the reclaimed area had grown in well and matched the surrounding areas.

Photo 3: The reclaimed cabin pad.

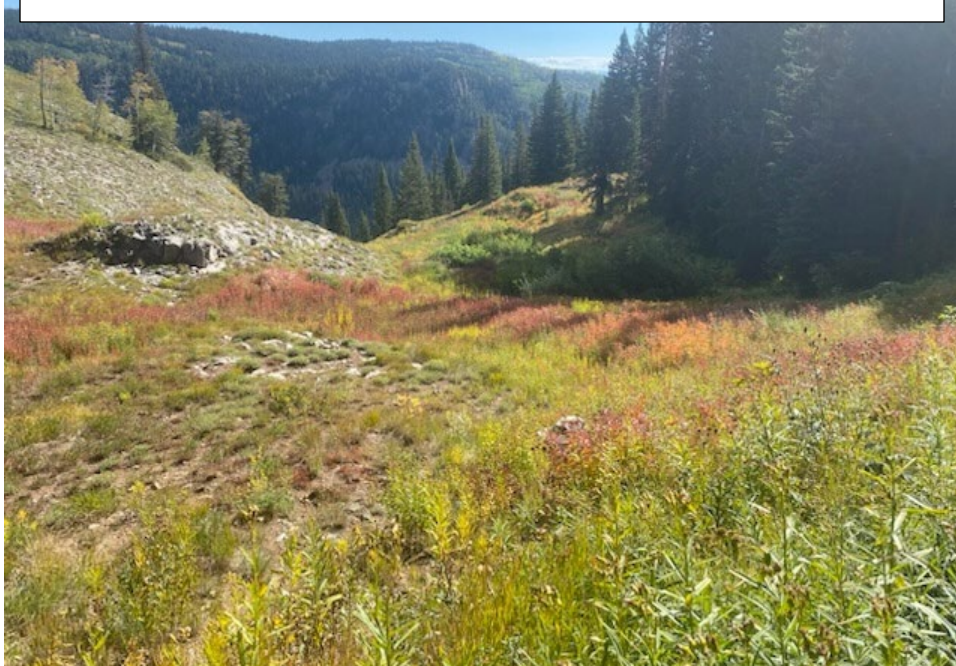
Photo 4: Vegetated and stable reclaimed pad.

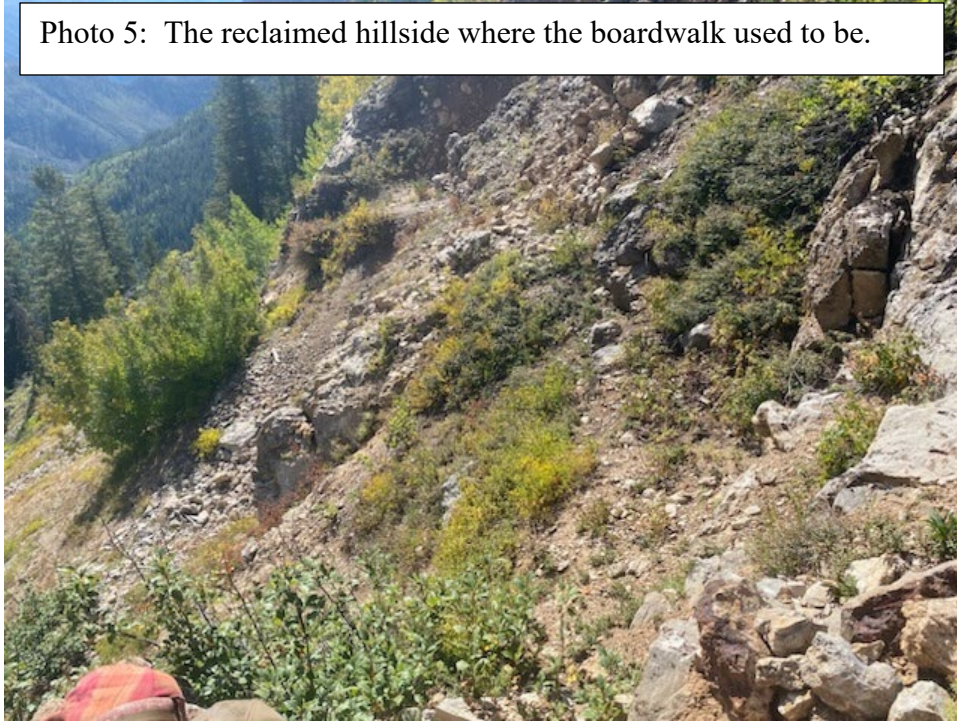
The access to the portals area used to be a boardwalk made of timbers. The boardwalk had been removed (Photo 5). The slope of the area was steep and composed of a mix of vegetation and loose rock. Vegetation to rock ratio was approximately 80%:20%.

Photo 5: The reclaimed hillside where the boardwalk used to be.

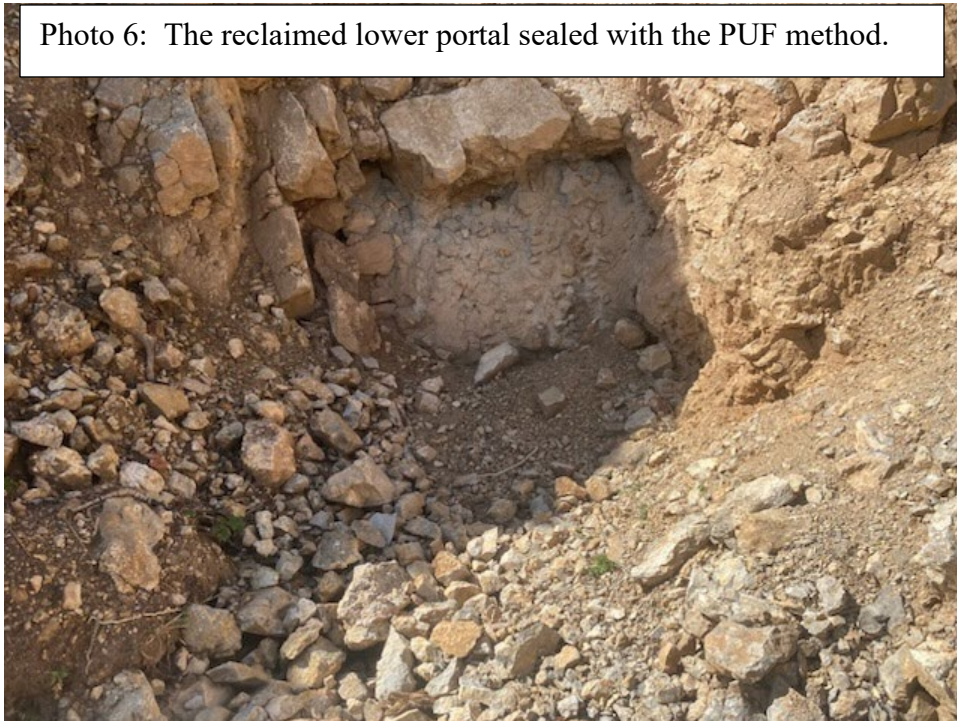
The portals and staging area were reclaimed and the portals were sealed (Photo 6). The hill side where these areas are located was extremely steep and had lots of loose rock (Photo 7). The portals seals were intact and stable. The steepness of the hill has facilitated small rockslide that have begun to cover over the portals and staging area. Due to the steepness of the hill, vegetation was sparse. All timbers from the portals and boardwalk have been removed from the site. PUF Closure method was used to seal the portals. All 2 inch rail had been removed from the site.

Photo 6: The reclaimed lower portal sealed with the PUF method.

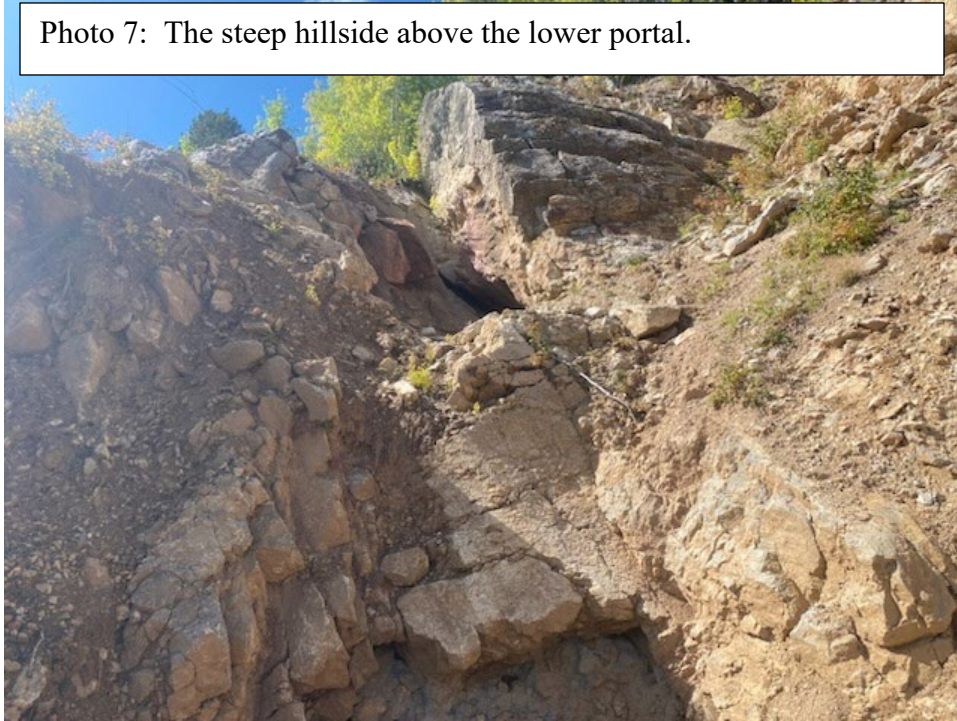
Photo 7: The steep hillside above the lower portal.
