Huddleston-Berry
Engineering & Testing, LLC

Subject: Summary of Instrumentation Monitoring
3rd Quarter 2023
Bowie Coal Waste Disposal Area No. 2
Paonia, Colorado

SUBJECT: Summary Report, 3rd Quarter 2023, Inclinator and Active Vibrating Wire Piezometer Data July – September 2023, Bowie Mine #2 Coal Waste Disposal Area (CWDA) #2

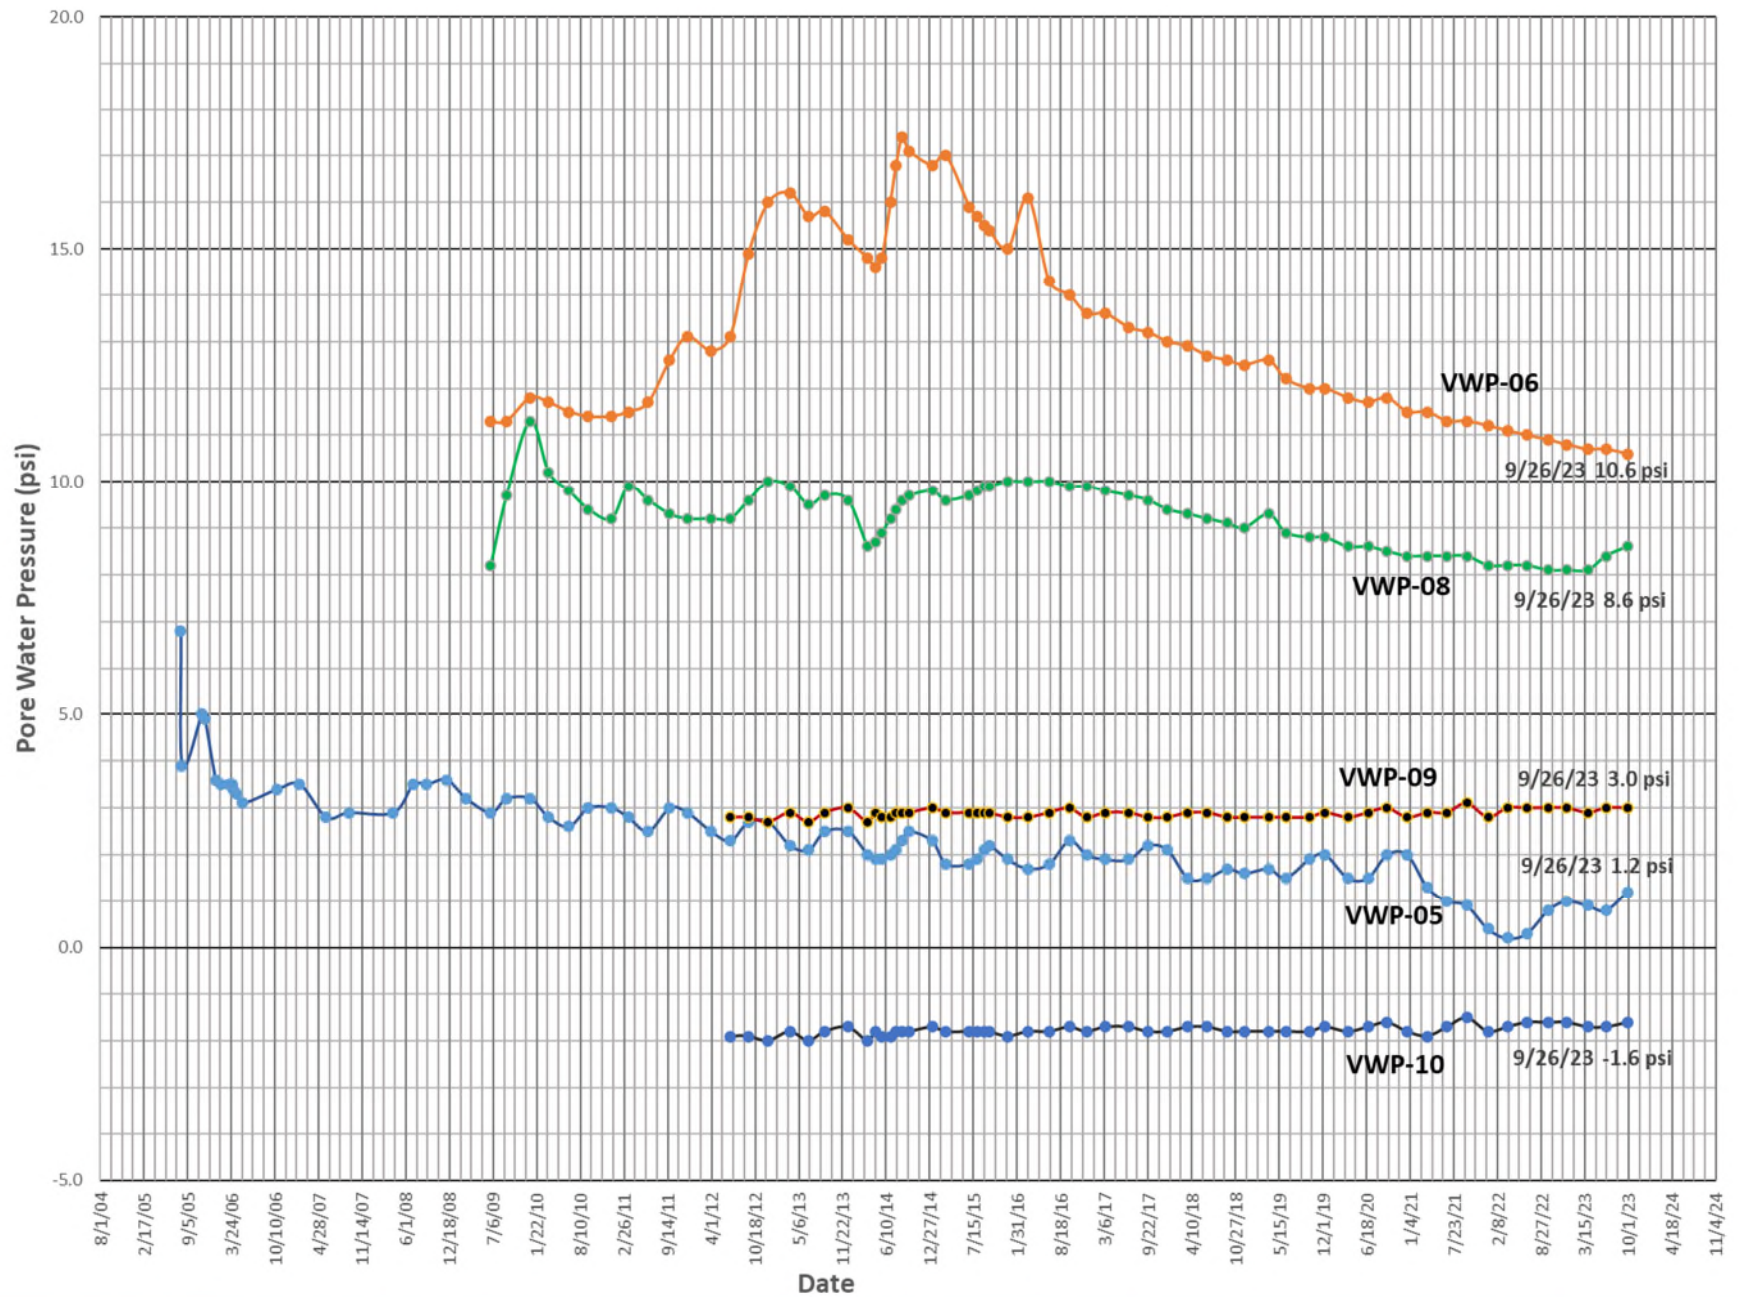
Figure 2 - Bowie Mine #2 - CWDA #2
Active Vibrating Wire Piezometer Data

As seen on Table 1 and Figure 2, the VWP readings and trends are consistent with recent and historic readings. When compared to a year ago, pore pressure readings did not change in two of the VWP's (VWP-09 and VWP-10) and the other three changed by small amounts (-0.3 to 0.5 psi). When compared with last quarter (Q2 2023), pore pressures also changed by relatively small amounts (-0.1 to 0.4 psi) for all five VWP's. Although four of the five VWP's remain steady or have general declining trends in pore pressure over the life of the VWP's, one of the piezometers (VWP-05) has exhibited pronounced seasonal cyclical behavior for its lifespan, except from mid-2021 to mid-2022 where there was a steady decline in pore pressures. This piezometer generally (but not always) shows low pore pressures for Q1 and Q2 and higher pressures for Q3 and Q4, with a net loss of 5.6 psi over the lifetime of that VWP. The other four VWP's have experienced net changes of +/-0.7 psi or less since installation, meaning current readings are very similar to initial readings. For VWP-09 and VWP-10, pressures have been consistent throughout the lifetime of the piezometers; however, for VWP-06 and VWP-08, they experienced wild fluctuations in pore water pressure in the first half of their lifetimes but have settled to pressures similar to the installation pressures in the past several years.

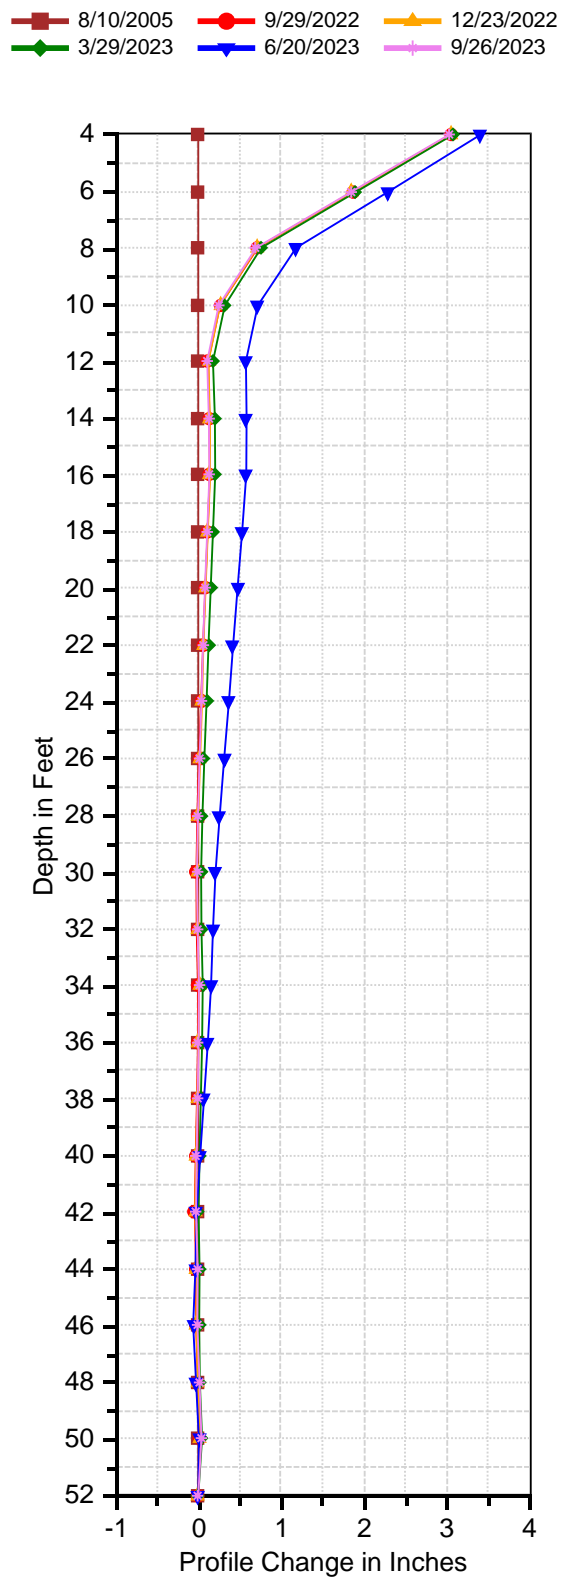
BOWIE BG05_4 A

As described in previous reports, historic displacements indicated on the plots for the approximate upper 12-14 feet of the inclinometers since installation in 2005 are due to placement of cover soil on the face of the waste pile during revegetation operations in late 2006 and early 2007. This man-caused displacement is documented in a report by Buckhorn Geotech dated December 22, 2008, to Bowie Resources called *Revised Stability Evaluations for Coal Mine Waste Disposal Area No. 2, Bowie No. 2 Mine*.

Based on the current inclinometer readings, there has not been evidence of significant downslope movement (Axis A) in any of the inclinometers since 2007 and they are generally consistent with previous readings. Some "noise" which is understood to be relatively common in orthogonal direction (Axis B) readings, was observed over the past few years for all three inclinometers. This can be due to various mechanical or installation causes that are unrelated to slope movement. For example, grout voids, poor grout coverage, or soil settlement around the instrument can all contribute to vibrations and pipe movement that impacts inclinometer readings. Software bias adjustments were applied which filtered this noise. All readings were consistent with previous ones and the "displacement" error was within equipment tolerances and not deemed to be due to slope movement.
