### MINERALS PROGRAM INSPECTION REPORT

<b>MINE NAME:</b> Tomahawk Mine	<b>MINE/PROSPECTING ID#:</b> M-1991-003	<b>MINERAL:</b> Clay (general)	<b>COUNTY:</b> Pueblo
<b>INSPECTION TYPE:</b> Monitoring	<b>WEATHER:</b> Clear	<b>INSP. DATE:</b> July 24, 2023	<b>INSP. TIME:</b> 08:30
<b>OPERATOR:</b> General Shale Brick, Inc.	<b>OPERATOR REPRESENTATIVE:</b> Jason McGraw	<b>TYPE OF OPERATION:</b> 112c - Construction Regular Operation

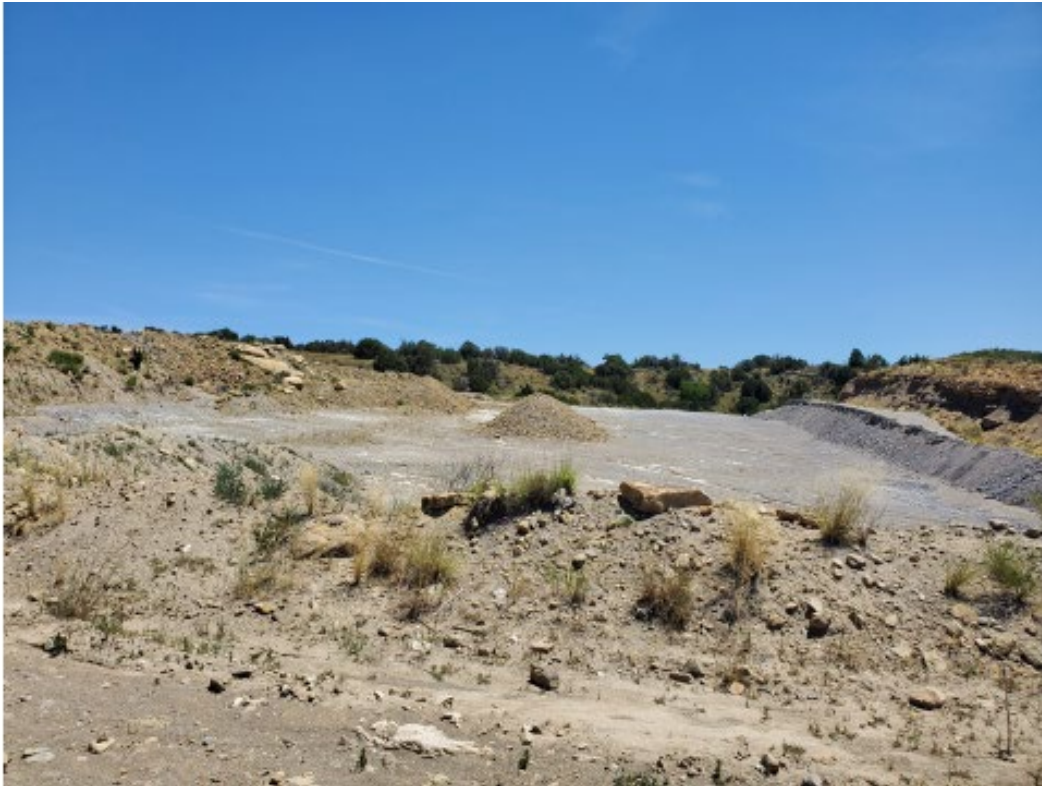
Activity onsite in the past few years has consisted of removing stockpiled clay material. There is currently a highwall approximately 400 feet long and 20 feet high (Photos 1-3; Map 2) in the area labeled as having major disturbance on Maps 1 and 2 and on the 2023 annual report (see Figure 2). Clay material had been removed from this pit and stockpiled in a few locations on the flat area north of the pit (Photo 4, 5 and 6: Moderate disturbance area: Maps 1-2, Figure 2). The Operator has been gradually removing the stockpiled material from this area to transport offsite. For the foreseeable future, the Operator plans to continue to transport stockpiled material offsite before extracting any more material.

**Photo 1:** Looking east into pit or 'major disturbance area'.

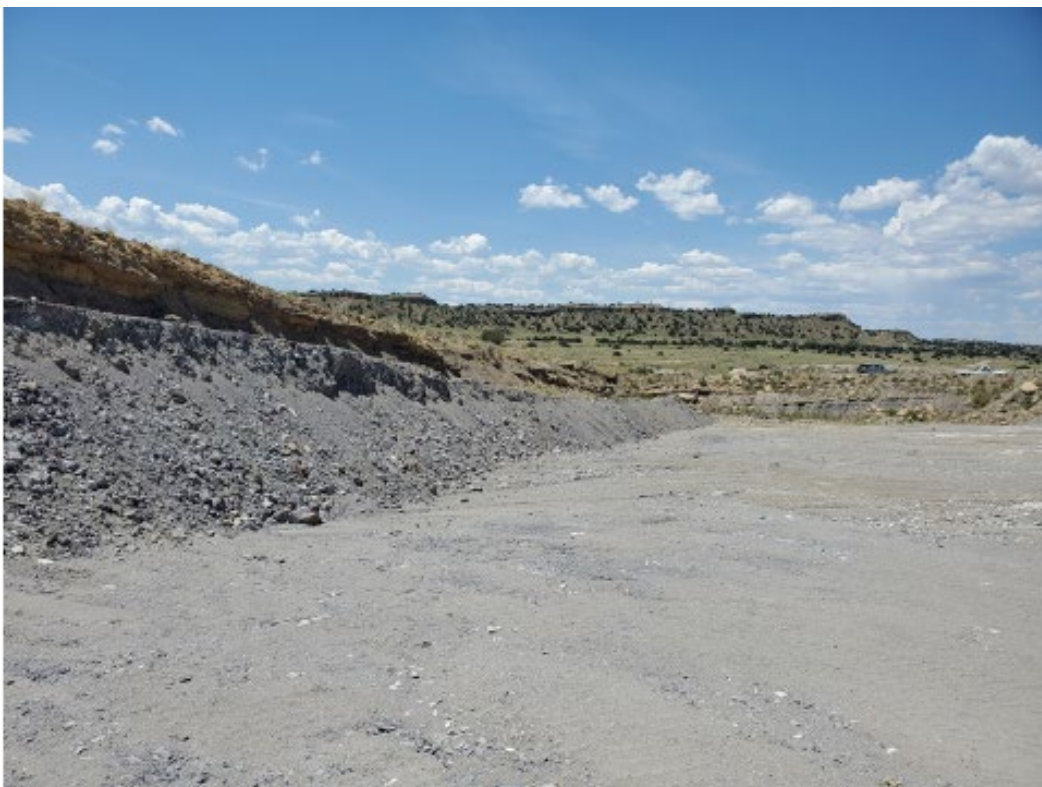
**Photo 2:** Looking west along the highwall, standing in the pit.

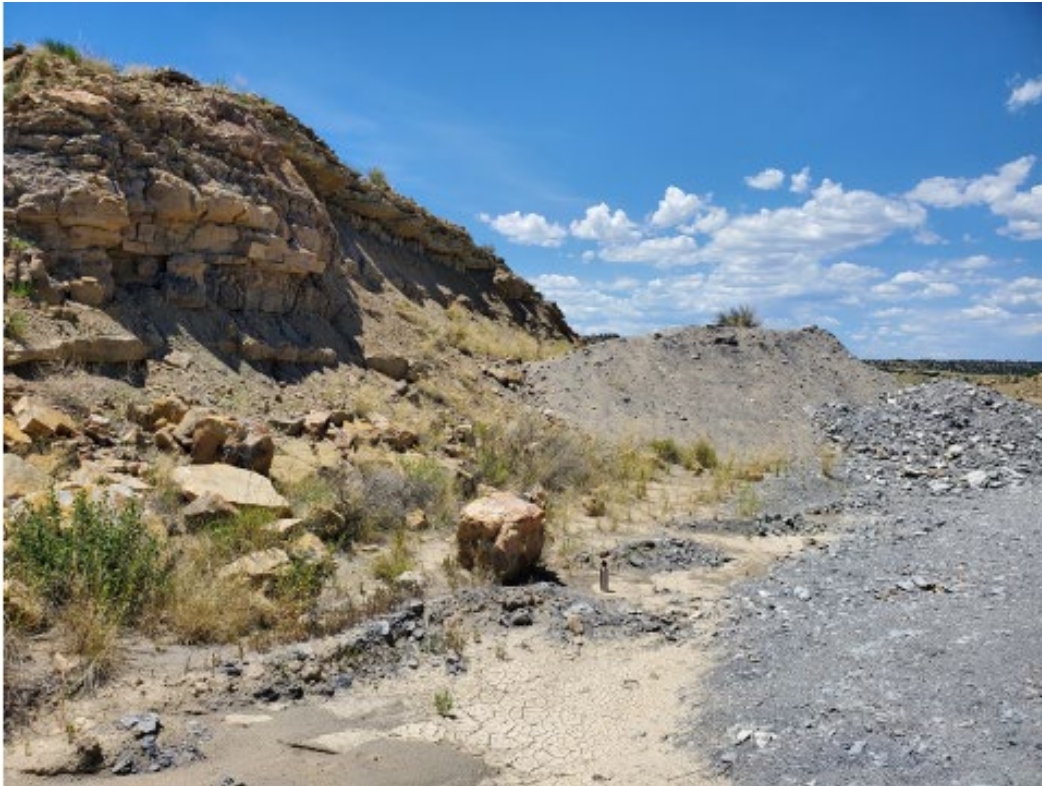
**Photo 3:** Looking west along the highwall where clay material is stored against it, from the southeast corner of the pit.

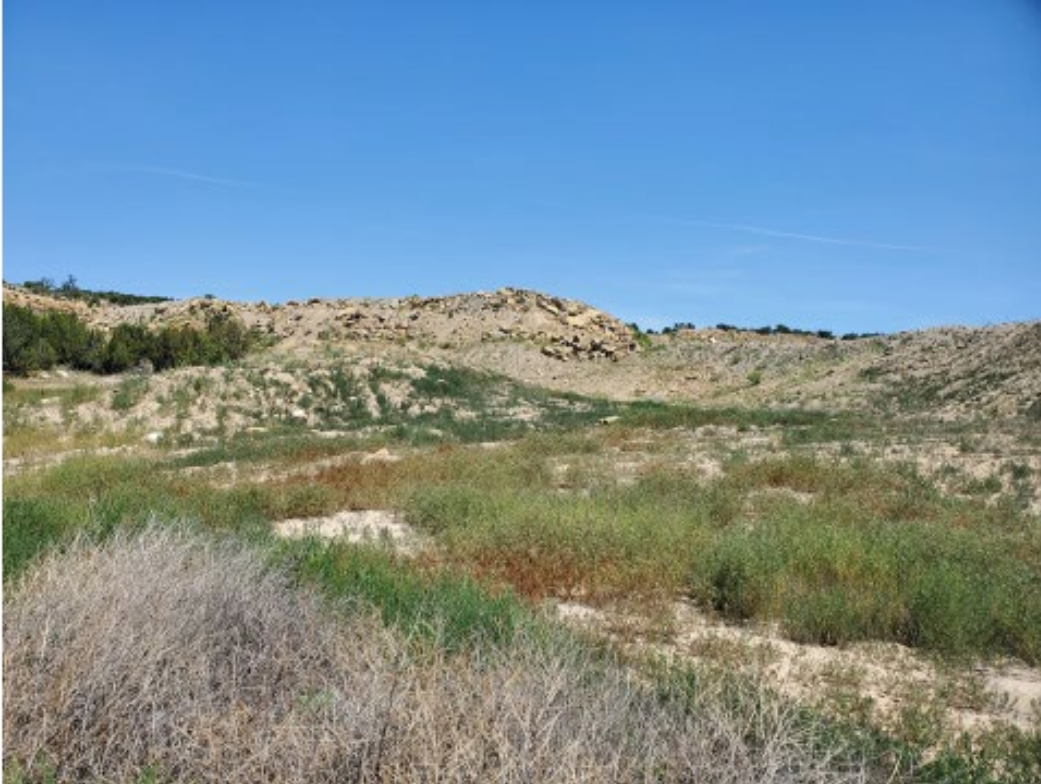
Partial reclamation has occurred within the pre-law disturbance areas. Portions of these areas have been backfilled and graded, however no re-topsoiling or seeding has occurred. A berm of material is left separating the reclaimed disturbance from on-going disturbance (Photos 7-10: Maps 1-2). The forward edge of the mine face in Phases 2, 4, and 6 are approved to remain as vertical cliffs pursuant to the mining and reclamation plans. Along the forward facing sides of what may be Phase 1 or Phase 2 (see discussion in the Signs and Markers section below) highwalls were observed, and photos were taken of various areas in the northern extent of current disturbance (Photos 11-15: Map 2). Undisturbed areas adjacent to these cliffs are shown in Photos 16 and 17. The mine plan refers to the cliffs occurring naturally along this face as the evidence for the stability of leaving this area as vertical faces, and evidence that their presence would be cohesive with the existing topography.

**Photo 7:** Looking west at backfilled and graded pre-law disturbance. A berm lines the actively disturbed area.

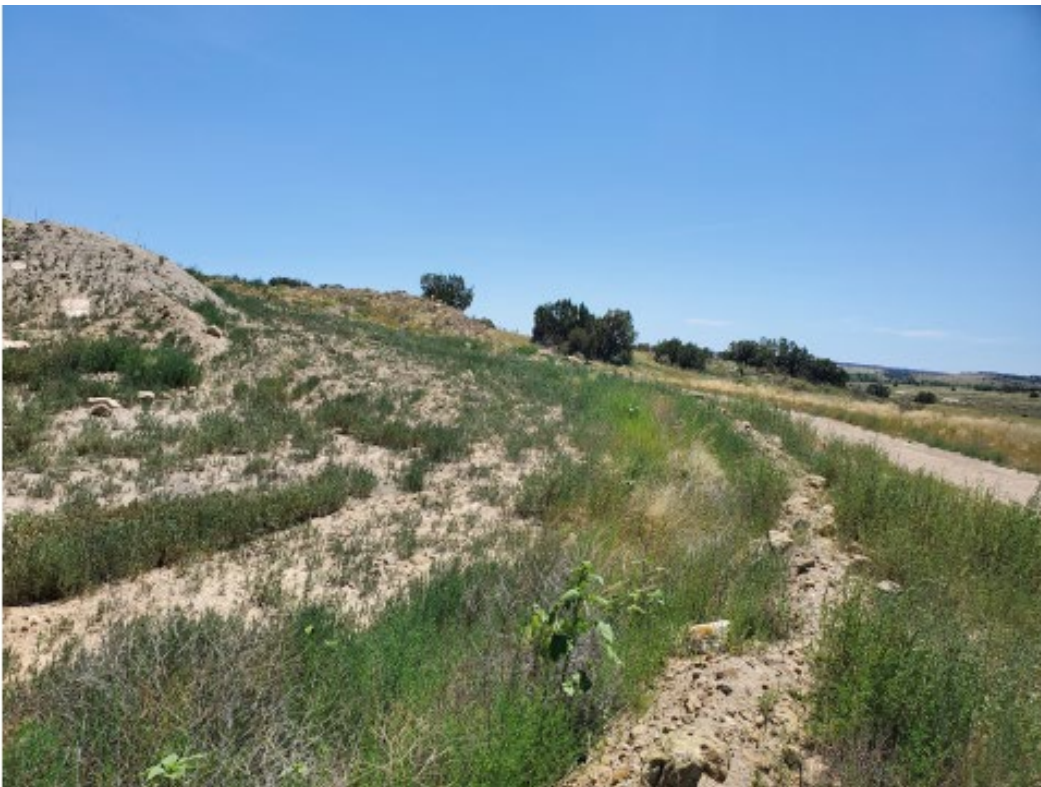
**Photo 8:** Looking west at backfilled and graded pre-law disturbance from just north of the access road. A berm lines the actively disturbed area.

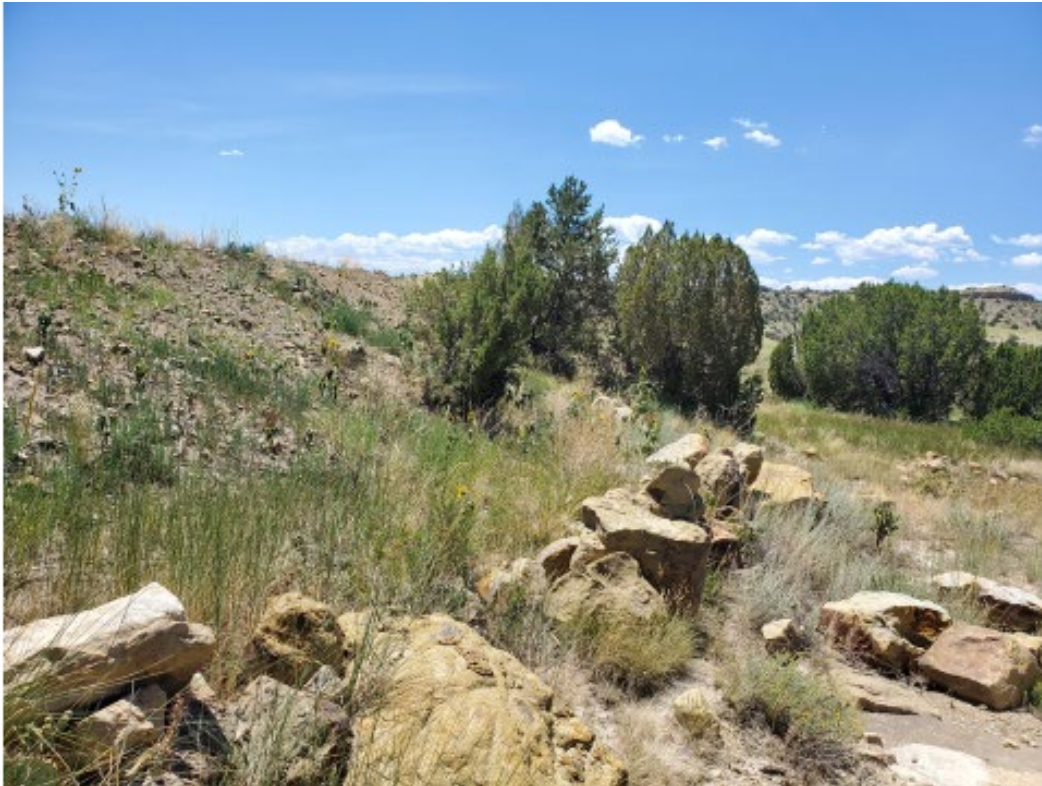
**Photo 9:** Looking south along the berm separating the active disturbance from the pre-law disturbance.

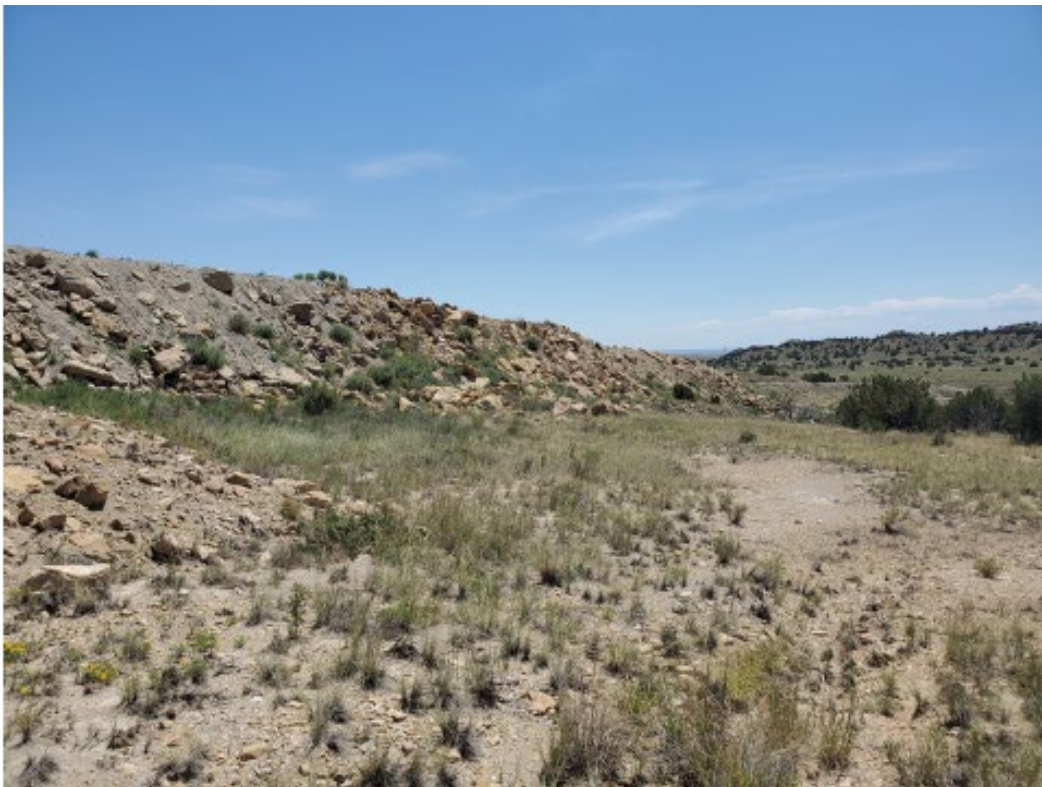
**Photo 10:** Looking south-east at a backfilled and graded pre-law disturbance, and the berm separating active and past disturbance.

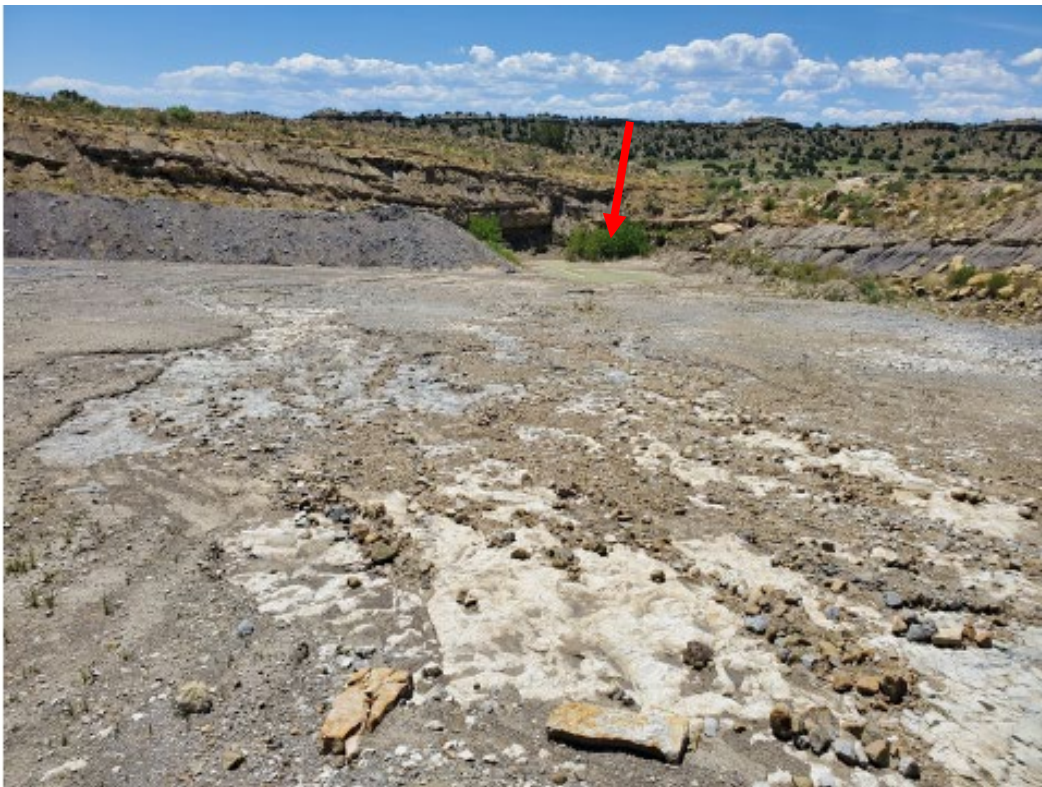
In the pit, there is a small depression in the south-west corner at the base of the highwall (Photo 18: Map 2). This area serves as a sediment catchment basin when storm water enters the pit. The Operator stated that the permit area is generally very dry, and that any water infiltrates or evaporates within 72 hours. The Operator stated that they routinely clean out the sediment trapped in the catchment. The catchment acts as sort of a filter, and allows clay material carried in run-off to settle out. The settled clay is then collected and stored with the stockpiled material. The mine plan states that there are not clean water diversion structures north of the disturbance, because the water naturally runs off the land to the south-east and into the drainages. No

**Photo 18:** Looking at the southwestern corner of the pit. Drainage within the pit settles in the catchment located at the base of the arrow.

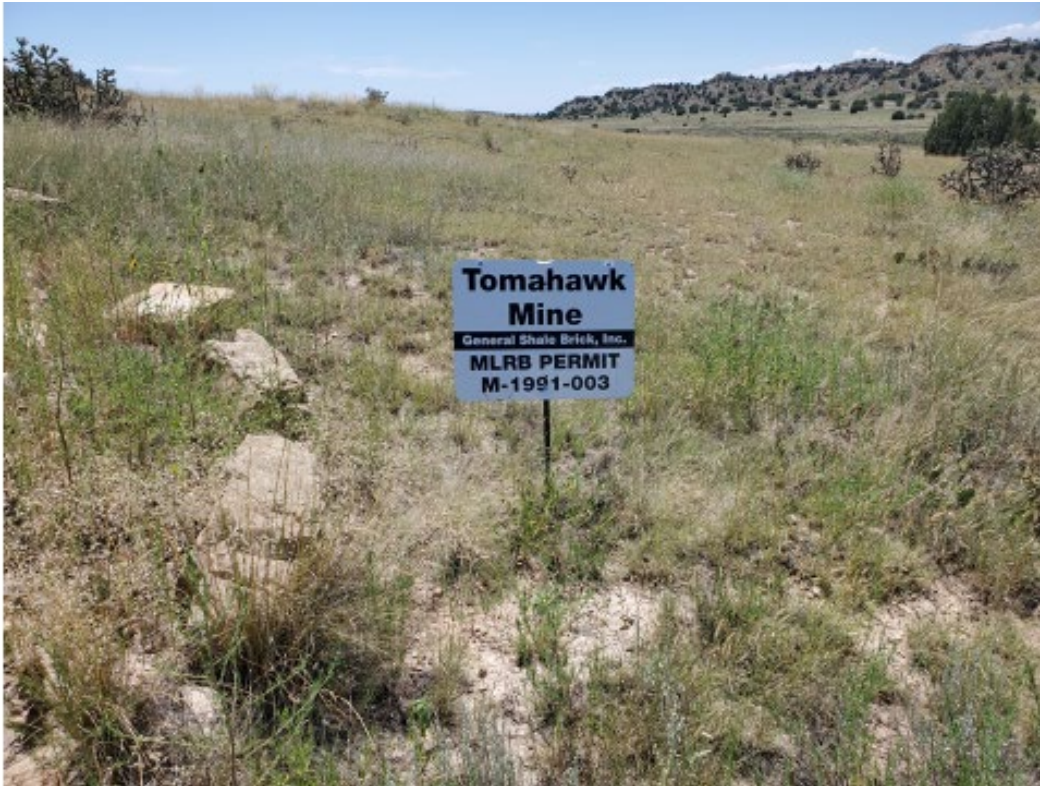
A mine sign was posted in compliance with Rule 3.1.12(1) at the entrance to the site (Photo 19, Maps 1-2). There is a discrepancy in the placement of the Phases between the approved mining plan map and the on-ground disturbance (see Figures 1-2 and Maps 1-2). The Division showed the Operator the discrepancy, that seems to indicate that mining has occurred in Phases 1, 2, 3, and 4, when the operation is approved to only be working in a maximum of two Phases at a time (one in reclamation and the other being actively mined). The Operator stated that the configuration of the Phases were constructed to avoid the drainages. During the inspection, at the southeastern-most corner of the disturbance in the 'Major disturbance' area, the drainage canyon was observed beyond the pit's containment berm to the east (Photo 20, Maps 1-2). The Operator stated that they have stayed out of the drainages. The Division and Operator believe that the approved map may not be accurately drawn to represent the topography on-site.

**Photo 19:** Mine sign posted at the entrance to the site.

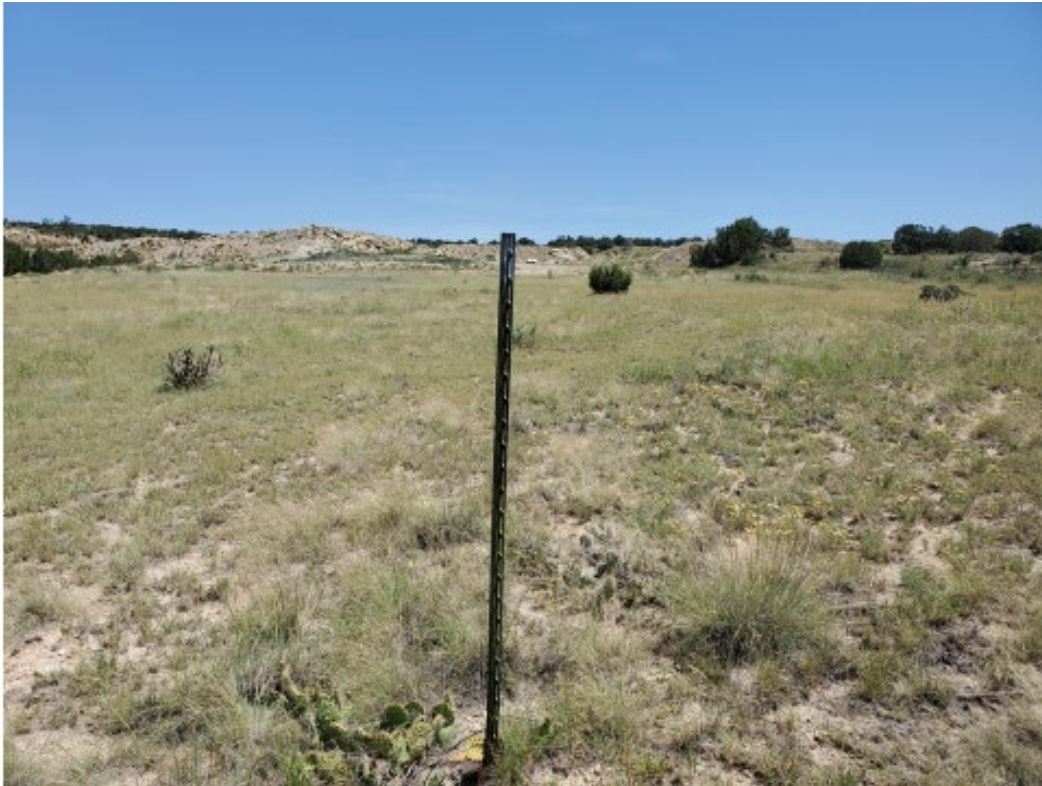
**PROBLEM:** The affected area boundary markers are missing or incorrectly placed. This is a problem for failure to maintain boundary markers around the affected area as required by Section 3.1.12(2) of the rule.

However, the affected land boundary was not marked on-site. The only marker observed on-site was a permit boundary marker southwest of the disturbance on-site (Photo 21: red marker on Maps 1 and 2). The absence of markers has made it unclear if the disturbance onsite is within the approved affected land boundaries. This **has been cited as a problem** for failure to maintain marked affected area boundaries pursuant to Rule 3.1.12(2). The Operator shall conduct a survey and replace the affected area boundary markers for each phase, or for each current phase, and provide photos and coordinates of the markers to the Division by the corrective action date.

**Photo 21:** Looking east at a permit boundary marker.

**CORRECTIVE ACTIONS:** The Operator shall conduct a survey and replace the boundary markers in the correct location(s). The Operator shall provide proof to the Division that this has been done by the corrective action date.

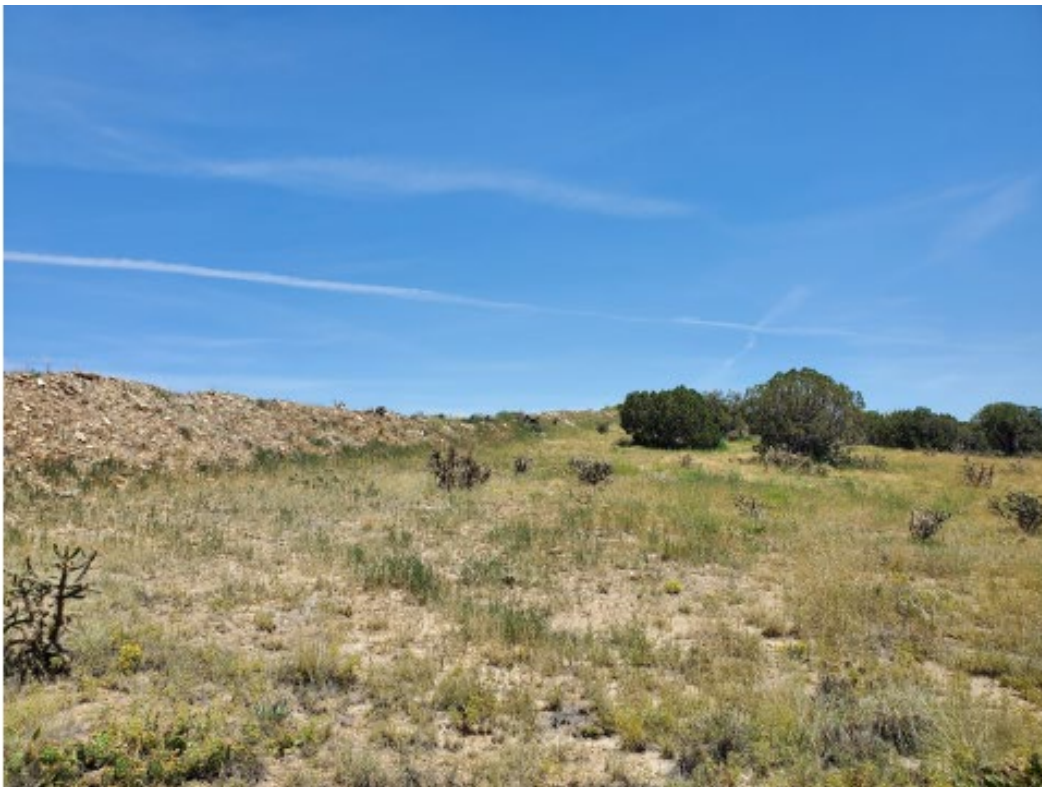
A topsoil berm is placed above the highwall, to the south side of the major disturbance (see Photo 22 and Map 2), out of the way of ongoing mining operations pursuant to Rule 3.1.9(3). The topsoil in the area is thin and in some areas, non-existent. The topsoil that has been salvaged appears to be in stable condition and the Division did not observe any signs of erosion (Photo 23).

**Photo 22:** Looking north-east at the topsoil berm lining the southern border of the major disturbance area.

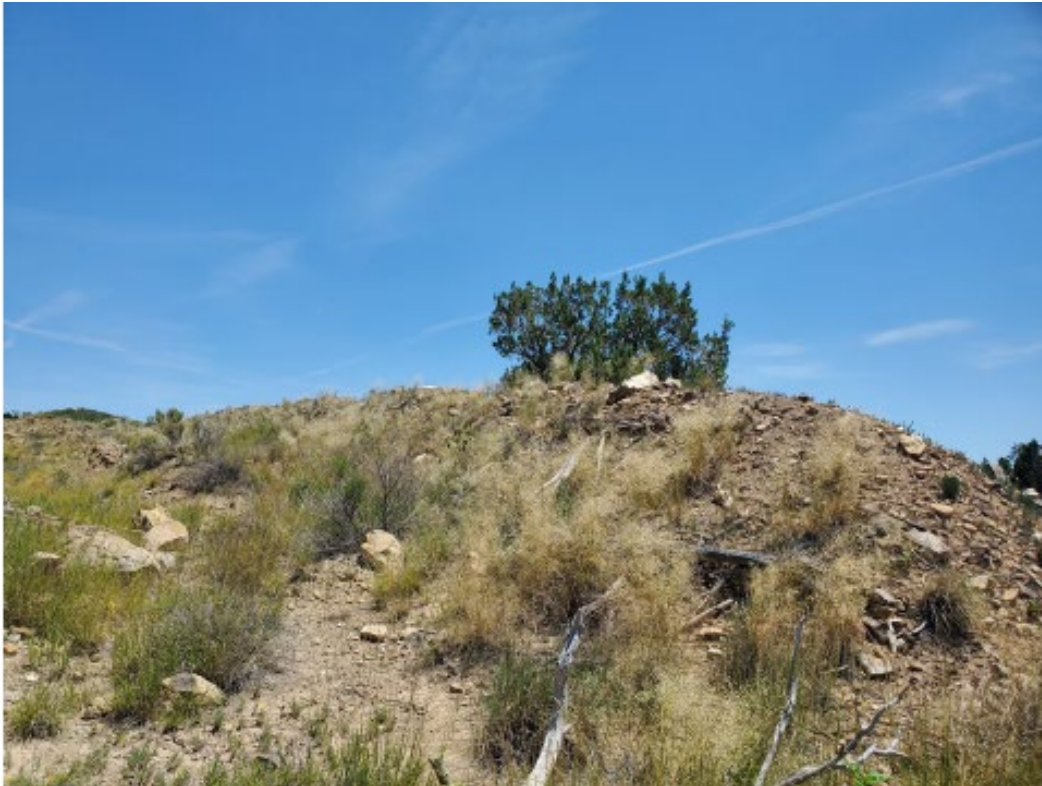
**Photo 23:** Looking south-east at the vegetated topsoil berm.

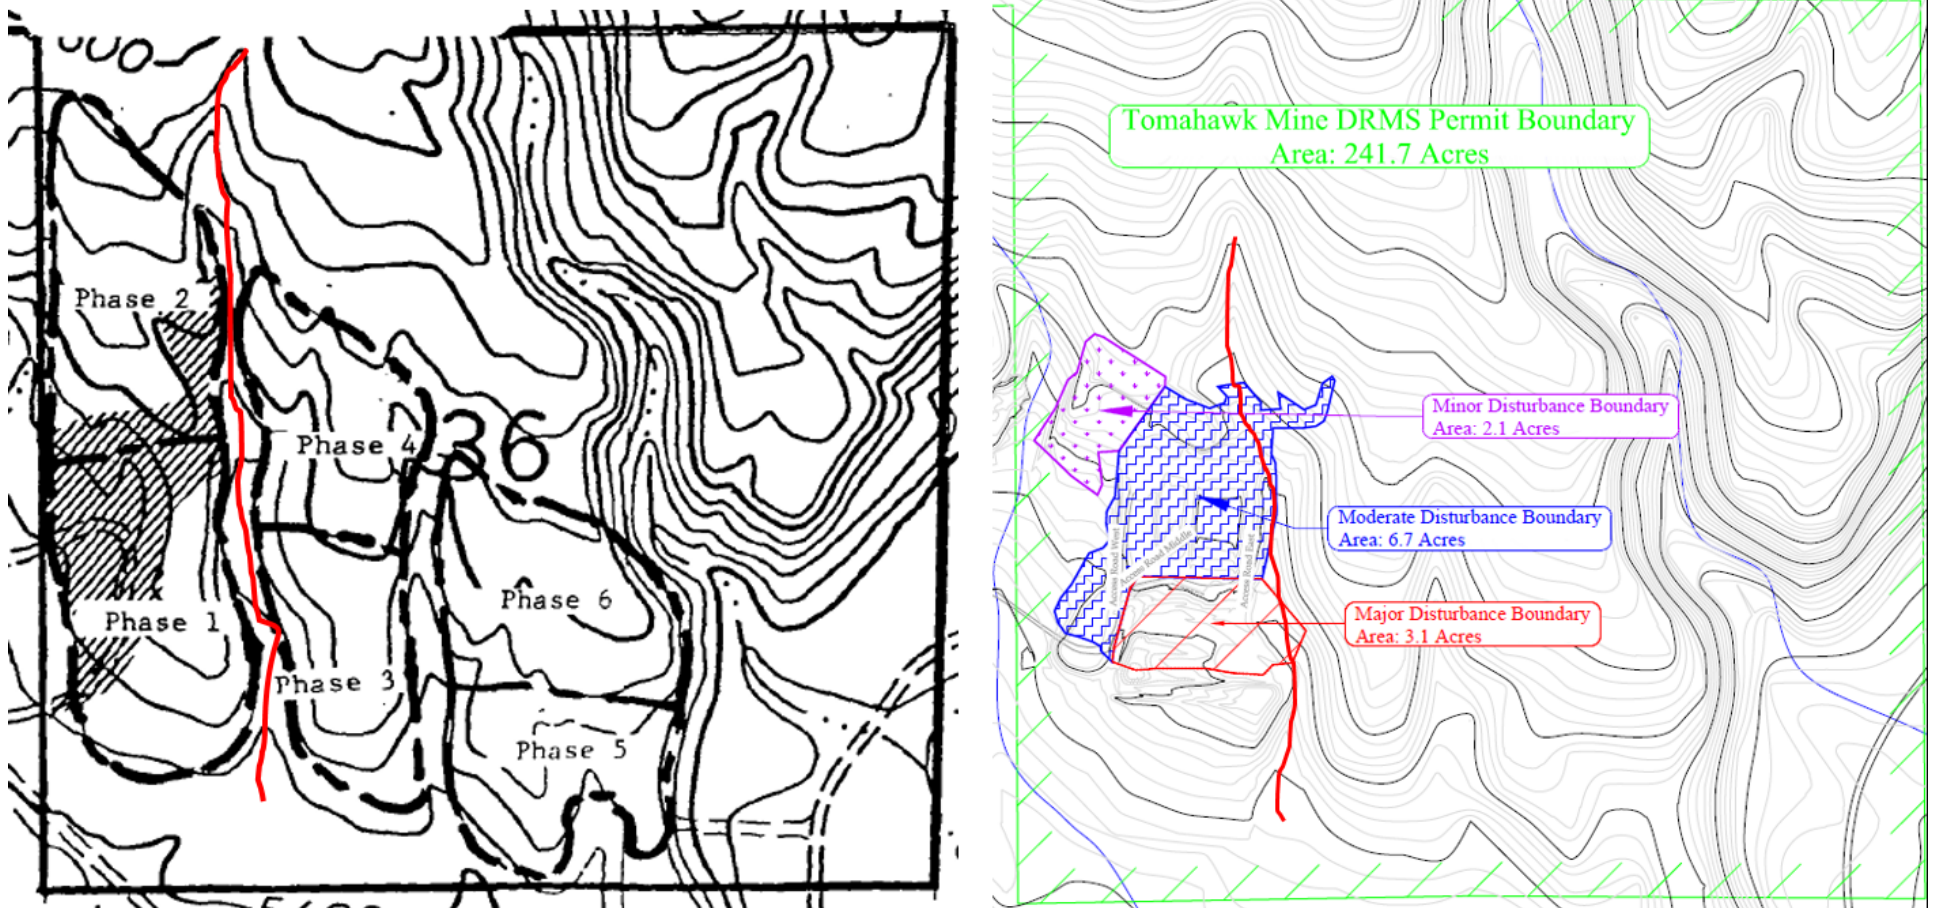
**Figure 2:** The image on the left was captured from the approved mining plan map, and the image on the right is from the Operator's 2023 annual report map. The red line indicates the approximate location of the drainage way. In comparison with field observations, it is unclear if disturbance has actually occurred in the drainage ways, or if the polygons on the 2023 map encompass the extent of disturbance instead of total disturbance.
