MINERALS PROGRAM INSPECTION REPORT
PHONE: (303) 866-3567

MINE NAME: Colony Shale Oil Project	MINE/PROSPECTING ID#: M-1980-047	MINERAL: Oil shale	COUNTY: Garfield
INSPECTION TYPE: Surety-Related Inspection	WEATHER: Clear	INSP. DATE: October 23, 2023	INSP. TIME: 08:30
OPERATOR: Caerus Cross Timbers LLC	OPERATOR REPRESENTATIVE: Jason Eckman	TYPE OF OPERATION: 112 - Hard Rock Regular Operation	
REASON FOR INSPECTION: Surety Related	BOND CALCULATION TYPE: Partial Bond	BOND AMOUNT: \$9,500,000.00	
DATE OF COMPLAINT: NA	POST INSP. CONTACTS: DRMS	JOINT INSP. AGENCY: None	
INSPECTOR(S): Amy Yeldell	INSPECTOR'S SIGNATURE:

This inspection was conducted as part of the Colorado Division of Reclamation, Mining and Safety's (Division) normal monitoring program. The Colony Oil Shale Project is a Hard Rock 112 permitted site located northwest of Parachute Colorado in Garfield County. The entire mine was inspected, excluding the underground areas. Colony consists of 5,712.05 acres with a maximum disturbance of 527 acres. The Division currently holds a financial warranty in the form of a corporate surety in the amount of \$9,500,000.00. Amy Yeldell of the Division conducted the inspection. Jason Ec

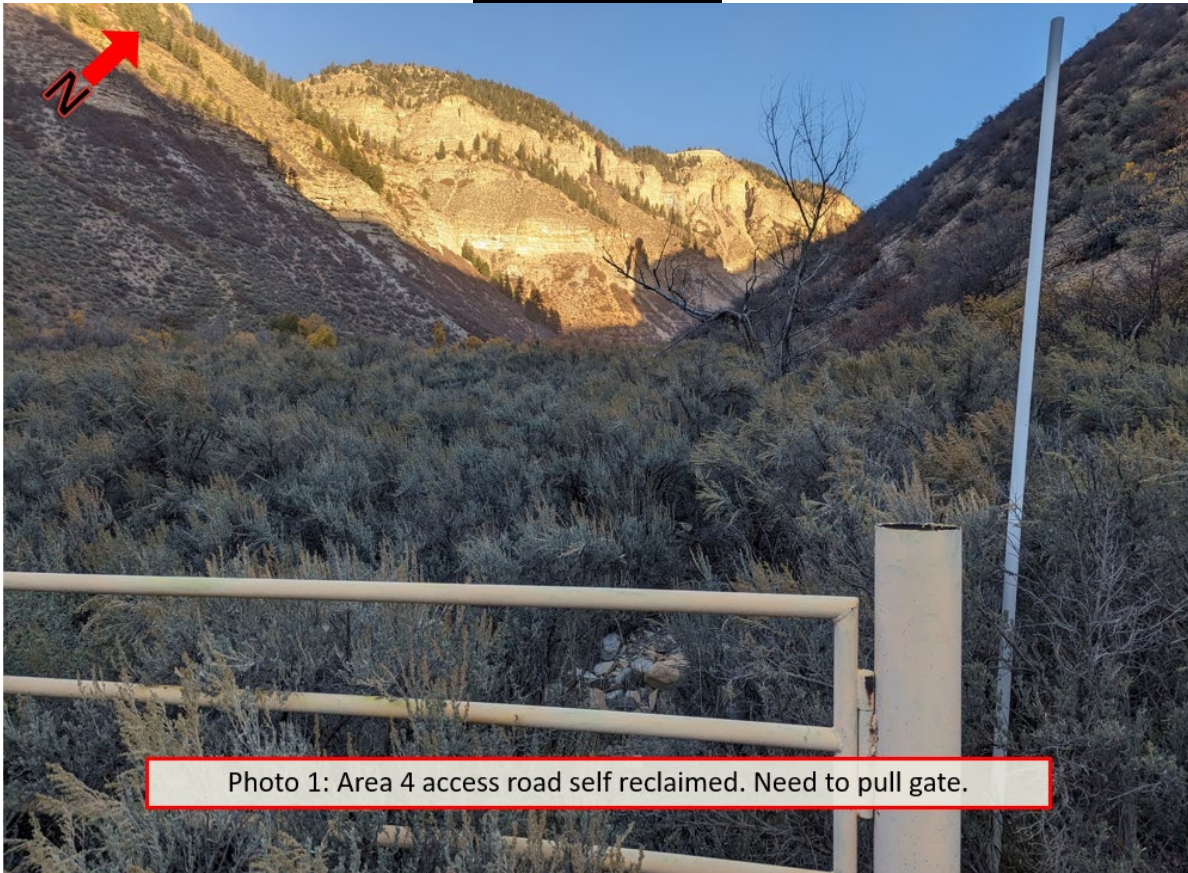
*Area 4 Alternate access road. The road area is self-reclaimed and only identifiable by white PVC posts delineating affected lands. Vegetation consists of mature sage and perennial grasses (Photo One). There is a gate and jersey barrier that needs to be removed. Once removed a portion of Area 4 is eligible for release.

Photo 1: Area 4 access road self reclaimed. Need to pull gate.

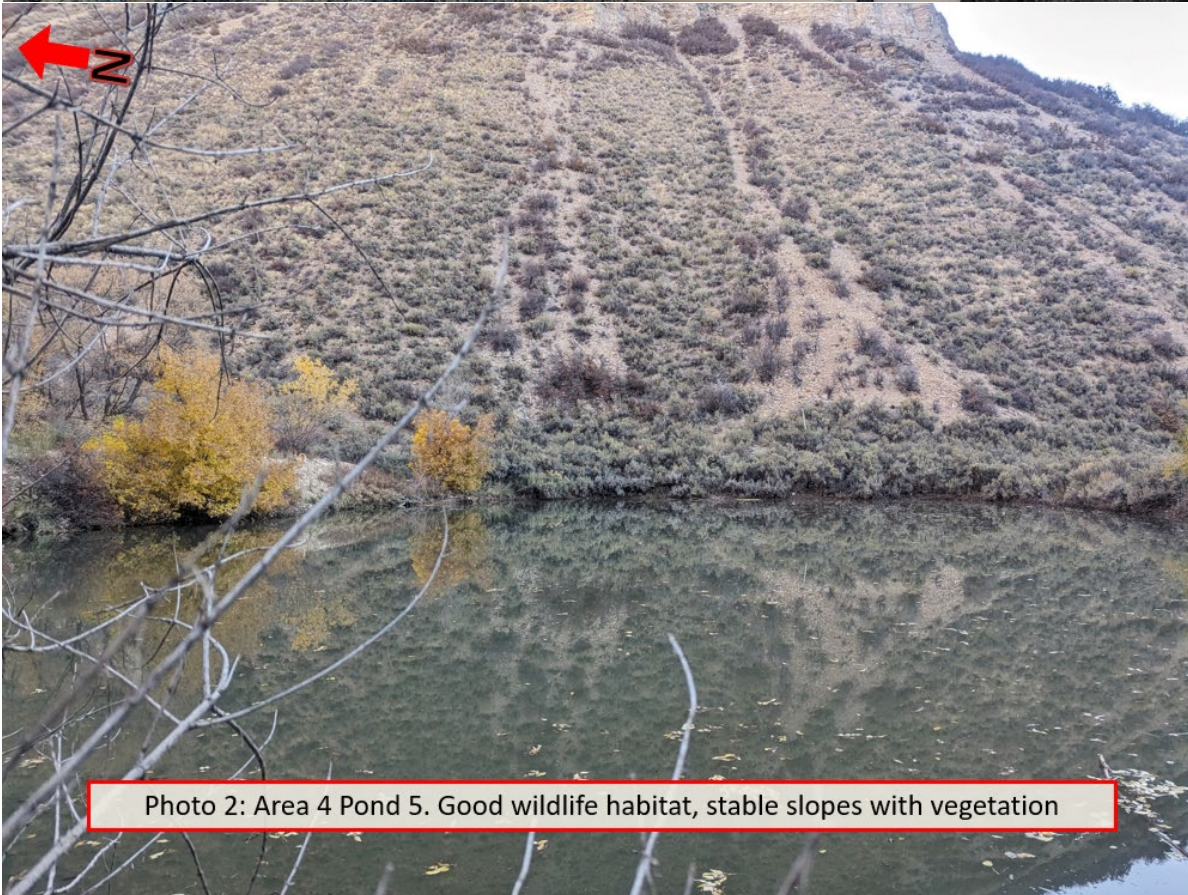
*Area 4 Ponds #3, 4 and 5. Sediment catchment ponds are inundated with water (Photos Two and Three). The banks of the ponds have diverse and well-established vegetation. Vegetation consists of trees, shrubs forbs and grasses with no noxious species observed. The ponds are within a ravine along a creek, slopes are steeper than a 3H: 1V however blend naturally with surrounding topography. No visible signs of erosion were observed. The spillway of the pond appears to be armored with concrete. Pond 3 has a short access road that is a two track (Photo Four). This area should be ripped and reseeded. The Division also recommends placing boulders or some other sort of obstruction along the road to detour vehicle access.

Photo 2: Area 4 Pond 5. Good wildlife habitat, stable slopes with vegetation

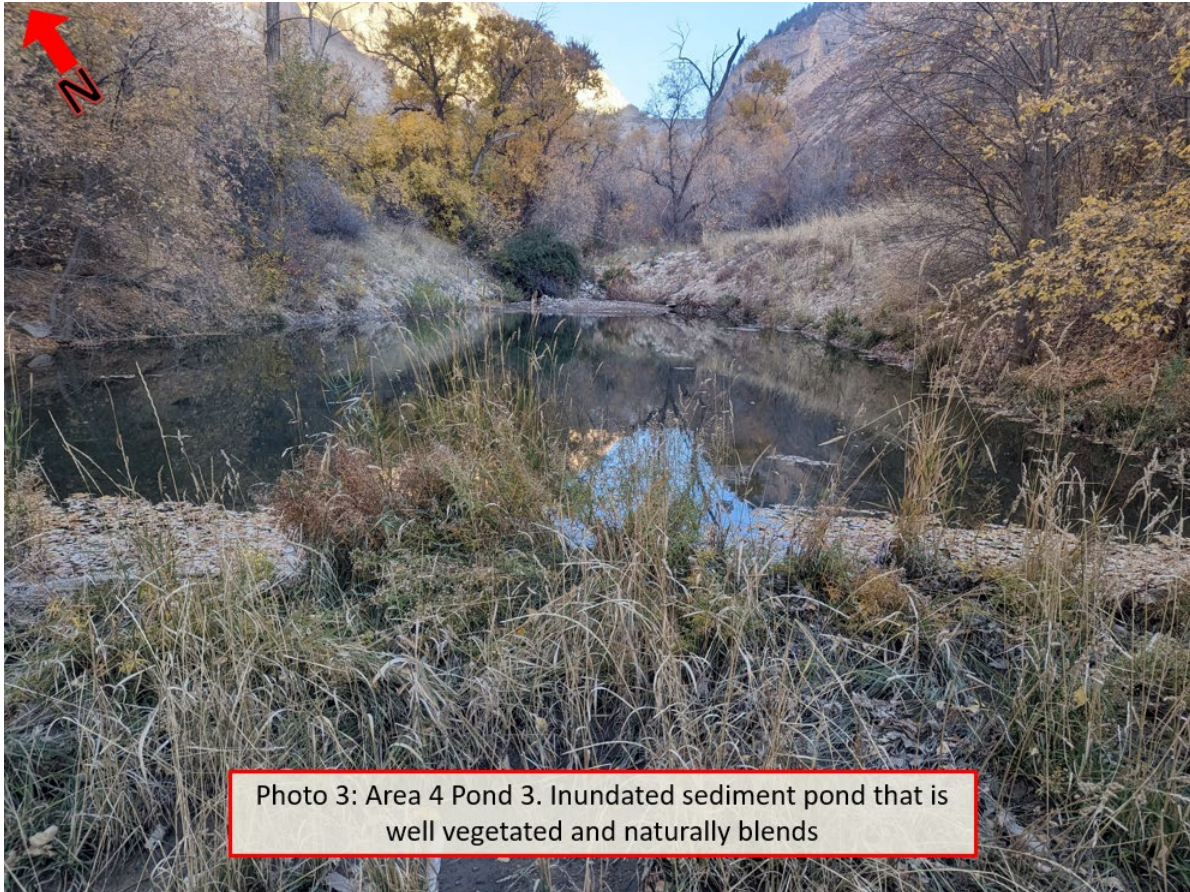
Photo 3: Area 4 Pond 3. Inundated sediment pond that is well vegetated and naturally blends

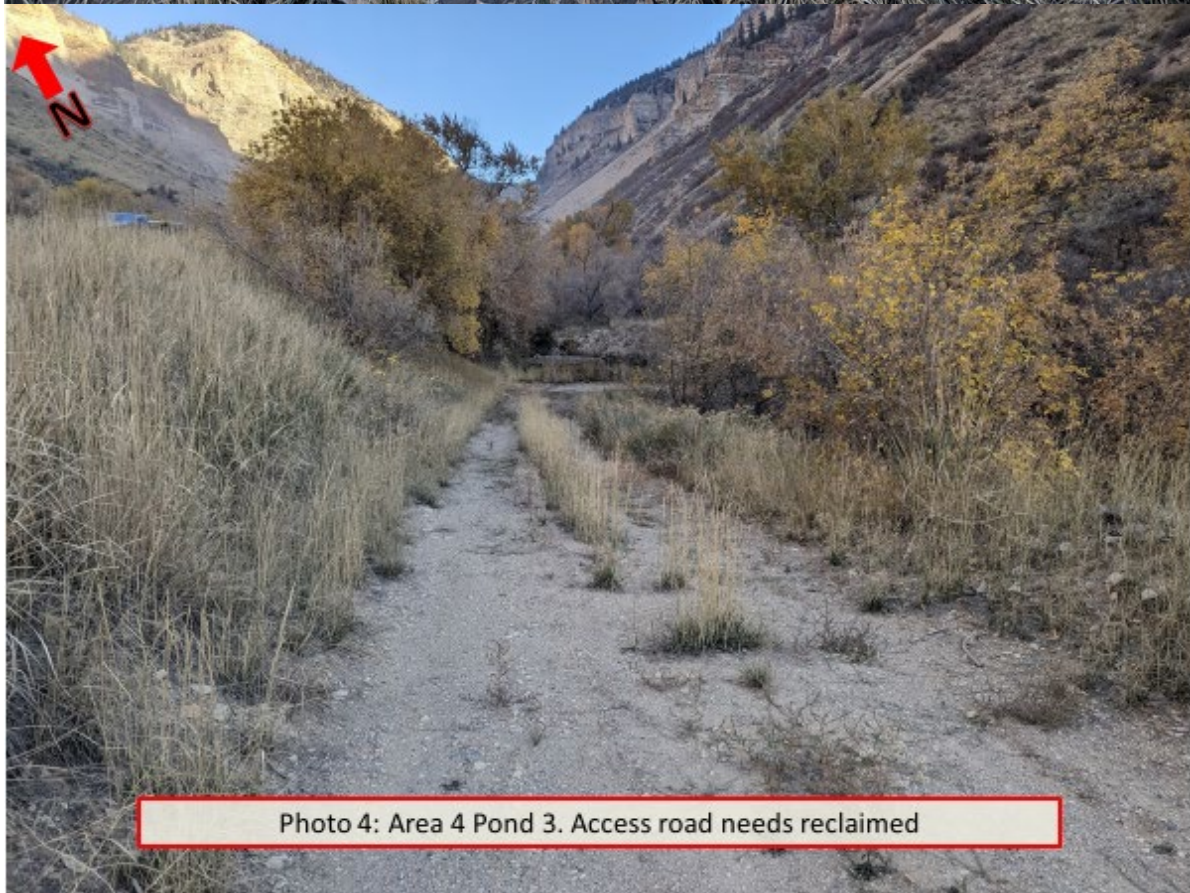
Photo 4: Area 4 Pond 3. Access road needs reclaimed

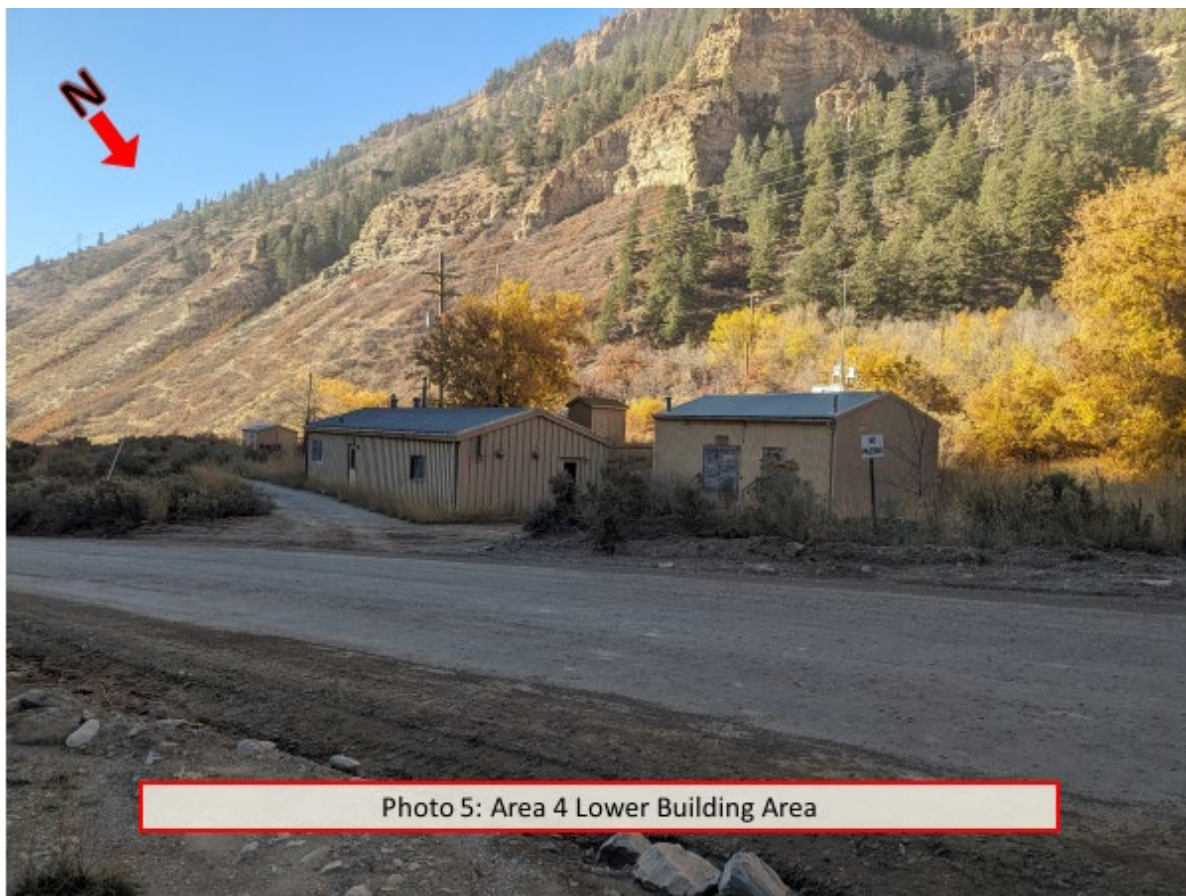
Area 4 Lower Building Area. Within the area to the west side of the road are three large buildings and three smaller shed type structures (Photo Five). Additionally, there is a 1,000-gallon propane tank (empty). A diesel tank (empty) and a generator located within a shed are in secondary containment (Photo Six). The containment under the fuel had water inside. There is a weather station. Above the laboratory area accessed by a separate road is a fueling area. There is a concrete secondary containment structure with two fuel tanks inside. The diesel

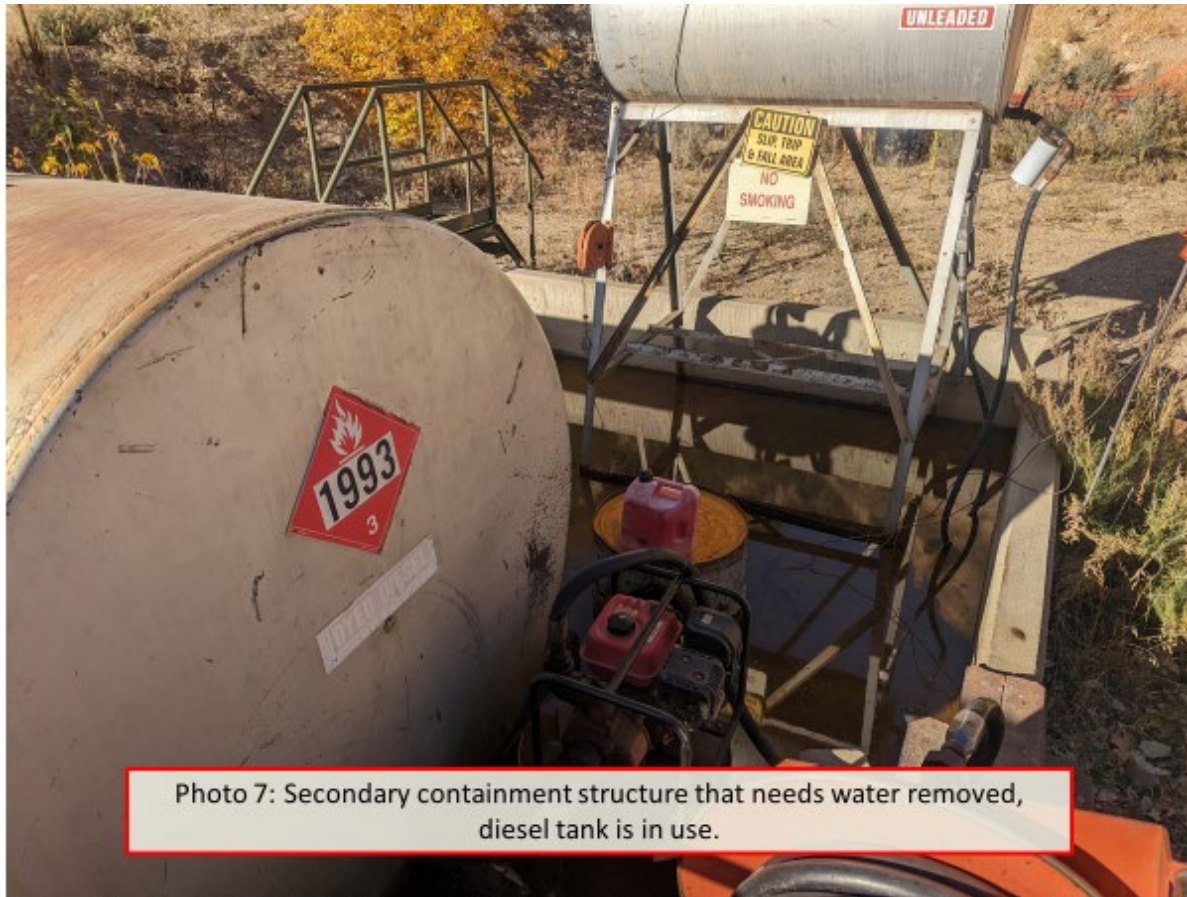
tank has fuel and appears to be in use while the gasoline is empty. The containment has water and needs to be pumped out (Photo Seven). There is also an empty plastic secondary containment structure to temporarily place items within. If this structure is going to be used in the future it also needs to be pumped out. A trash roll-off was also located in this area and was in use. Division staff entered most of the buildings. The laboratory still has lots of historical equipment inside. Caerus has some equipment for going underground stored inside as well. The Records Storage building is mostly empty aside from an ATV, fertilizer, and old air monitoring equipment (Photo Eight). This building is being utilized by their ranch manager. Division staff did not enter the core shed. There are also several single electrical poles and wire connecting Area 4 and 5. This power is not tied into the power grid (Xcel Energy). During the inspection staff discussed leaving some of the buildings for continued use. This will require updating the Reclamation Plan and providing documentation from the County that they are permitted to remain postmining. Regardless, the Division will require information regarding their construction. For each building, please provide the dimensions and building material type, foundation thickness (reinforced?). And for reclamation if a building is to be removed indicate where the demolished structure will go and if the foundation will be removed or backfilled.

All fuels observed on site were stored within secondary containment. It is noted that several of the secondary containment structures had water in them and should be pumped out.

Photo 7: Secondary containment structure that needs water removed, diesel tank is in use.

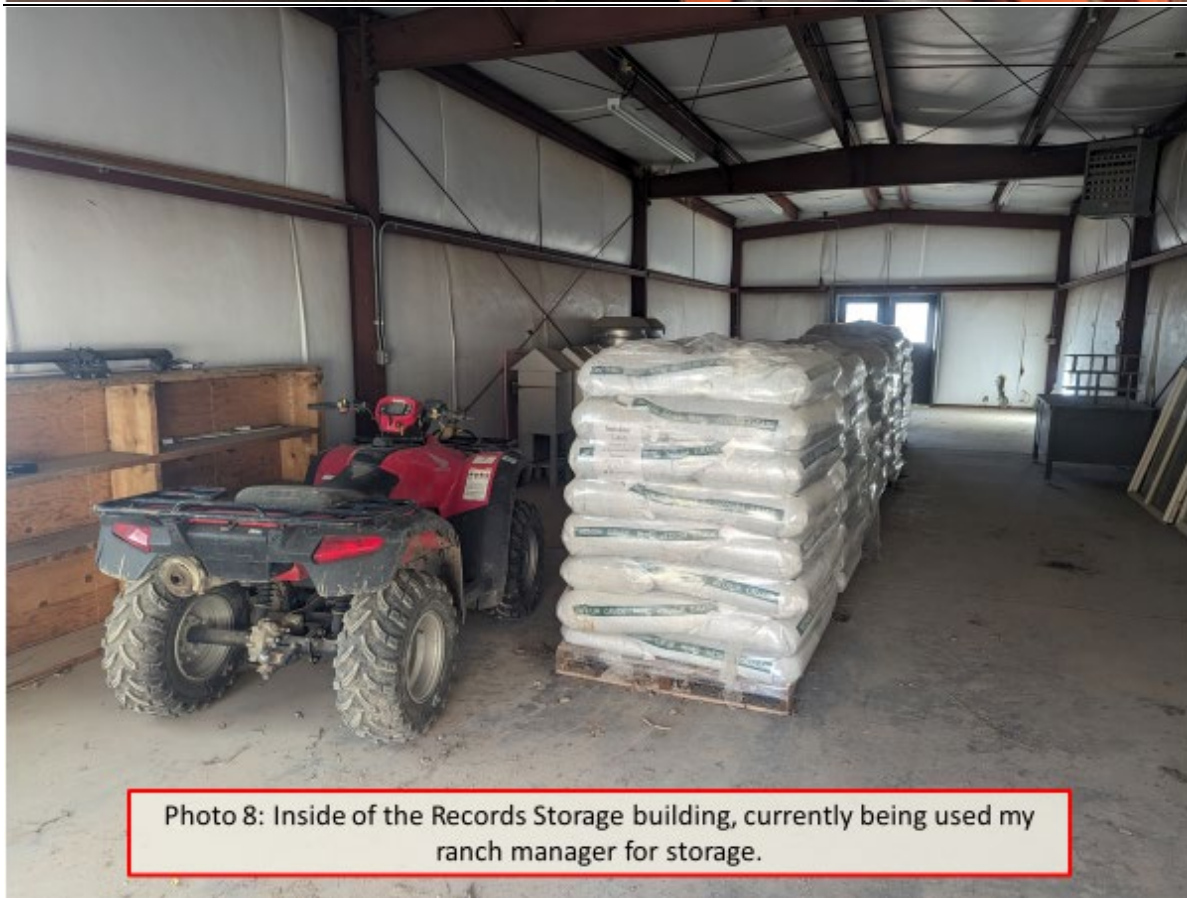
Photo 8: Inside of the Records Storage building, currently being used by my ranch manager for storage.

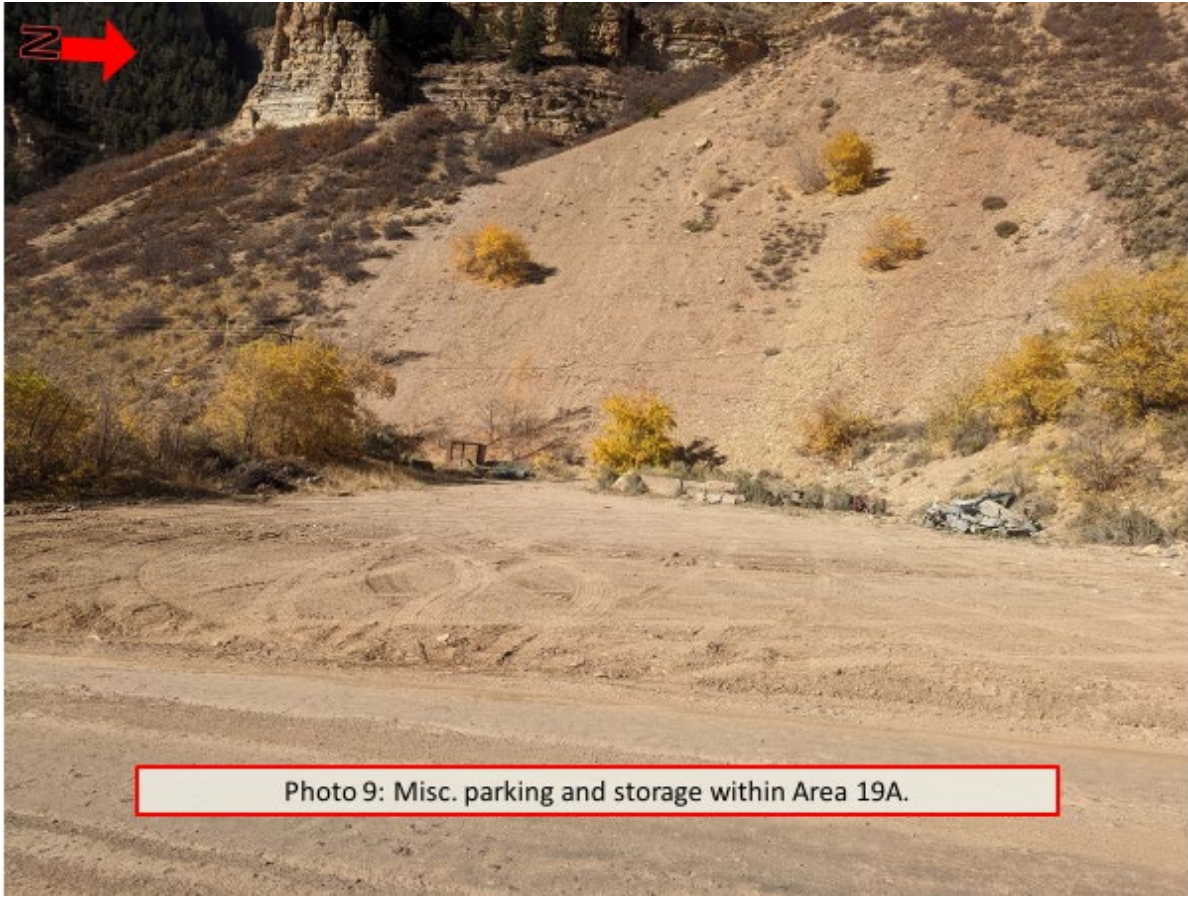
Area 19A Power Pole Corridor. Additional single electrical poles and wire are located within area 19A. This area is largely self-reclaimed and is mostly evident based on the overall height/size of vegetation relative to adjacent vegetation. These poles and wire need to be removed. In updating the Reclamation Plan, please provide the Division with the pole count for this area. Some spot seeding may also be required after their removal. A pull off is located within Area 19 and is currently being used for miscellaneous storage and parking (Photo Nine). This area will need to be ripped and seeded. The Division also recommends blocking it off to detour future use.

Photo 9: Misc. parking and storage within Area 19A.

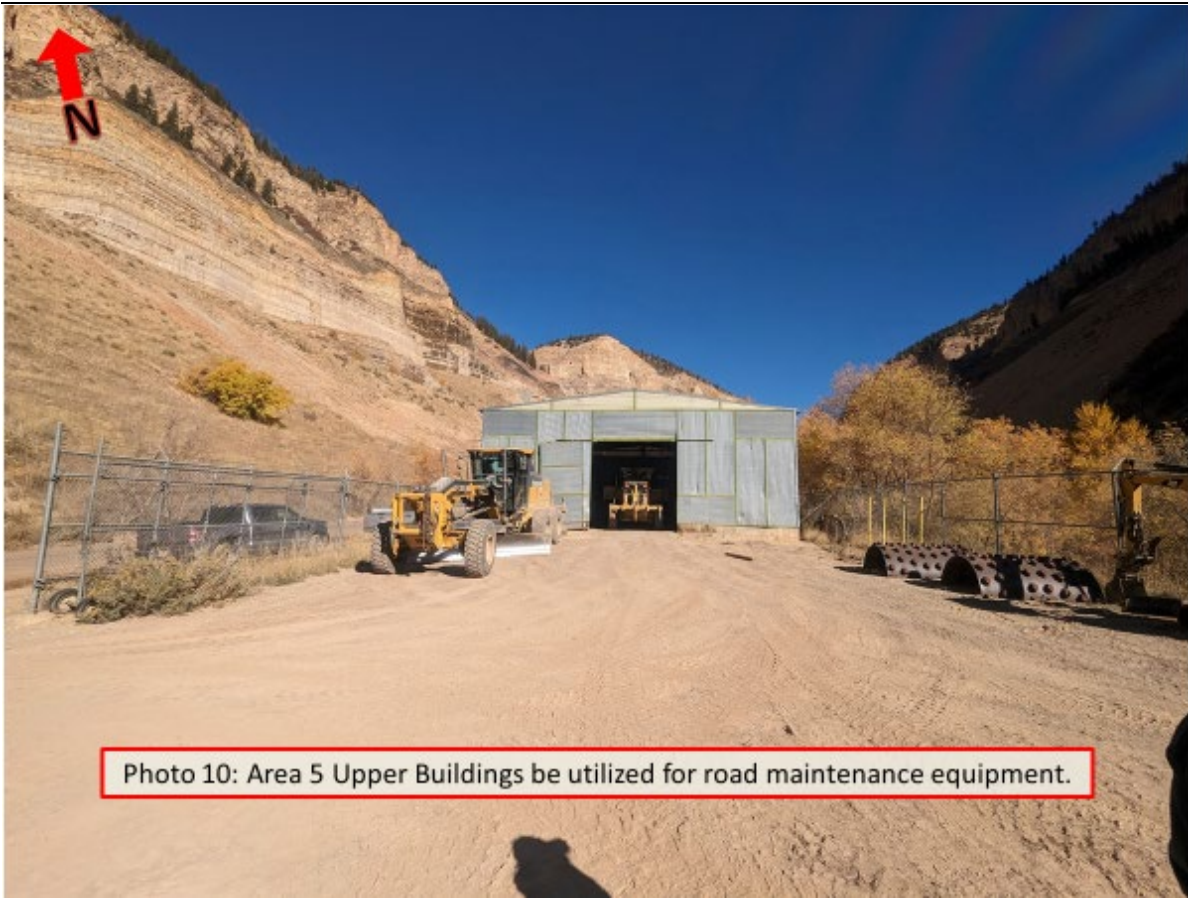
Area 5 Upper Building Area. There are three larger buildings/ shops located in this area. The electrical poles continue into this area from Area 4 and will need removed. Additionally, there is a smaller yellow generator building and a 1,000-gallon propane tank. All three of the buildings are currently in use to store road maintenance equipment (Photo Ten). As previously mentioned, this will require updating the Reclamation Plan and providing documentation from the County that the buildings are permitted to remain postmining. The Division will require information regarding their construction and details regarding removal if it will not remain postmining.

Photo 10: Area 5 Upper Buildings be utilized for road maintenance equipment.

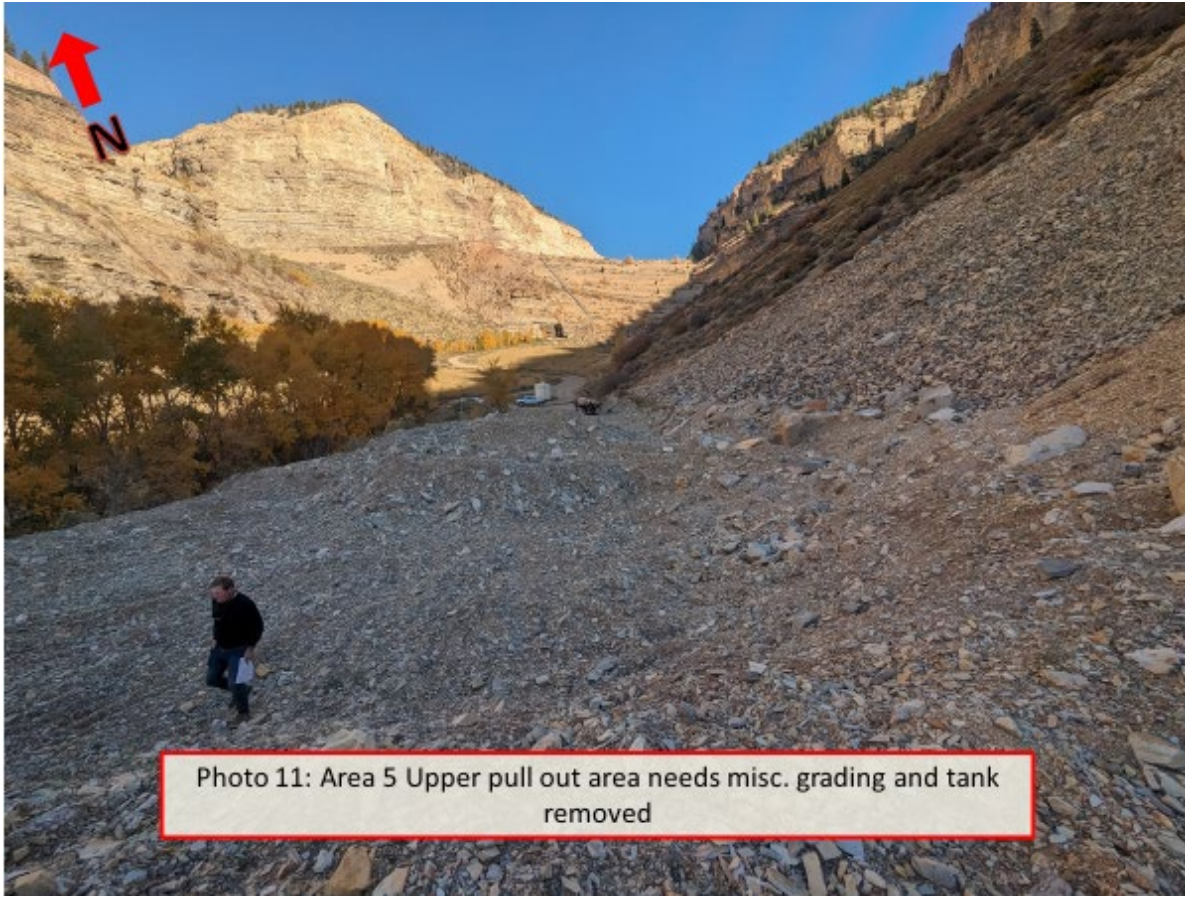
Area 5 Pullout. The northern portion of area 5 is a pull out just before the mine bench. There is a large white empty tank presumed to be for water storage (Photo Eleven). Caerus indicated they do not use it. This item should be removed. There is a flat area located at the base of the scree path above the creek. It is unclear if this was affected for mining purposes or just to keep rocks from entering the creek. There are random holes and berms along this graded area that need contoured. The Operator should attempt to blend and smooth while putting an emphasis on directing water to avoid erosion into the creek. Once graded the area should be seeded. Shrubs and other deeply rooted species will likely favor this area over grasses due to the rocky nature of the soils.

Photo 11: Area 5 Upper pull out area needs misc. grading and tank removed

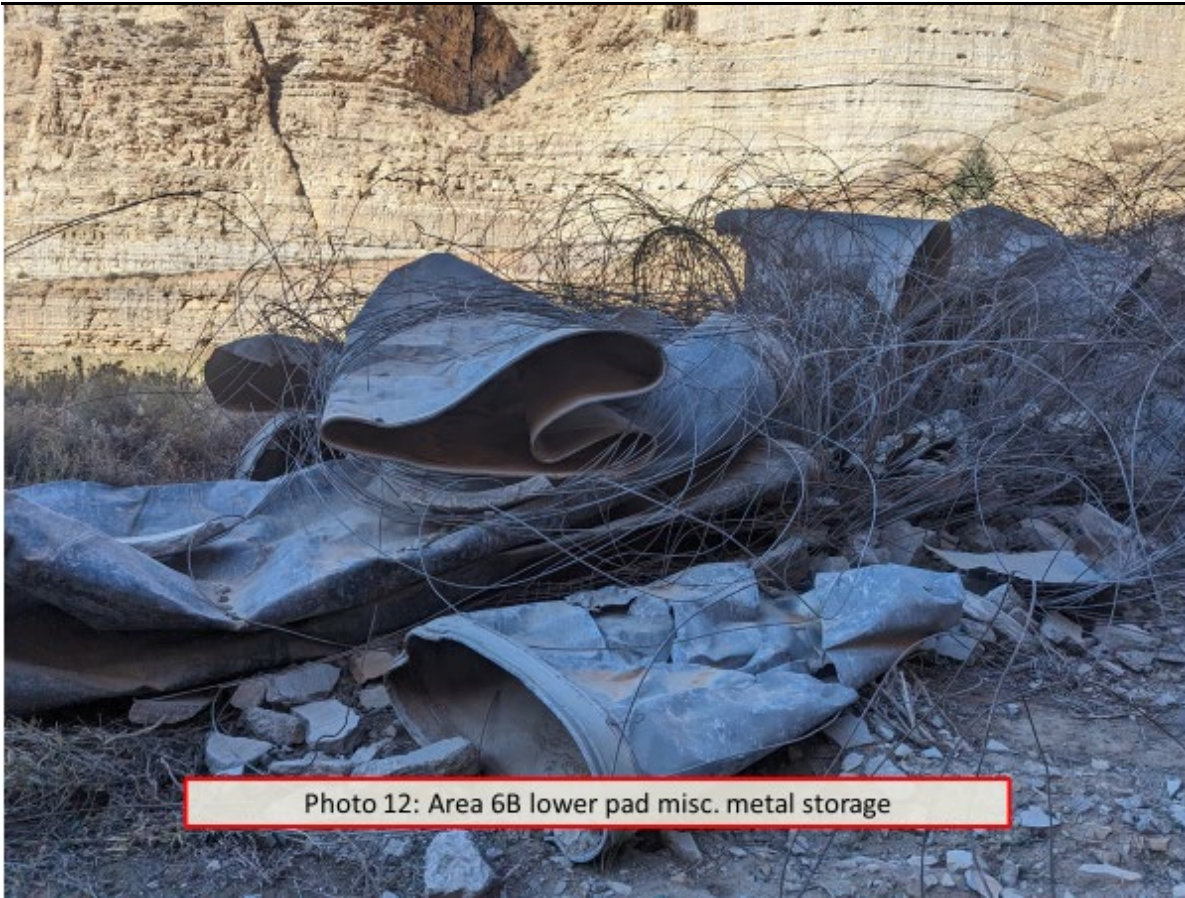
Lower 6B pad area. There is a plugged and abandoned gas well located within this bench. Additionally, there is what appears to be an open monitoring well with submersible pump. This well should be abandoned if not required for monitoring. Miscellaneous wire and culverts are being stored in the northeast corner of the pad (Photo Twelve). This material is slowly being removed over time. Mr. Seymour indicated that this pad has been seeded several times. Hydromulch material was observed. Some portions of the pad have well established shrubs but overall, the site is lacking perennial grasses and other early seral species. The windsock and electrical for the helicopter pad remain in place along the face of the highwall. The west or entrance of the pad appears to be frequently used for parking/ pull-off of the main road (Photo Thirteen). If Caerus would like to leave this area, they will need to update the Reclamation Plan to reflect the areas where vegetation will not be

Photo 12: Area 6B lower pad misc. metal storage

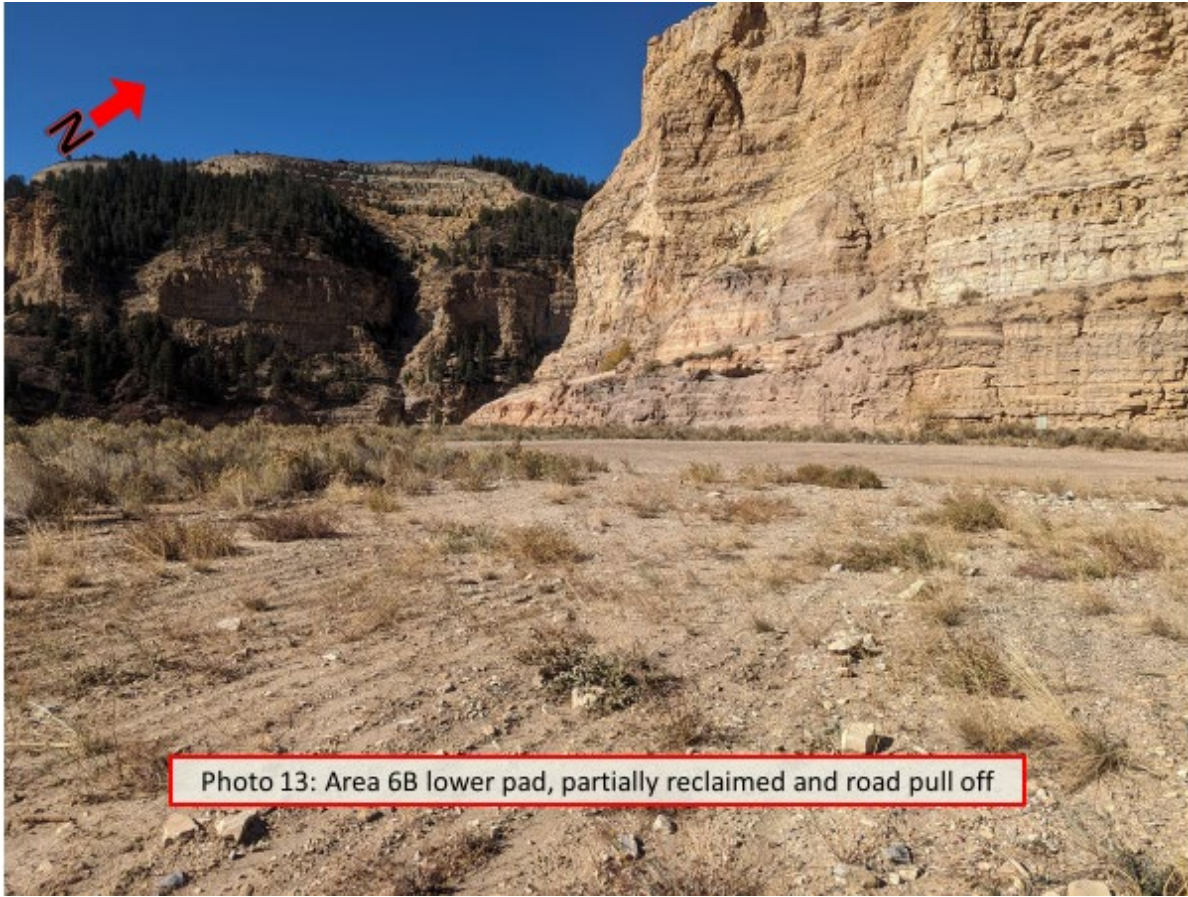
Photo 13: Area 6B lower pad, partially reclaimed and road pull off

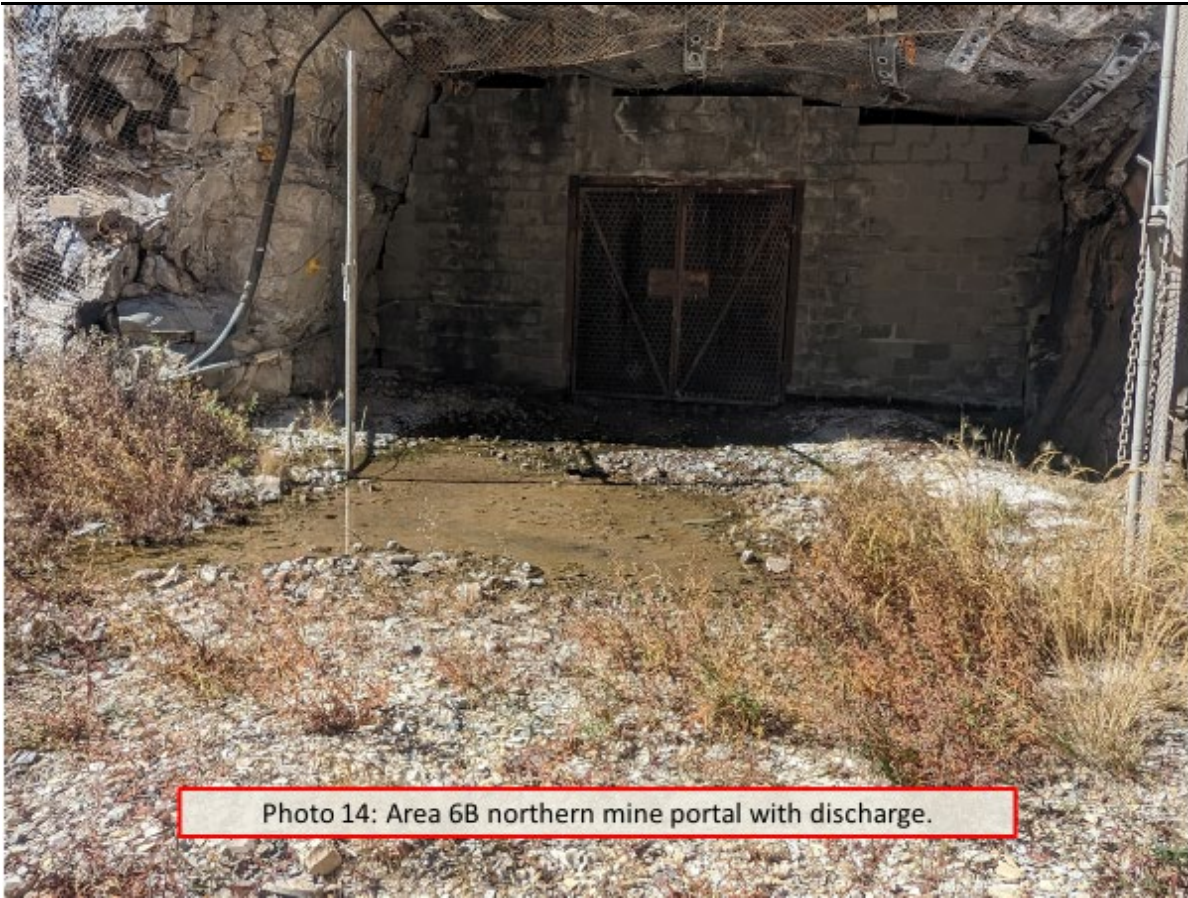
Water was observed discharging from the northern portal on the mine bench (Photo Fourteen). Please specifically address how this discharge will be addressed within the revised Reclamation Plan. Upon completion of final reclamation, the Operator will be required to provide documentation assuring that all wells have been abandoned or use transferred.

Photo 14: Area 6B northern mine portal with discharge.

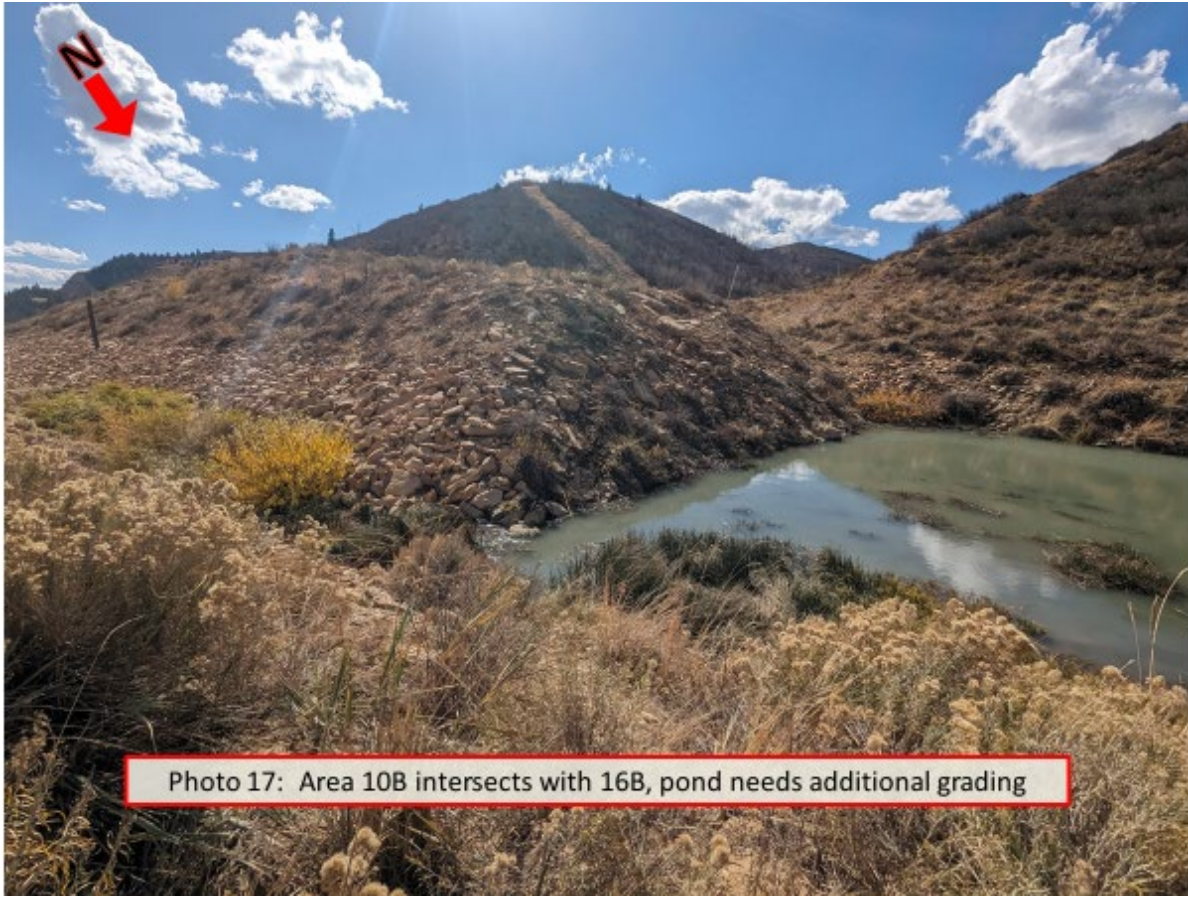
Area 10B. This area is largely self- reclaimed and mostly comprised of perennial grasses. A large culvert goes under the road to direct drainage into the Davis Gulch Dam. There is also a sediment pond with water and a spillway. The slope, though steeper than a 3H:1V is stable and well established with vegetation. Some minor grading will be required where area 15B/16B intersects 10B (Photo Seventeen). There is also an abandoned well in the rip-rap spillway area.

Photo 17: Area 10B intersects with 16B, pond needs additional grading

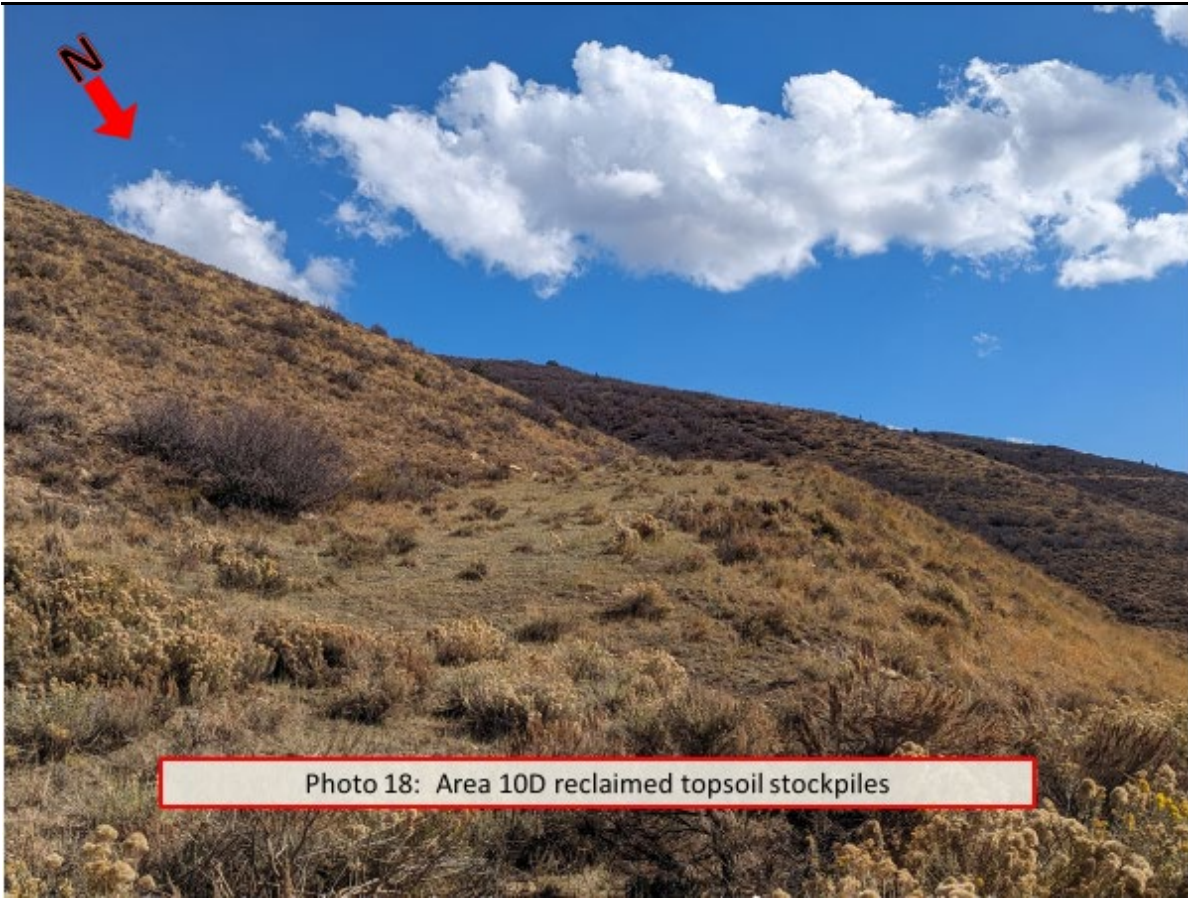
*Area 10D Topsoil Stockpile. These stockpiles were placed on the side of a hill and appear to be natural and blend with surrounding topography (Photo Eighteen). Given the well-established vegetation and the steep slope the Division would advise against using these stockpiles if sufficient quantities of topsoil are available from the other locations. This area will likely be extremely difficult to reclaim if redisturbed.

Photo 18: Area 10D reclaimed topsoil stockpiles

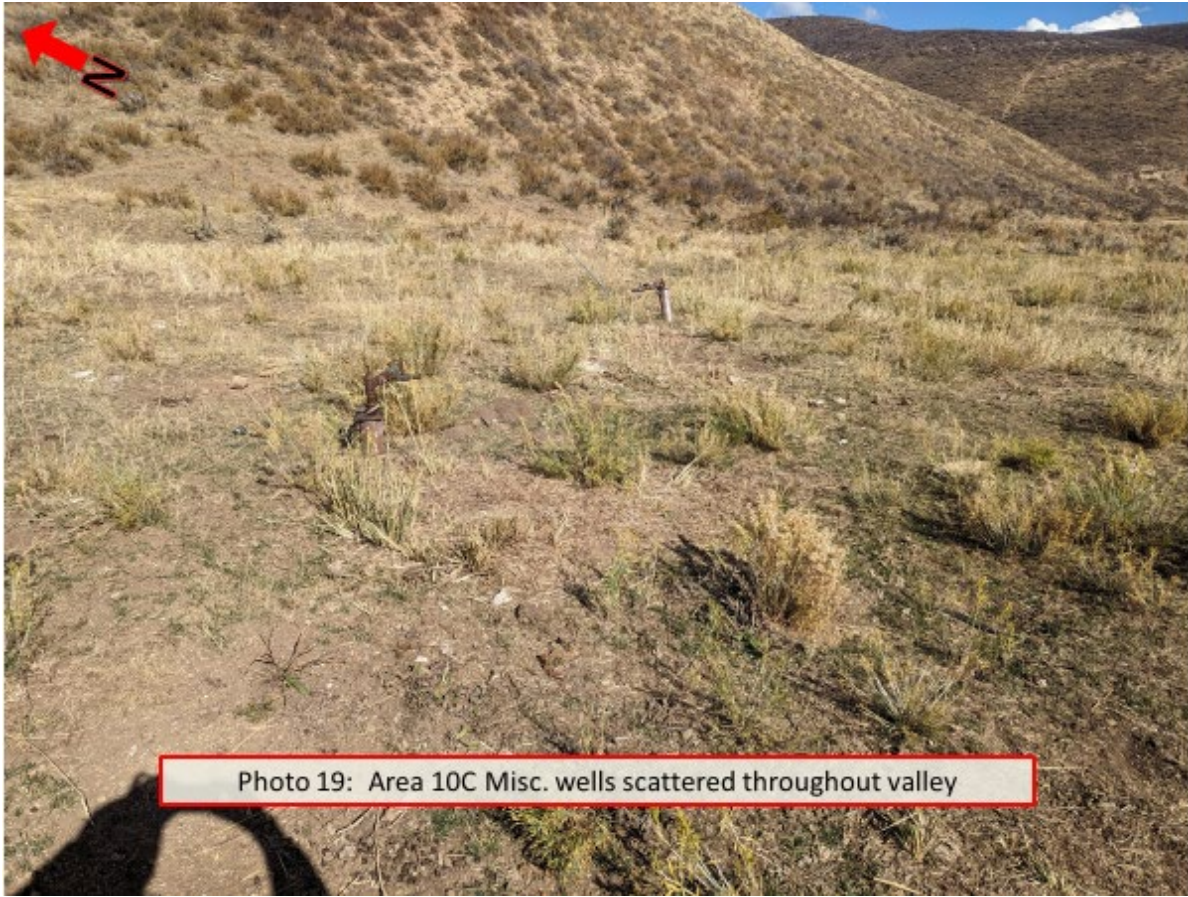
Area 10C Loop Road. There are several wells located on the north side of the loop road (Photo Nineteen). The Division and Caerus were unclear what the purpose of these wells were and if it was related to mining activities. If they are mining related, they will need to be abandoned. Please provide the Division with an inventory of the wells, locations, and details (construction and abandonment). There were two additional monitoring wells on the south side of the loop road. Please provide information of the construction and abandonment of these wells as well. Overall vegetation in this area blends naturally. Only touch up seeding from the abandonment of the wells will be required.

Photo 19: Area 10C Misc. wells scattered throughout valley

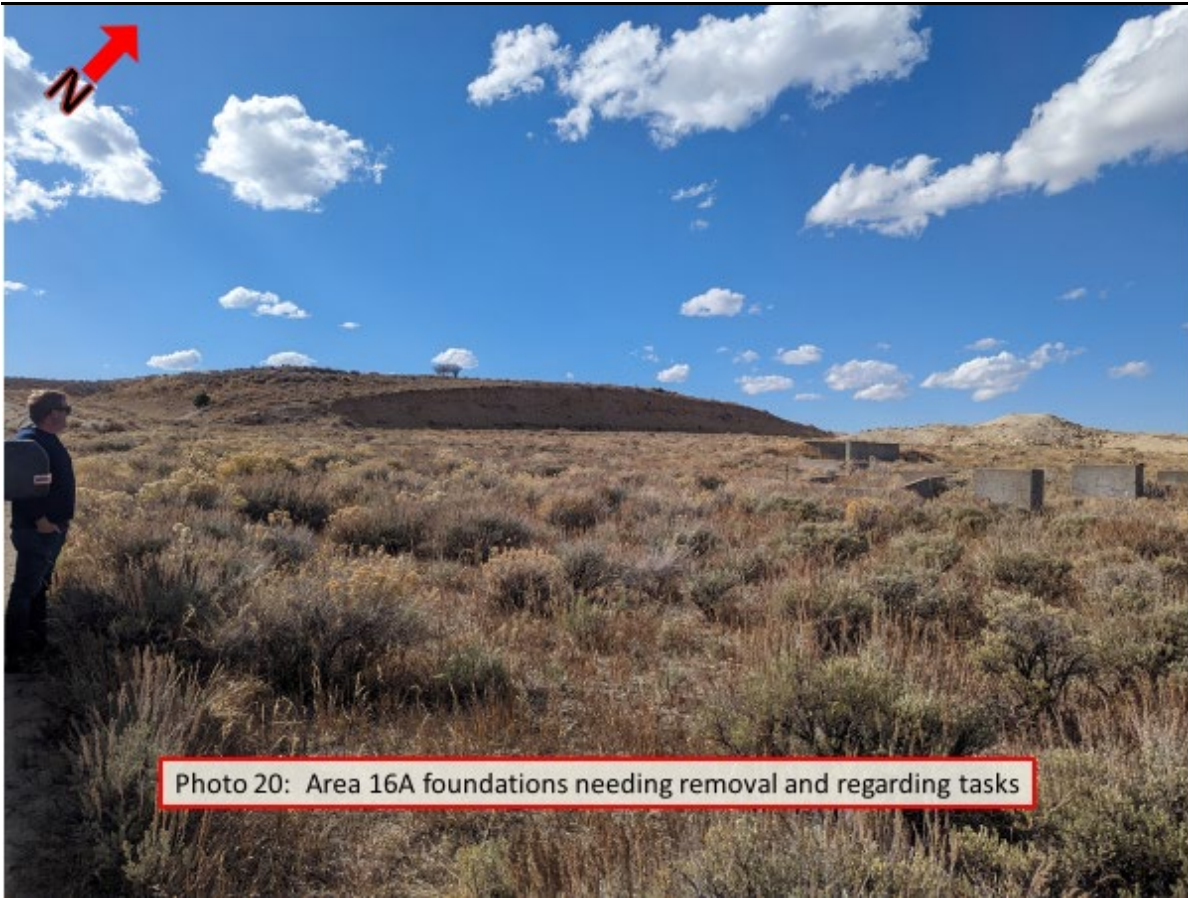
Area 16A LaSal Laydown. This flat pad area has a highwall that can be cut/fill along the west side. The Highwall is approximately 200 yards by 40 ft tall at a 1H: 1V slope. The perimeter of the pad will need to be pulled back since the entire pad appears to be built up on the ridge. Located on the pad are several foundations that will require removal (Photo Twenty). The buried water pipeline will need to be plugged. There was also a monitoring well adjacent to the jersey barriers. If no longer needed from monitoring it will also need to be abandoned.

Photo 20: Area 16A foundations needing removal and regarding tasks

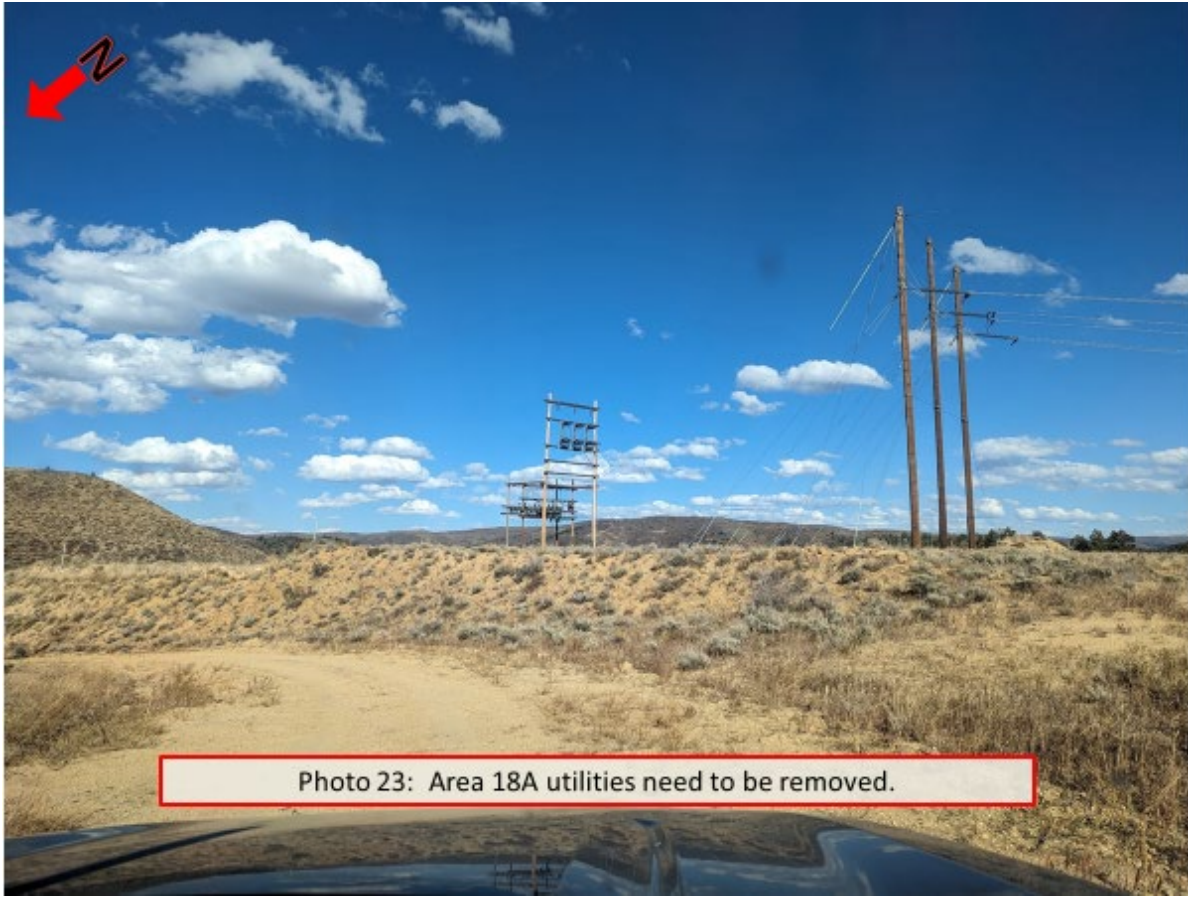
Area 18A Switch yard. This is where the transmission lines terminate. Electrical equipment needs to be removed (Photo Twenty-Three). The South side of the pad area needs to be pulled back. Additional sloping and general contouring is necessary on the northwest side.

Photo 23: Area 18A utilities need to be removed.
