MINERALS PROGRAM INSPECTION REPORT
PHONE: (303) 866-3567

MINE NAME: Colony Shale Oil Project	MINE/PROSPECTING ID#: M-1980-047	MINERAL: Oil shale	COUNTY: Garfield
INSPECTION TYPE: Surety-Related Inspection	WEATHER: Clear	INSP. DATE: October 23, 2023	INSP. TIME: 08:30
OPERATOR: Caerus Cross Timbers LLC	OPERATOR REPRESENTATIVE: Jason Eckman	TYPE OF OPERATION: 112 - Hard Rock Regular Operation	
REASON FOR INSPECTION: Surety Related	BOND CALCULATION TYPE: Partial Bond	BOND AMOUNT: \$9,500,000.00	
DATE OF COMPLAINT: NA	POST INSP. CONTACTS: DRMS	JOINT INSP. AGENCY: None	
INSPECTOR(S): Amy Yeldell	INSPECTOR'S SIGNATURE:

This inspection was conducted as part of the Colorado Division of Reclamation, Mining and Safety's (Division) normal monitoring program. The Colony Oil Shale Project is a Hard Rock 112 permitted site located northwest of Parachute Colorado in Garfield County. The entire mine was inspected, excluding the underground areas. Colony consists of 5,712.05 acres with a maximum disturbance of 527 acres. The Division currently holds a financial warranty in the form of a corporate surety in the amount of \$9,500,000.00. Amy Yeldell of the Division conducted the inspection. Jason Ec

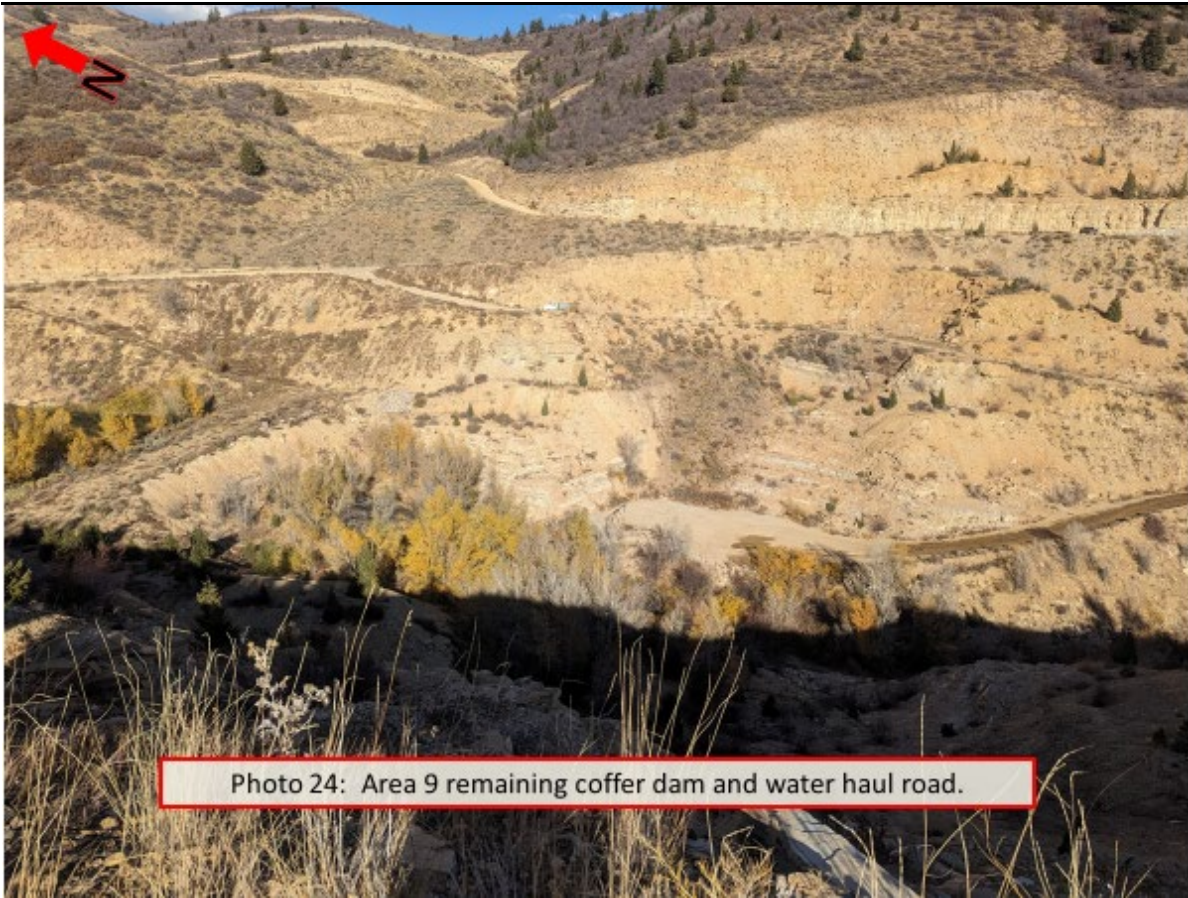
Area 9 Davis Gulch Dam. The full dam across the gulch was never constructed. A smaller cofferdam that appears to function as a sediment pond was constructed to the north in preparation for the final dam. The gulch was largely stripped of loose soil down to rock. More than thirty years later soils and rock have sloughed in areas and vegetation has volunteered. A switch back road extends to the south then cuts back north to the base of the current dam (Photo Twenty-Four). A gravity fed water horse, supplies water for dust suppression. It is located at the end of the road drawing its water from the pond above. Clarify in the revised Reclamation Plan if this road will remain and if any additional reclamation will take place.

Photo 24: Area 9 remaining coffer dam and water haul road.
