MINERALS PROGRAM INSPECTION REPORT
PHONE: (303) 866-3567

MINE NAME: East Douglas Creek Gravel Pit	MINE/PROSPECTING ID#: M-1998-054	MINERAL: Gravel	COUNTY: Rio Blanco
INSPECTION TYPE: Monitoring	WEATHER: Clear	INSP. DATE: October 24, 2023	INSP. TIME: 10:30
OPERATOR: Rio Blanco County	OPERATOR REPRESENTATIVE: Clint Chappell	TYPE OF OPERATION: 112c - Construction Regular Operation	
REASON FOR INSPECTION: Normal I&E Program	BOND CALCULATION TYPE: None	BOND AMOUNT: \$0.00	
DATE OF COMPLAINT: NA	POST INSP. CONTACTS: None	JOINT INSP. AGENCY: U.S.BLM	
INSPECTOR(S): Amy Yeldell	INSPECTOR'S SIGNATURE:

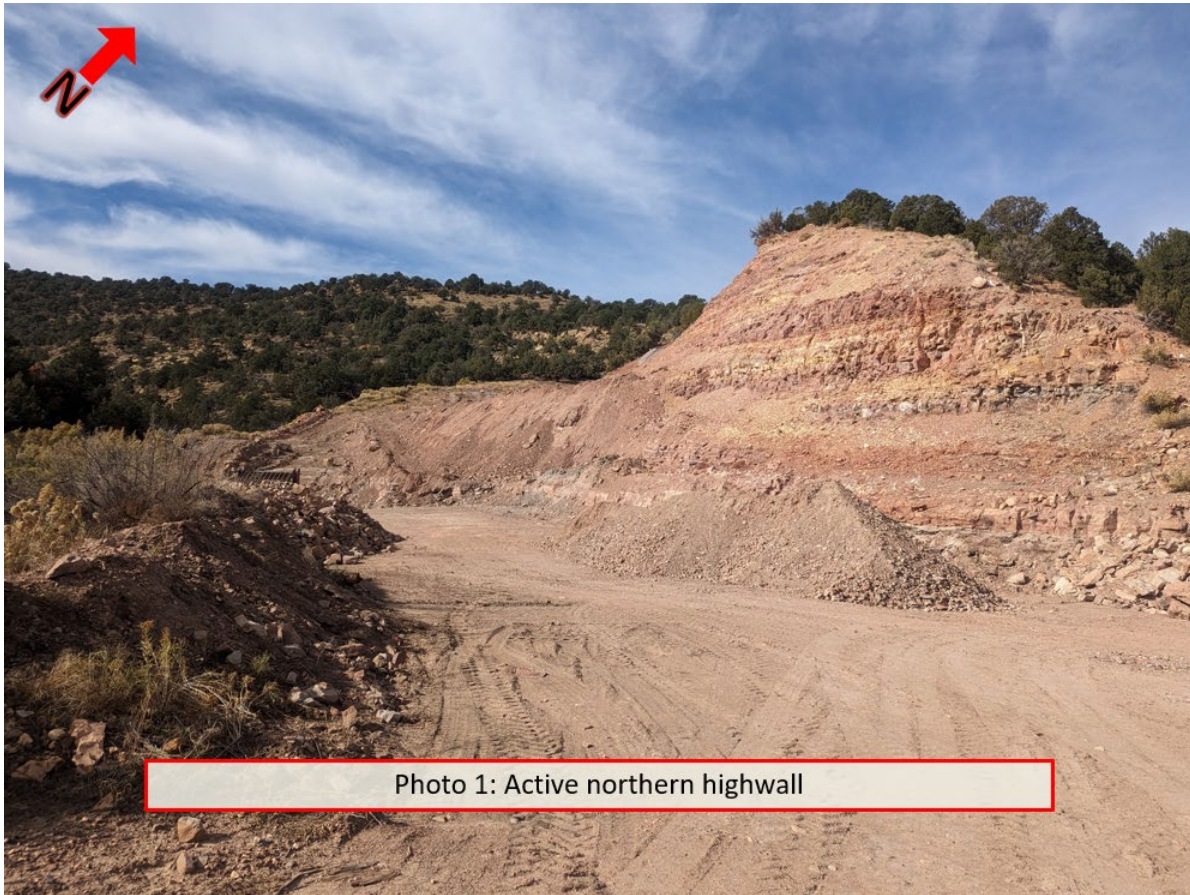
The northwestern portion of the permit is the active highwall. It is approximately 100 feet tall, 200 feet wide and sloped at a 1H: 1V. To the right or south of the vertical highwall is a slope that's been dozed down and used to access the top of the highwall (Photo One). This area will require additional grading in order to reduce the grade as backfill is not feasible. It was briefly discussed that add additional land to the north may be necessary to extend life of mine and make final reclamation easier. Increasing the permit size (adding acreage) will require an amendment.

Photo 1: Active northern highwall

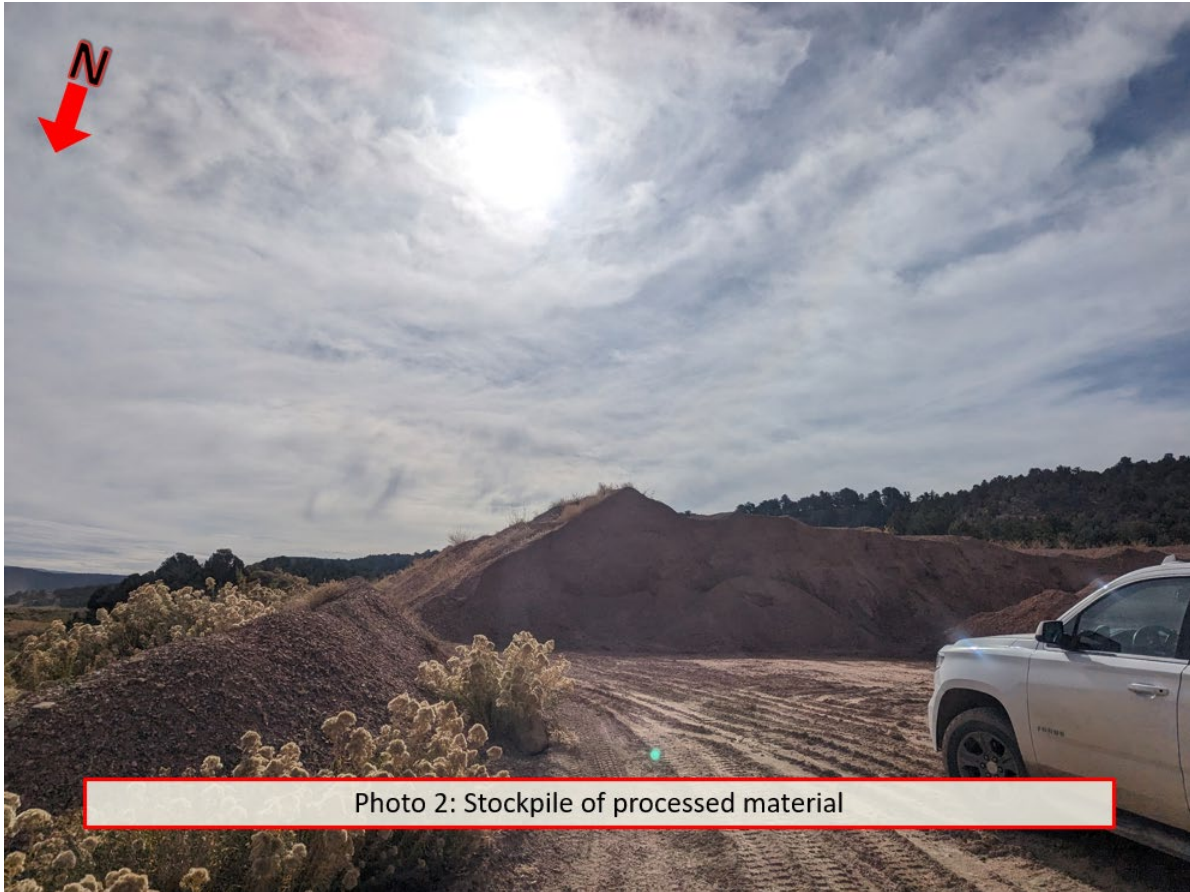
One main stockpile of process material was located on site (Photo Two). It is approximately 15 feet tall and appears stable. It has been a number of years since the material was crushed. Given the stockpile size future crushing is not anticipated in the near future.

Photo 2: Stockpile of processed material

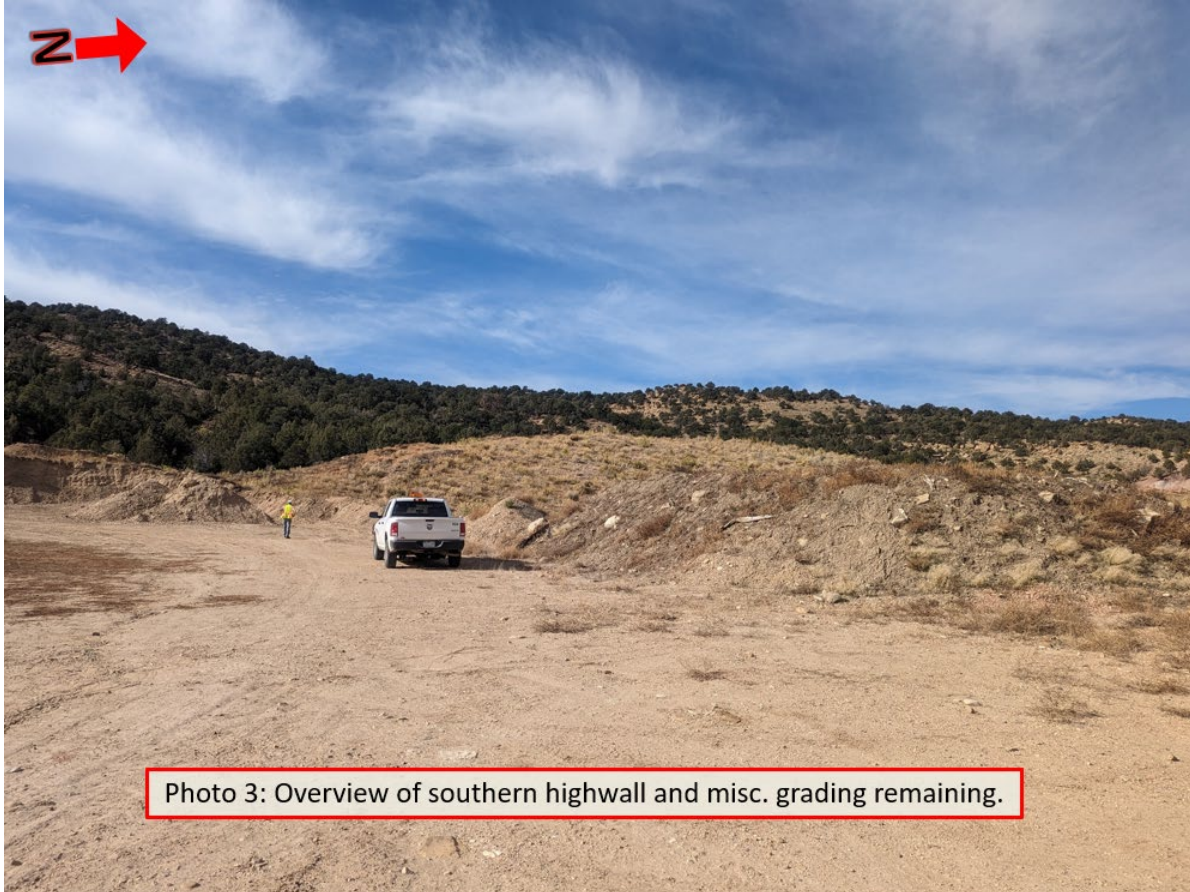
On the southern portion of the permit area is one small remaining highwall that that needs blended out. Additionally there are some random piles in the southern area that need general blending prior to revegetation (Photo Three).

Photo 3: Overview of southern highwall and misc. grading remaining.

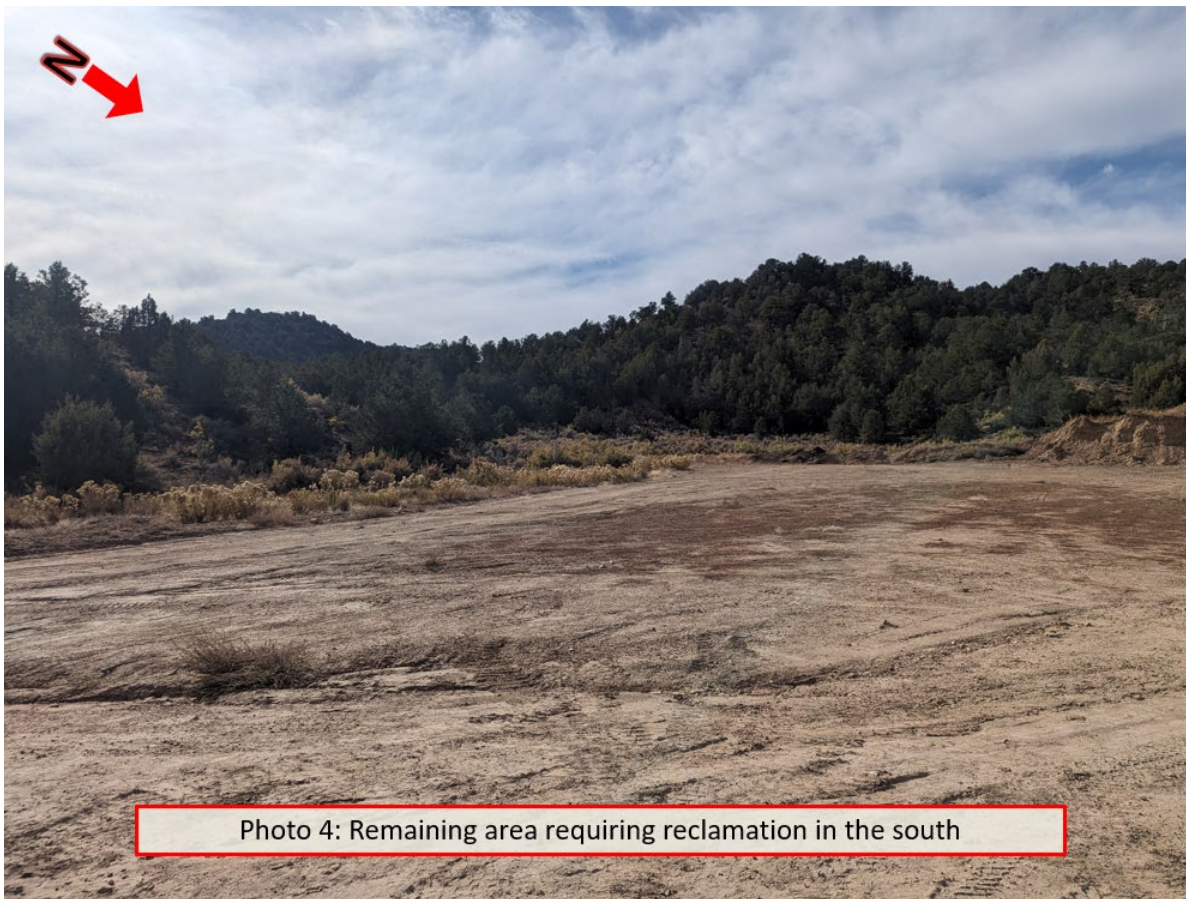
Portions of the southern permit area have been reclaimed. The majority of slopes have been regraded and have well-established shrubs and desirable vegetation. Approximately a one and half acre parking area remains (Photo Four). As this area moves towards reclamation, decompaction and rough grading is encouraged to trap additional moisture and facilitate vegetation establishment. Additionally ensure that newly reclaimed areas get surveyed and treated as necessary for weeds since newly established areas are more vulnerable.

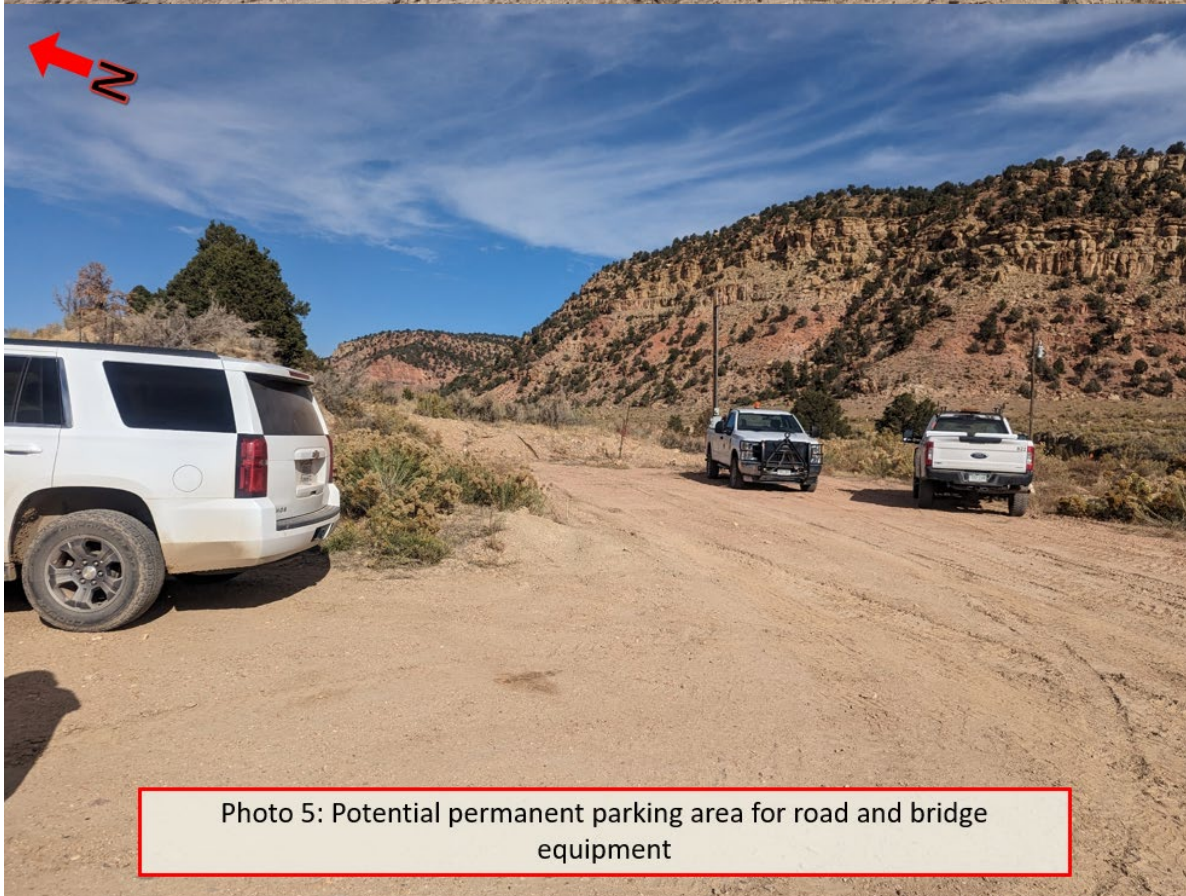
In the southern permit area, it was discussed about leaving a small driveway to access the electrical pole (Photo Five). During the winter months a grader is staged behind the locked gate and plugged in to facilitate snow removal. If the County would like to leave this area post reclamation, they will need to update the Reclamation Plan and associated map depicting the area where vegetation will to be established.
