**MINERALS PROGRAM INSPECTION REPORT**  
**PHONE: (303) 866-3567**

<b>MINE NAME:</b> Cedar Point Picture Rock Quarry	<b>MINE/PROSPECTING ID#:</b> M-2004-048	<b>MINERAL:</b> Stone	<b>COUNTY:</b> San Miguel
<b>INSPECTION TYPE:</b> Multi Person Inspection	<b>WEATHER:</b> Clear	<b>INSP. DATE:</b> October 18, 2023	<b>INSP. TIME:</b> 09:58
<b>OPERATOR:</b> Robert Daugherty	<b>OPERATOR REPRESENTATIVE:</b> Robert Daugherty	<b>TYPE OF OPERATION:</b> 110c - Construction Limited Impact	
<b>REASON FOR INSPECTION:</b> Surety Release Requested	<b>BOND CALCULATION TYPE:</b>	<b>BOND AMOUNT:</b> \$7,321.00	
<b>DATE OF COMPLAINT:</b> NA	<b>POST INSP. CONTACTS:</b> None	<b>JOINT INSP. AGENCY:</b> None	
<b>INSPECTOR(S):</b> Lucas West	<b>INSPECTOR'S SIGNATURE:</b>

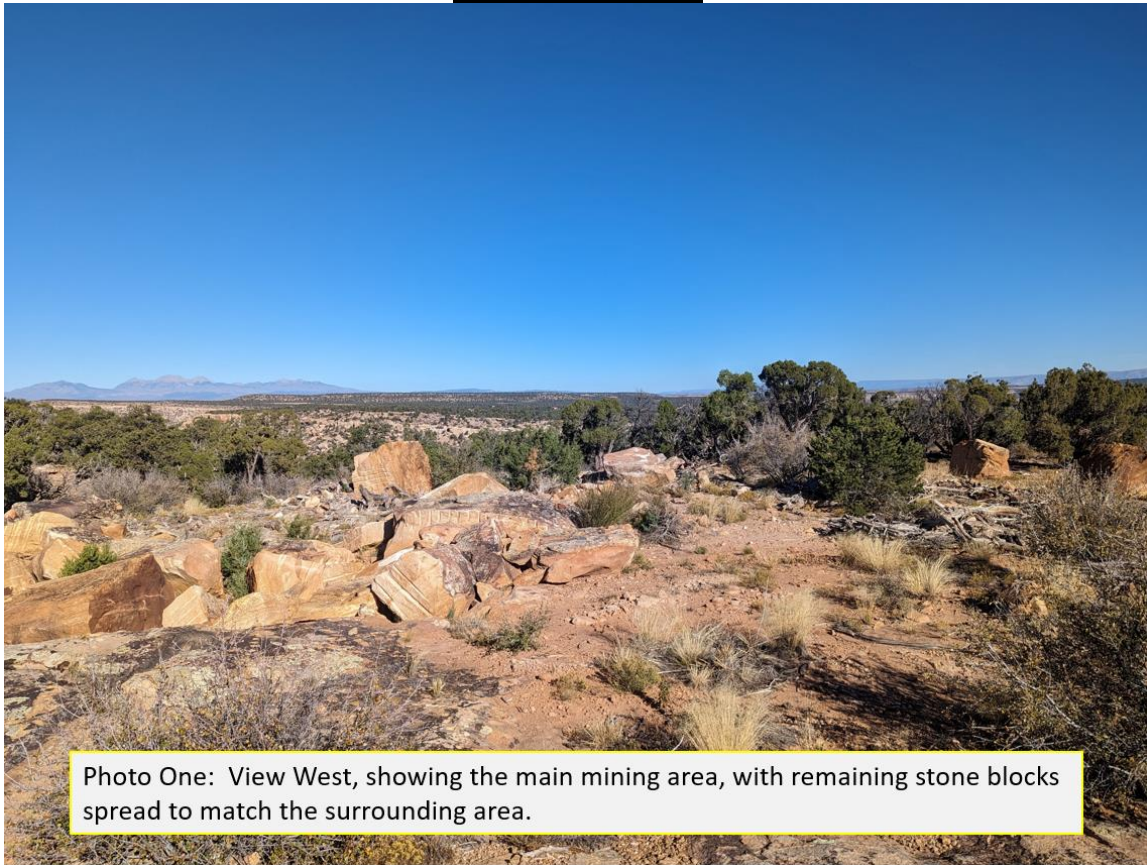
Photo One: View West, showing the main mining area, with remaining stone blocks spread to match the surrounding area.

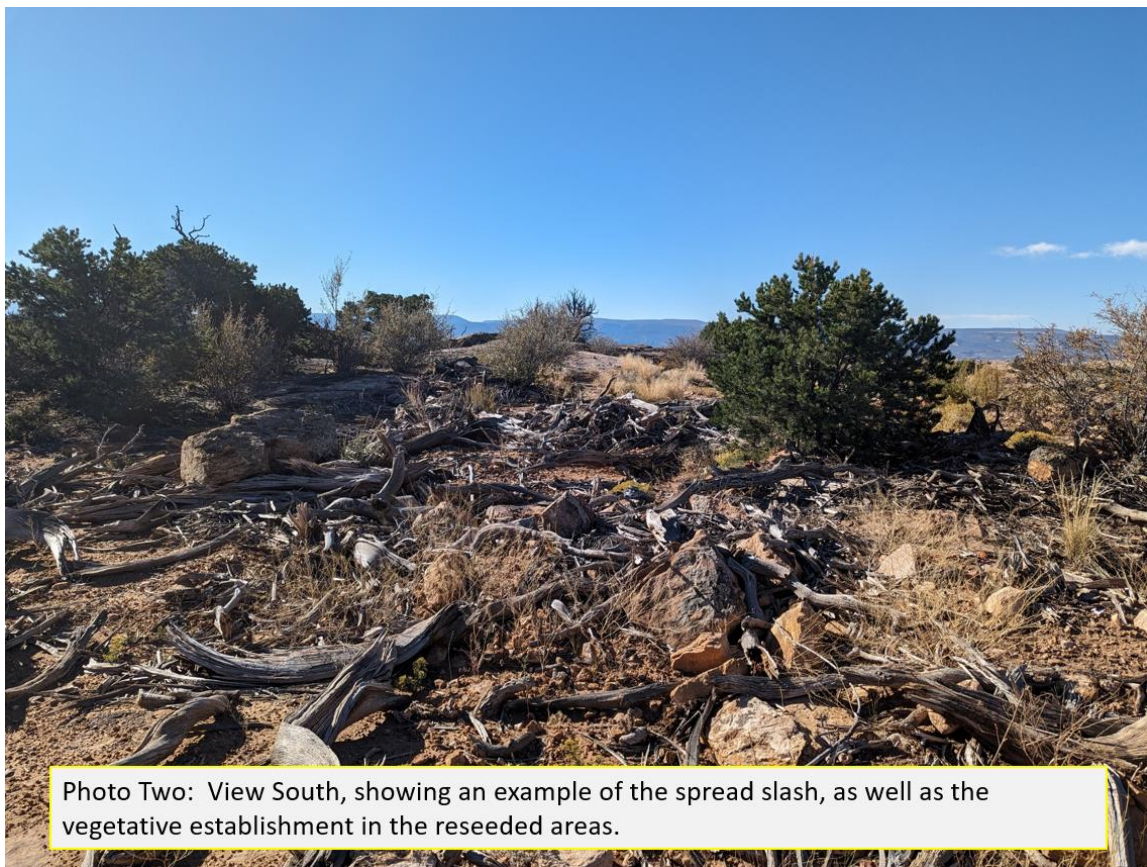
Photo Two: View South, showing an example of the spread slash, as well as the vegetative establishment in the reseeded areas.

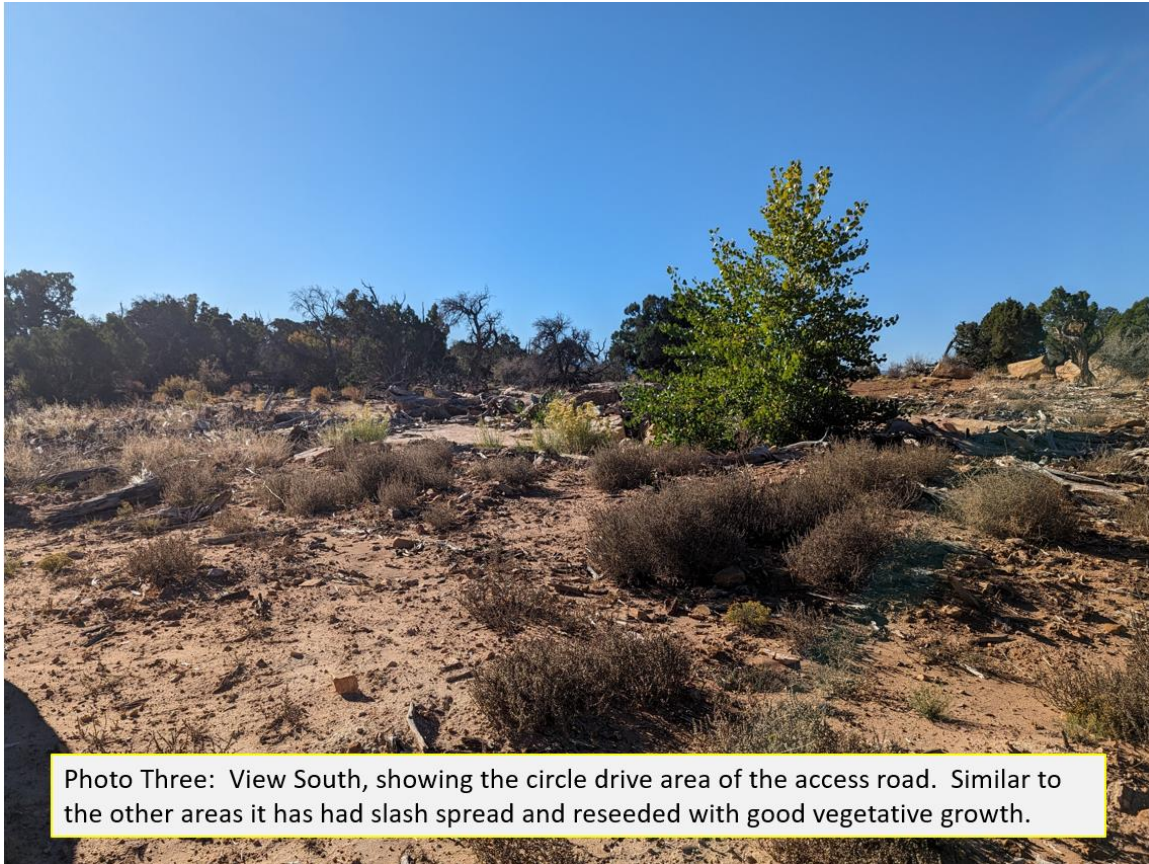
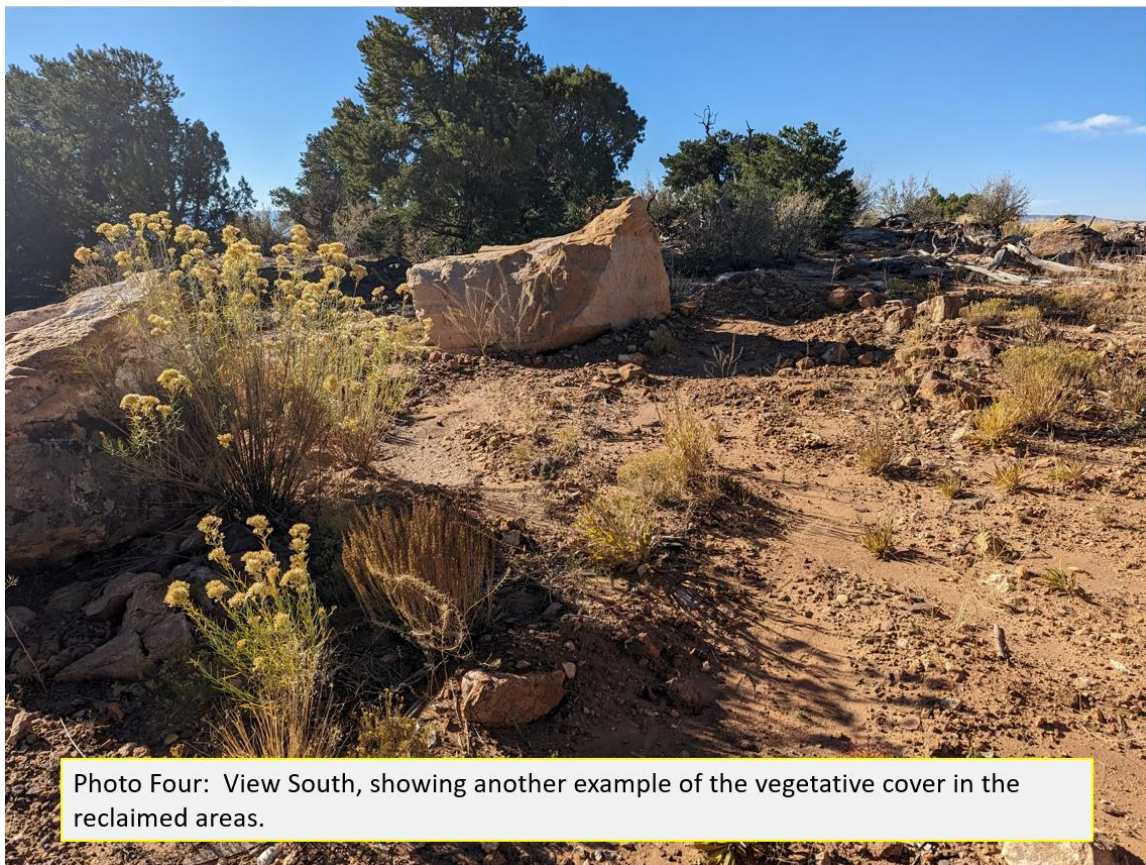
The access road, which leads to the site from County Road 14Z and makes a loop within the permitted area is also in good condition. The road is rough in some spots but still provides good access to the site. The main loading and parking area of the site is also in good condition. The area has been spread with slash similar to other parts of the reclaimed areas and reseeded. The vegetative cover is also supplemented by volunteer species, which the Operator was careful not to disturb during reclamation efforts. This area can be seen in Photos Three and Four. No signs of significant erosion, or noxious weeds were noted on site.
