MINERALS PROGRAM INSPECTION REPORT
PHONE: (303) 866-3567

MINE NAME: Shot Rock Pit	MINE/PROSPECTING ID#: M-2012-023	MINERAL: Crushed stone material	COUNTY: Las Animas
INSPECTION TYPE: Monitoring	WEATHER: Clear	INSP. DATE: October 24, 2023	INSP. TIME: 01:00
OPERATOR: Tamrock Gravel LLC	OPERATOR REPRESENTATIVE: Brent Tamburelli	TYPE OF OPERATION: 112c - Construction Regular Operation	
REASON FOR INSPECTION: Normal I&E Program	BOND CALCULATION TYPE: None	BOND AMOUNT: \$22,800.00	
DATE OF COMPLAINT: NA	POST INSP. CONTACTS: None	JOINT INSP. AGENCY: None	
INSPECTOR(S): Amber Gibson Brock Bowles Jocelyn Carter	INSPECTOR'S SIGNATURE:

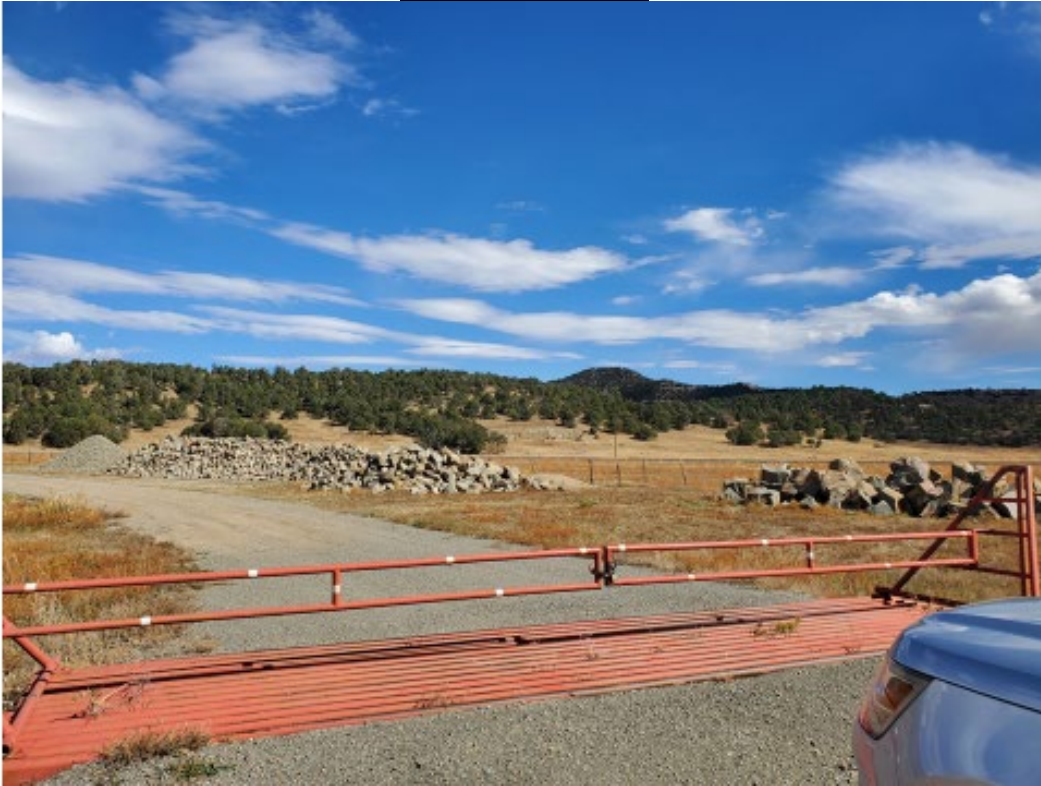
Upon reaching the gate located at the entrance to the parcel containing the permit site, the Division noted the presence of a variety of processed stockpiled material along the eastern side of the entrance road (see Photo 1). The Division informed the Operator that the presence of stockpiles off-site is a **possible violation** (as cited above). Additionally, the construction of a road (see Roads below) and the presence, construction, and use of a scale (see Support Facilities Not on Site below) lead the Division to believe that approximately 0.62 acres have been affected by mining outside of the permit boundary. The Division believes the disturbance located outside of the permit boundary meets the statutory definition for affected land (Rule 1.1(3)) and being part of a mining operation (Rule 1.1(30)). The Division will bring this matter before the Mined Land Reclamation and set the Operator up for a hearing pursuant to Rules 3.3.1 and/or Rule 3.3.2.

Photo 1: Looking northeast at the stockpiled material located on the Operator's land, east of the entrance road.

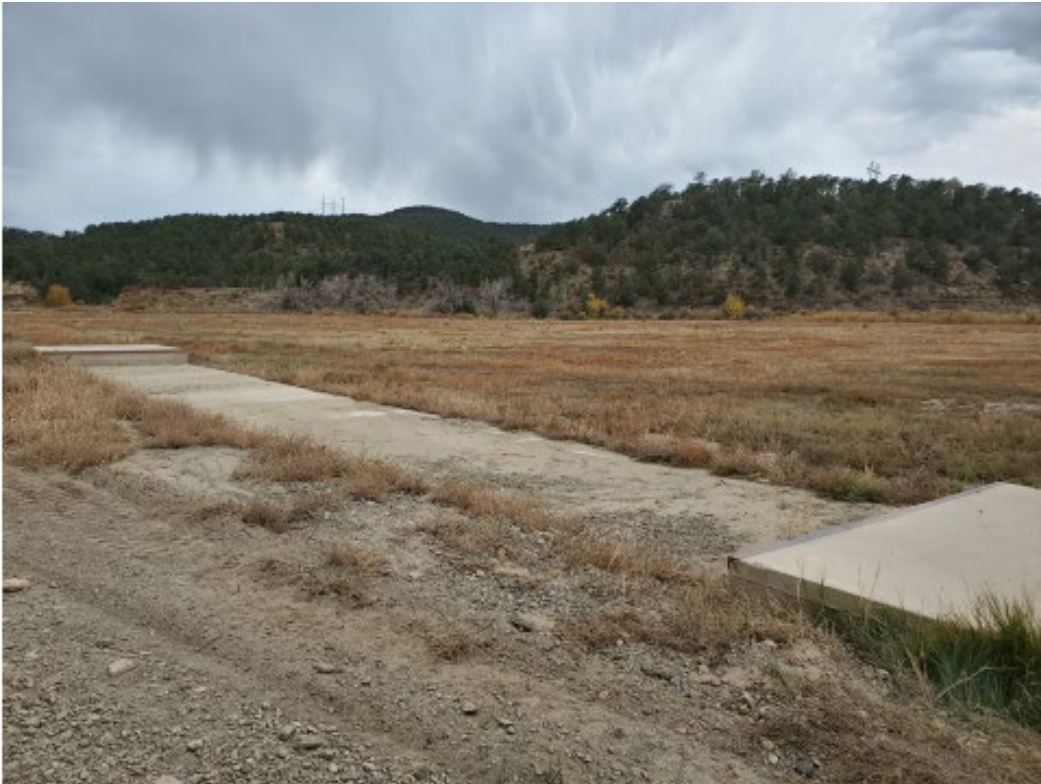
A scale indicated to have been used for mining purposes has been removed from the Operator's land. The Operator stated that the scale was sold in May 2023. However, the foundation for the scale remains (see Photo 2). The construction and use of a scale in relation to the mining operation falls under the definition for affected land pursuant to Rule 1.1(3) and being part of a mining operation pursuant to Rule 1.1(30). This scale seems to have been used in conjunction with mining operations (see Maps 1 and 2), and is therefore included

in the off-site damage possible violation above.

Photo 2: Looking southwest at the foundation for a scale that was used in connection with the mining operations.

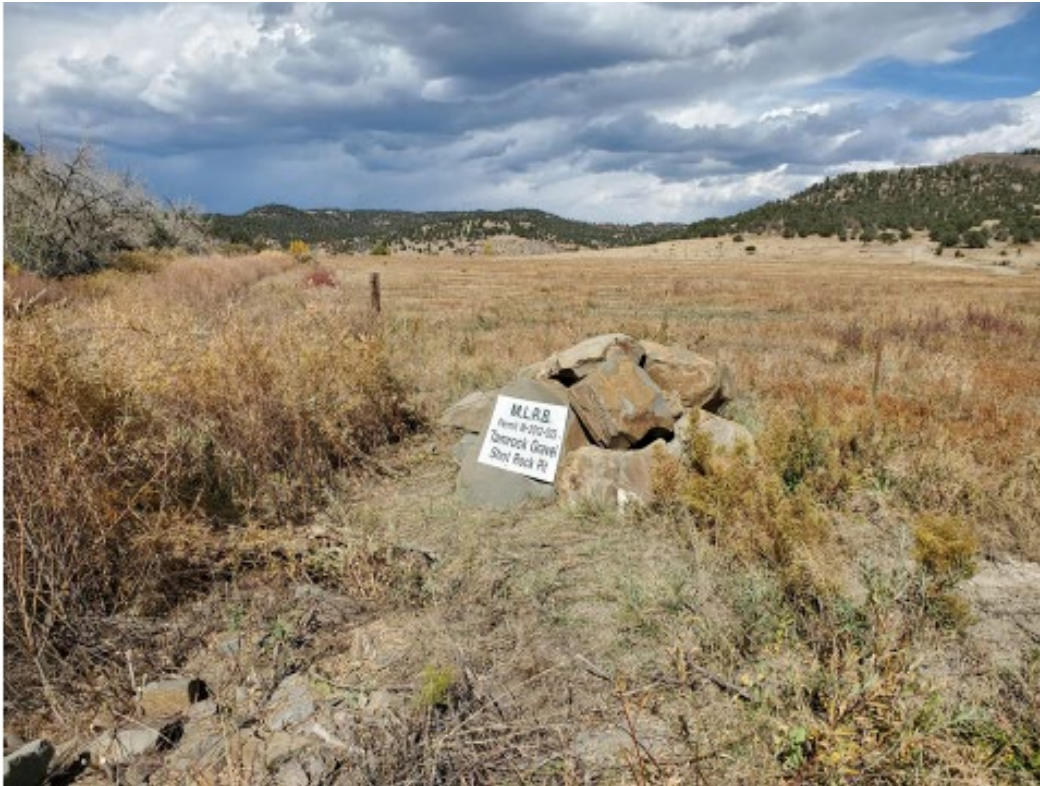
A mine sign was posted to the west of the entrance road gate in compliance with Rule 3.1.12 (see Photo 3).

Photo 3: Looking northwest at the mine sign posted at the front of the entrance road to the pit.

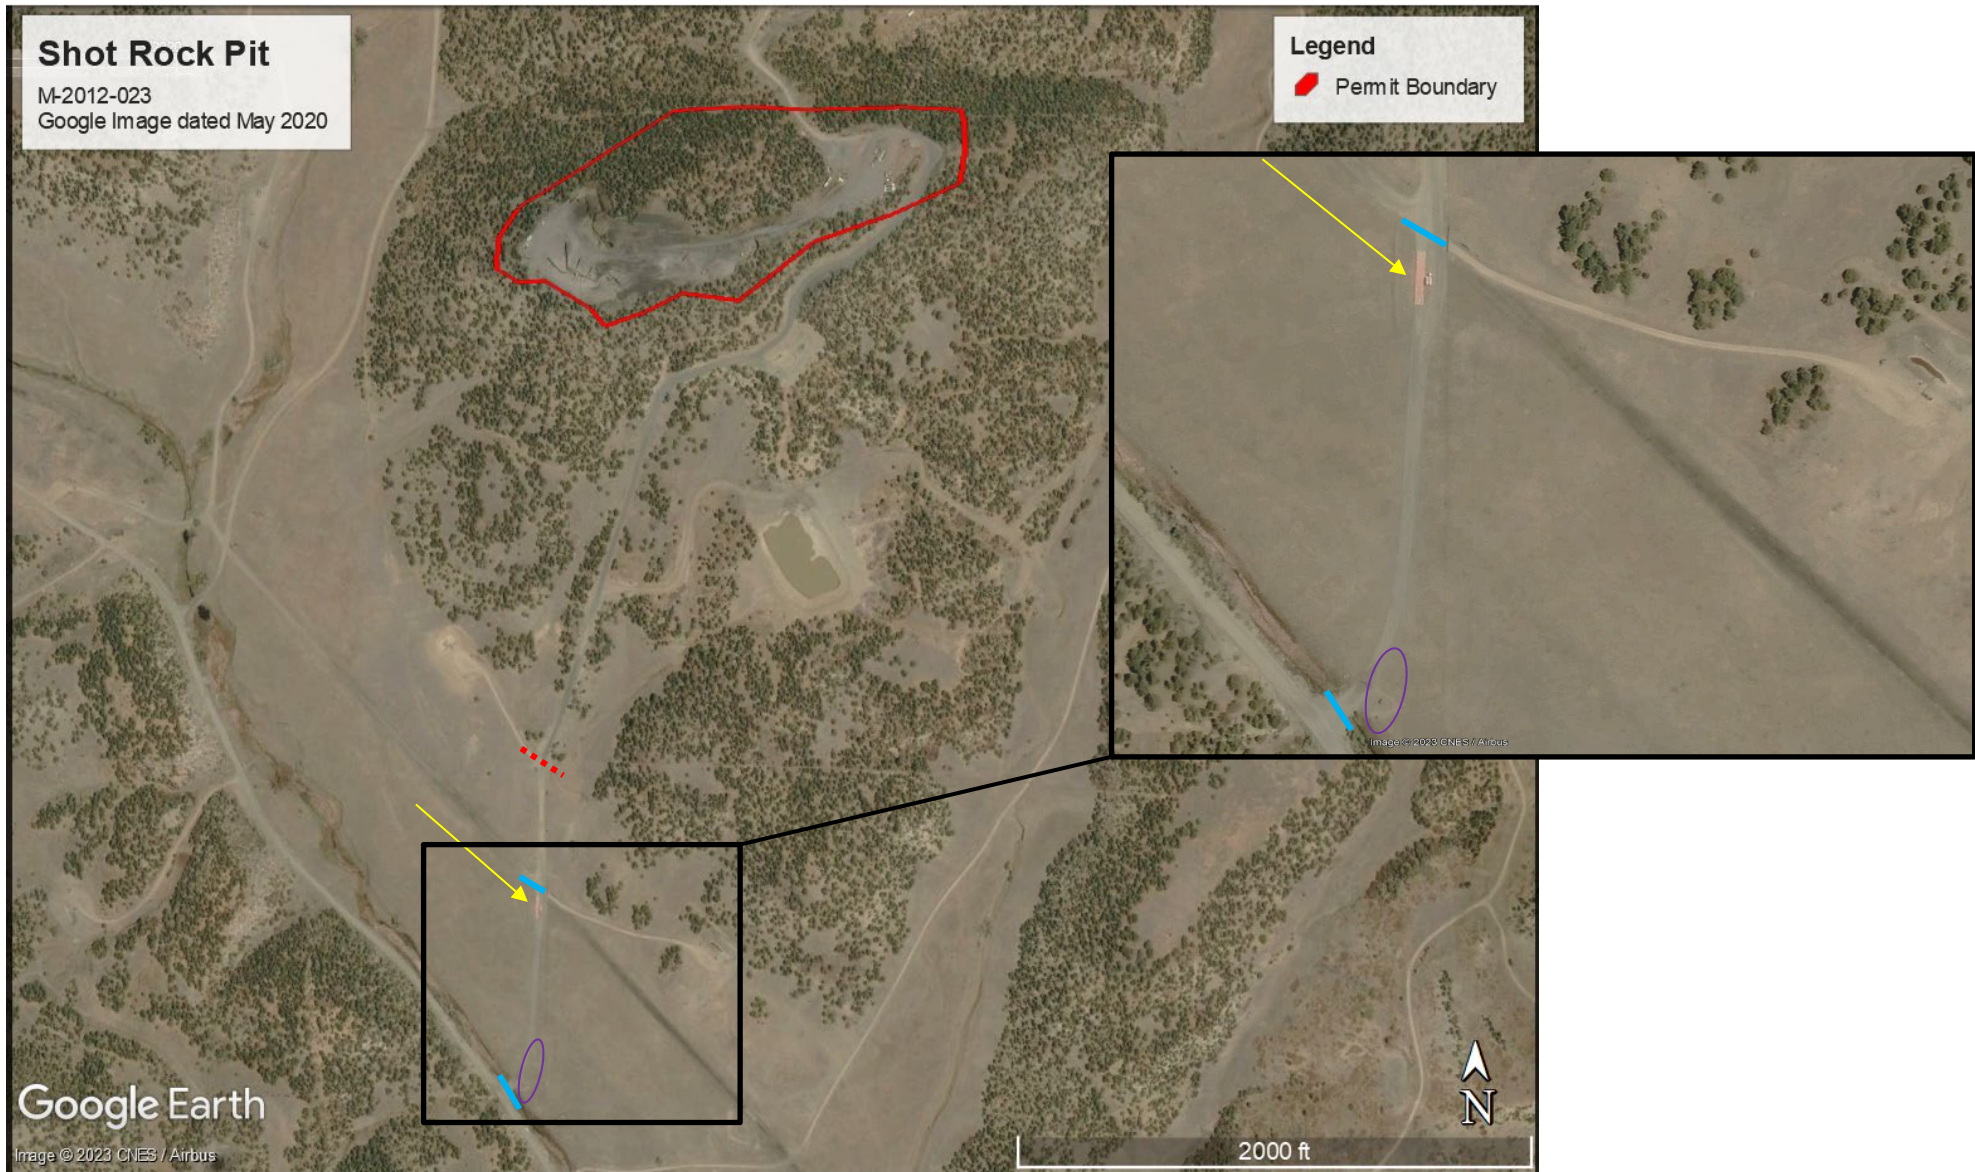
POSSIBLE VIOLATION: Approximately 0.62 acres of land has been affected outside of the approved permit boundary. This is a possible violation at this time pursuant to: 1.) C.R.S. 34-32.5-109(1) for failure to first obtain from the board or office a reclamation permit prior to engaging in a new operation. AND/OR 2.) C.R.S. 34-32.5-116(4)(i) for failure to protect areas outside of the affected land from slides or damages occurring during the mining operation.

A road was constructed that leads from CR 26.5, across the Operator's land, into an existing road that leads up to the permit boundary. The construction and use of the road in relation to the mining operation falls under the definition for affected land pursuant to Rule 1.1(3) and being part of a mining operation pursuant to Rule 1.1(30). This road seems to have been used in conjunction with mining operations (see Maps 1 and 2), and is therefore included in the off-site damage possible violation above.

Map 1: Map generated using Google Earth Pro to show the permit boundary, constructed connecting road (between blue lines), scale house (indicated by yellow arrow), and stockpile (purple oval) locations. The constructed road, scale house, and stockpile area equates to approximately 0.62 acres of off-site mining disturbance. The red dashed line indicates where the landowner's gate was locked, denying entrance to the site. The most recent areal imagery available on Google Earth is dated May 2020.

CORRECTIVE ACTIONS: This possible violation will require a hearing before the Mined Land Reclamation Board.

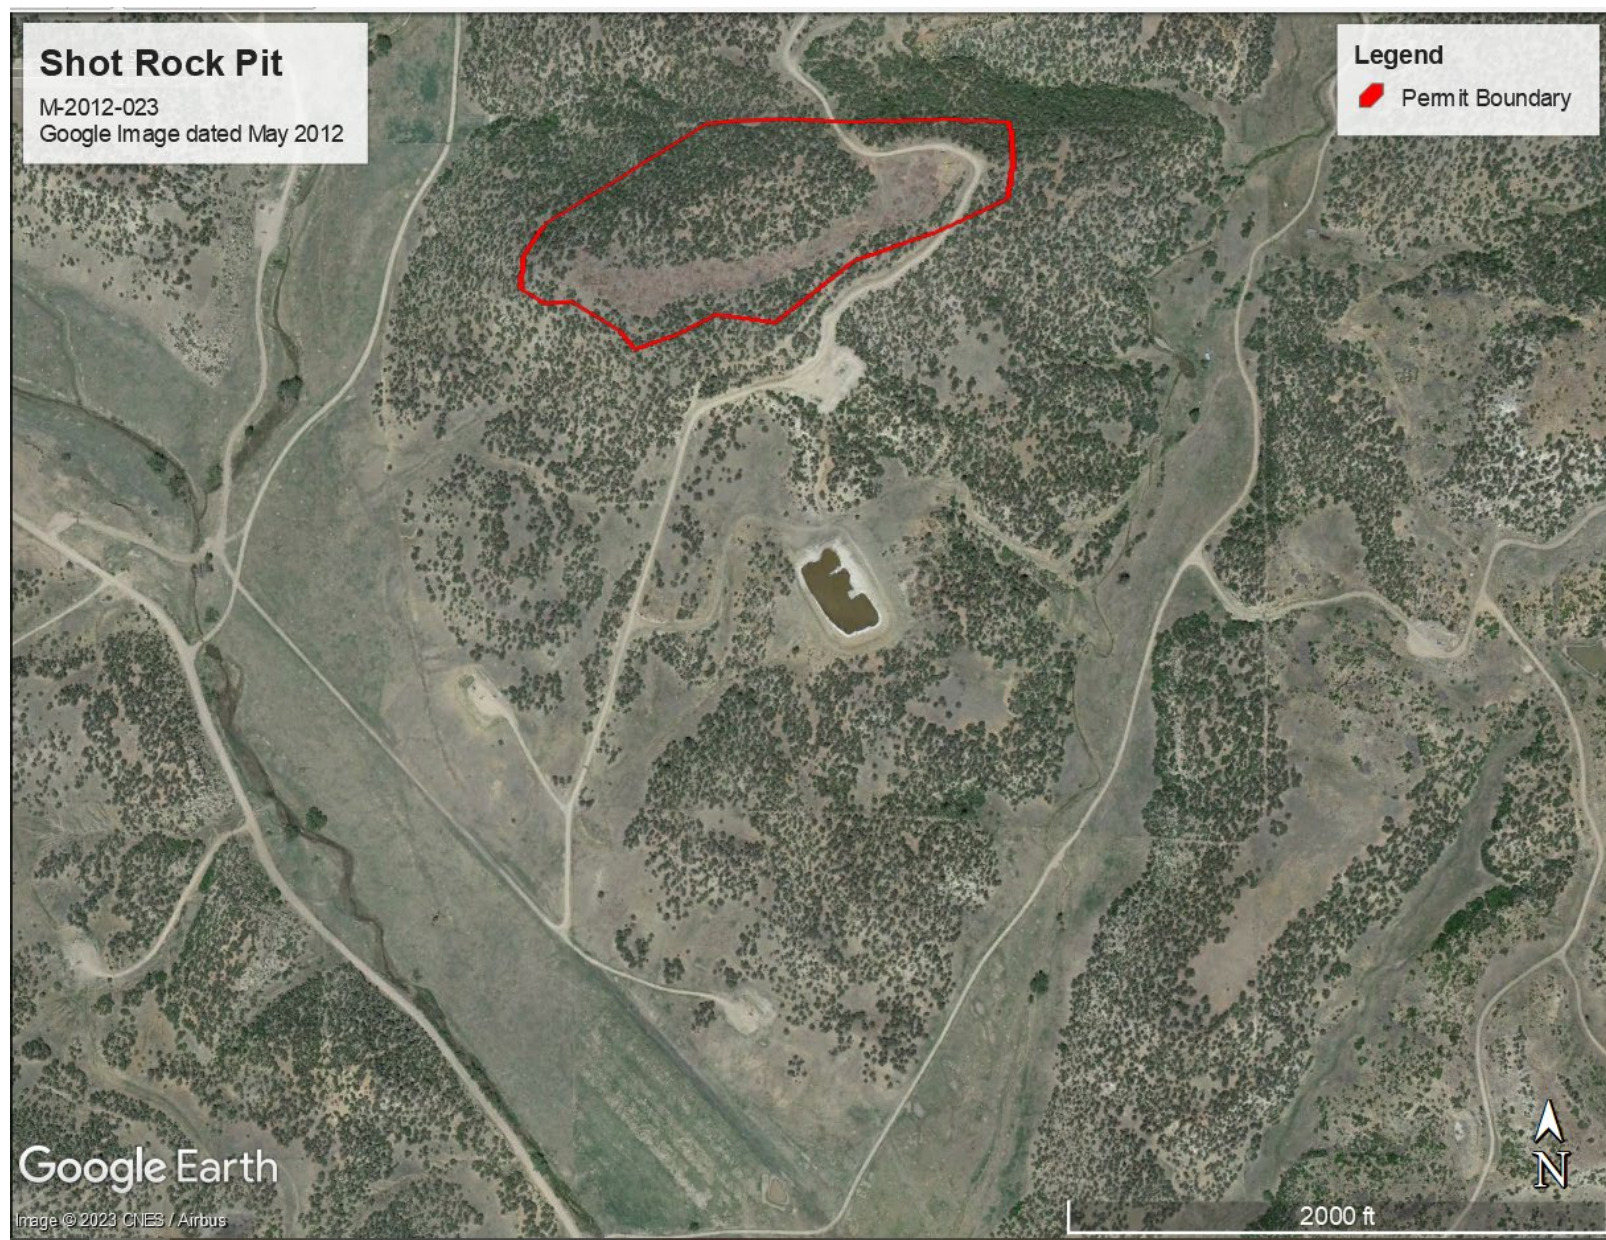
Map 2: Map generated using Google Earth Pro to show how the area where the constructed connecting road, scale house, and stockpile looked prior to mining operations. The areal imagery sourced for this map from Google Earth is dated May 2012.
