RE: North River Gravel Pit Extension, Permit No. M-1999-007, Unresolved Problem(s) Noted in a Past Inspection Report

MINERALS PROGRAM INSPECTION REPORT
PHONE: (303) 866-3567

MINE NAME: North River Gravel Pit Extension	MINE/PROSPECTING ID#: M-1999-007	MINERAL: Gravel	COUNTY: Rio Blanco
INSPECTION TYPE: Surety Release Inspection	WEATHER: Clear	INSP. DATE: July 24, 2023	INSP. TIME: 12:30
OPERATOR: George T. Weldon Construction, LLC	OPERATOR REPRESENTATIVE: None	TYPE OF OPERATION: 110c - Construction Limited Impact	
REASON FOR INSPECTION: Surety Release Requested	BOND CALCULATION TYPE: None	BOND AMOUNT: \$11,750.00	
DATE OF COMPLAINT: NA	POST INSP. CONTACTS: None	JOINT INSP. AGENCY: None	
INSPECTOR(S): Amy Yeldell	INSPECTOR'S SIGNATURE:

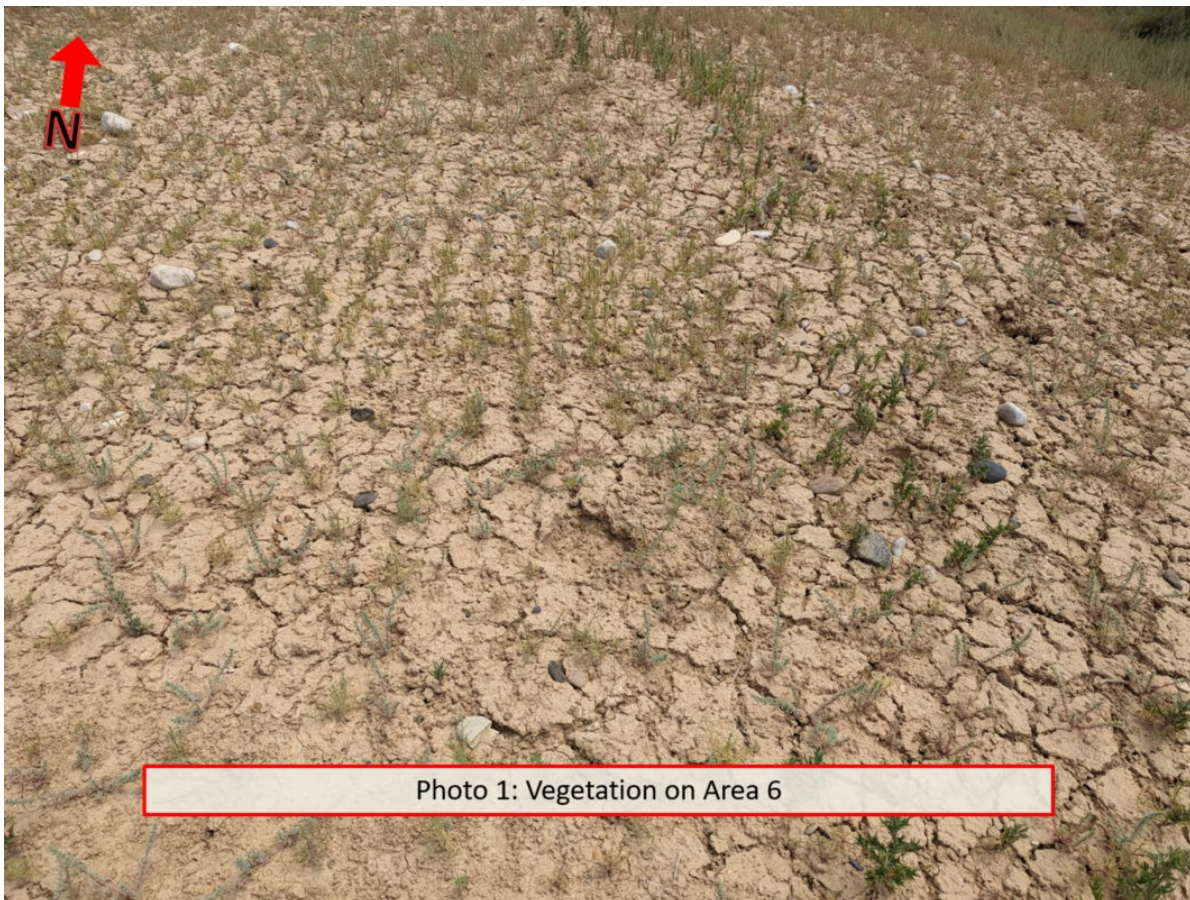
Area 6 has been properly graded. Signs of seeding, in the form of drill rows was observed. Almost no desirable species were to be found aside from a few stray plants. The reclaimed area was nearly only Halogeton, Russian Thistle and Kochia were observed (See Photo One).

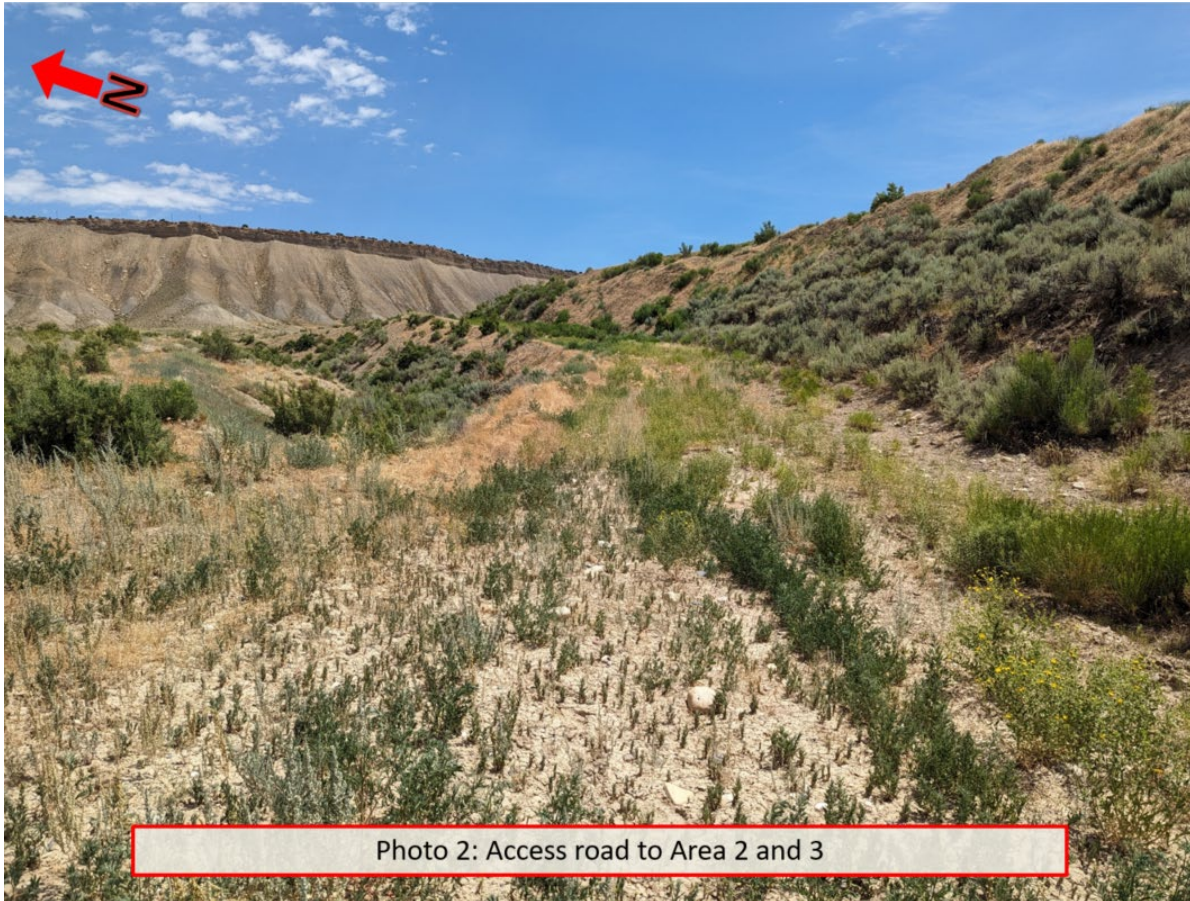
Photo 2: Access road to Area 2 and 3

The access road to area 2 and 3 remains flat for future use but overall is well vegetated. Species are diverse and

generally weed free with some Kochia (See Photo Two). Little to no erosion was observed. Cover/density is comparable to undisturbed adjacent areas. It is noted on the northeast side of Area A adjacent to the access road several tires and other trash from historical use was observed.

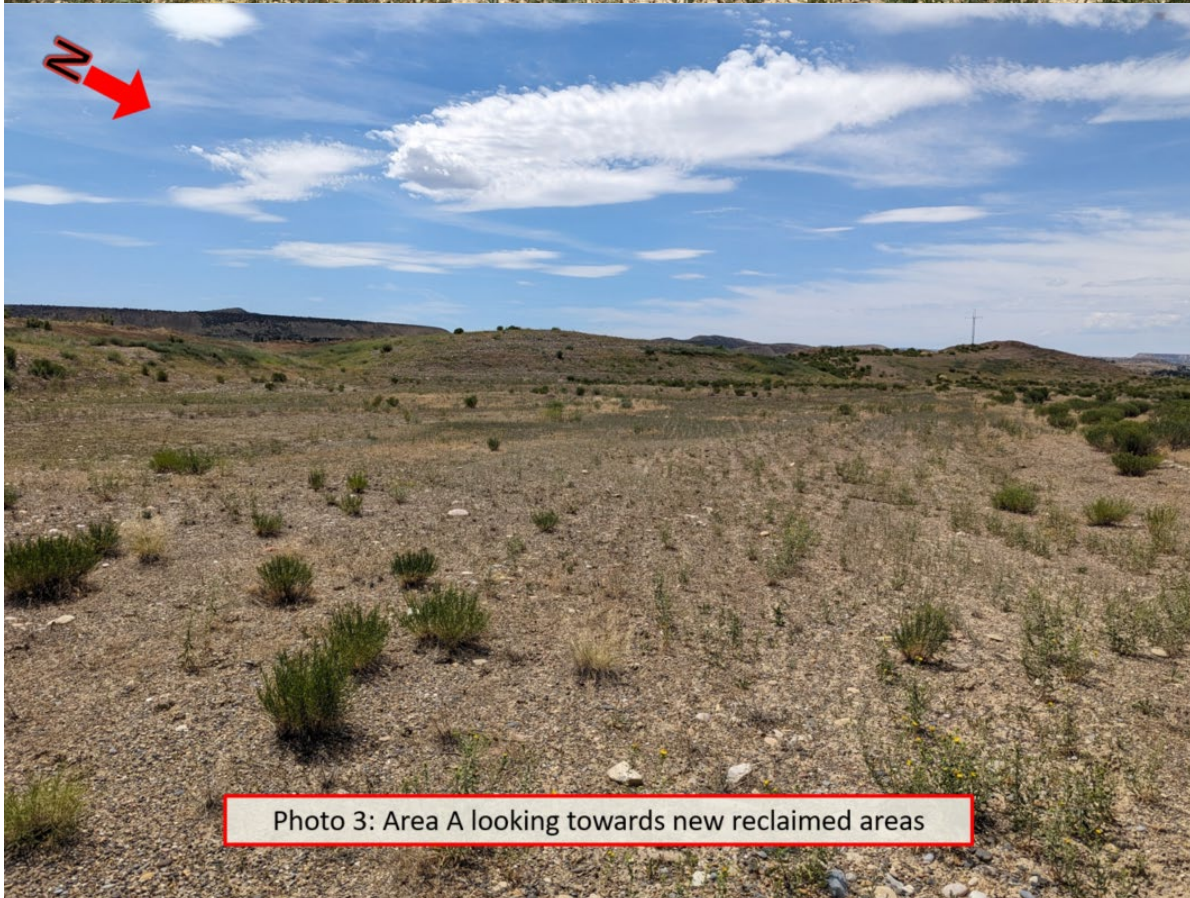
Photo 3: Area A looking towards new reclaimed areas

Area A did not require any sort of grading for final reclamation and has had volunteer shrubs (rabbit brush and saltbush) due to it being deserted. Only the southwestern portion of Areas A appear to have additional seeding. Cover is comprised of mostly desirable forbs (annual flowers) and shrubs. The recently reclaimed southwestern area has a lower density of desirable cover (See Photo Three). The rocky more open areas have significantly higher densities of cheatgrass and Russian Thistle.

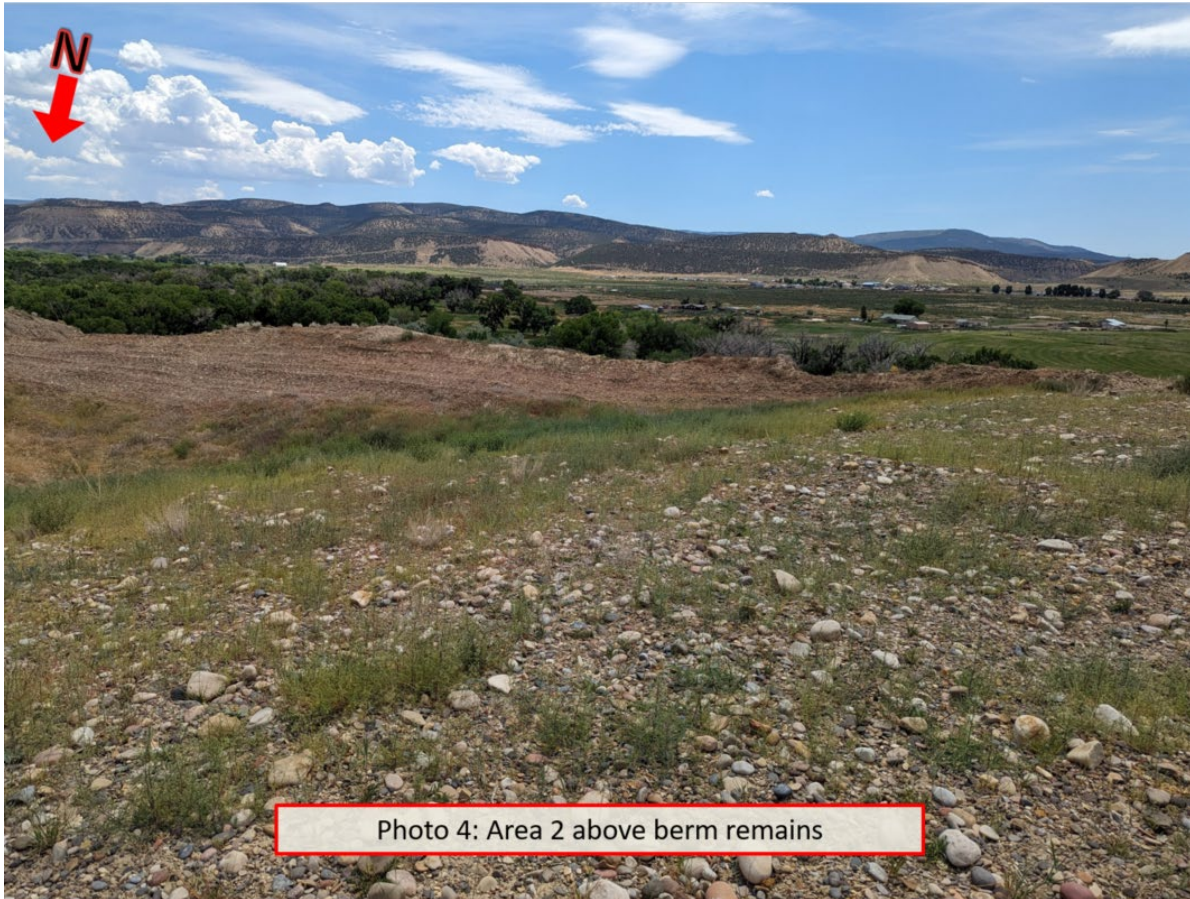
The slopes of Area 2 have generally all been regraded to a 3H: 1V or less. A few areas have random misc. piles but are difficult to access due to their proximity to the river (cliff) (See Photo Four). Some shrubs (rabbit brush) and flowers (curly cup gumweed) have established. However the majority of cover is Russian Thistle.

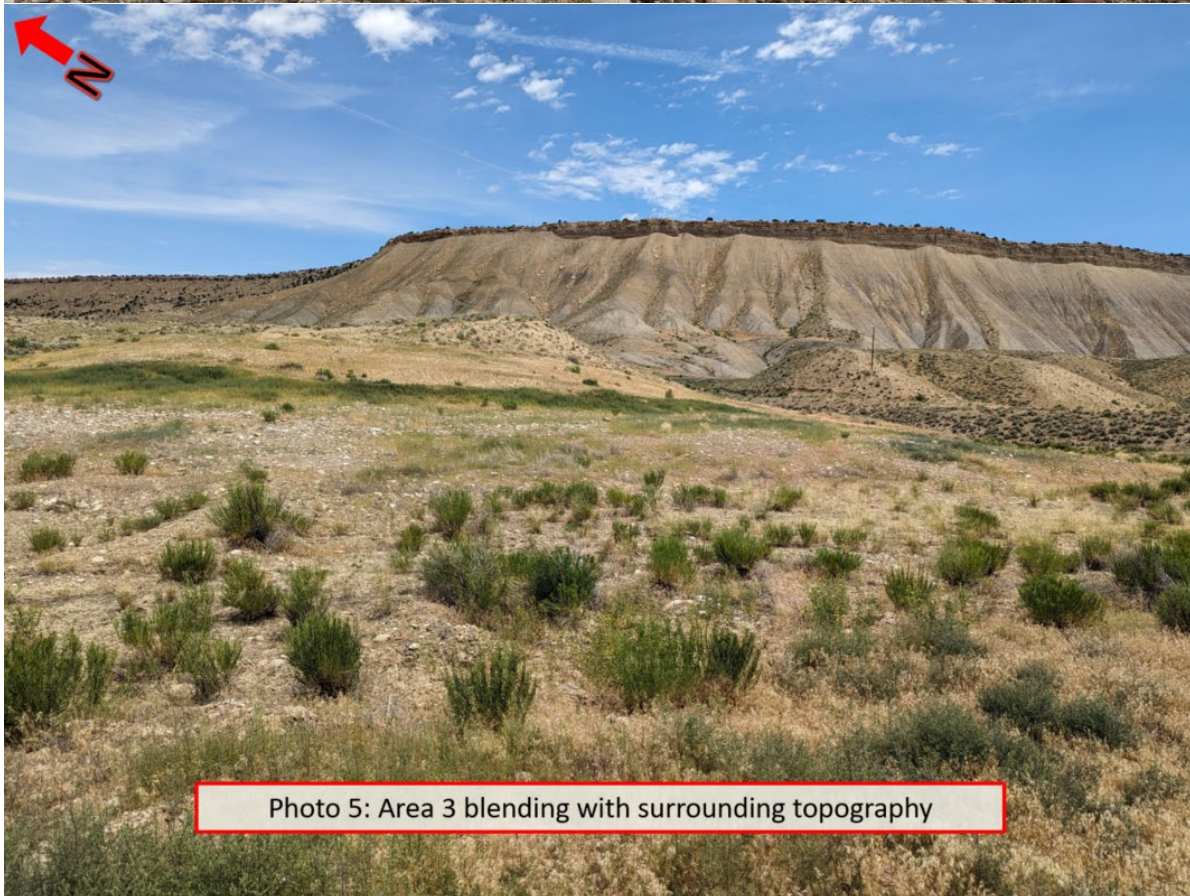
Sloping in Area 3 has also been completed and blends nicely with the surrounding topography (See Photo Five). Again overall cover is comprised of approximately 80% weeds with the only desirables being a hand full of shrubs. The access road from Area 3 to B has very little desirable species and cover is almost entirely Halogeton.

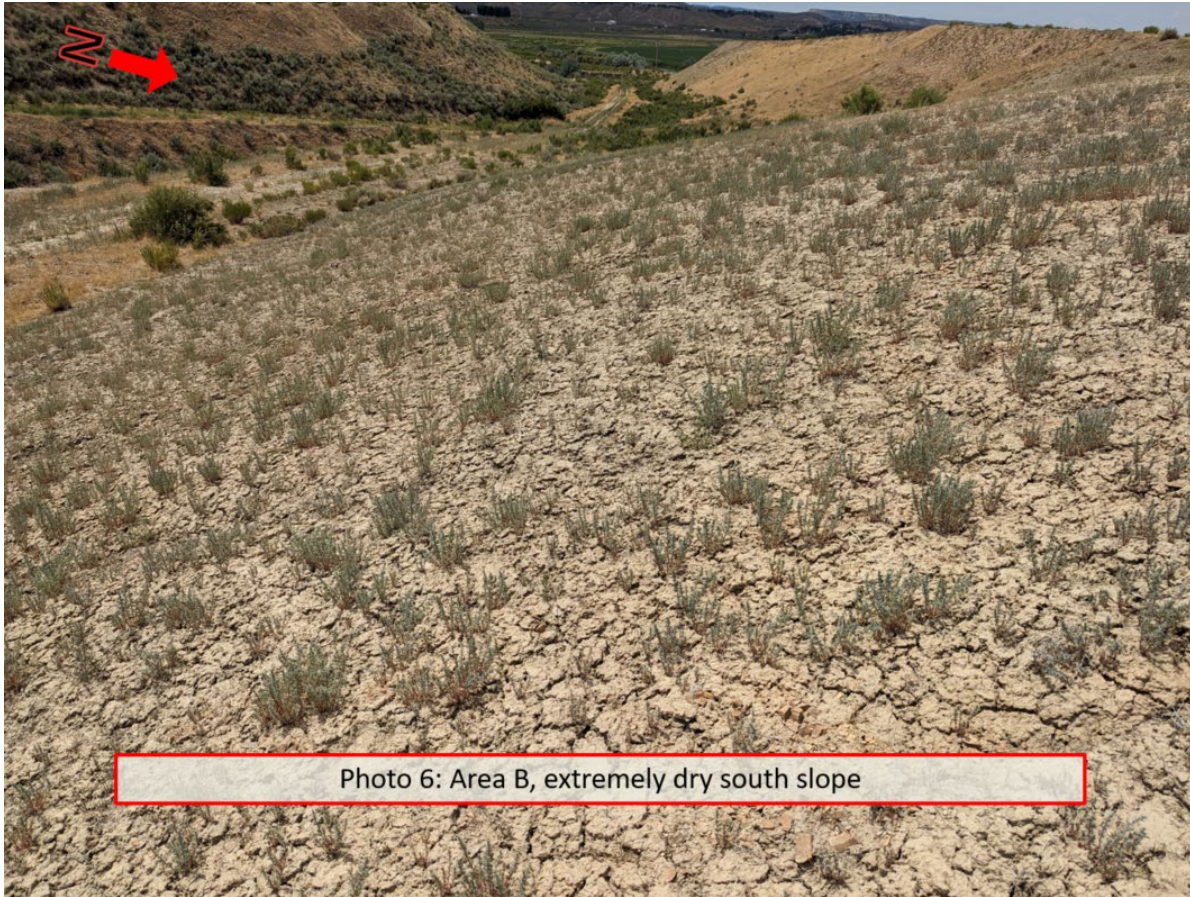
Area B is a south facing slope that was significantly dryer than the surrounding areas. It was almost entirely Halogeton with a few sparse and significantly smaller saltbushes. No grasses were observed within the recently reclaimed areas despite seeding efforts being observed in the form of drill rows (See Photo Six).

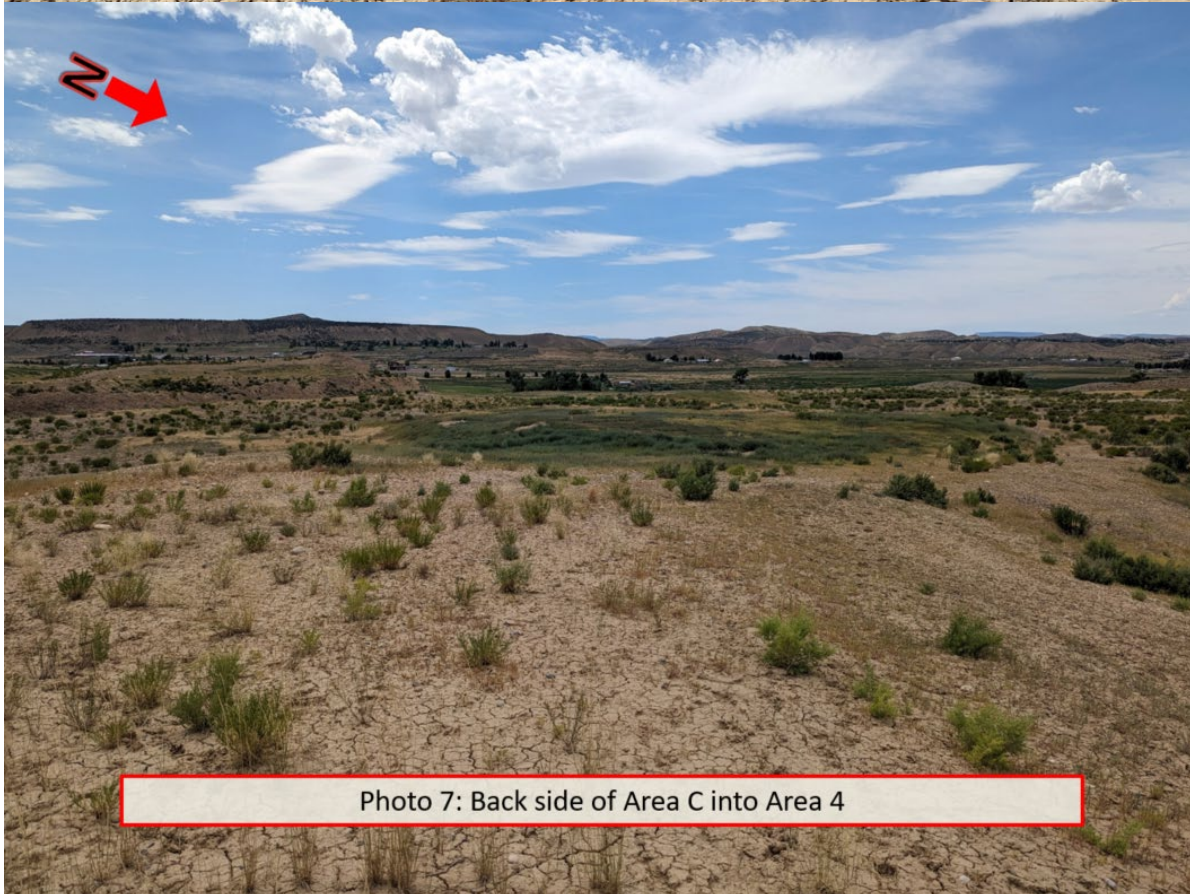
The Division next inspected the back side of Area C into Area 4. Overall reclamation success in this area is also poor (See Photo Seven). Green areas are almost entirely Russian Thistle and not actually desirable species. Sparse areas (no reclamation) did have some perennial grasses and low shrubs and forms. These areas also appear to have soil overtop the gravel.

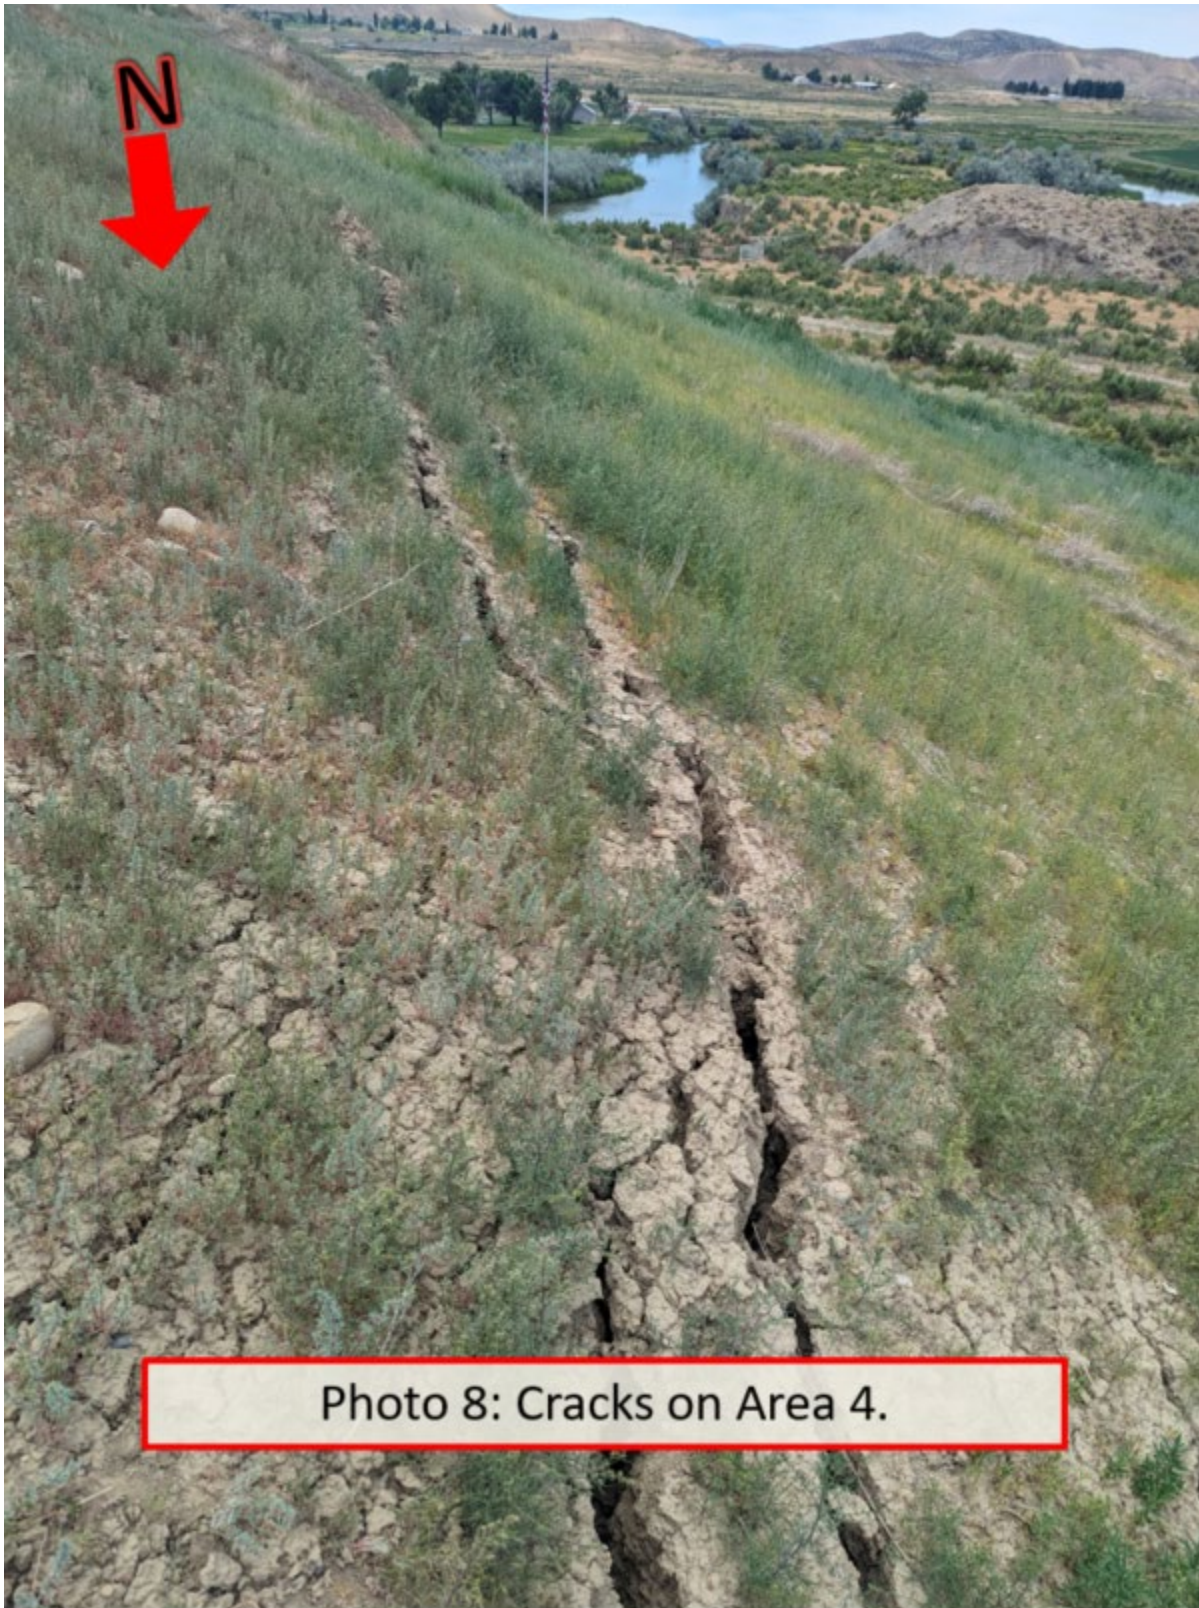
The western slope of area 4 has a stress crack (See Photo Eight and Nine). This slope will need to be repaired (graded) and reseeded. Given that sufficient material is on site a more gradual slope that is sufficiently compacted may resist settling better. The interstitial grade adjacent to the crack appears to be steeper than a 3H: 1V though the overall grade is a 3H: 1V. The crack is perpendicular to the slope and runs nearly the entire length of the slope. Smaller less apparent cracks were observed below the main one. This area will need to be repaired and reseeded.

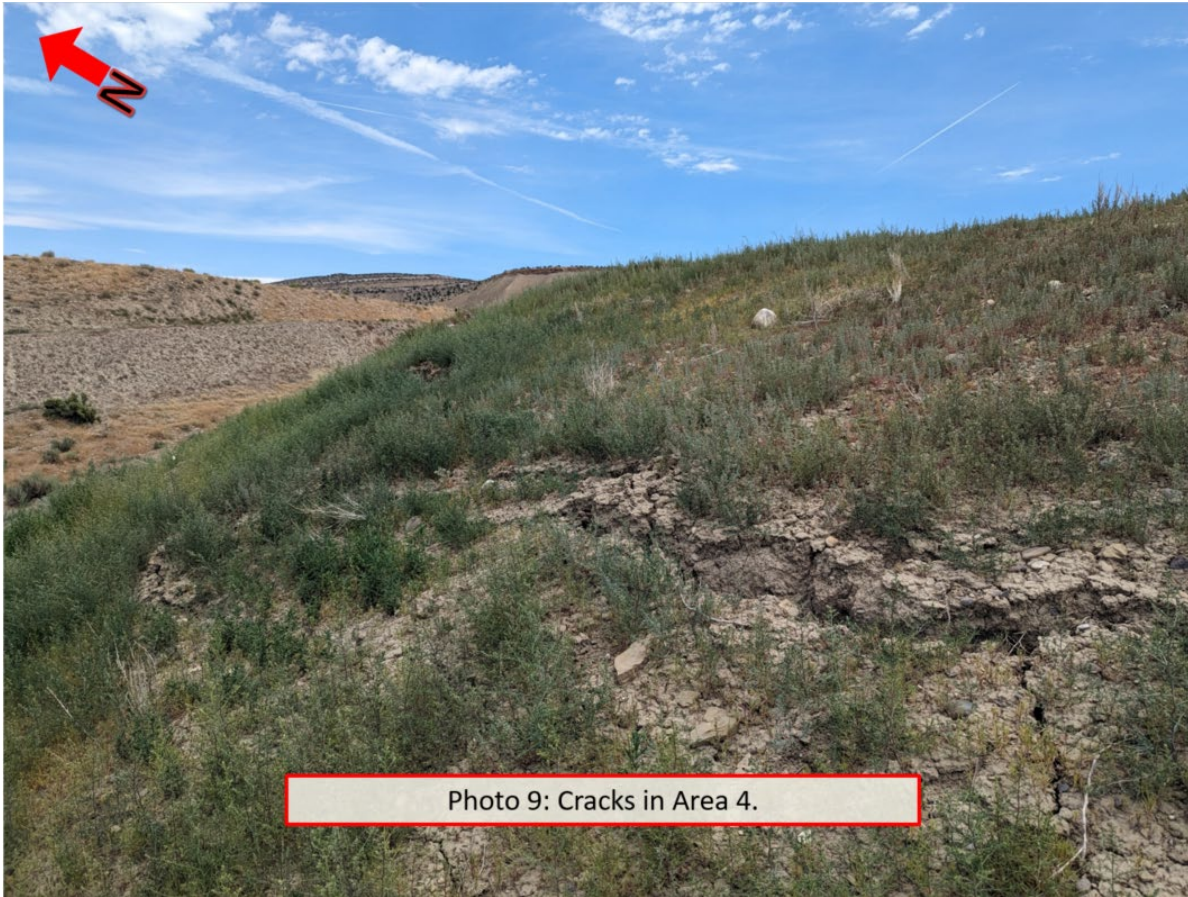
Photo 9: Cracks in Area 4.

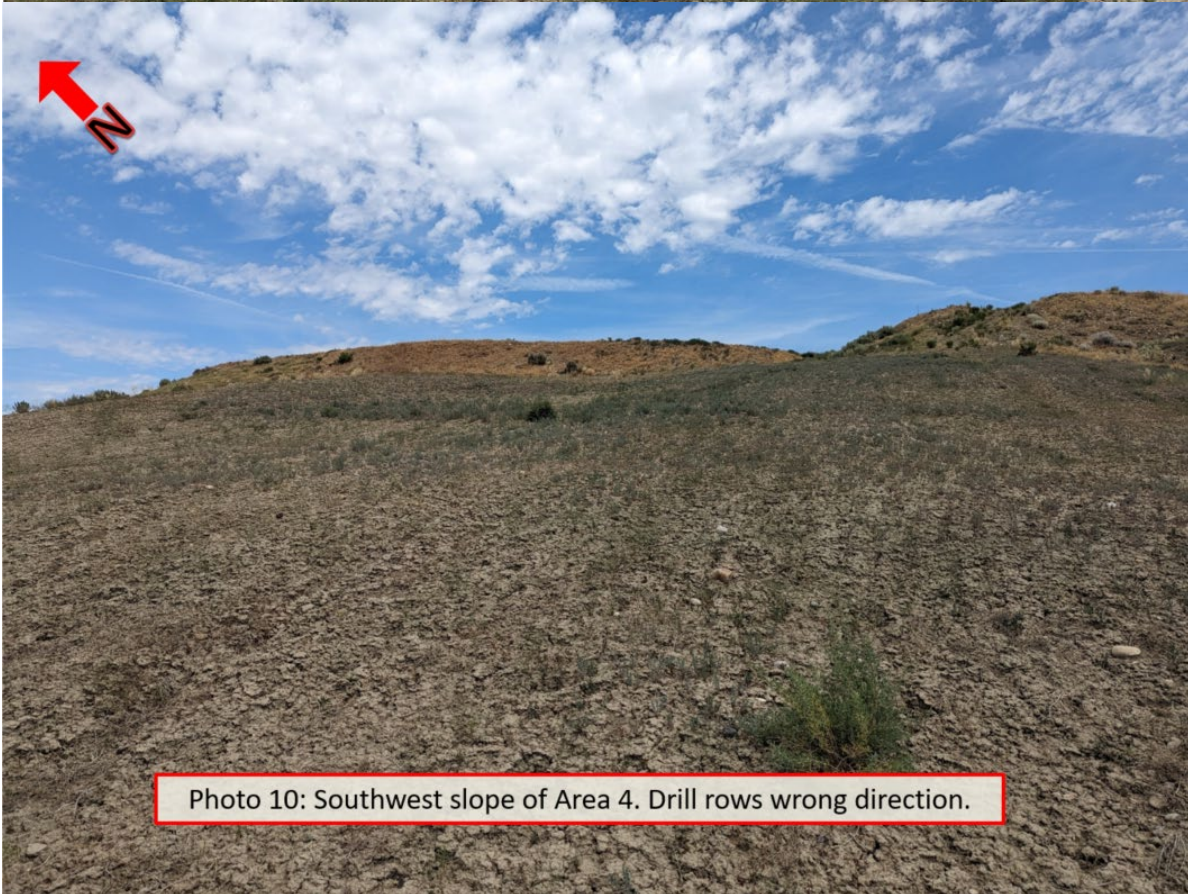
Vegetation on the southern west facing slope of area 4 is lush but unfortunately all non-desirable species. The northern west facing slope appears to be sufficiently graded and is far more arid. Only sparse Russian Thistle with very few shrubs or other desirable species were observed. One note is that the drill rows of the northern slope are going with the grade which will facilitate erosion in the event of precipitation (See Photo Ten). All disking and seeding should be done perpendicular to the grade to trap moisture and prevent erosion.

Photo 10: Southwest slope of Area 4. Drill rows wrong direction.
