## **Denver Field Branch Bond Release Evaluation Report**

Permittee:	Oxbow Mining, LLC
Operator:	Oxbow Mining, LLC
Site:	Elk Creek Mine
Permit No:	C-1981-022
Date of Inspection:	October 25, 2023
Inspection Type:	Partial Phase III bond release
Weather:	
Operator Representative:	Doug Smith
State Official:	Leigh Simmons
USFS Official:	Dan Gray
OSMRE Official:	Tom Medlin #562

This was a partial Phase III bond release inspection of reclaimed mine ventilation and coal exploration boreholes, drill pads, and associated road segments at the Elk Creek Mine in Delta and Gunnison counties, Colorado.

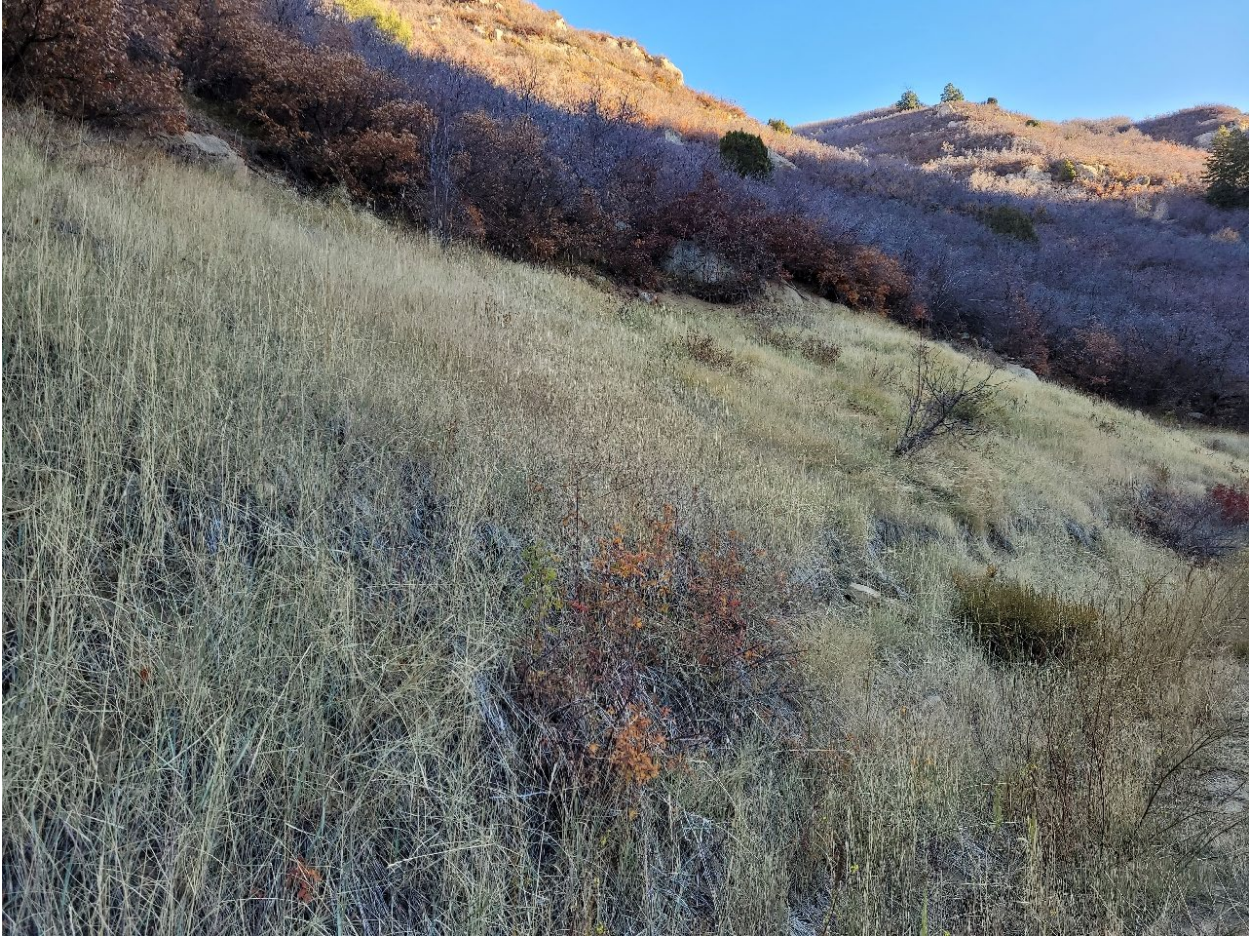
Figure 2. Pad GVB-LW12-03, previously reclaimed and fully released under SL-5.

**GVB-LW12-03 road:** 0.83 acres (ac.) Road permanently retained on landowner request. GVB-LW12-03 pad previously reclaimed and fully released under SL-5. No issues were noted. See Figure 2.

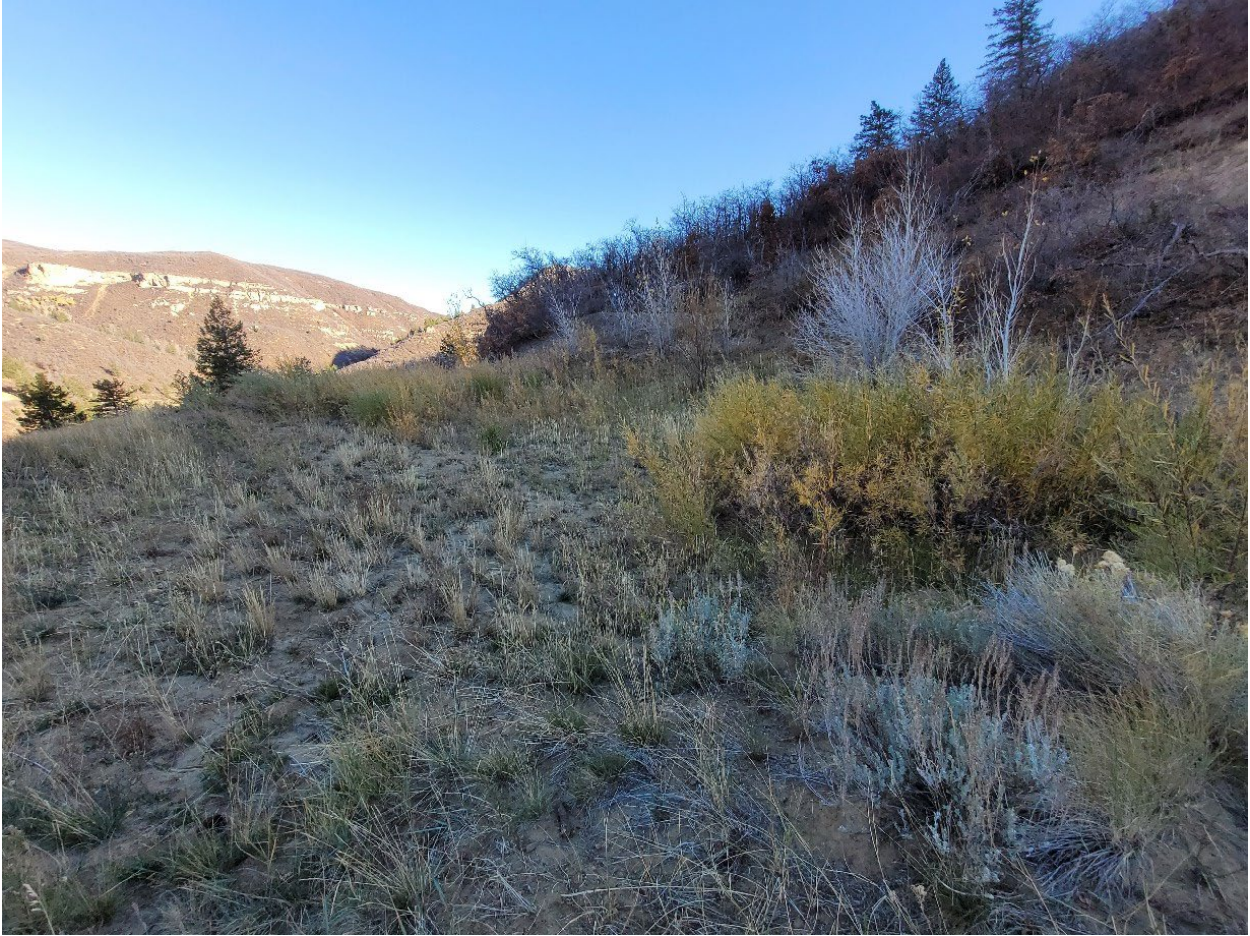
Figure 3. Pad GVB-LW10-05.

**GVB-LW10-05 and road:** 0.79 ac. Road permanently retained on landowner request. No issues with the pad were noted. See Figure 3.

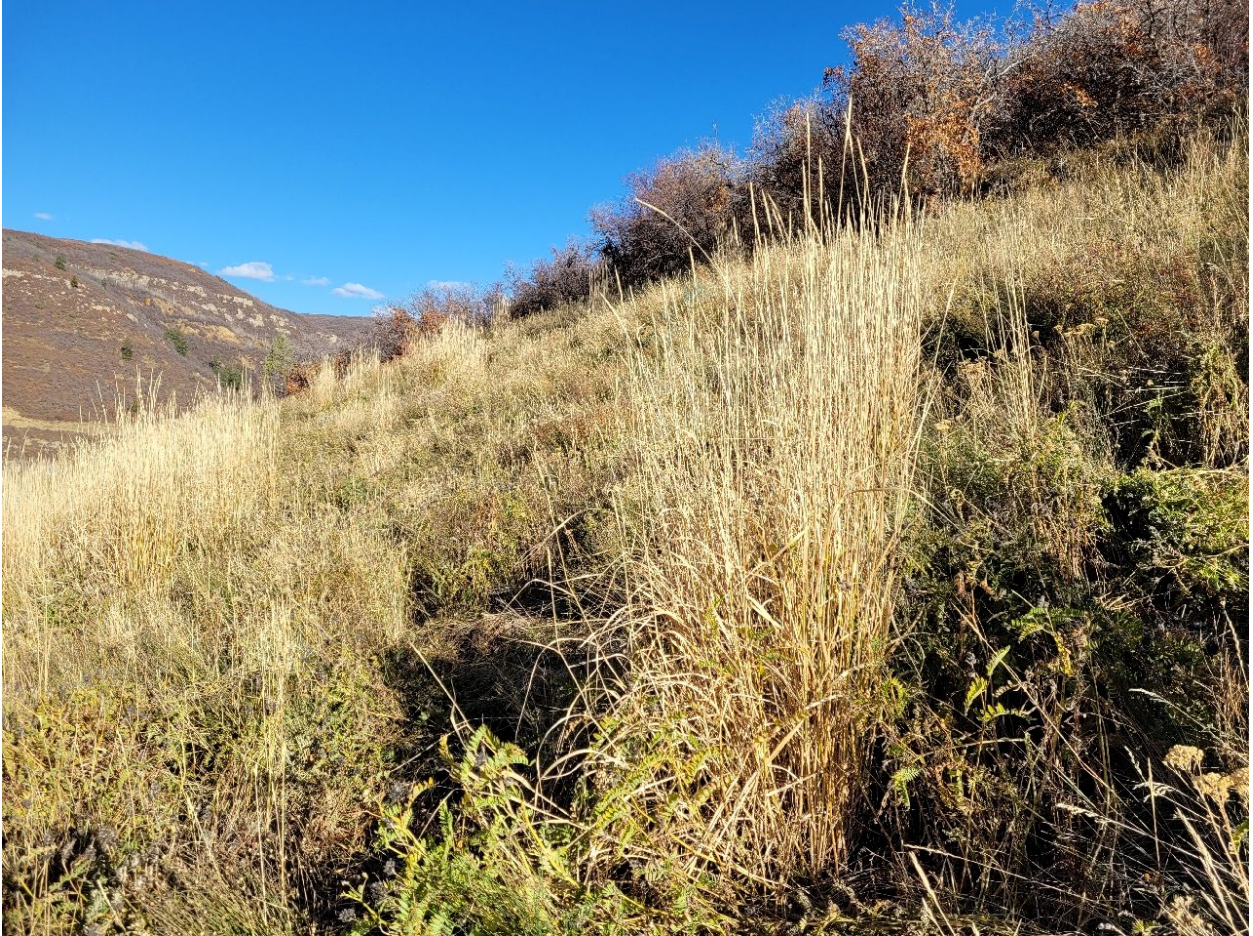
Figure 4. Pad GVB-LW09-05.

**GVB-LW09-05 and road:** 1.15 ac. No issues were noted. See Figure 4.

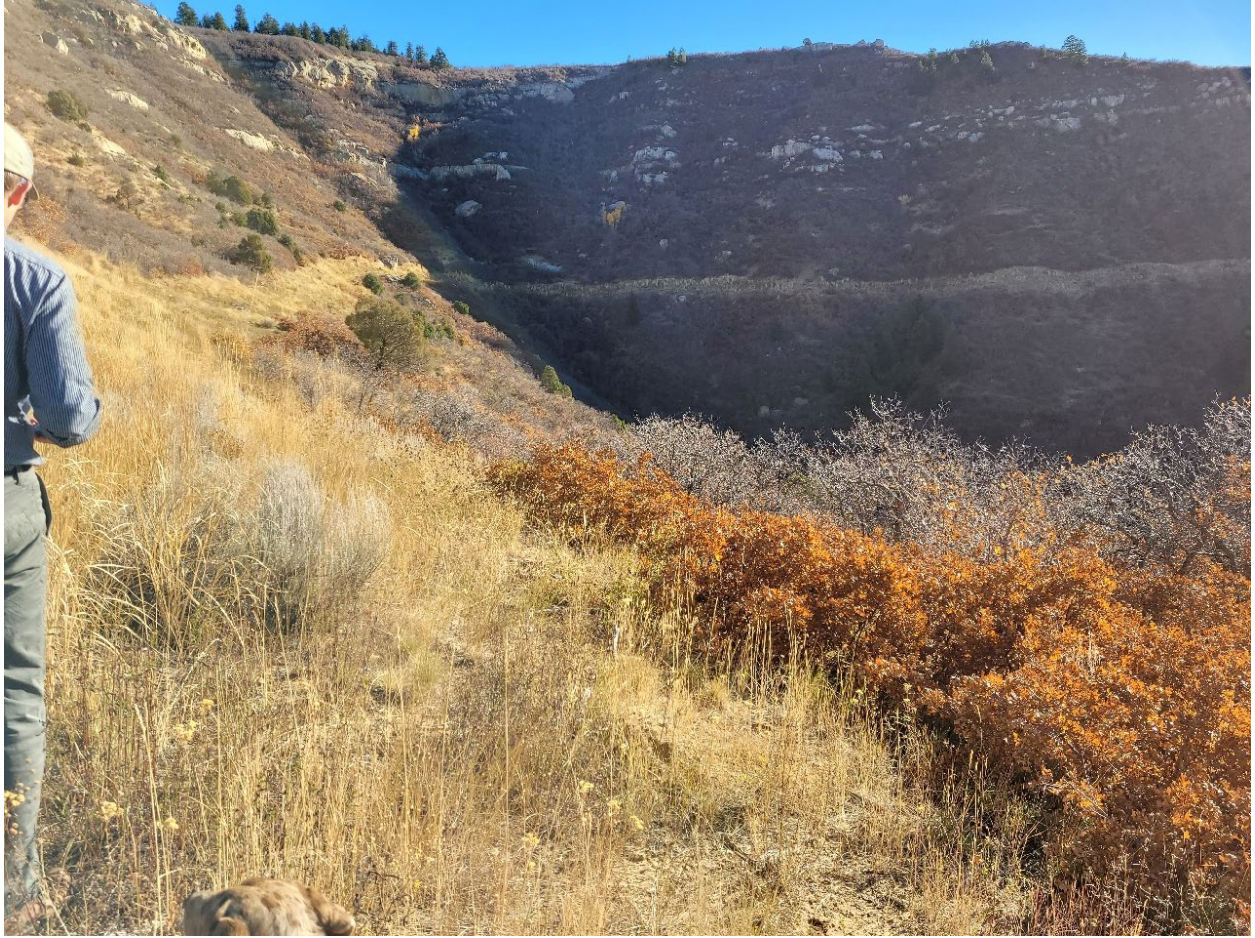
Figure 5. Road to GVB-LW15-01A, -01B, and -02, as seen from GVB-LW09-05.

**GVB-LW15-01A, -01B, and -02:** 1.77 ac. A minor slide had occurred in an undisturbed area along the road between pads GVB-LW09-05 and GVB-LW15-01A, -01B, and -02. Mr. Smith hand sown seed from the approved mix to help stabilize the disturbance. No issues with pad GVB-LW15-01A, -01B, and -02 were noted. See Figures 5 – 8.

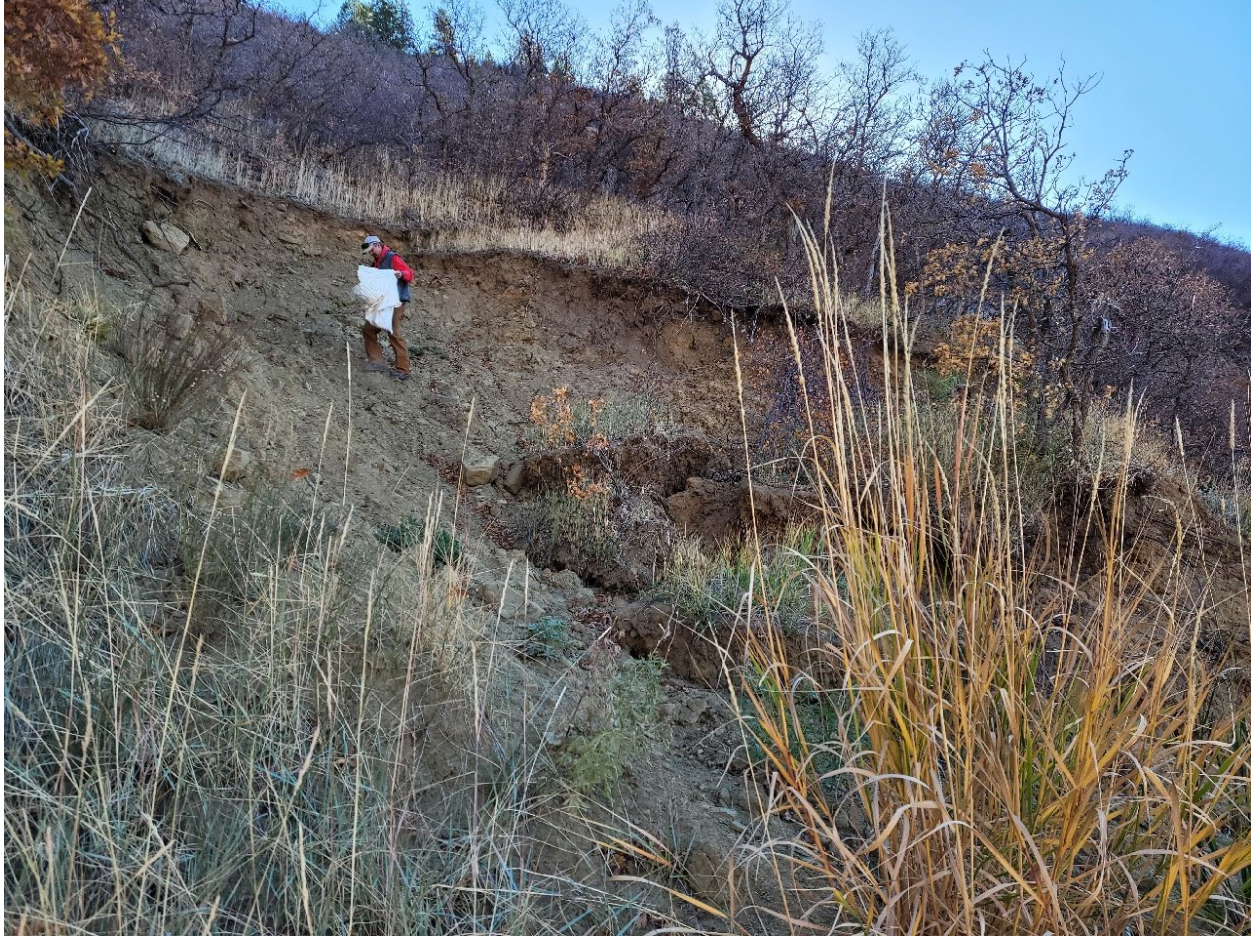
Figure 6. Small slide in undisturbed area along road between pads GVB-LW09-05 and GVB-LW15-01A, -01B, and -02.

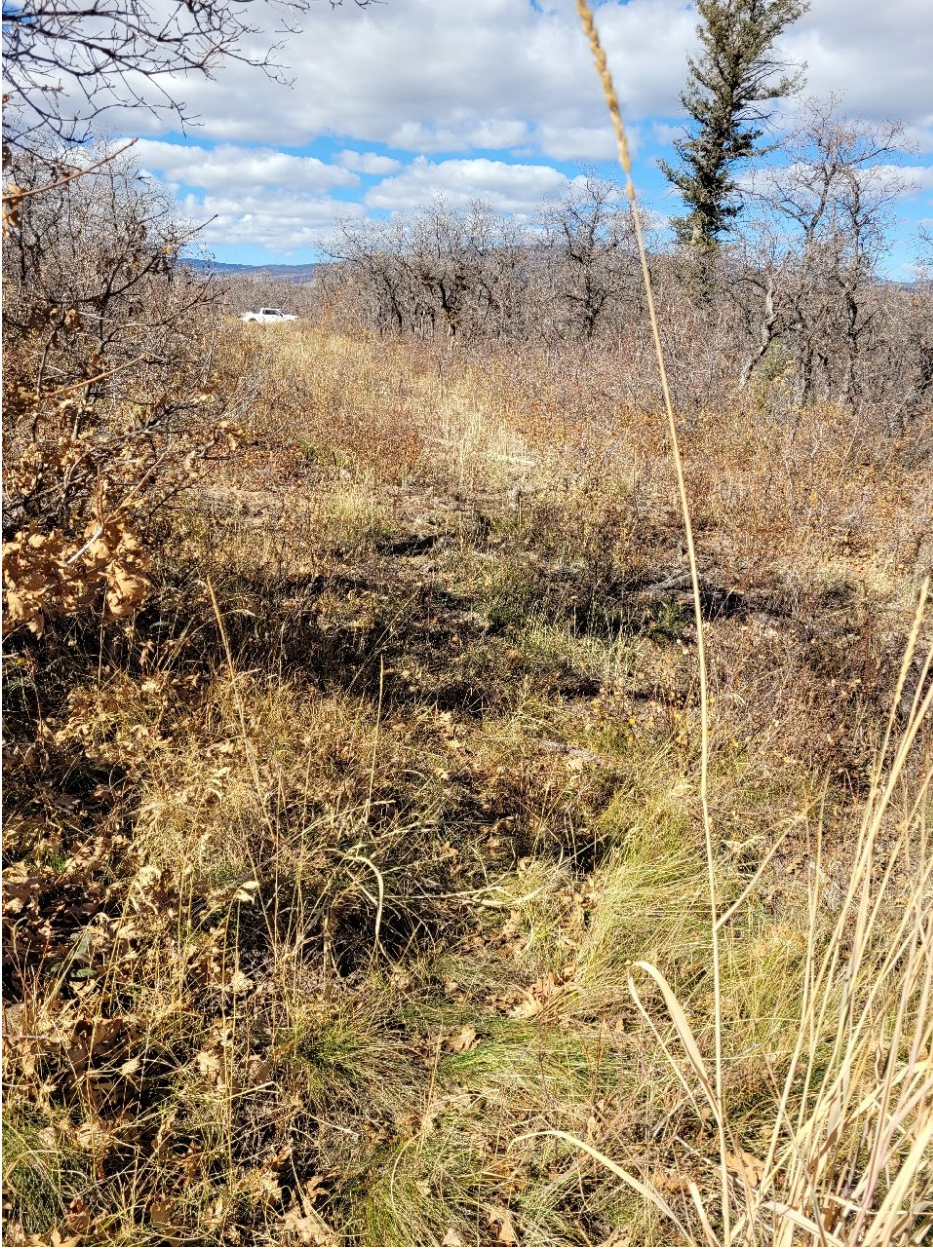
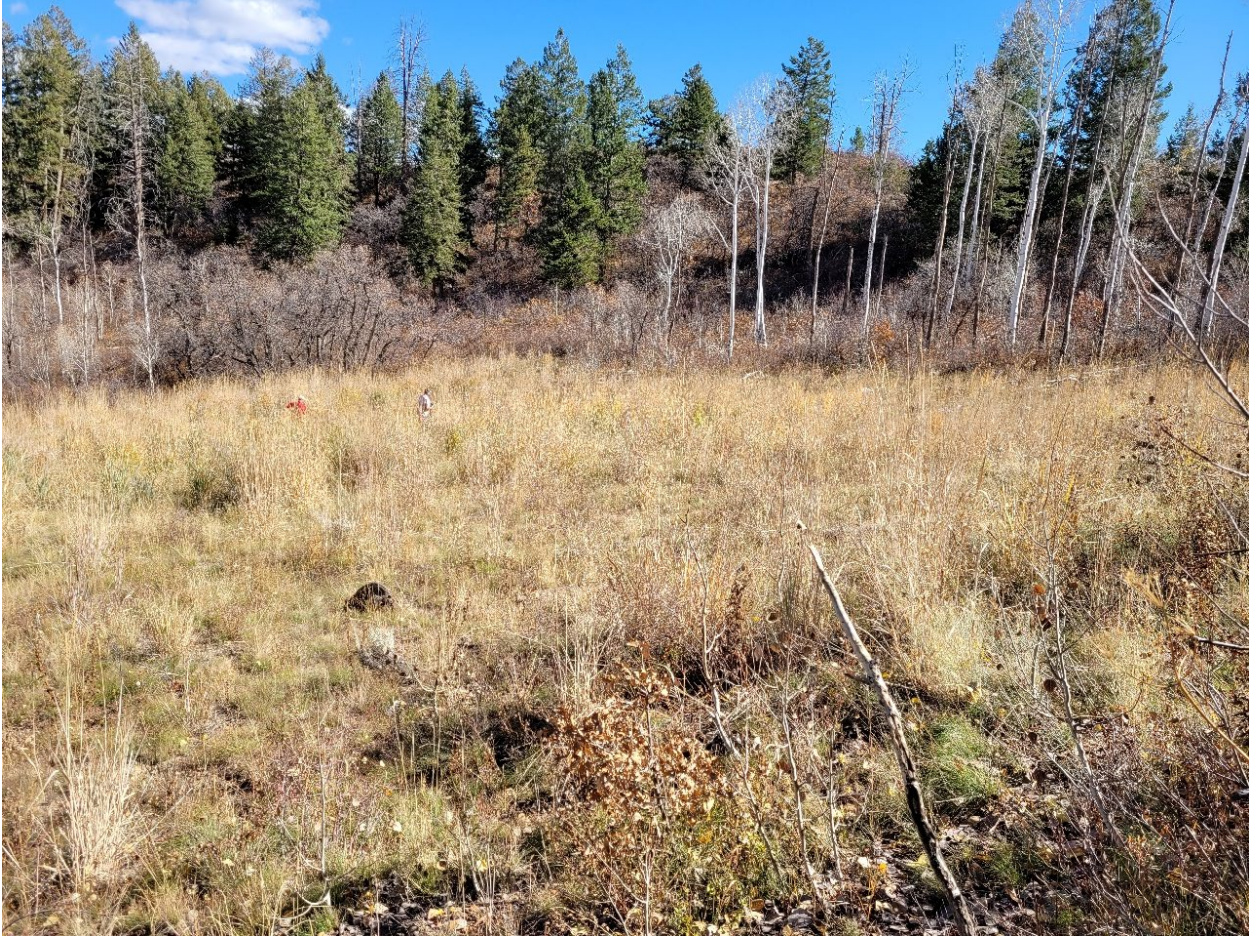
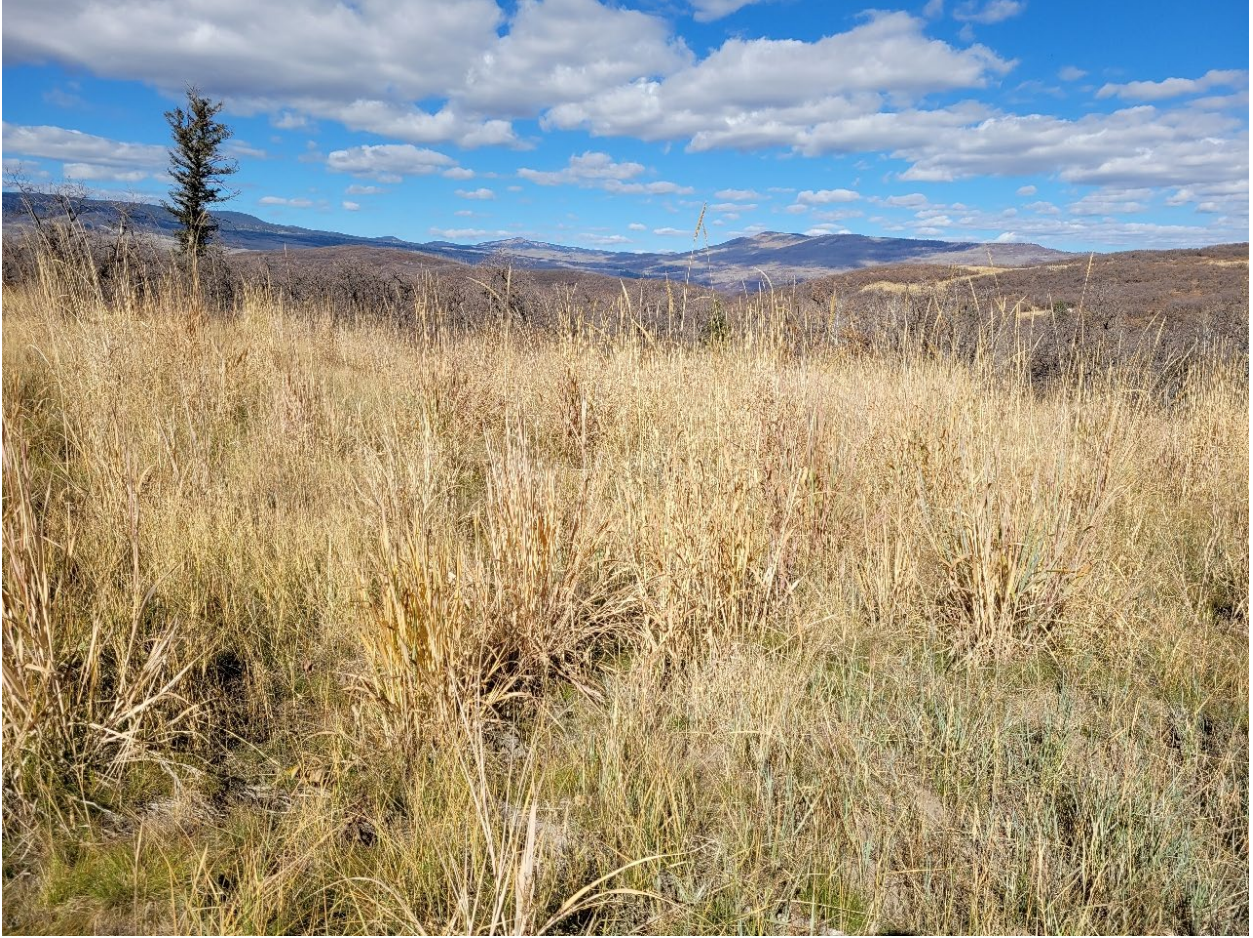
**GVB-LW17-01A, -01B, and road:** 1.09 ac. No issues were noted. See Figures 9 – 11.

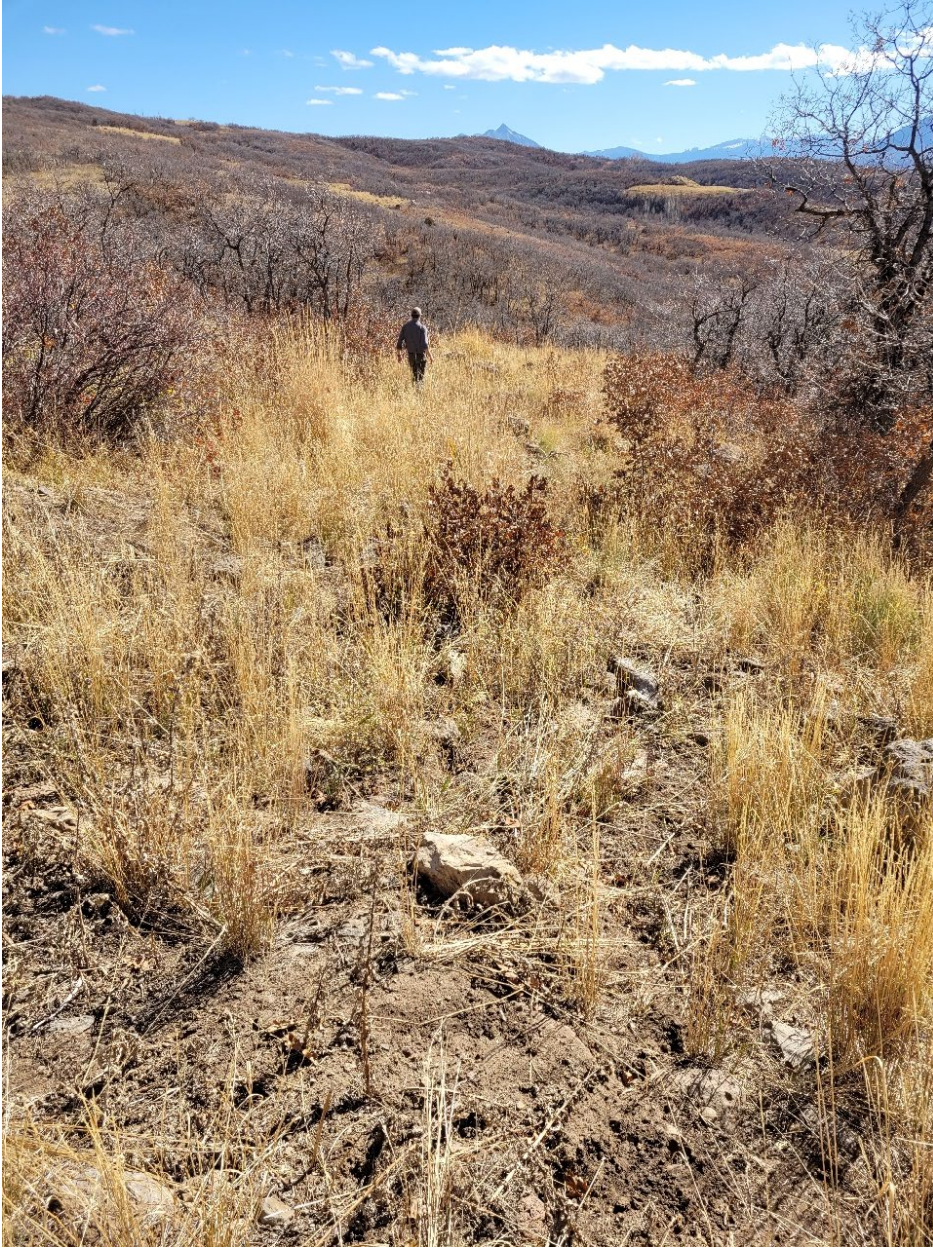
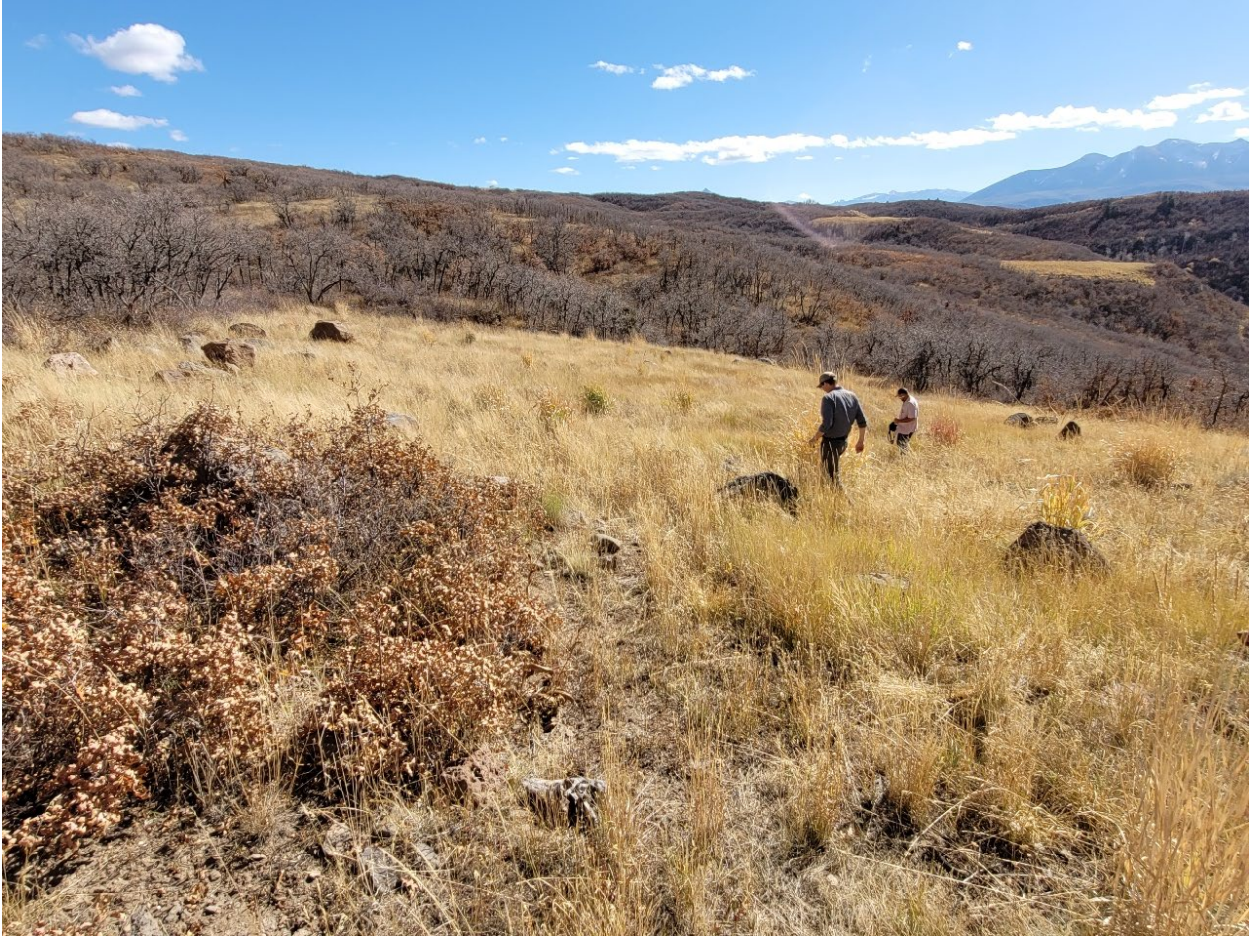
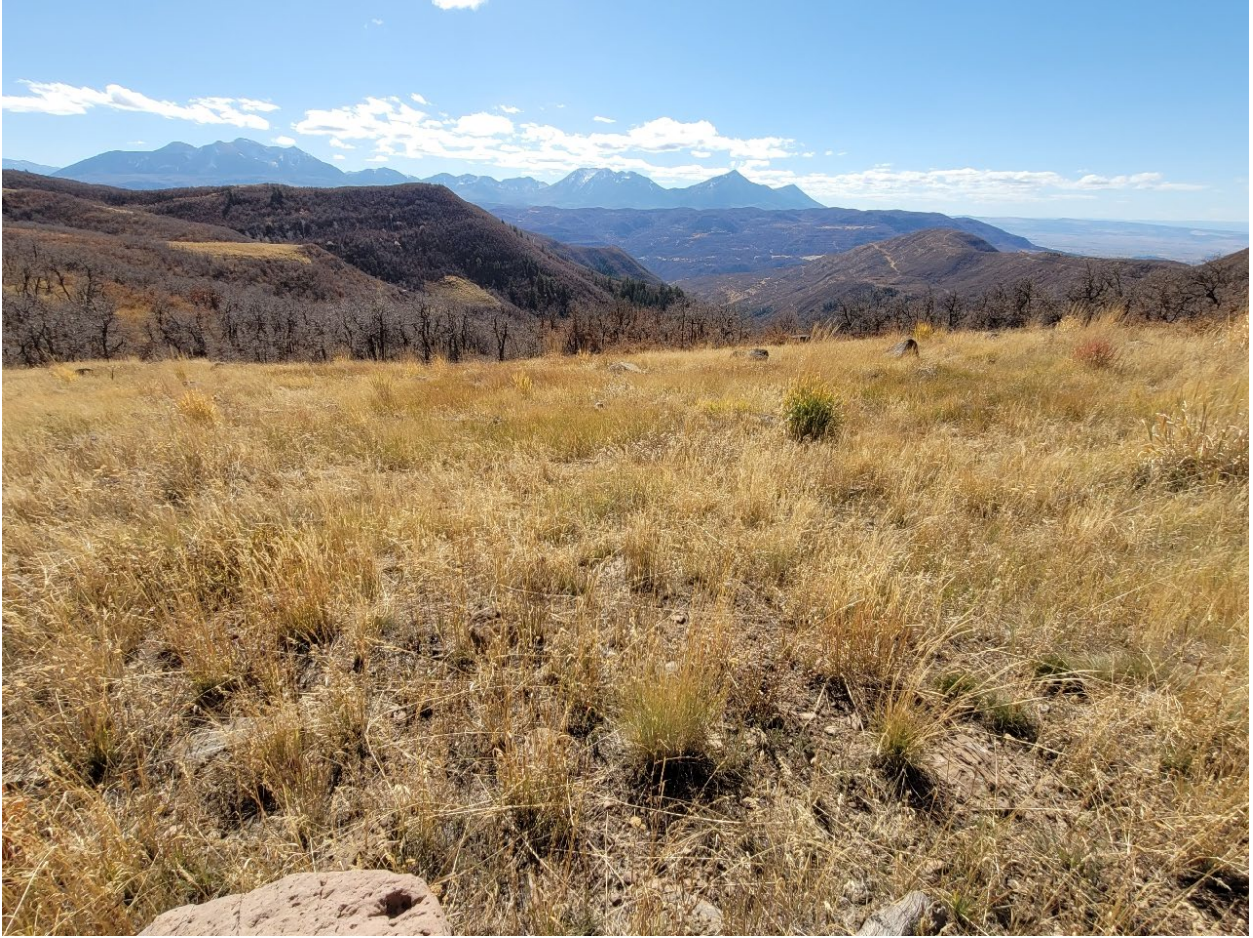
**GVB-LW17-03 and road:** 0.86 ac. No issues were noted. See Figures 12 – 14.

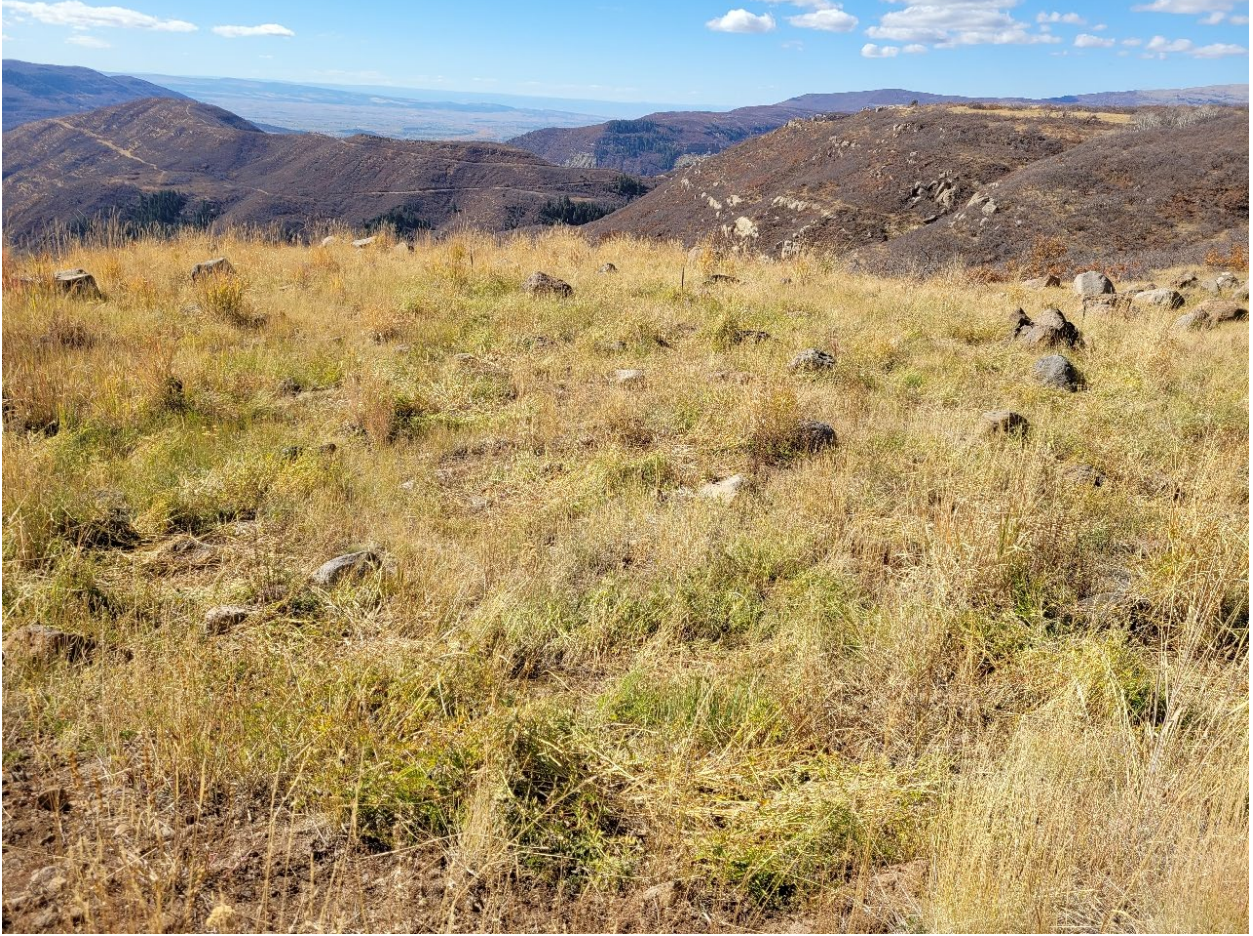
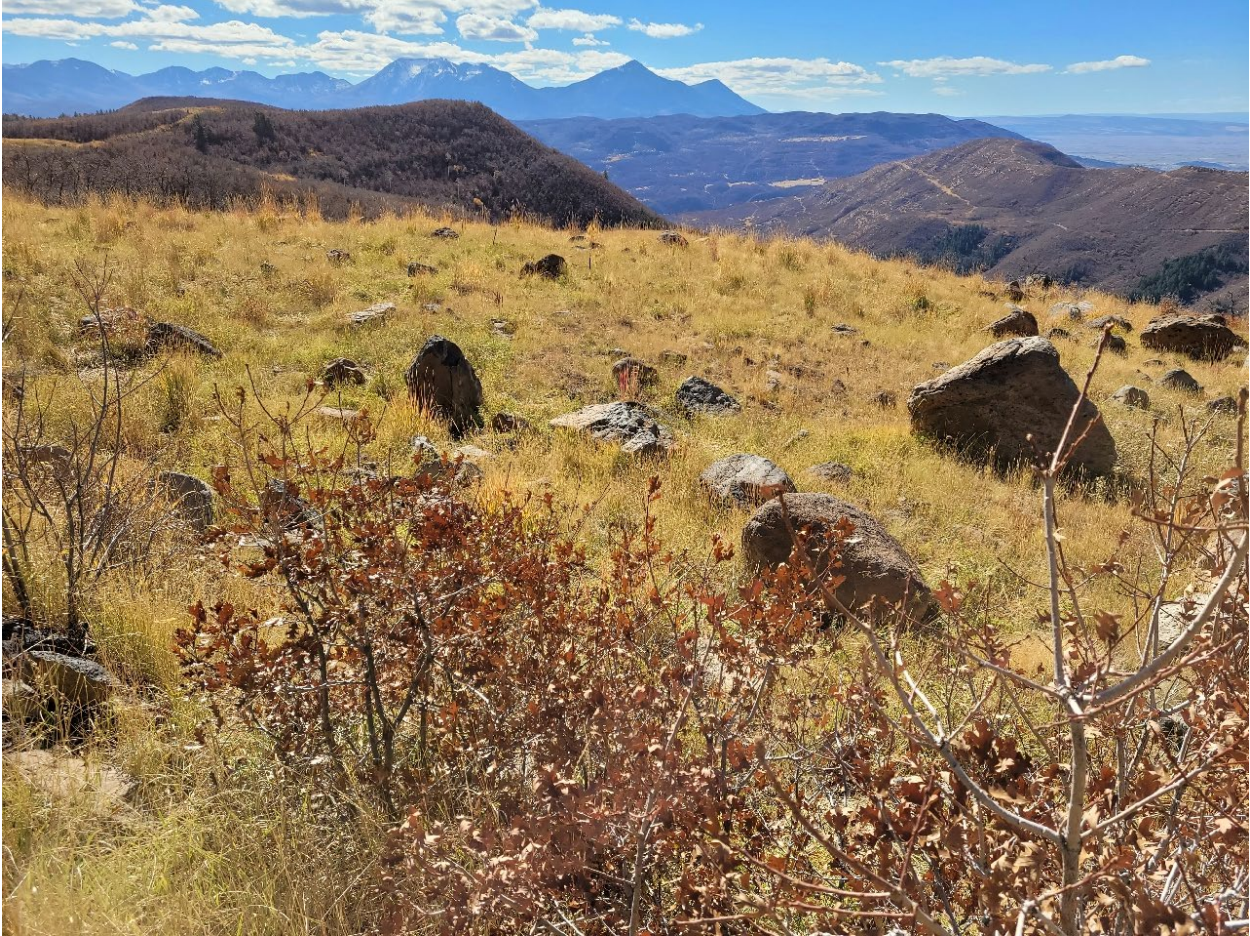
**GVB-LW17-04, -04B, and -04C:** 0.96 ac. No issues were noted. See Figures 15 – 16.

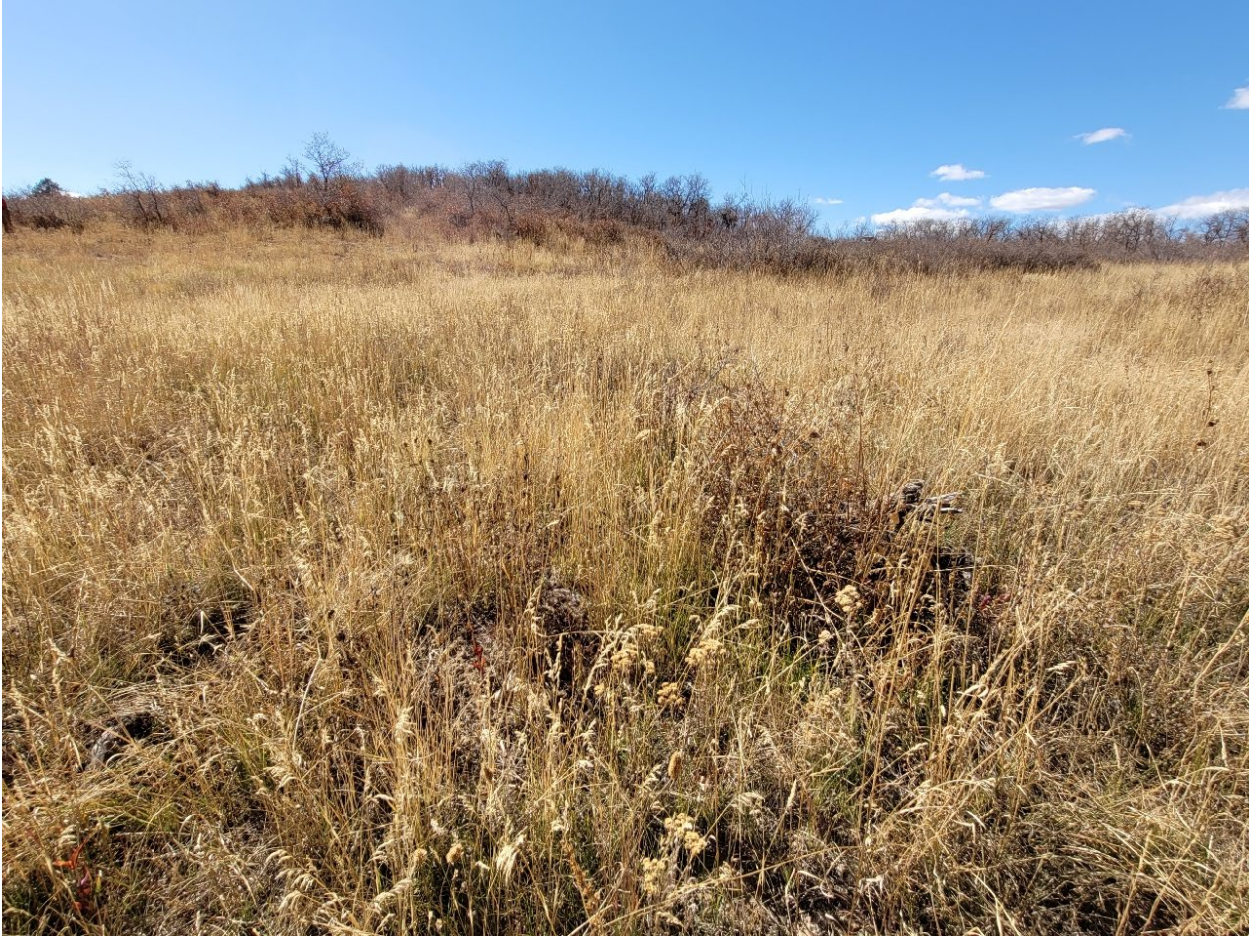
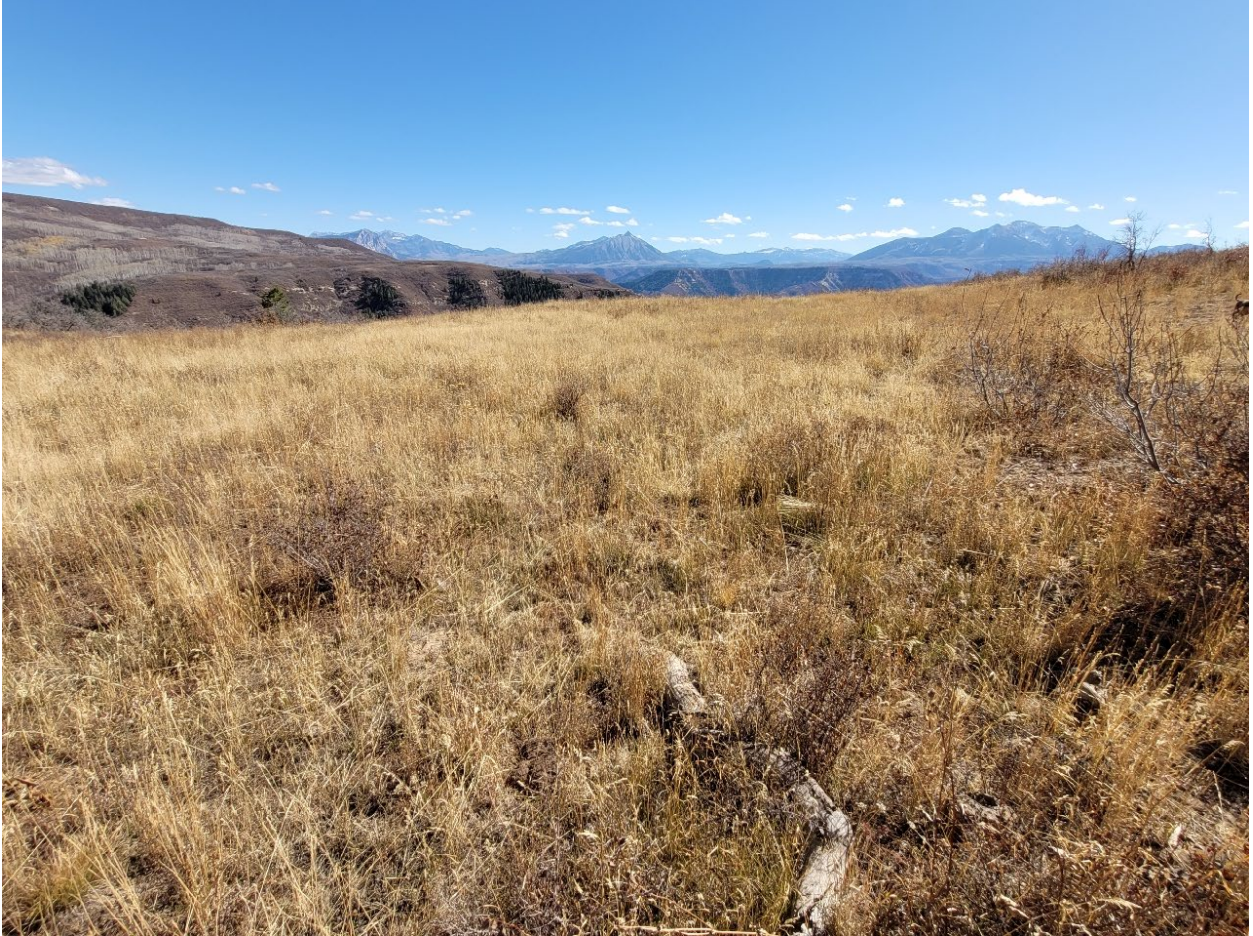
**GVB-LW15-08 and road:** 0.91 ac. No issues were noted. See Figures 17 – 18.

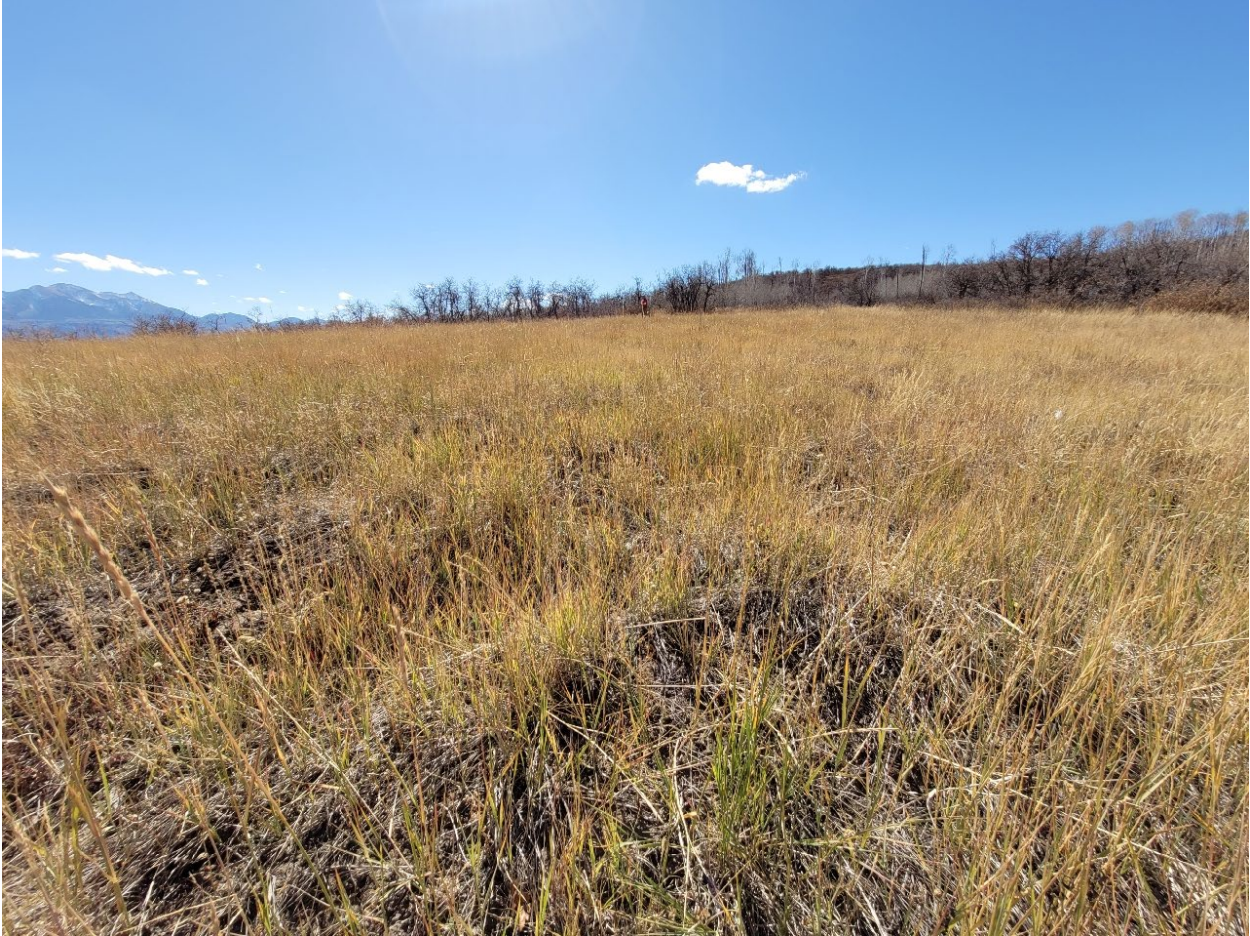
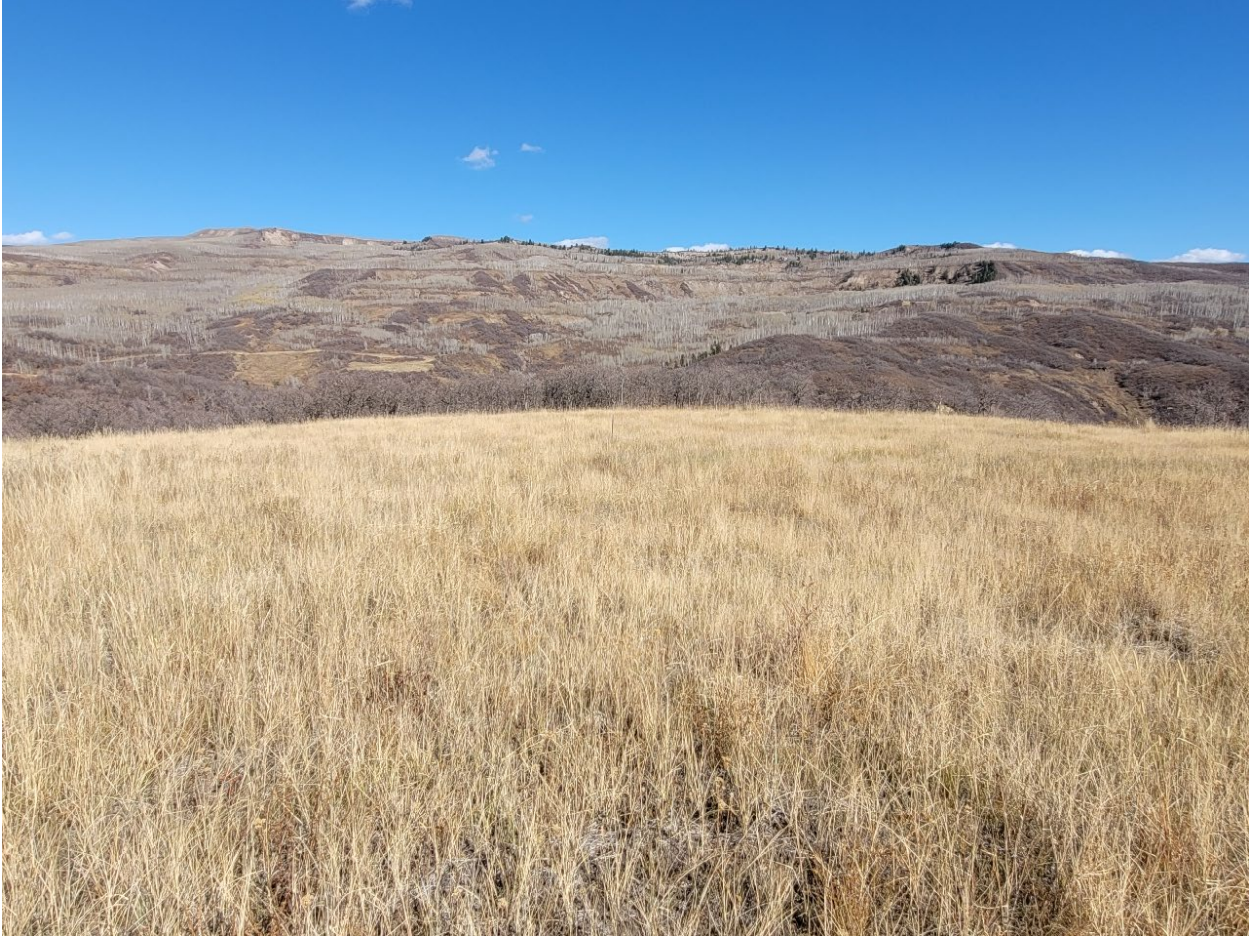
**GVB-LW17-09:** 0.98 ac. No issues were noted. See Figures 19 – 20.

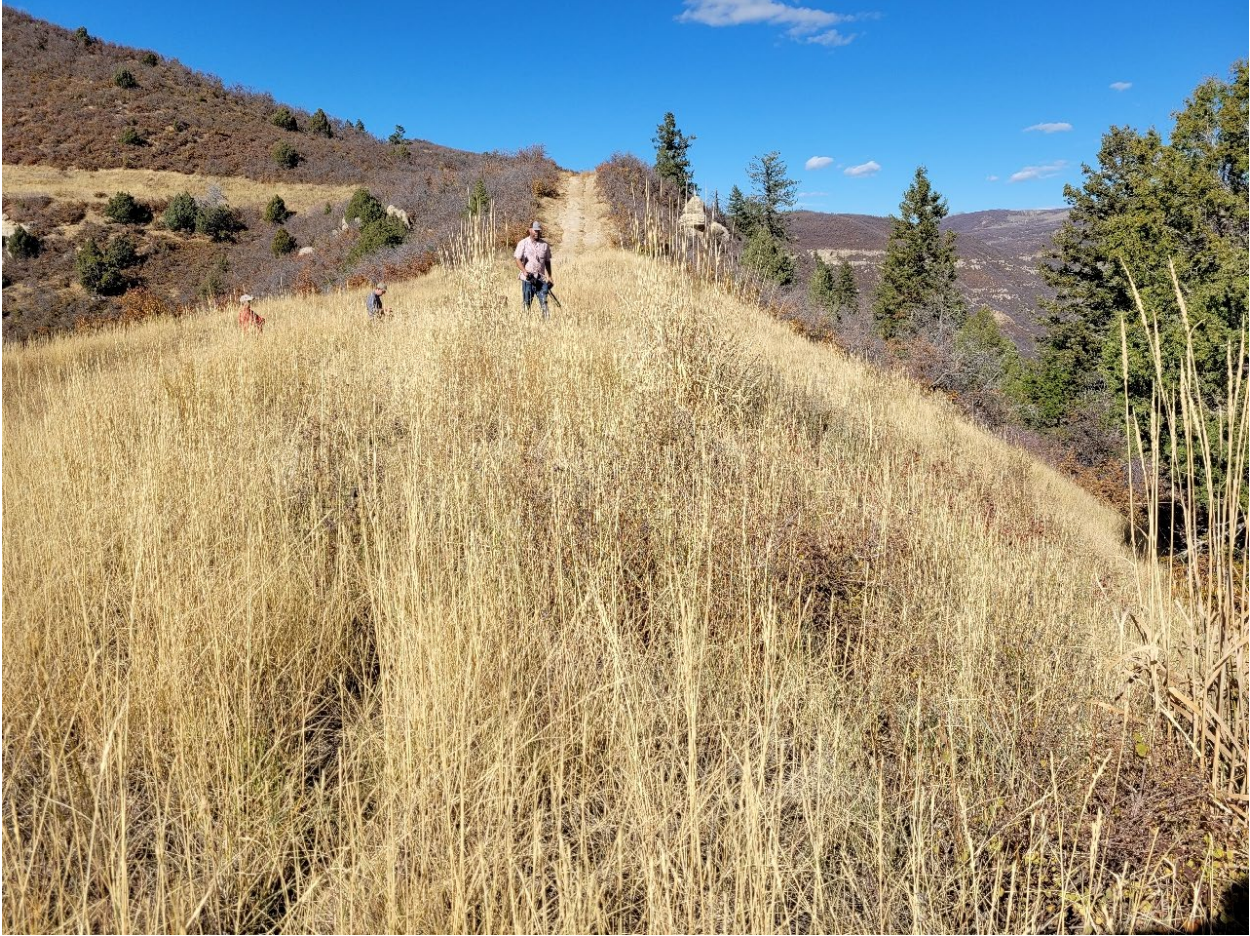
Figure 21. GVB-LW08-03.

**GVB-LW08-03:** 0.16 ac. No issues were noted. See Figure 21.
