STATE OF
COLORADO

Permit Number: C-1981-044 Mine Name: Williams Fork Mines Operator: Moffat County Mining, LLC Operator Address: MS Miranda Kawcak 29515 Routt County Road #27 Oak Creek, CO 80467	County: Moffat Operation Type: Underground Permit Status: Active Ownership: Private Operator Representative Present: Miranda Kawcak
Operator Representative Signature: (Field Issuance Only) This report was issued electronically from the Divisions' Denver Office.

Inspection Start Date: 1 November, 2023 Inspection Start Time: 14:00 p.m. Inspection End Date: 1 November, 2023 Inspection End Time: 15:45 p.m.		Inspection Type: Coal Partial Inspection Inspection Reason: Normal I & E Weather: Clear	
Joint Inspection Agency: None		Joint Inspection Contacts:	
Post Inspection Agency: None		Post Inspection Contacts:	
Inspector(s): Robin Reilley, GISP	Inspector's Signature:

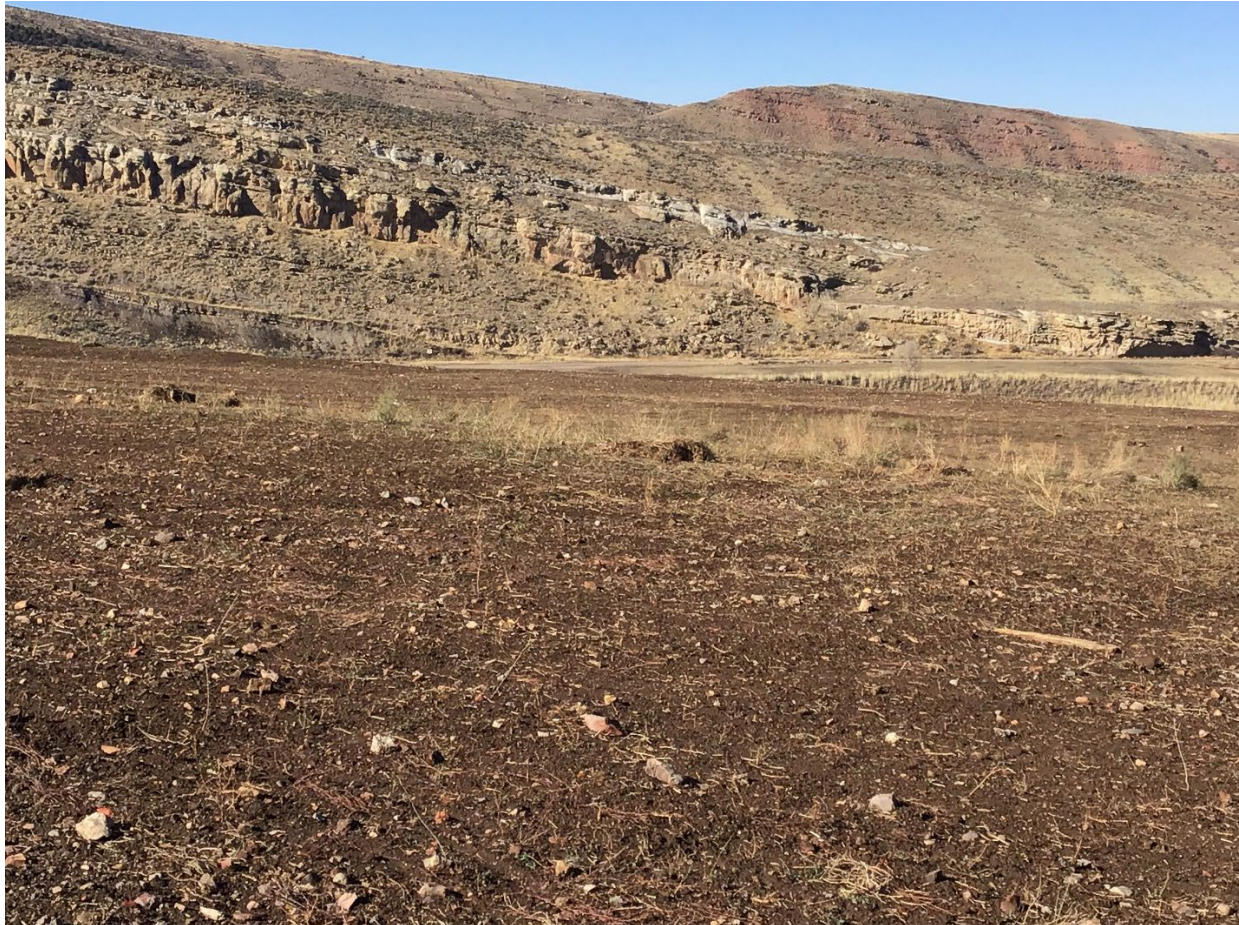
Rills and gullies on the slope below the No 5 Portal to the 5A-P1 Pond had been graded and the slope had been seeded.

- Pond 5A-P1 at 5A at portal was dry at the time of inspection. Rills and gullies the length of the slope to the pond had been graded and repaired.

Photo 1: Regraded slope to the 5A-1 Portal Pond.

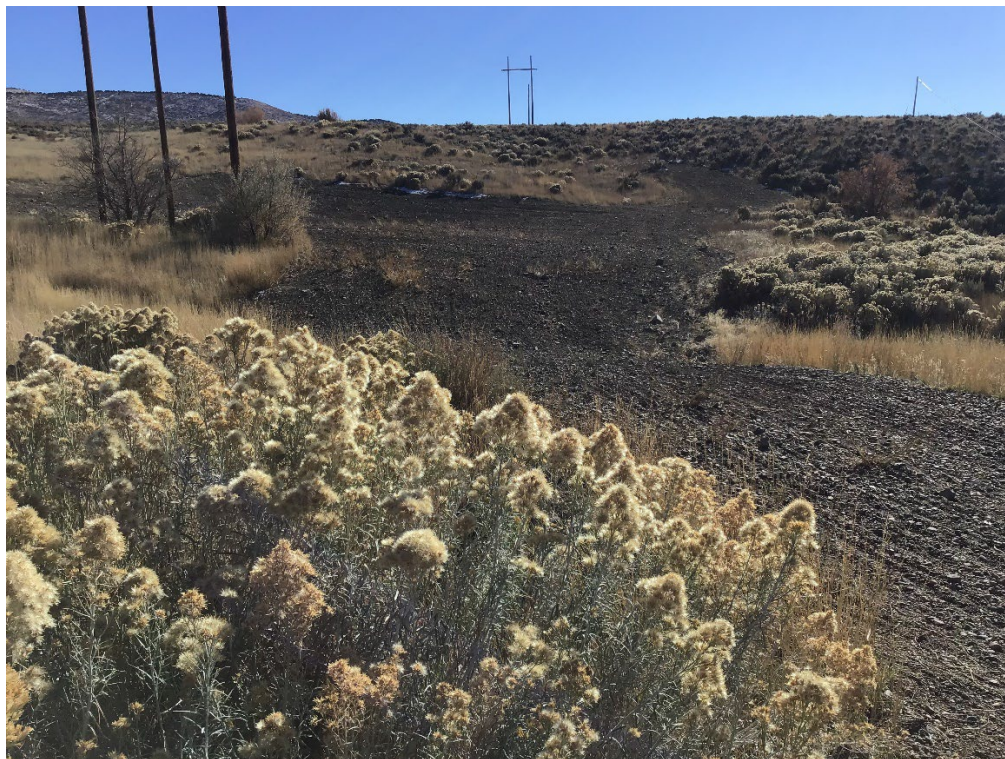
***Photo 2:** Regraded and seeded slope at haul road intersections.*

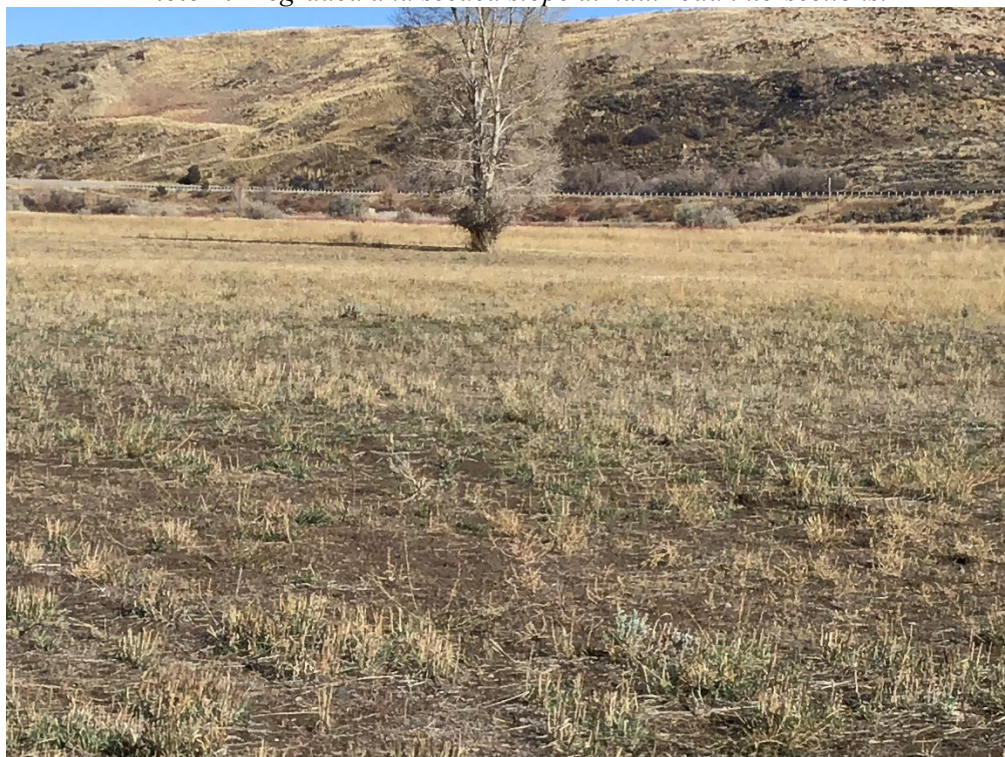
***Photo 3:** Bottom lands at south end of site looking north.
Green cool season grasses are notable in the vegetation.*

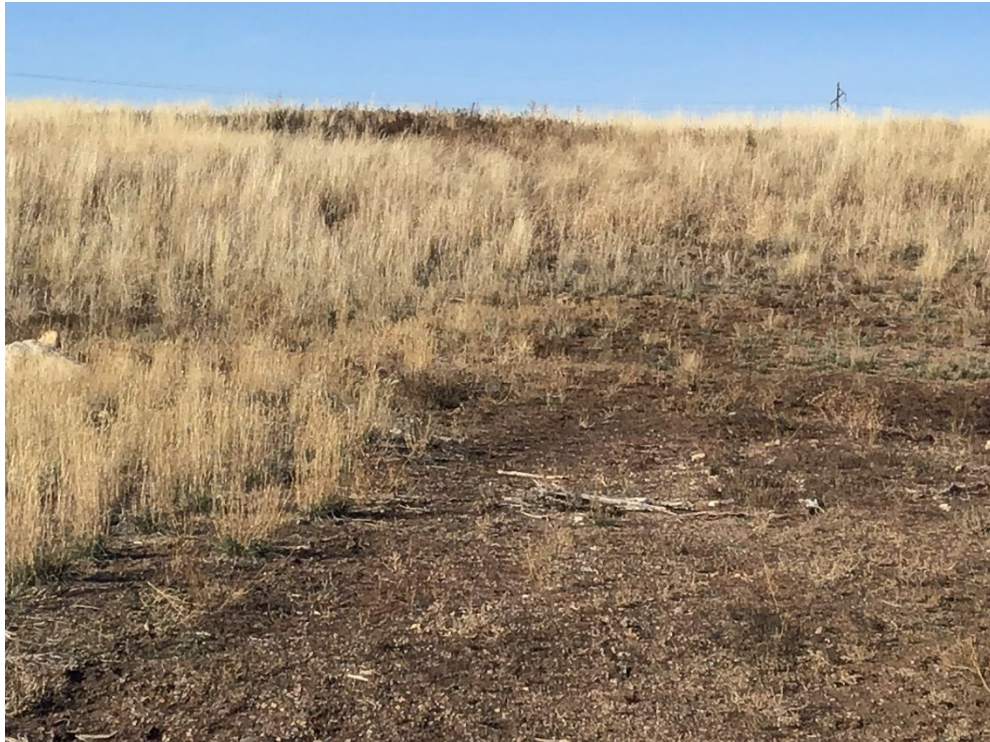
- Reclamation, (topsoil and seeding) at the 5A Portal has been completed.
- The refuse pile remains weedy.
- Cropland areas along the Williams Fork River consisted of hay stubble and appeared adequately vegetated.
- Vegetation in the reclaimed areas had mostly gone dormant although in the cropland areas cool season vegetation was green.

Photo 4: Refuse Pile looking northwest.

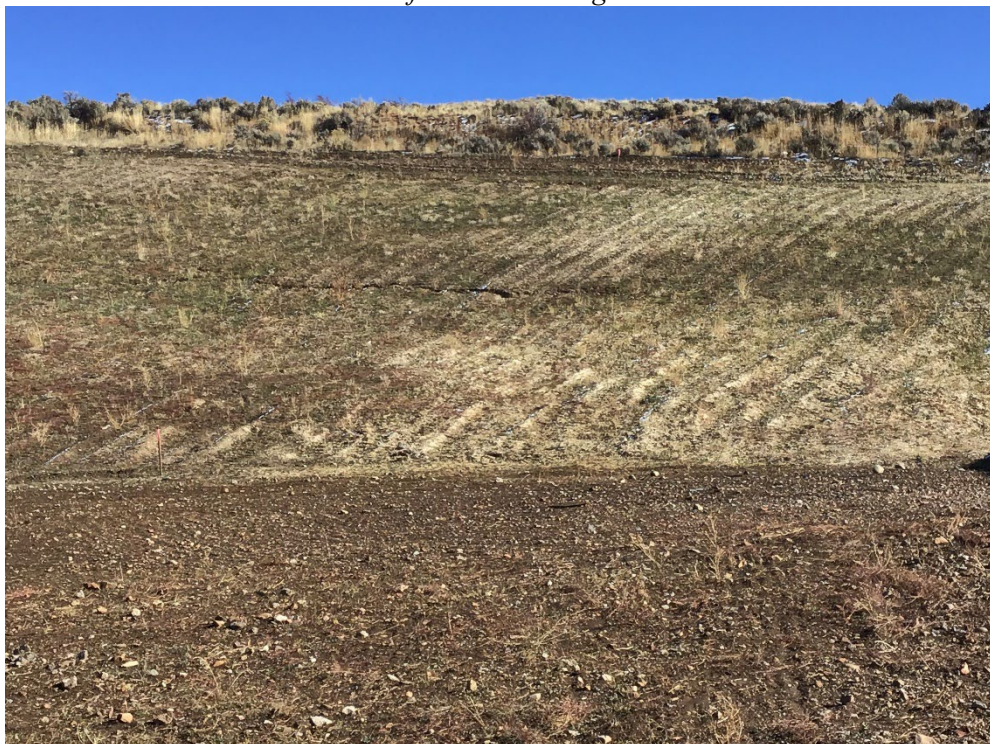
A crack exists mid slope at the 5A portal. Both DRMS and Moffat Co. Mining will monitor the crack.

Photo 5: Hydroseeded west facing slopes at the 5A Portal. Note the crack at midslope.
