## New Horizon Mine, C-1981-008, SL-26 Inspection Report

Attached is the Division's report for the SL-26 Bond Release inspection conducted on October 26, 2023. Please feel free to contact me if you have any questions or concerns.

**PERMIT INFORMATION**

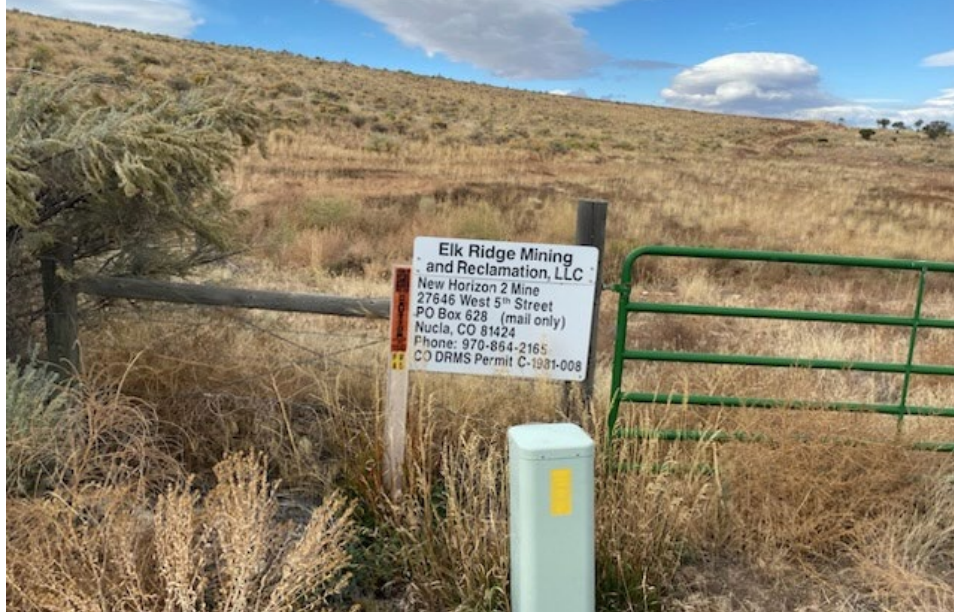
Both the C-15 Ditch and the SP-2 Stock Pond are located in the northeast corner of the permit area. The pond and ditch were accessed on the west side of 2700 Road through a gate. A Mine Identification sign was placed at the entrance to the permit boundary near the SP-2 Stock Pond (Photo 1). The mine ID sign displayed the permit number and the current contact information for the operator. The sign was placed in an unobstructed location and was in good condition.

Photo 1: The Mine ID sign placed at the gate at the entrance to the permit area near SP-2.

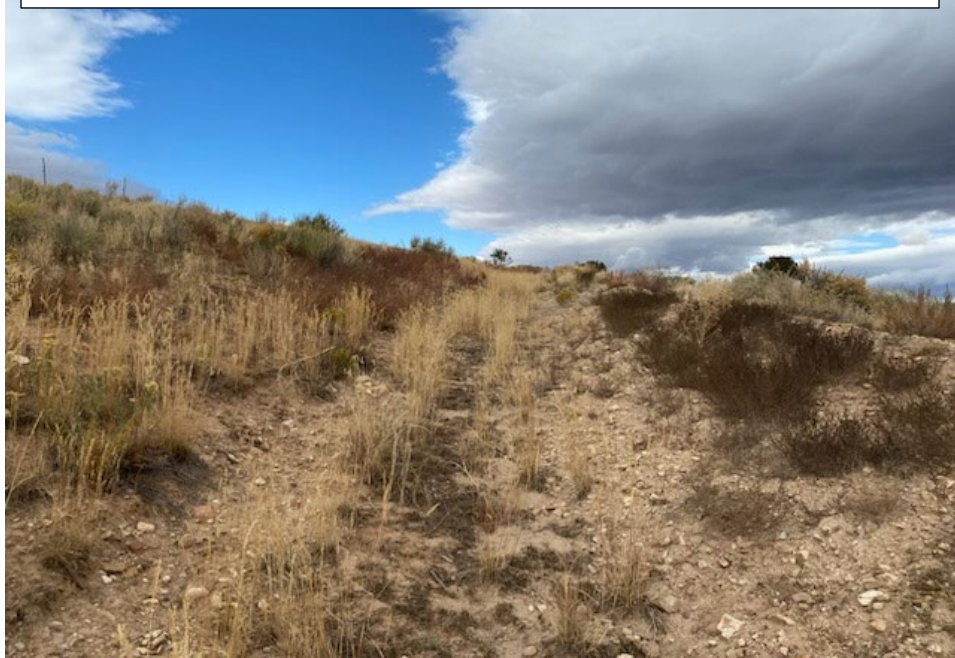
The C-15 Ditch is located on the hillside to the west of the SP-2 Stock Pond. The ditch was dry during the inspection. The ditch is roughly four feet across and two feet deep. The northern side of the channel was an embankment. The channel bottom was observed to be stable with no indications of down-cutting or erosion (Photo 2). Some vegetative growth has helped stabilize the channel. The vegetation within the channel was small and would not impede the ditch's ability to function. The north embankment was also vegetated and stable (Photo 3). There were no signs of sloughing, cracking or obstructions identified. Some small pieces of a broken PVC pipe were identified within the C-15 Ditch (Photo 4). These pieces of debris were removed from the channel

Photo 2: The C-15 Ditch channel.

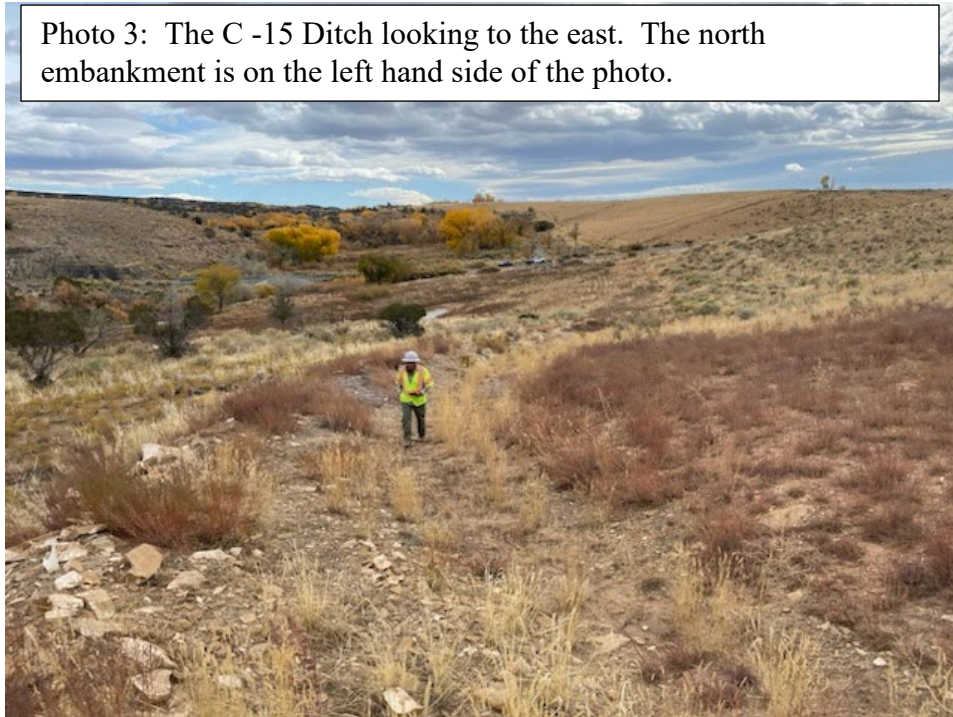
Photo 3: The C -15 Ditch looking to the east. The north embankment is on the left hand side of the photo.

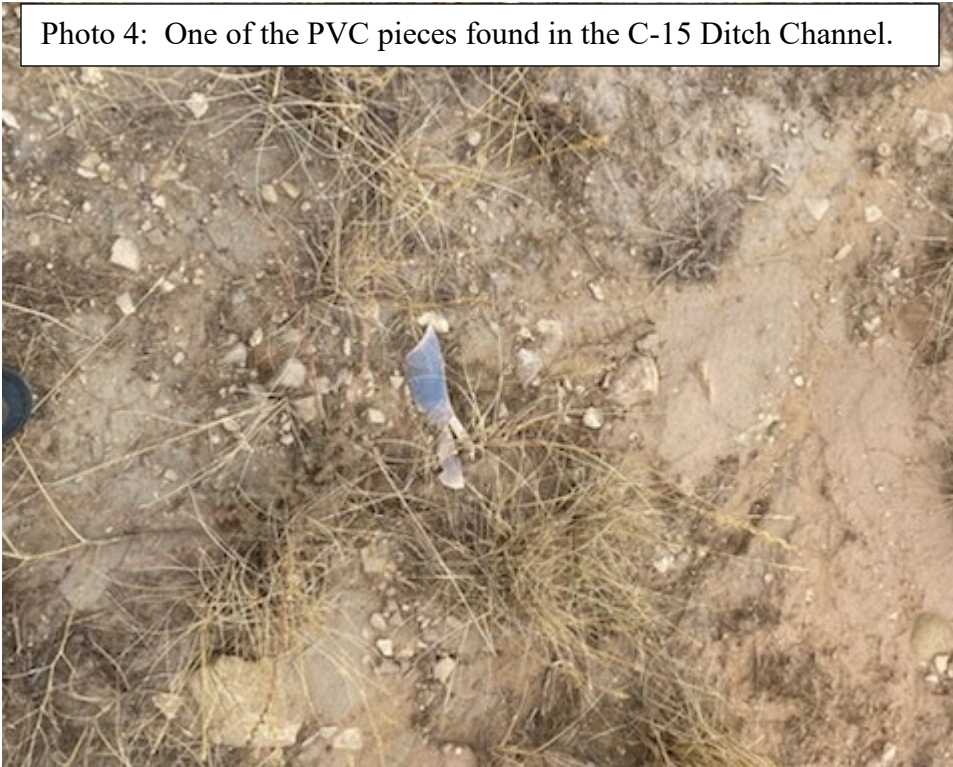
during the inspection. A small pile of barbed wire and a T-post were identified on the top of the north embankment for the ditch. The operator stated that they would go back that afternoon to remove the wire and marker. Based on the observations made during the inspection, the C-15 Ditch is sufficiently stable with vegetative cover. The ditch is capable of functioning as designed outlined in Attachment 2.05.3(3)-1 of the C-008 Permit Application Package.

Photo 4: One of the PVC pieces found in the C-15 Ditch Channel.

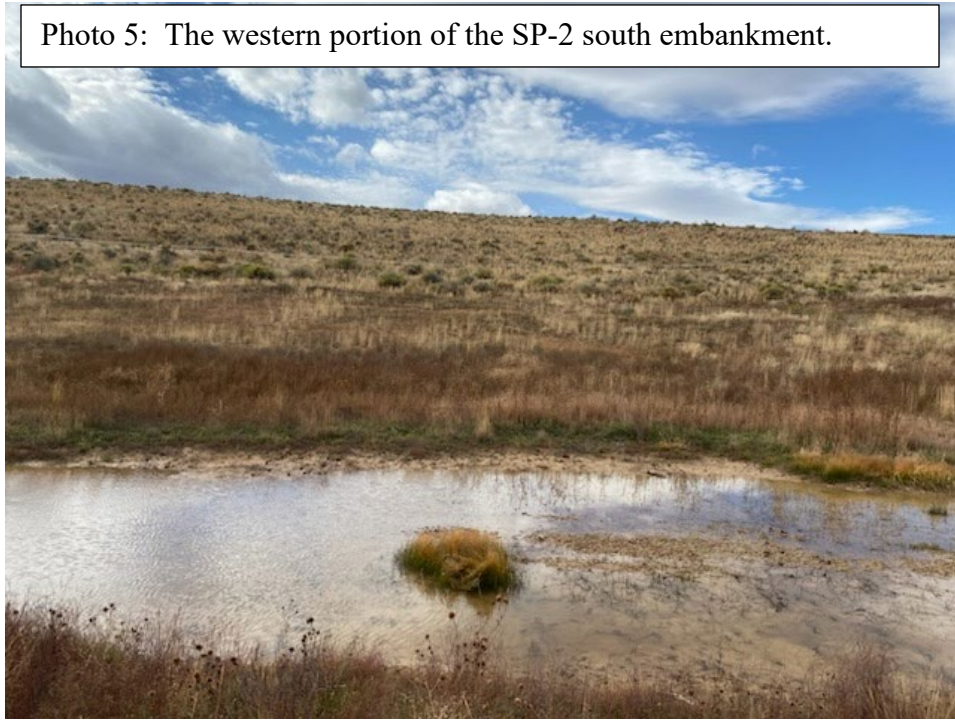
The SP-2 Stock pond was reduced in size and reclaimed to the approved post mining configuration in 2020. The southern embankment of the stock pond is located at the bottom of the adjacent hillside (Photo 5 and 6). The slope of the embankment was gentle approximately having an 8:1 slope as approved. The embankment slope was stable with vegetative cover. There were no erosional features identified. The eastern (Photo 7) and western (Photo 8) embankments of the stock pond were also identified to have vegetative cover supporting the embankments' stability. No indications of erosional features were observed. The east and west embankments matched the approved 3:1 slopes. The northern embankment for the stock pond is located on the down slope side of the hill. The slope of the embankment facing into the pond matched the approved slope of 4:1. The top of the embankment was flat and then the north facing portion of the north embankment started sloping gently, then increasing to match the approved 3:1 slope. The north embankment of the pond was stable with mature vegetative cover (Photo 9 and 10). There were no indications of erosional features. During the inspection of the SP-2 Stock Pond, no animal burrows, cracks, slumps or areas of saturated soils were observed. The SP-2 Stock Pond was holding water during the inspection. The level of water impounded in the pond was well below the pond's outlet. The outlet for the pond is located at the junction of the west and north embankments. The outlet is an open channel design with a depth of 5 feet and about 40 to 50 feet across the whole channel. The sides of the channel slope inwards to the channel bottom at an approximate rate of 3:1. The channel was stabilized with vegetative cover (Photo 11). The vegetation grown on the channel did not reduce the channel's capacity to function. There were no erosional; features observed within the channel structure. The inlet connecting the C-15 Ditch to the SP-2 Stock Pond is located at the junction of the west and south embankments of the SP-2 pond (Photo 12). The inlet for the pond was vegetated and stable. There were no indications of channel down-cutting or erosion identified. Based on the observations made during the inspection, the SP-2 Stock Pond has been reclaimed to the approved design outlined by Attachment 2.05.3(3)-39 and had sufficient vegetative cover to control and prevent erosion. The stock pond is capable of supporting the approved post mining land use to support the surrounding dry land pasture.

Photo 5: The western portion of the SP-2 south embankment.

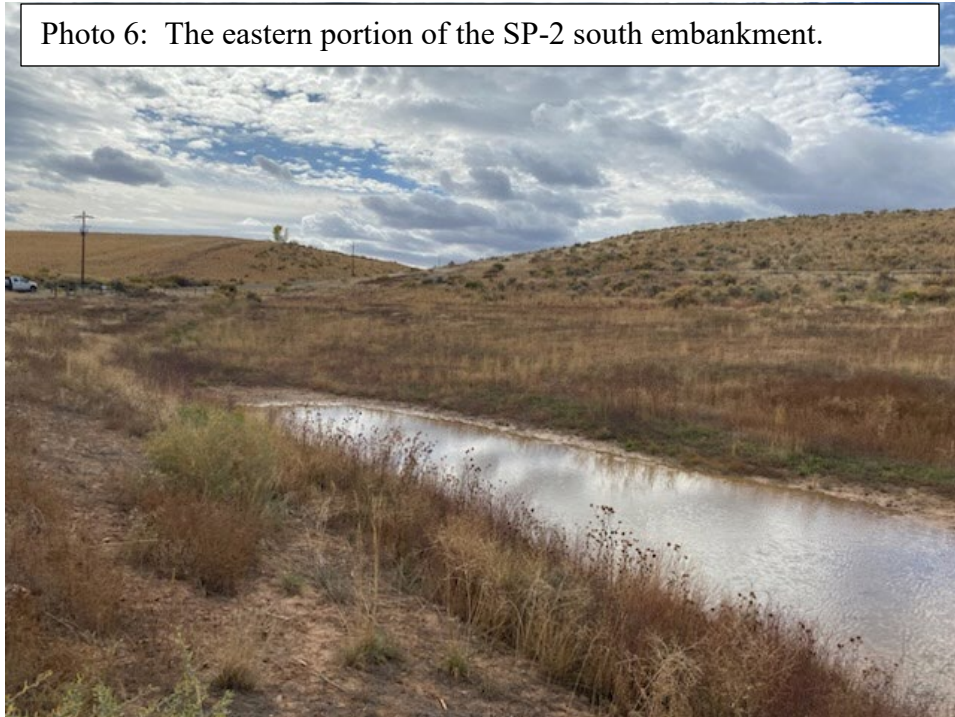
Photo 6: The eastern portion of the SP-2 south embankment.

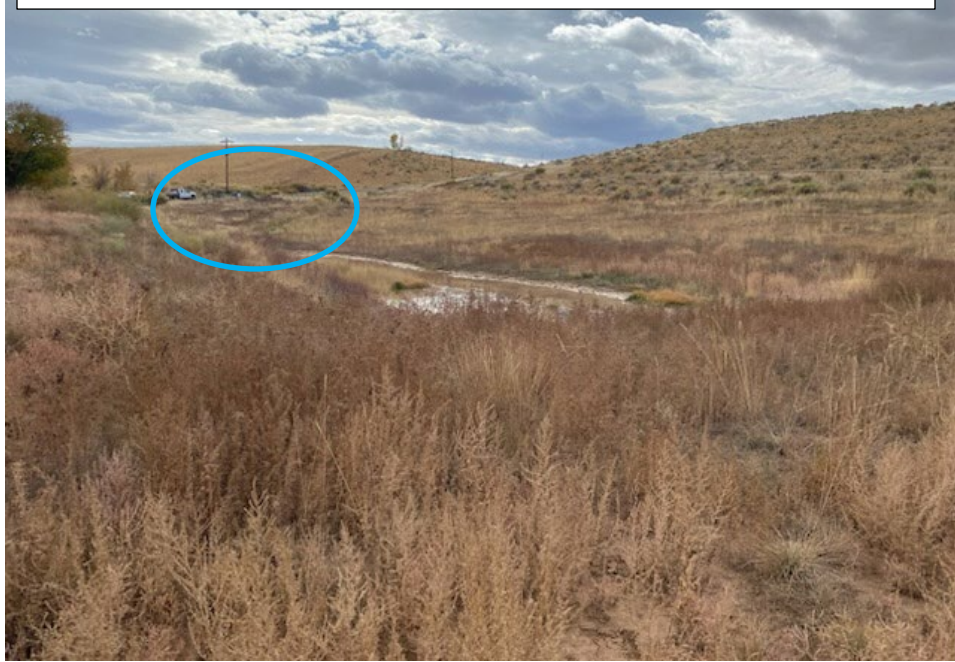
Photo 7: The east SP-2 embankment outlined in the blue circle.

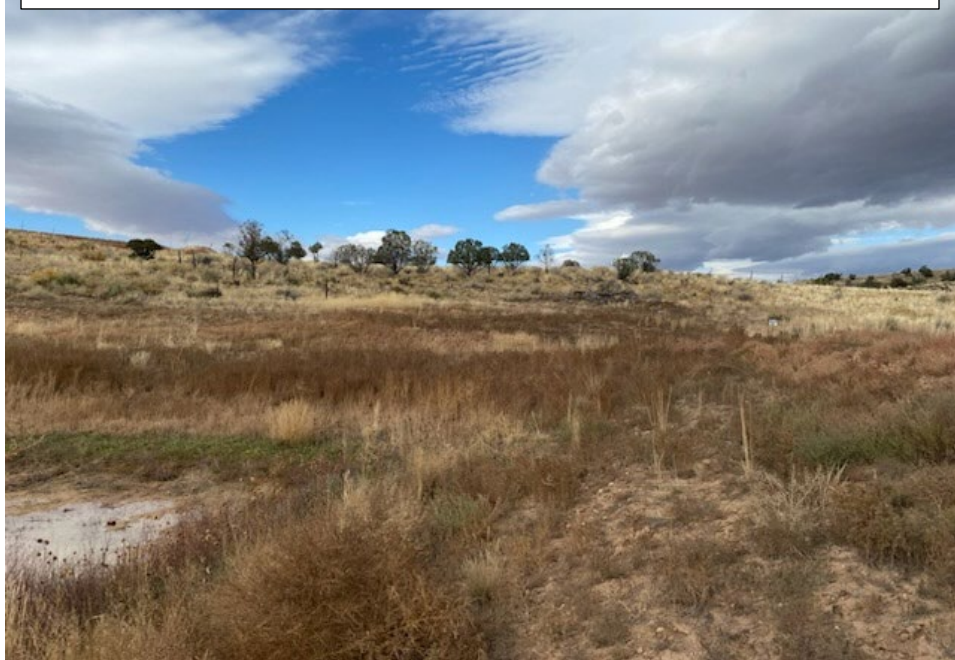
Photo 8: The west SP-2 embankment.

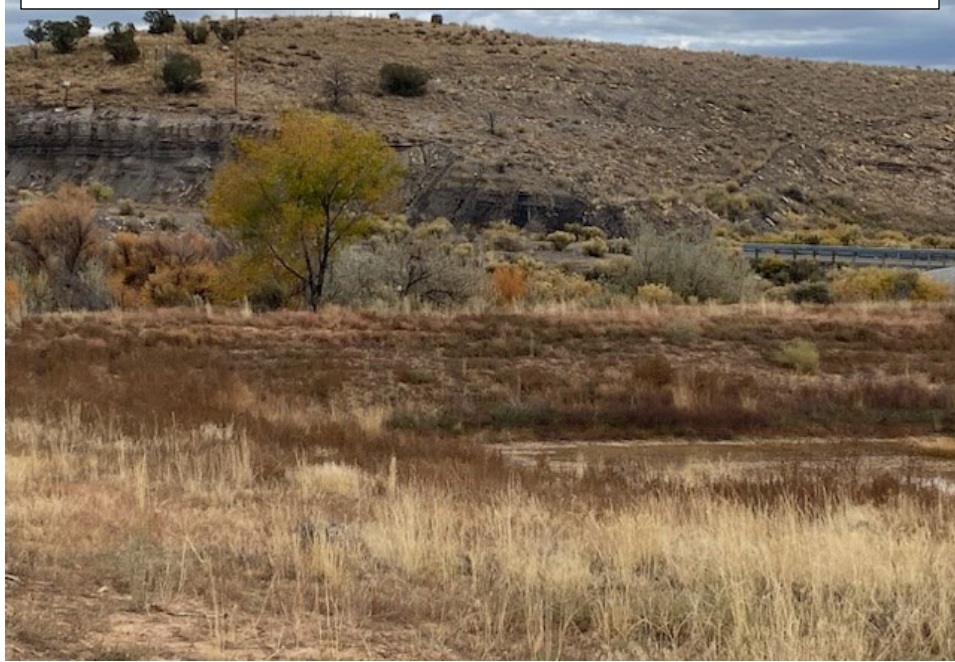
Photo 9: The western portion of the SP-2 north embankment.

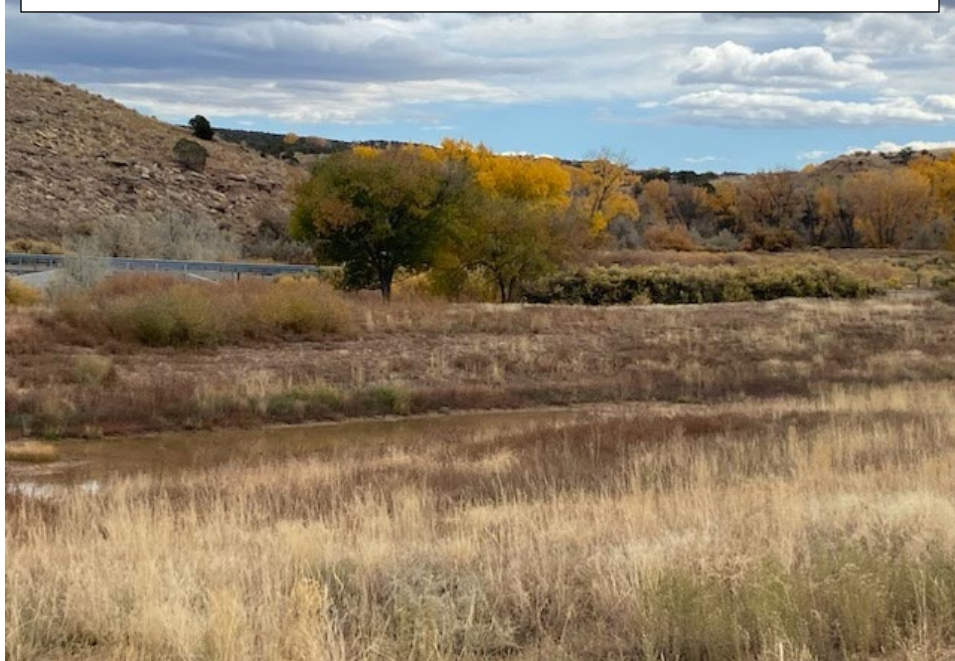
Photo 10: The eastern portion of the SP-2 north Embankment.

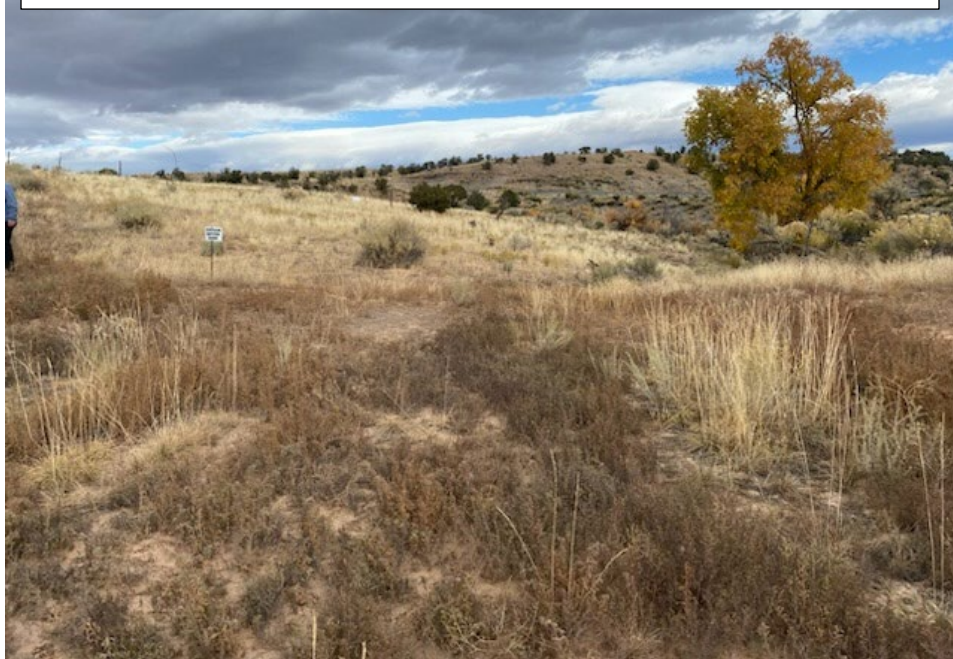
Photo 11: The discharge outlet for SP-2.

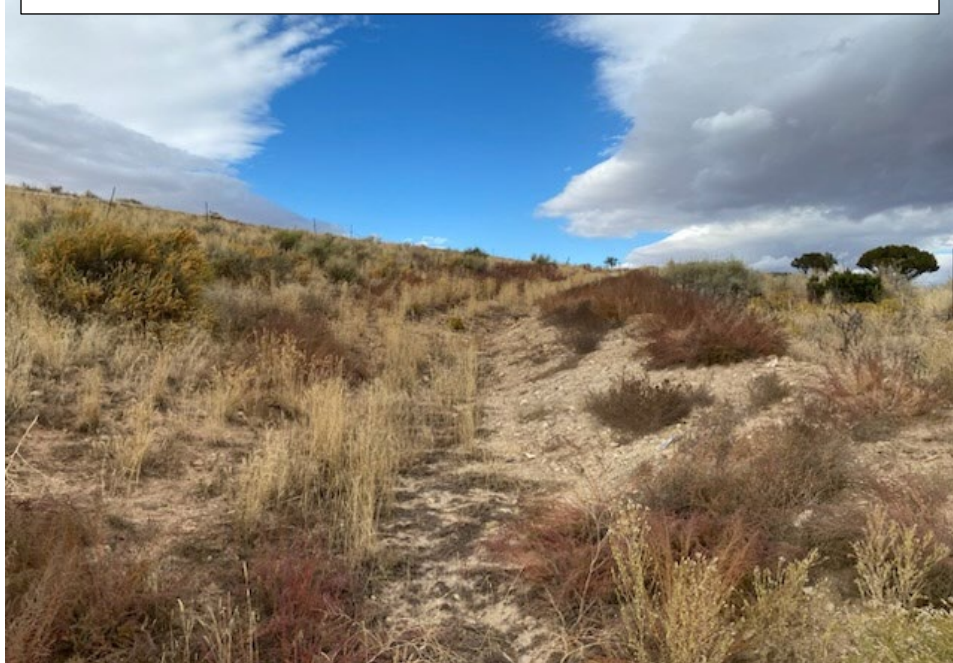
Photo 12: The inlet to the SP-2 Stock Pond.
