MINERALS PROGRAM INSPECTION REPORT
PHONE: (303) 866-3567

MINE NAME: East Douglas Pit	MINE/PROSPECTING ID#: M-1987-103	MINERAL: Sand and gravel	COUNTY: Rio Blanco
INSPECTION TYPE: Monitoring	WEATHER: Clear	INSP. DATE: October 24, 2023	INSP. TIME: 11:50
OPERATOR: Kilgore Companies LLC dba Elam Construction	OPERATOR REPRESENTATIVE: None	TYPE OF OPERATION: 110c - Construction Limited Impact	
REASON FOR INSPECTION: Normal I&E Program	BOND CALCULATION TYPE: Complete Bond	BOND AMOUNT: \$38,227.67	
DATE OF COMPLAINT: NA	POST INSP. CONTACTS: DRMS	JOINT INSP. AGENCY: U.S.BLM	
INSPECTOR(S): Amy Yeldell	INSPECTOR'S SIGNATURE:

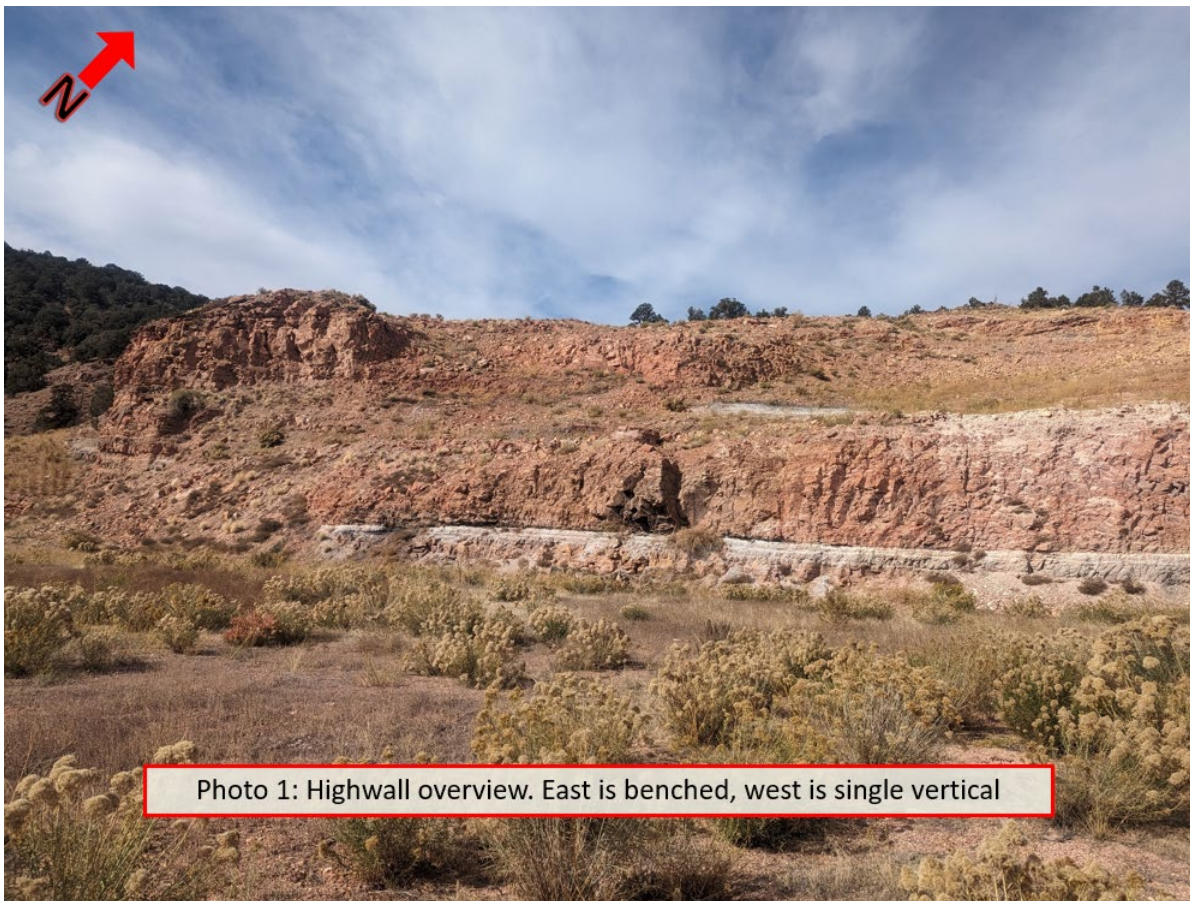
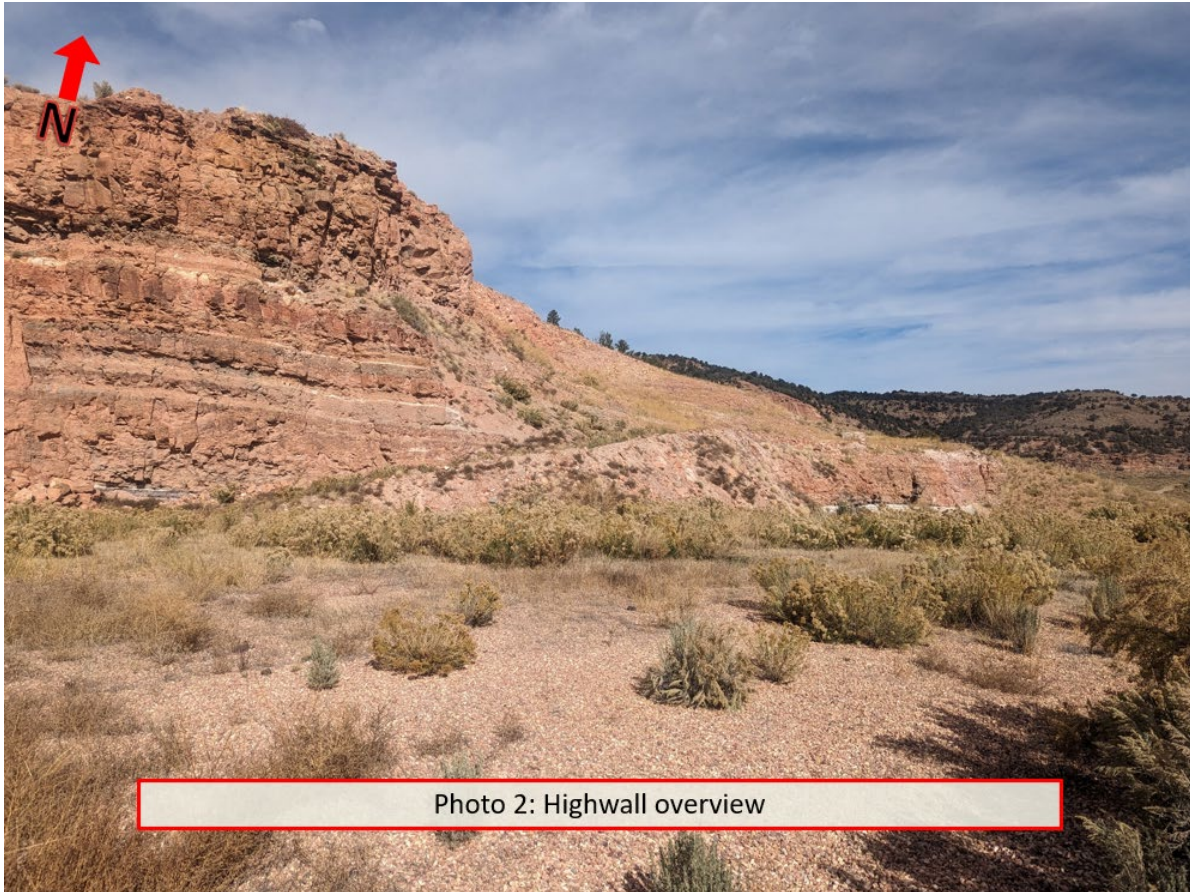
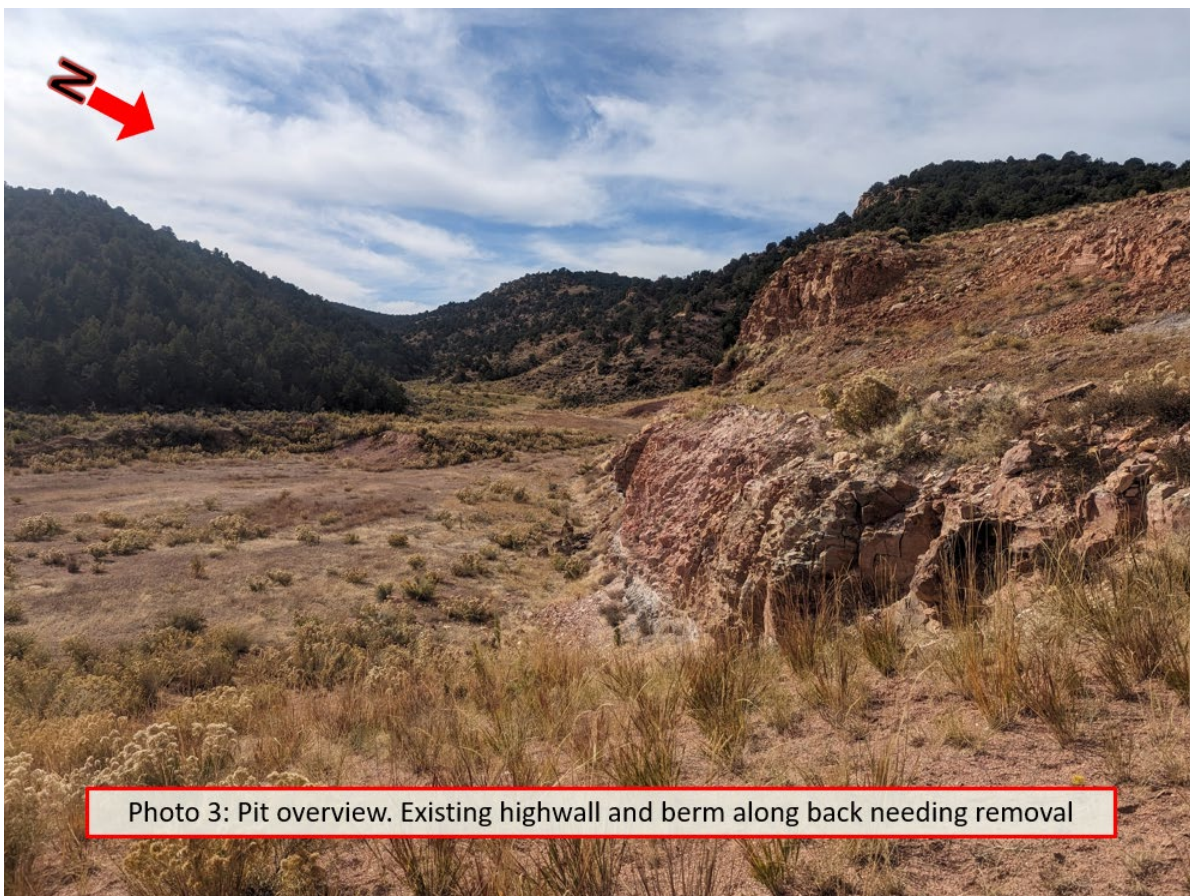
The main highwall is approximately 500 feet wide. The east (right side) has a series of benches while the west(left) side is a near vertical rock outcrop (Photo One-Three). The post mine land configuration is a series of benches approximately 20 foot high by 15 foot deep with the highwall on the northwest corner and a flat pad below. Along the south side is a flat graded out area with a 10 foot tall by 200 foot long highwall that is near vertical. This material would get graded out flat onto the pit floor and presumably is topsoil. A small previously reclaimed area on the west side of the permit will require additional grading. And along the south adjacent to the creek is a berm that will need to be blended out. All disturbed areas will need to be decompacted prior to topsoil and revegetation.

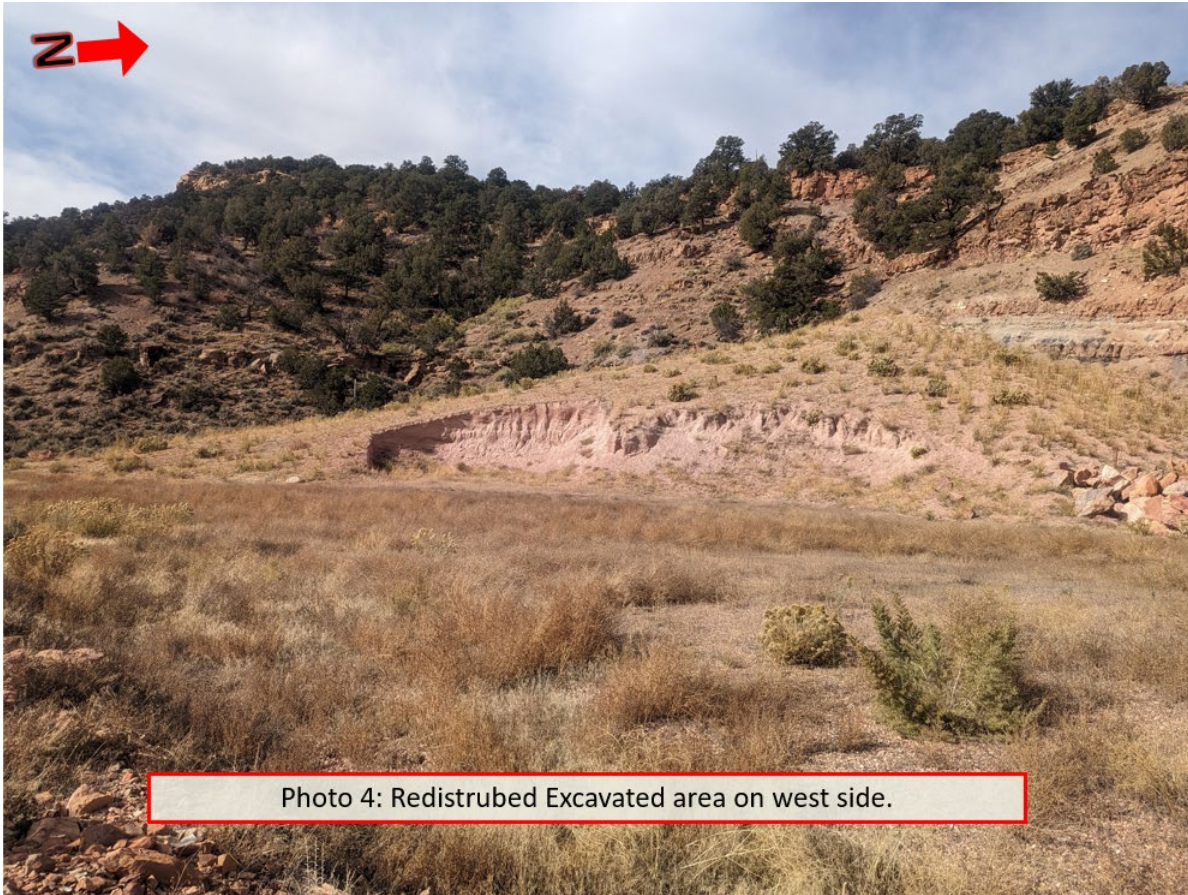
Much of the pit floor and other flat areas have self-reclaimed during the extended period between use. A small area on the far west appeared to be previously reclaimed was disturbed (Photo Four). Per the approved reclamation plan all "flat" areas will be topsoiled and revegetated while leaving near vertical rock bench highwalls bare. The pad floor has lots of well-established Rabbit Brush with some Russian Thistle and Mullen identified (Photo Five). Weeds are not cited as a problem at this time but noxious weeds should be treated to avoid a potential infestation.

Photo 4: Redistrubed Excavated area on west side.

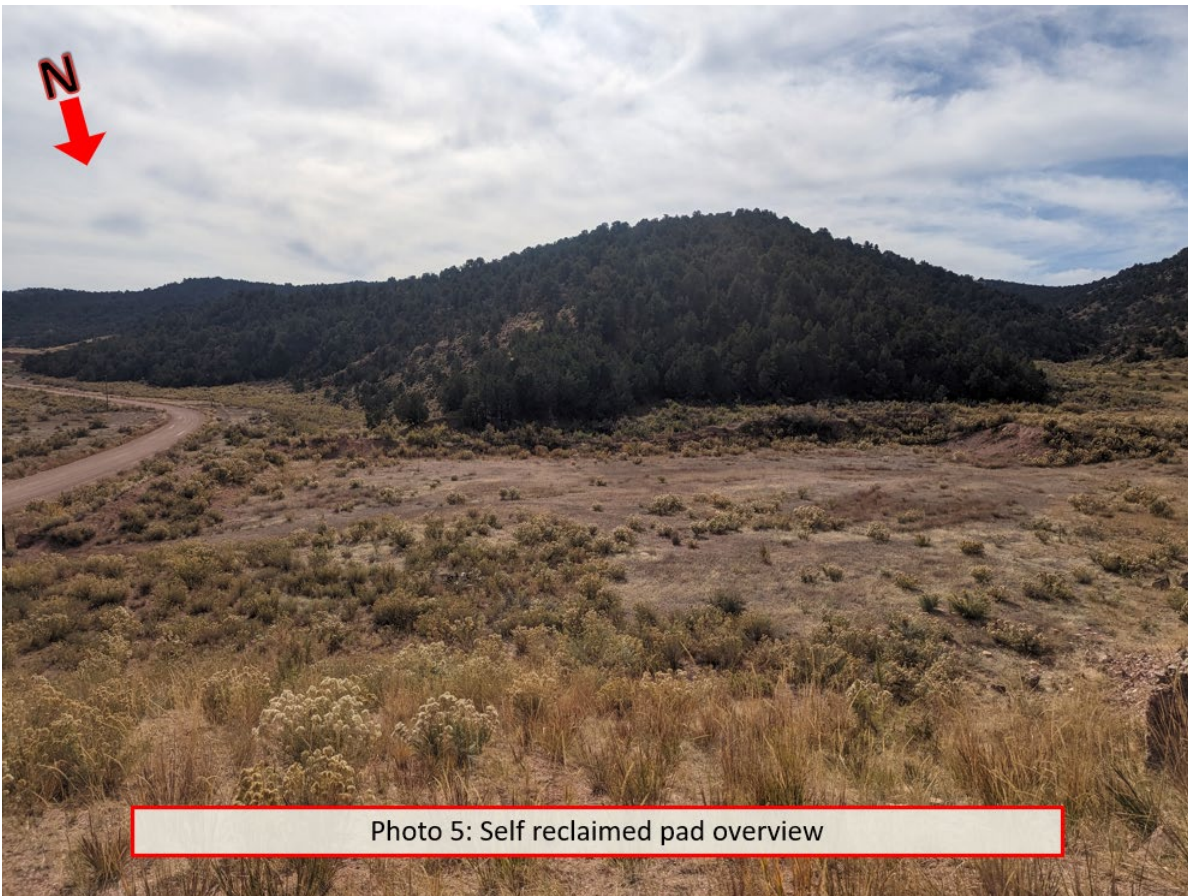
Photo 5: Self reclaimed pad overview

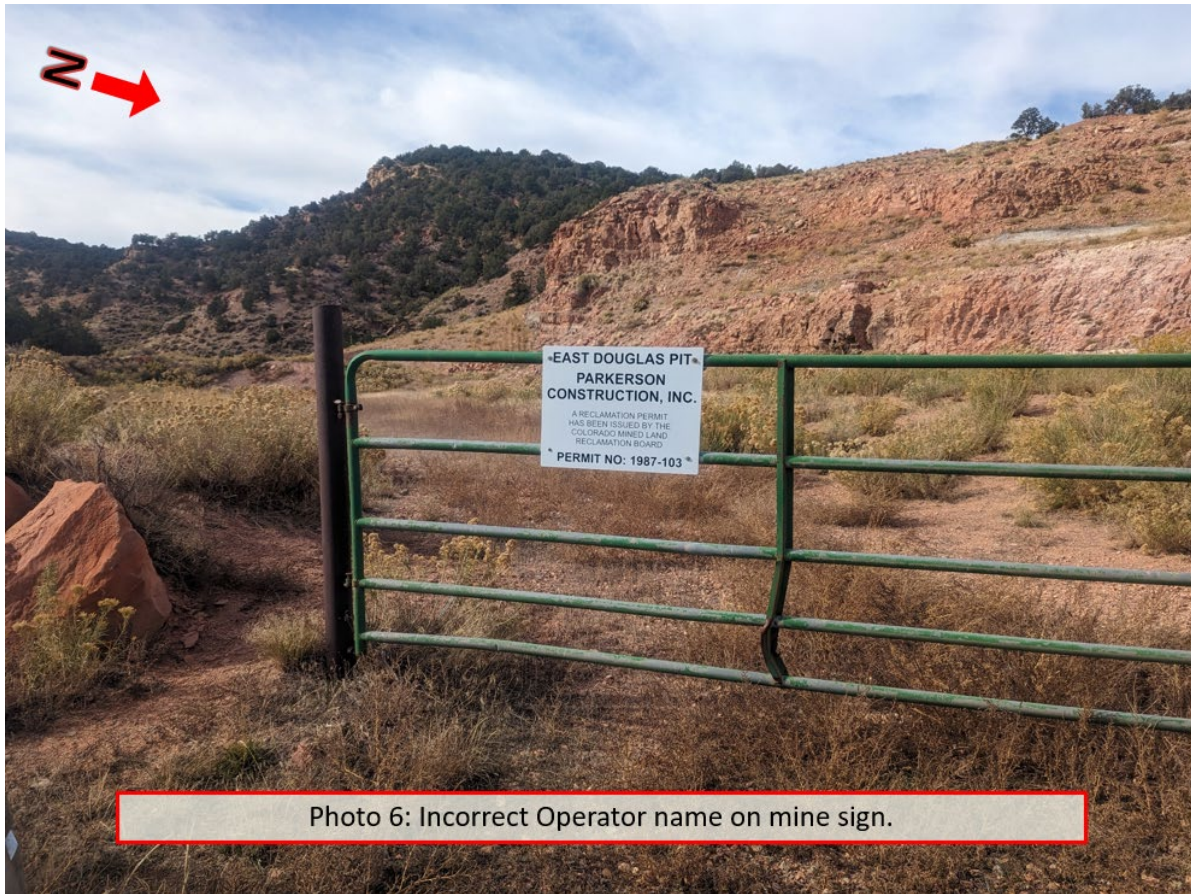
PROBLEM: The mine identification sign posted at the entrance of the mine site was incorrect. This is a problem for failure to post a mine identification sign as required by Section 3.1.12(1) of the rule. The Operator shall, at the entrance of the mine site post a sign, which shall be clearly visible from the access road, with a minimum size equaling one hundred and eighty-seven (187) square inches, such as eleven (11) inches in height and seventeen (17) inches in width, with appropriate font size, with the following: the name of the Operator, a statement that a reclamation permit for the operation has been issued by the Colorado Mined Land Reclamation Board; and the permit number.

A mine sign was posted at the entrance to the mine site as required by Rule 3.1.12(1). The information depicted was incorrect as it still displays the previous Operators name (Photo Six). This is cited as an inspection problem. By the corrective action date please submit to the Division photo documentation that the mine sign has been update to reflect the current Operators name. The permit boundary of the affected land was clearly delineated by t-post with white PVC sleeves as required pursuant to Rule 3.1.12(2).

CORRECTIVE ACTIONS: The operator shall, at the entrance of the mine site, post/update a sign which shall be clearly visible from the access road with the following: the name of the operator, a statement that a reclamation permit for the operation has been issued by the Colorado Mined Land Reclamation Board; and the permit number. The operator shall submit photo documentation that a proper sign has been posted by the corrective action date.
