**MINERALS PROGRAM INSPECTION REPORT**  
**PHONE: (303) 866-3567**

<b>MINE NAME:</b> BLM Burnt Shale Pit	<b>MINE/PROSPECTING ID#:</b> M-1985-170	<b>MINERAL:</b> Sandstone (silica, stone, quartzite)	<b>COUNTY:</b> Garfield
<b>INSPECTION TYPE:</b> Monitoring	<b>WEATHER:</b> Clear	<b>INSP. DATE:</b> October 24, 2023	<b>INSP. TIME:</b> 14:20
<b>OPERATOR:</b> Colorado Department of Transportation	<b>OPERATOR REPRESENTATIVE:</b> Lee DeGraffenried	<b>TYPE OF OPERATION:</b> 110c - Construction Limited Impact	
<b>REASON FOR INSPECTION:</b> Normal I&E Program	<b>BOND CALCULATION TYPE:</b> None	<b>BOND AMOUNT:</b> \$0.00	
<b>DATE OF COMPLAINT:</b> NA	<b>POST INSP. CONTACTS:</b> DRMS	<b>JOINT INSP. AGENCY:</b> None	
<b>INSPECTOR(S):</b> Amy Yeldell	<b>INSPECTOR'S SIGNATURE:</b>

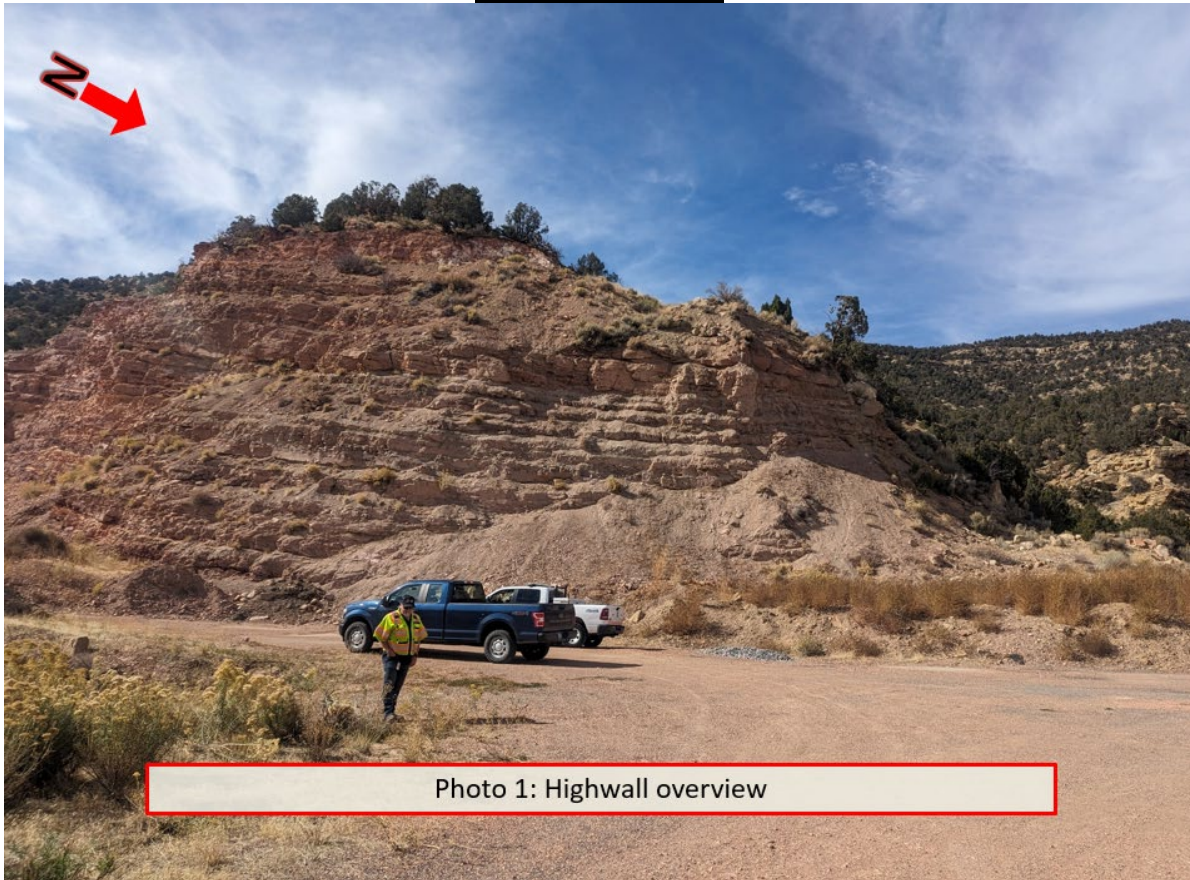
For the most part mining is still contained within the original permit boundary. Highwalls remain near vertical and have changed very little if at all as compared to the previous inspection. Material is removed from the rock outcrop moving in a west and southwest direction. Overall the site is stable with no erosion.

Photo 1: Highwall overview

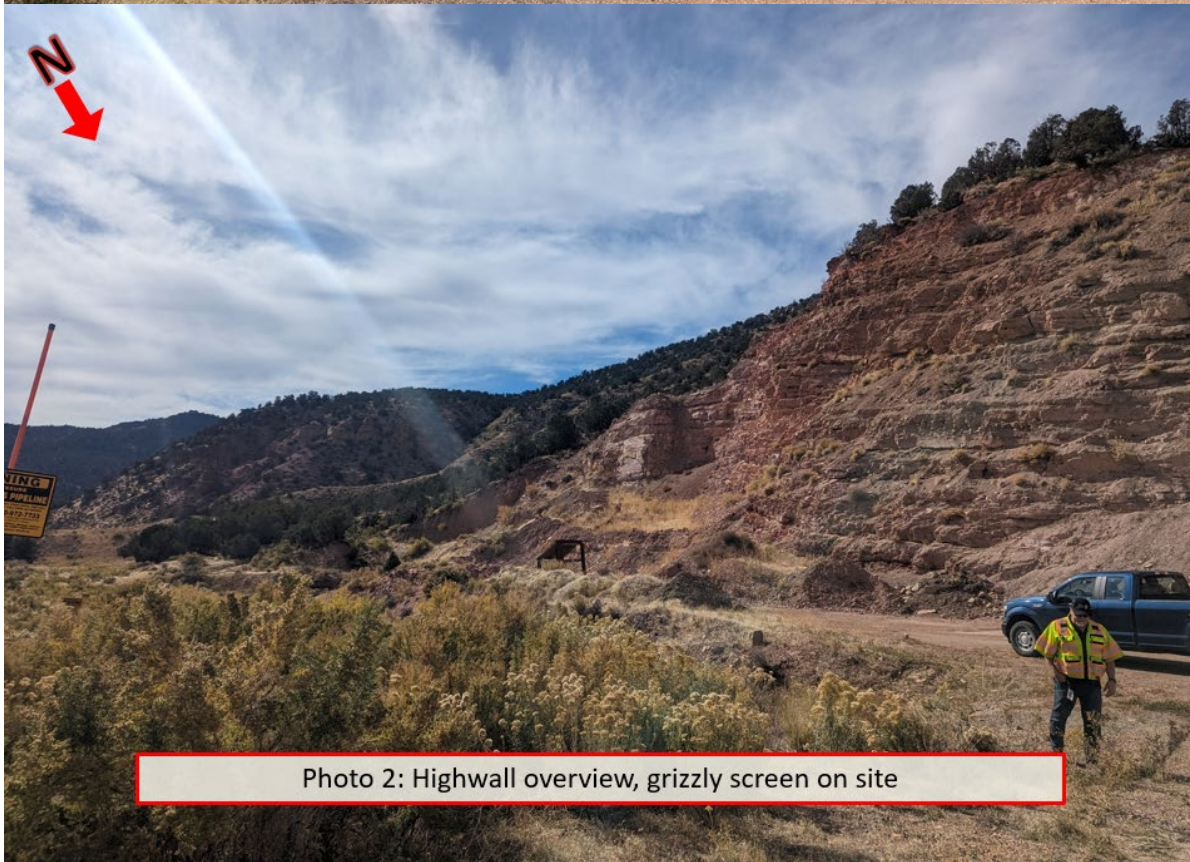
Only screening and crushing of rock takes place on site. A grizzly bar screen was observed on site. No washing of material occurs at this location. No cement or asphalt production is approved. All equipment used at this pit is portable. No equipment is currently site.

Photo 2: Highwall overview, grizzly screen on site

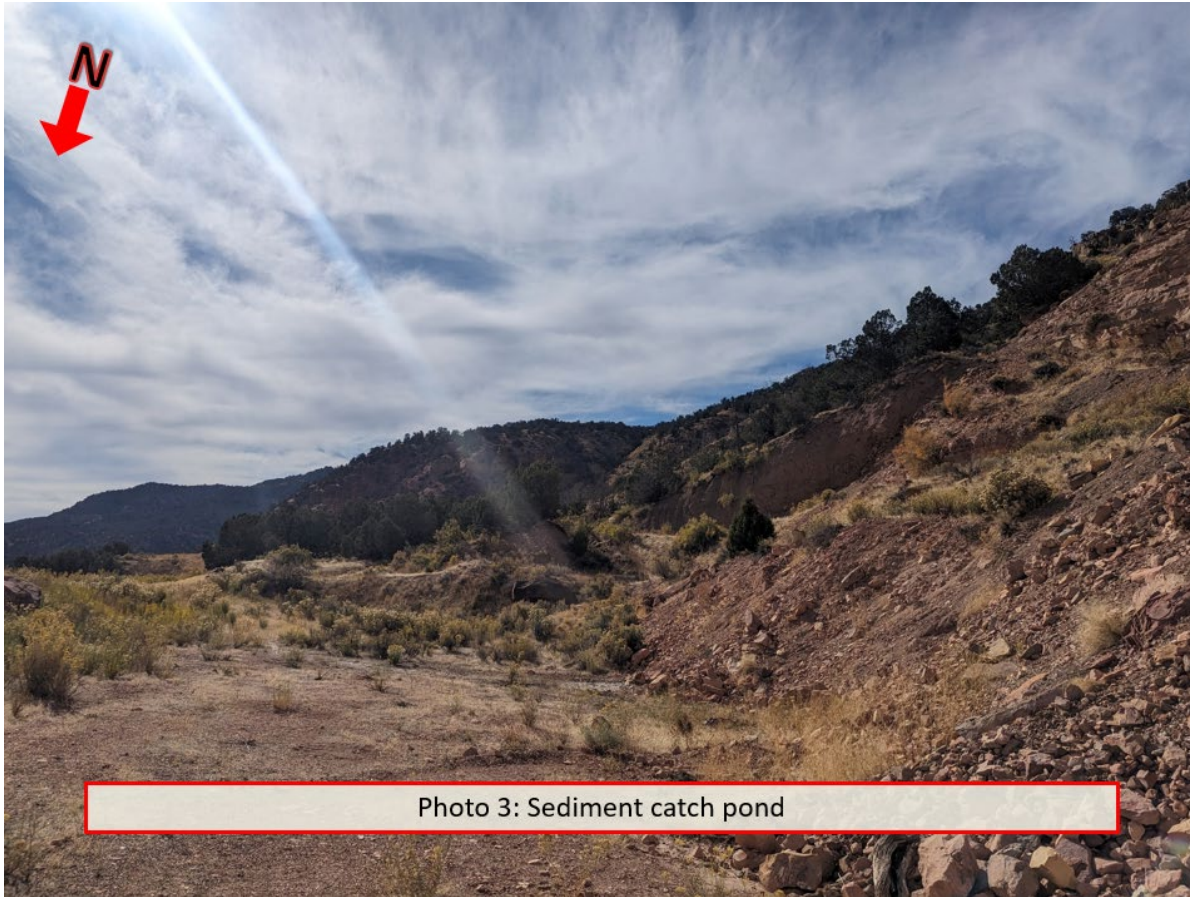
No exposed groundwater was observed. No water is used to process material at this site. A large depression served as a sediment catch pond on the east side of the pit.

Photo 3: Sediment catch pond

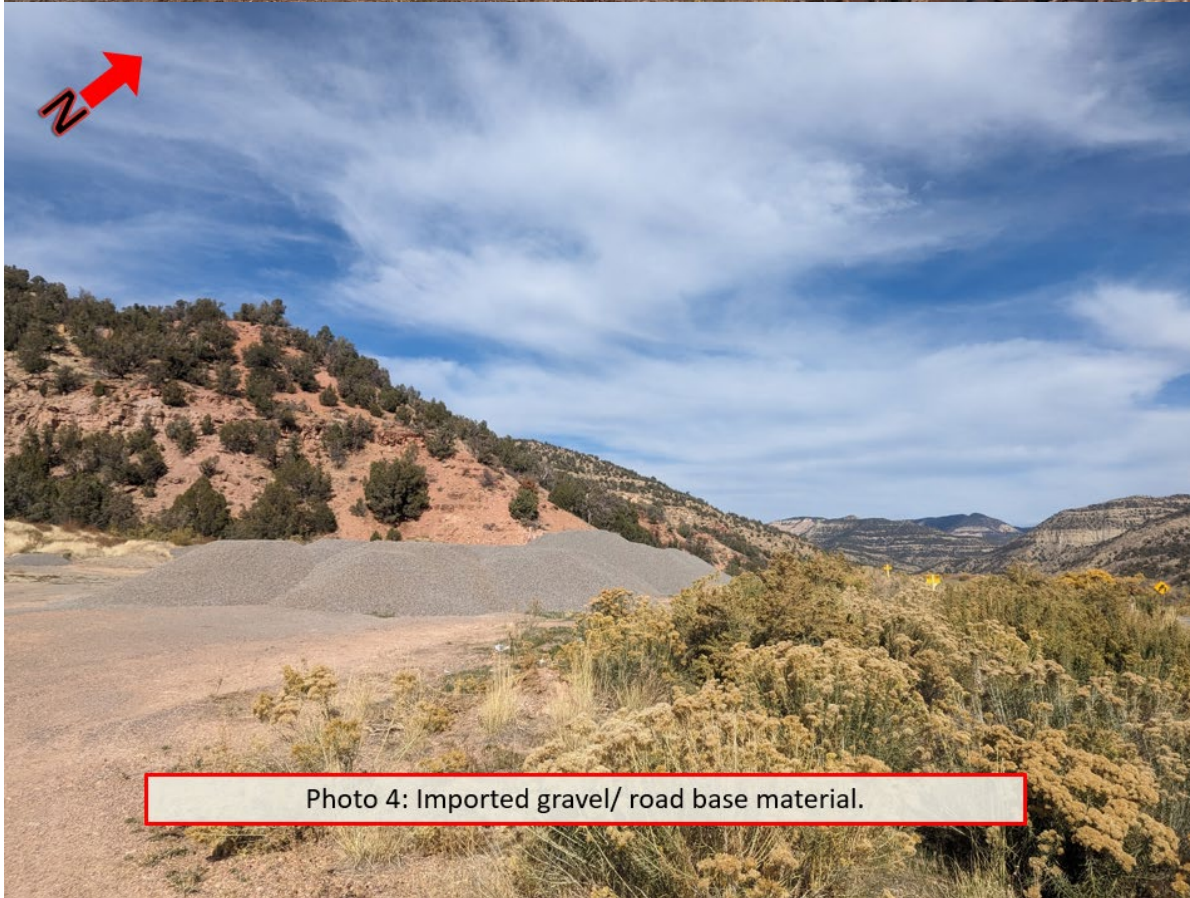
Imported road base material is stored on the northern side of the affected lands.

Photo 4: Imported gravel/ road base material.
