MINERALS PROGRAM INSPECTION REPORT

MINE NAME: Gold Hill Mill	MINE/PROSPECTING ID#: M-1994-117	MINERAL: Gold and silver	COUNTY: Boulder
INSPECTION TYPE: Preoperation Inspection	WEATHER: Clear	INSP. DATE: October 24, 2023	INSP. TIME: 09:00
OPERATOR: Colorado Milling Company, LLC	OPERATOR REPRESENTATIVE: Ben Langenfeld and Lewis Perkins	TYPE OF OPERATION: 110(2) - Hard Rock Limited Impact

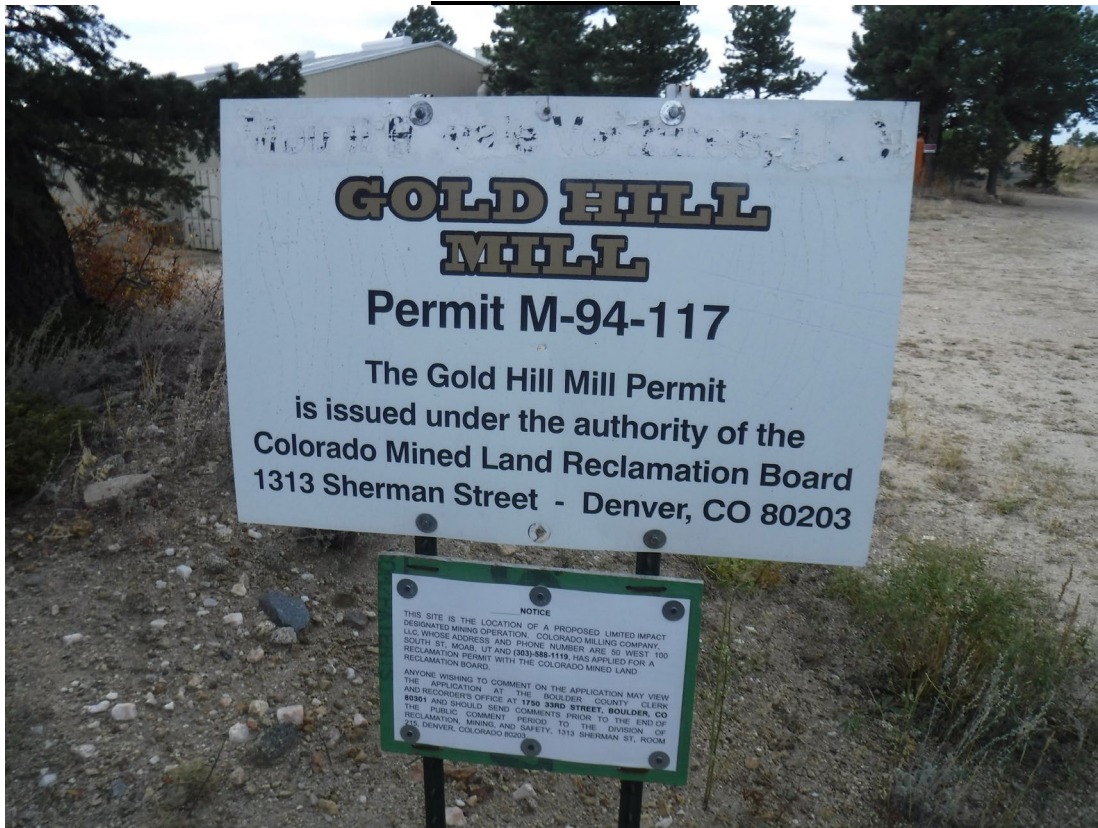
Photo 1: Mine sign at primary mine entrance and DMO Notice sign

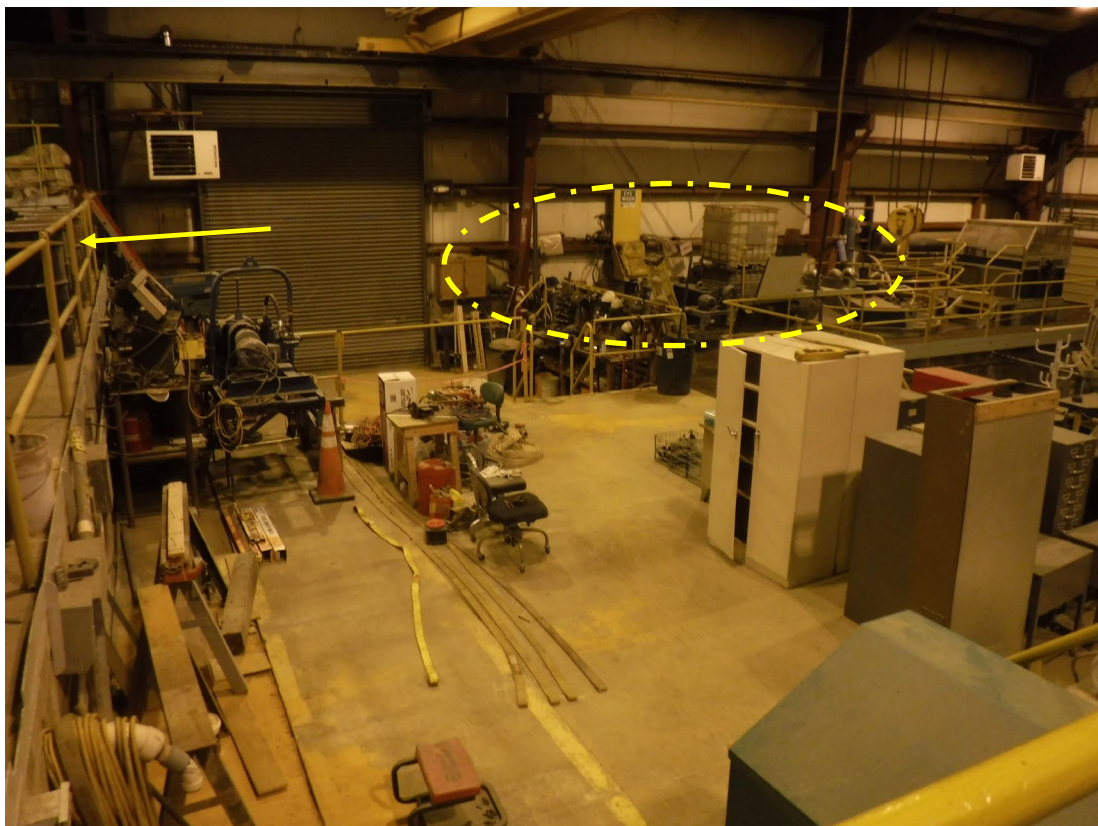
PROBLEM: Improper storage and presence of hazardous materials on site. During the inspection, 2 barrels of Xanthate, a half pallet of Soda Ash, one barrel of MIBC, several frothing and flotation agents and a few unlabeled containers were observed without secondary containment.

Photo 2: Inside the mill, yellow arrow shows the location of the Xanthate drum and circle shows the location of other chemicals

CORRECTIVE ACTIONS: All storage tanks, petroleum and any hazardous materials on site for any period of time shall have appropriate secondary containment. The operator shall provide photo documentation that all hazardous material containers have been removed from the site on or before the corrective action date. Additionally, the Operator shall provide documentation that the hazardous materials have been properly disposed of at a certified disposal facility.

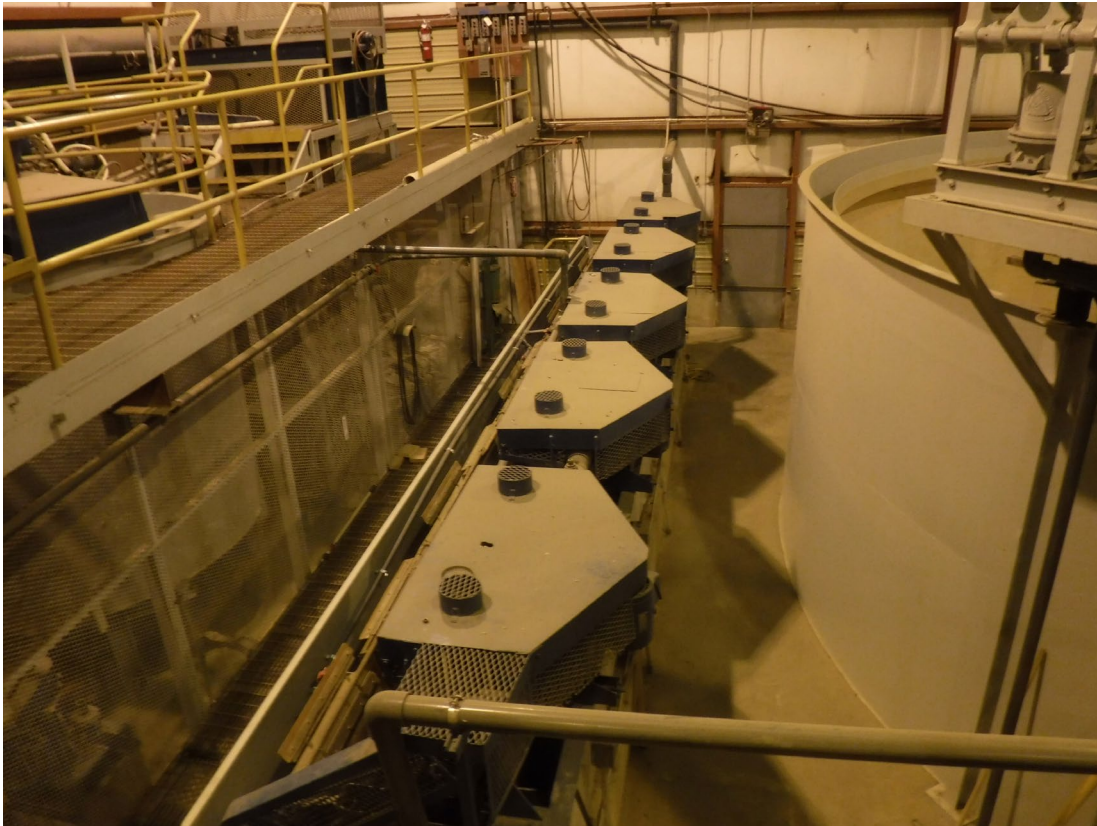
During the tour of the Mill building it was noted there was not adequate secondary containment for any of the vessels in the building. There were numerous floor drains where the precise outfall was unknown. A man door on the lowest floor did not fully seal and is located adjacent to the Gravity Process Thickener, Floatation Cells and Tailing Slurry Line. Located at the bottom of the Gravity Process Thickener there is a floor drain that is accessed by a ladder and exits out the bottom of the building through a small door way.

Photo 3: Frother heads and gravity thickener (right) the man door (center right) does not completely seal

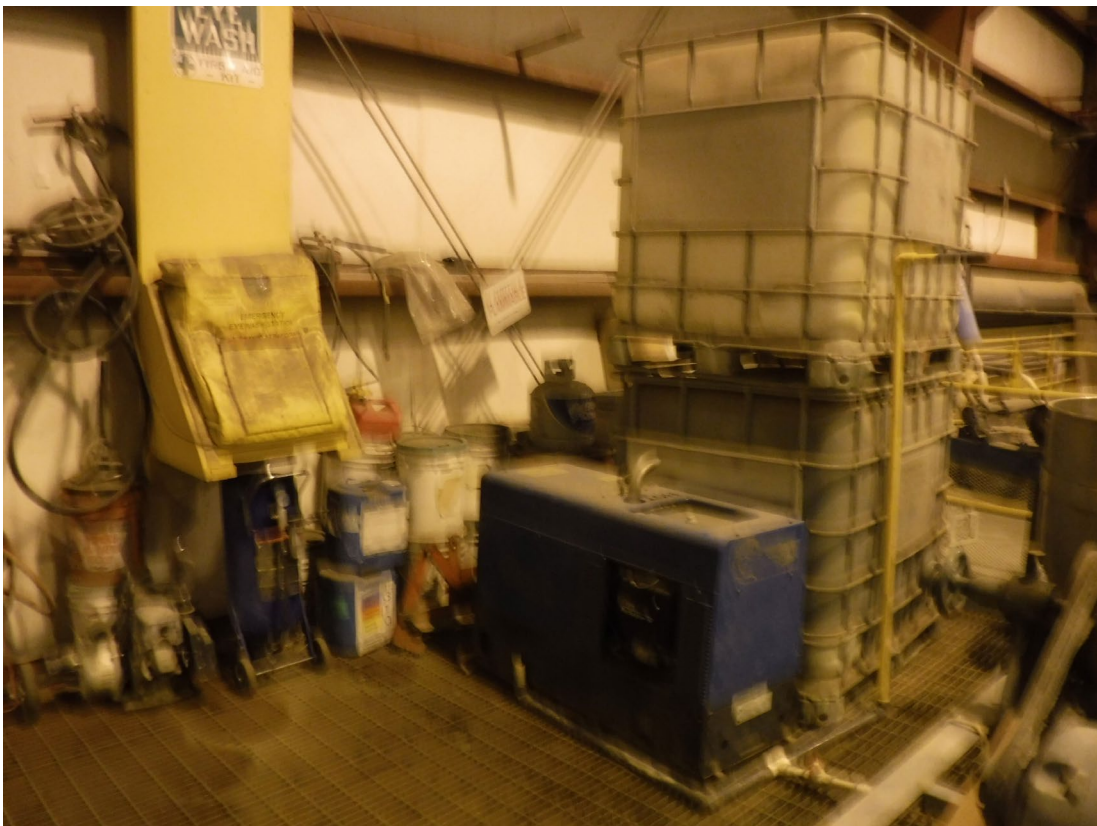
Photo 4: Location where other chemicals were stored, blurry photo due to low light conditions

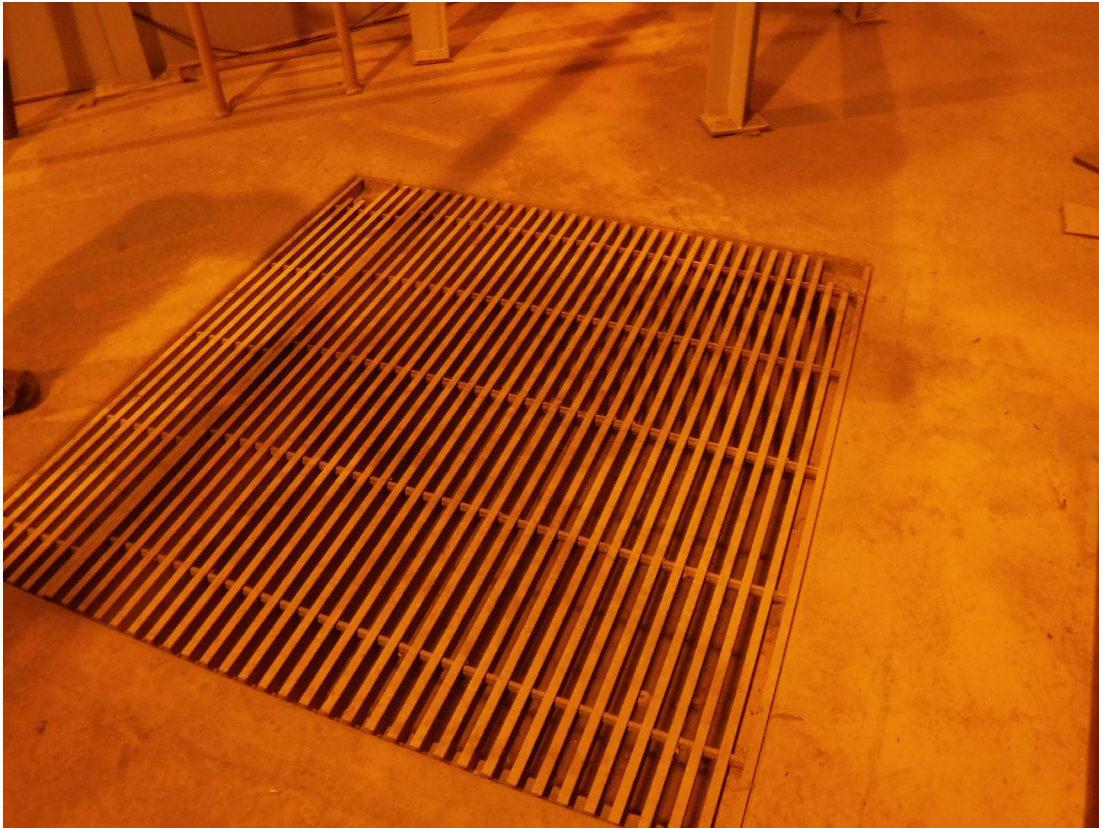
Photo 5: Floor drain in mill building, undetermined if it had an outlet or not

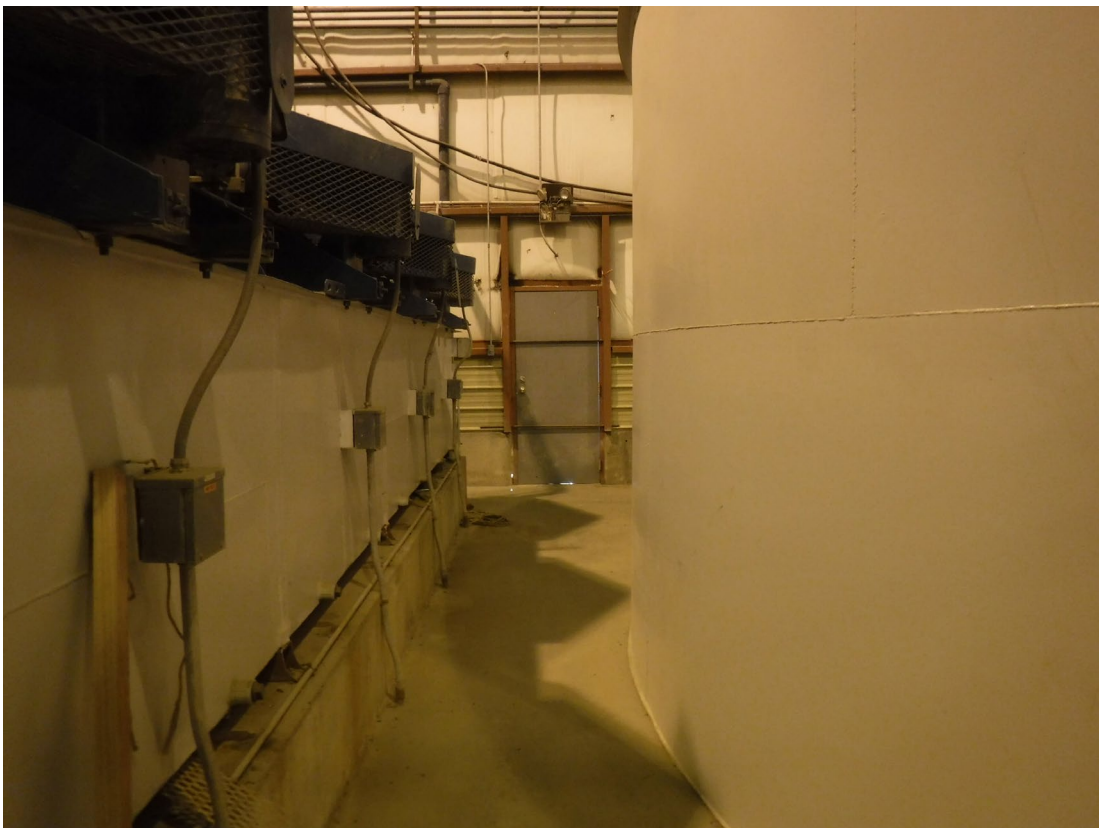
Photo 6: Man door on the lowest level of mill building not completely sealing

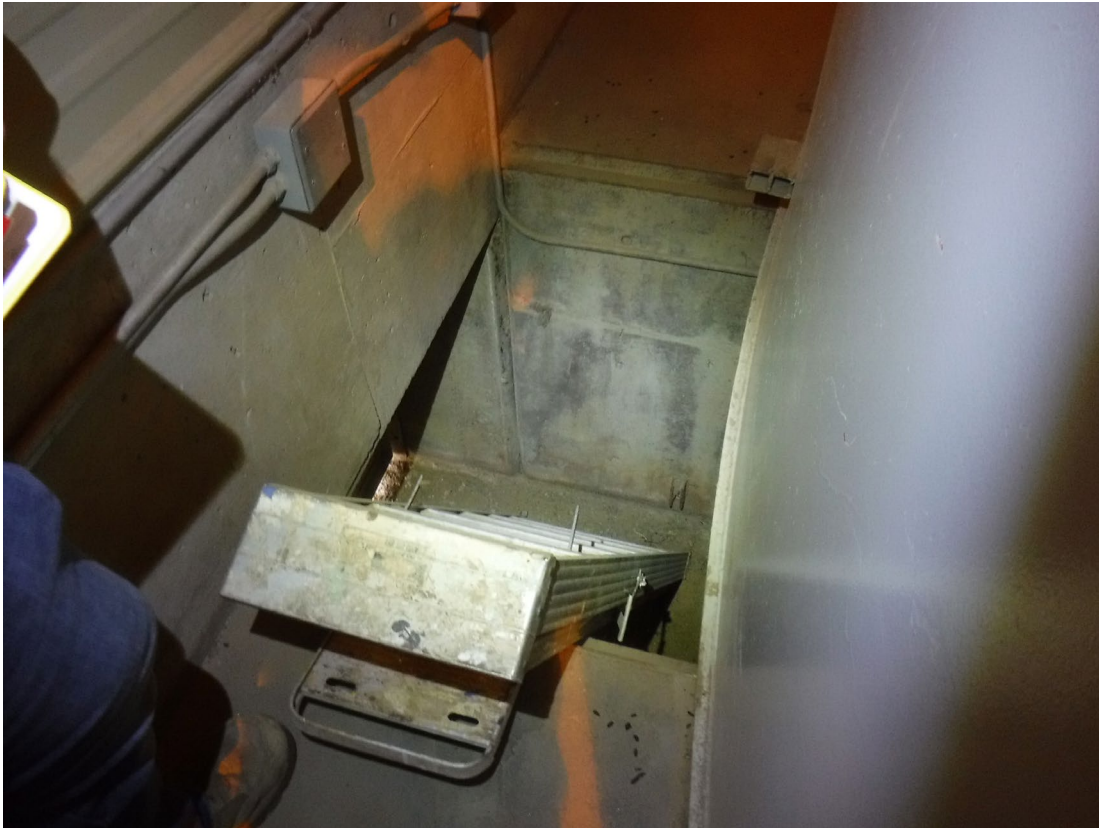
Photo 7: Drain located at the bottom of the Gravity Process Thickener, door to the left of the ladder exits the building

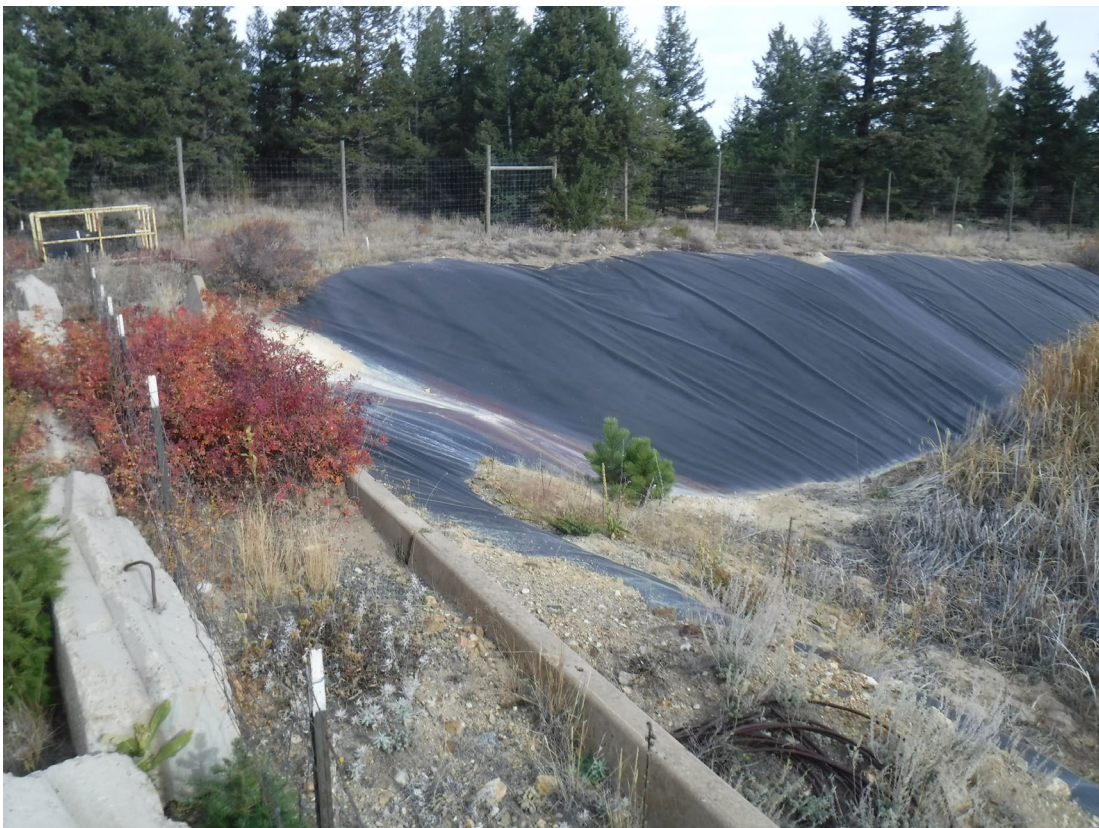
During the Tailings Storage Facility (TSF) inspection it was noted that there was woody vegetation (small coniferous trees) growing inside the TSF and along the anchor trench location. Moving around the TSF counterclockwise the Division noted animal burrows within the tailings material near the southern most portion. Animal burrows were also found along the southern portion of the TSF between the fence and the top of liner. Burrows were also noted outside of the fence as well.

Photo 8: Woody vegetation growing in the TSF and the red bush to the left of photo is growing in the approximate location of the anchor trench

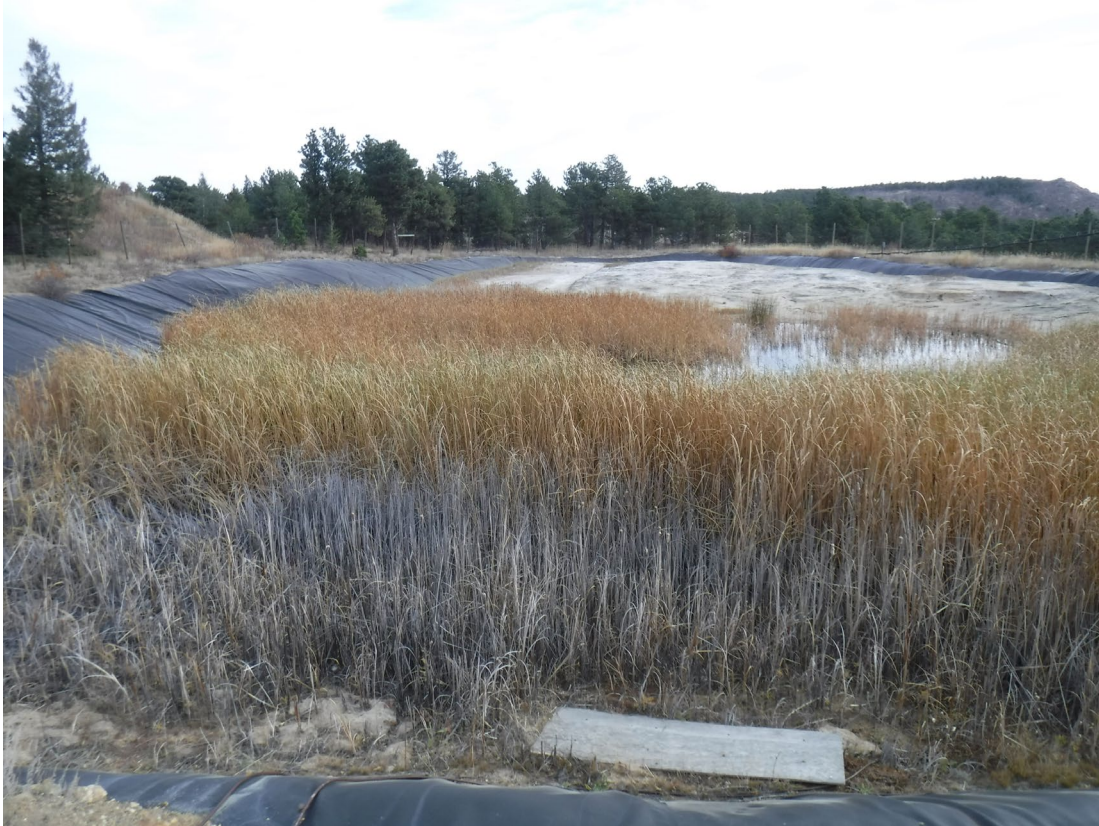
Photo 9: Vegetation growing in the TSF looking east

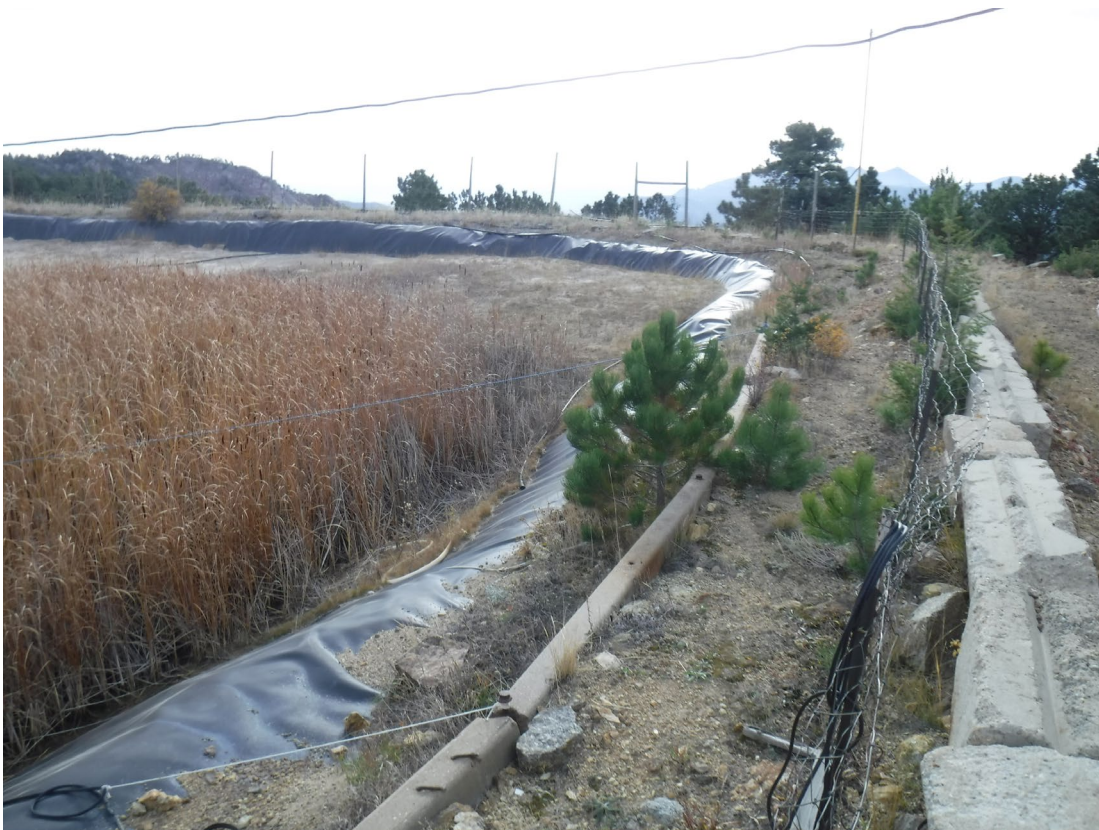
Photo 10: Vegetation growing in the anchor trench of the TSF, looking south

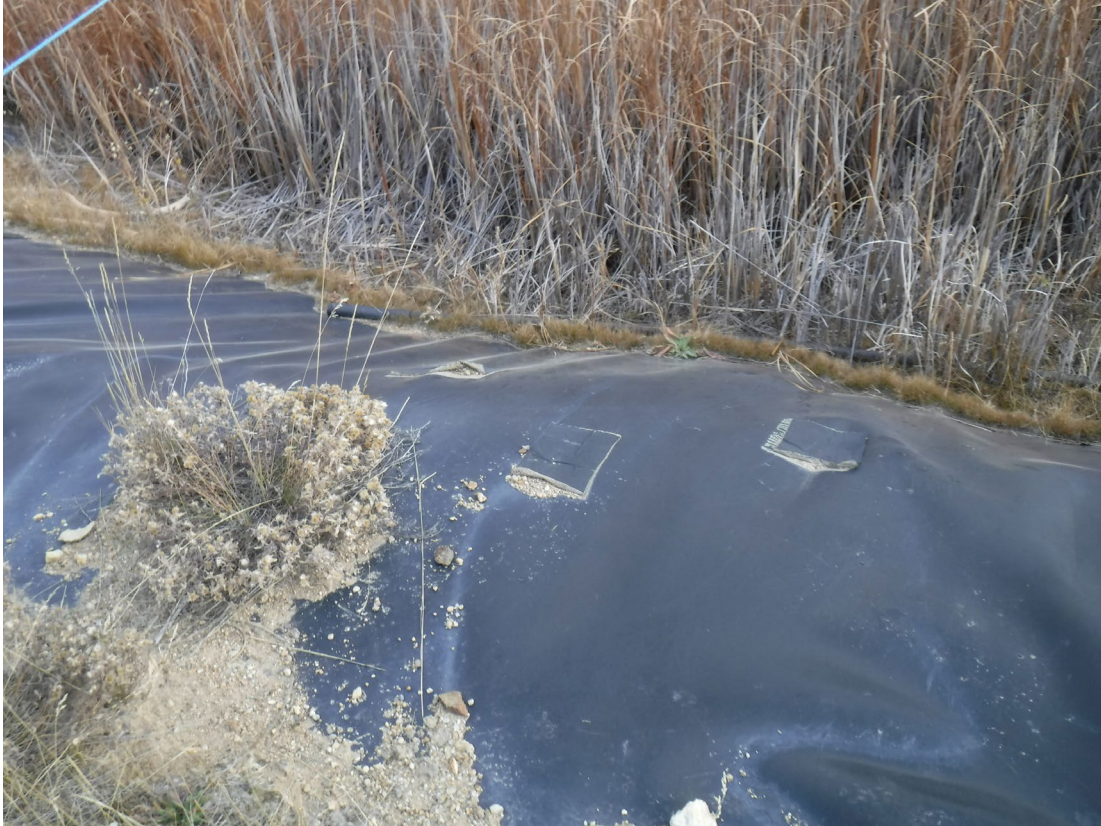
On the exposed portions of the liner the Division noted several locations where it appears patches on the liner are peeling away. Additionally, numerous cracks and tears through the liner were noted. In the eastern most area of the TSF there is patch (~ 6 inches by ~3 inches) that has peeled away and exposed the embankment material below. The Division measured the approximate depth from this patch to the tailings material in the TSF and found that it was less than 12 inches. The Division measured other areas around the TSF to determine how much available freeboard there was and found depth to tailings material varied but appeared to be 2 feet or less. In one location there was two feet of freeboard but only a foot of depth from where there was a crack through the liner.

Photo 11: Typical conditions of patches at the TSF

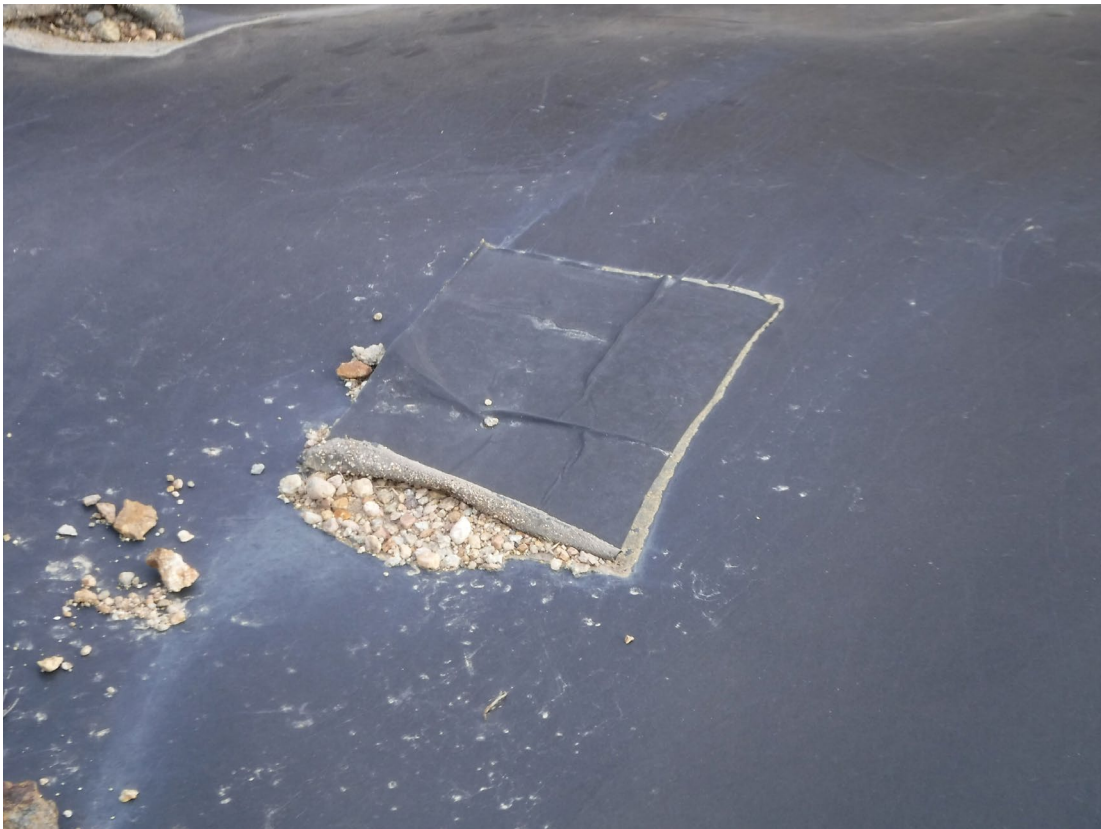
Photo 12: Close-up of patch, note peeling at edges

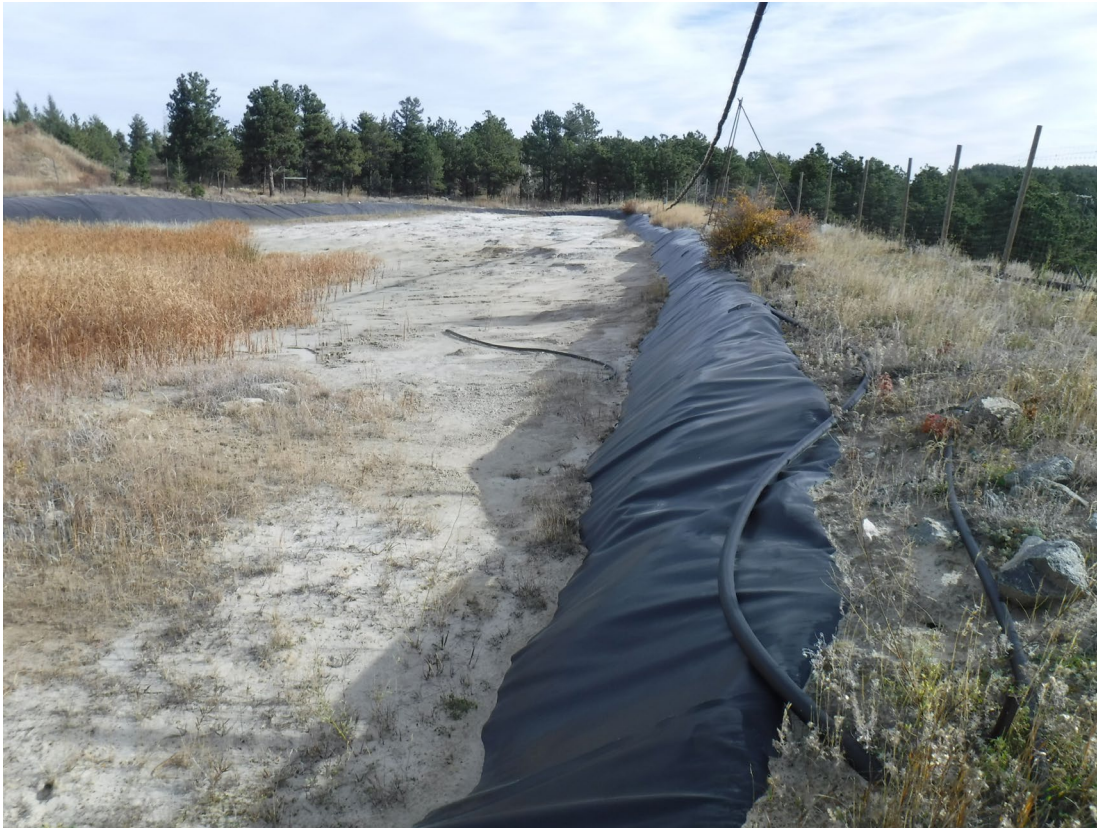
Photo 13: A view of the southern TSF embankment, looking NE, overhead line was used to deposit tailings into the pond

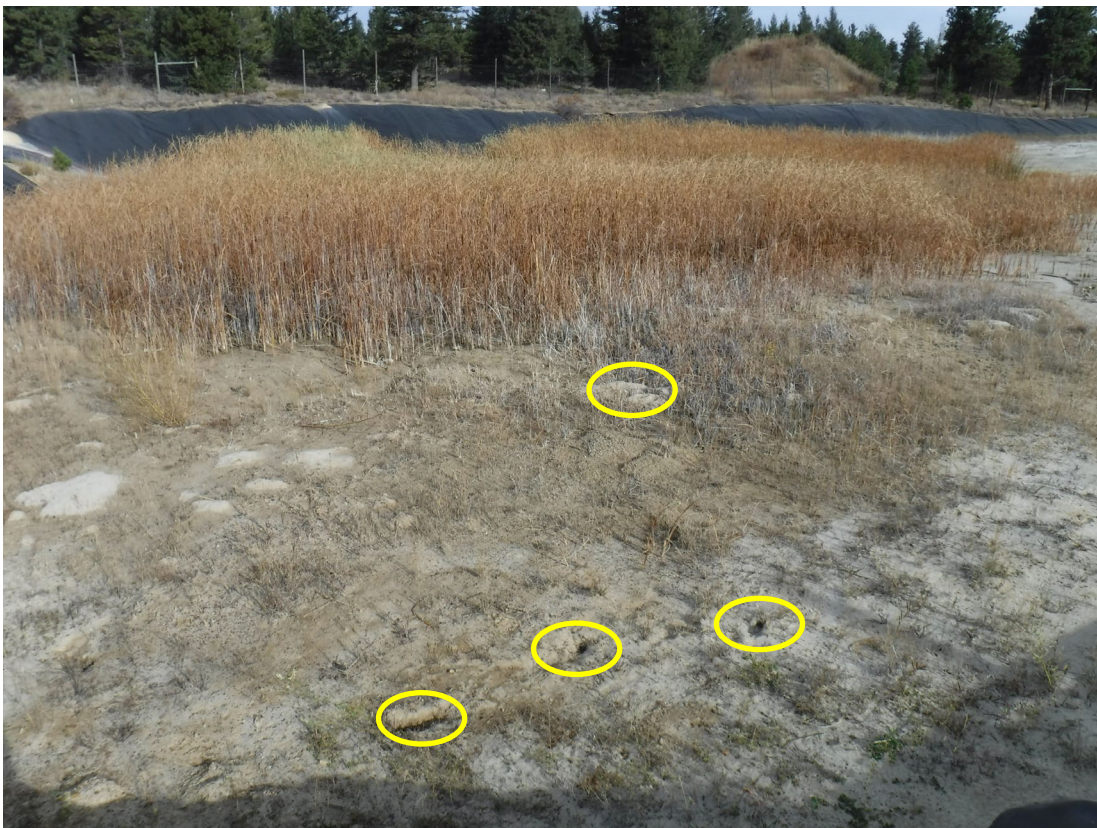
Photo 14: Animal borings in TSF

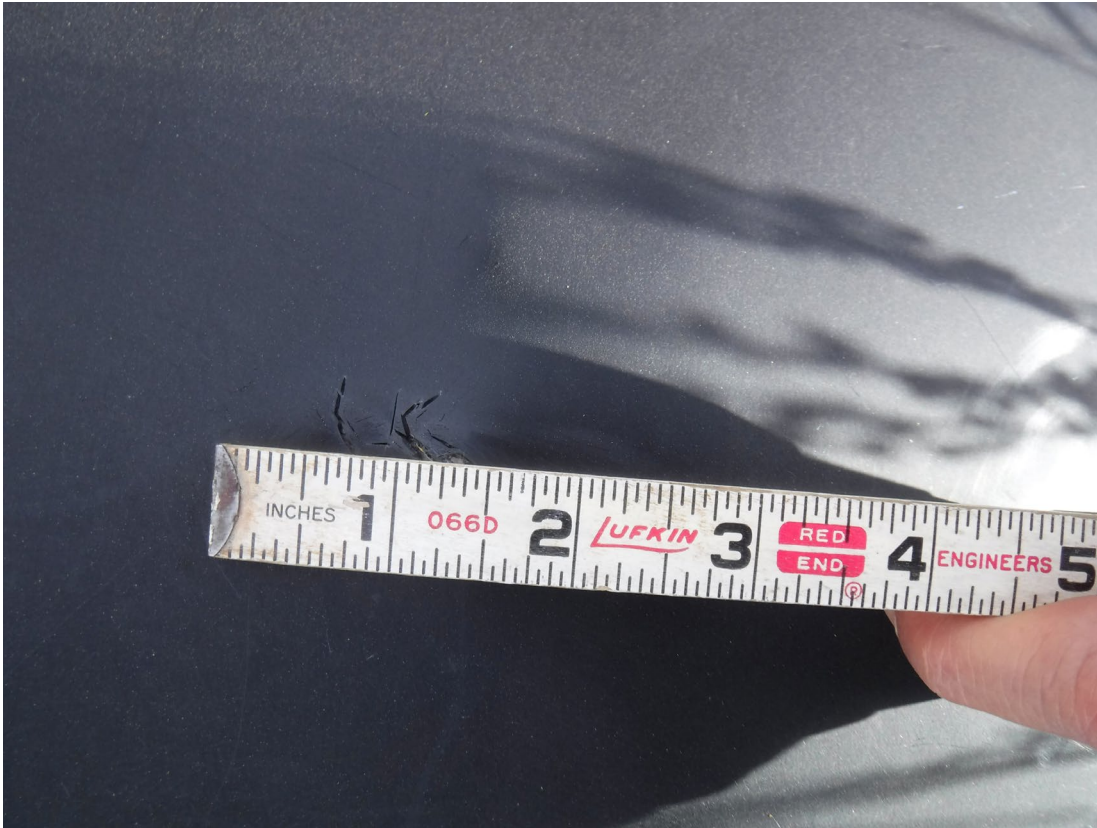
Photo 15: Typical crack in TSF liner

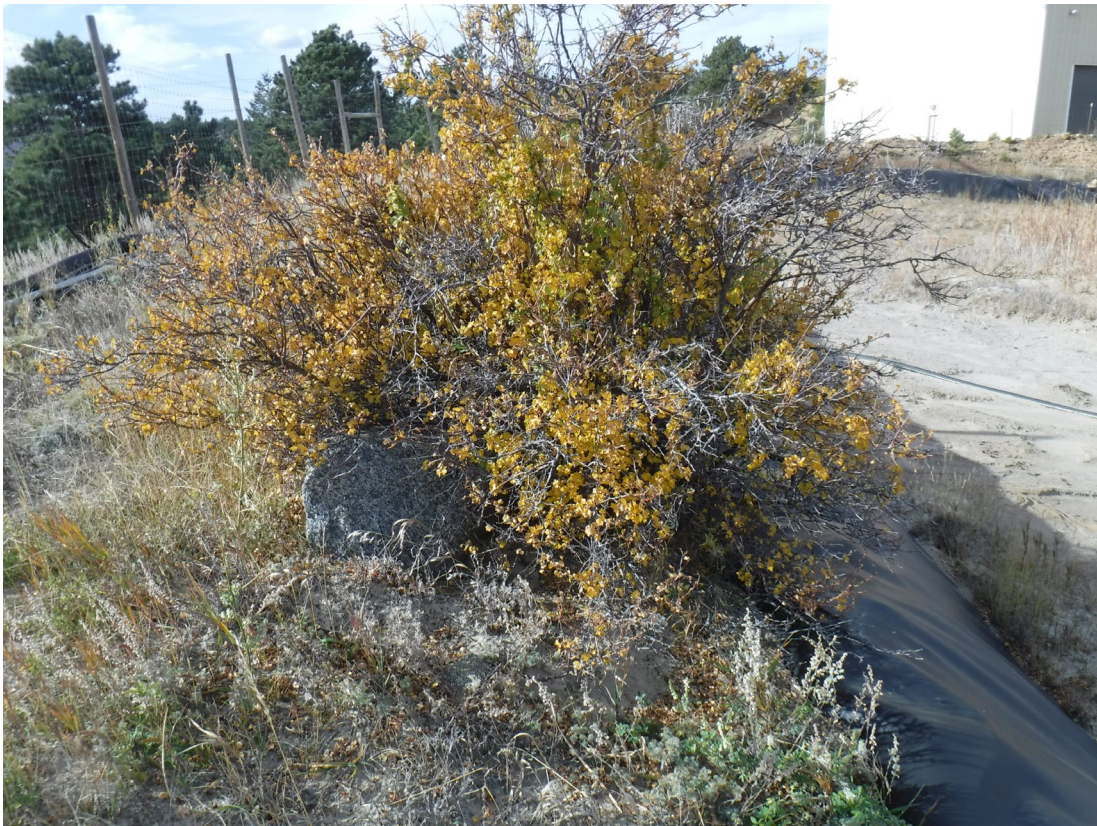
Photo 16: Vegetation growing in the anchor trench of the TSF, looking SW

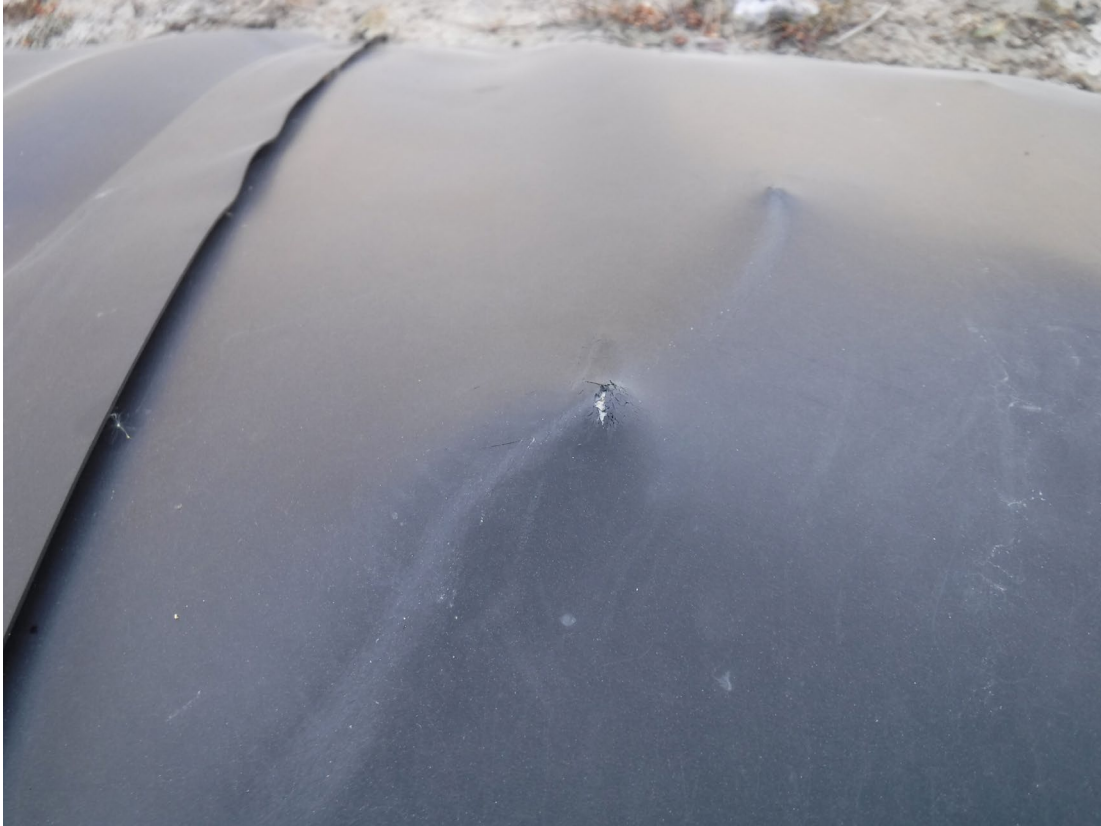
Photo 17: Crack in TSF liner with exposed subgrade material

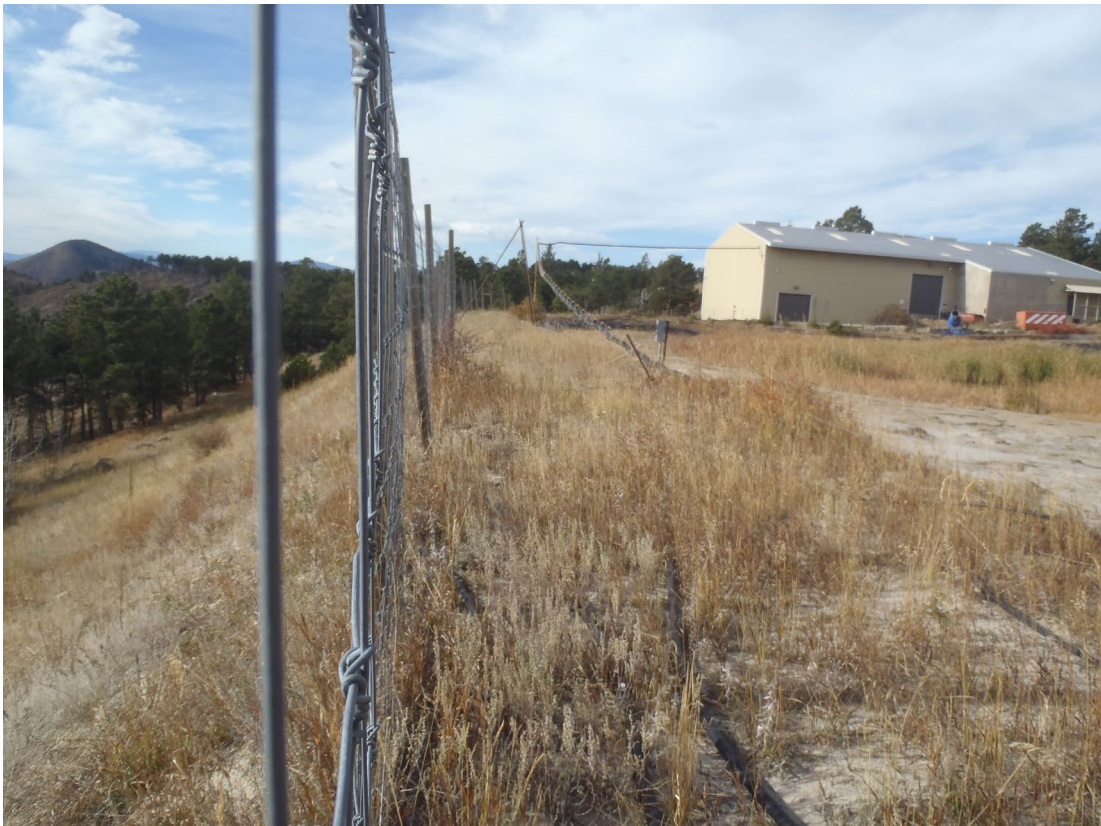
Photo 18: Looking SW along the TSF fenceline

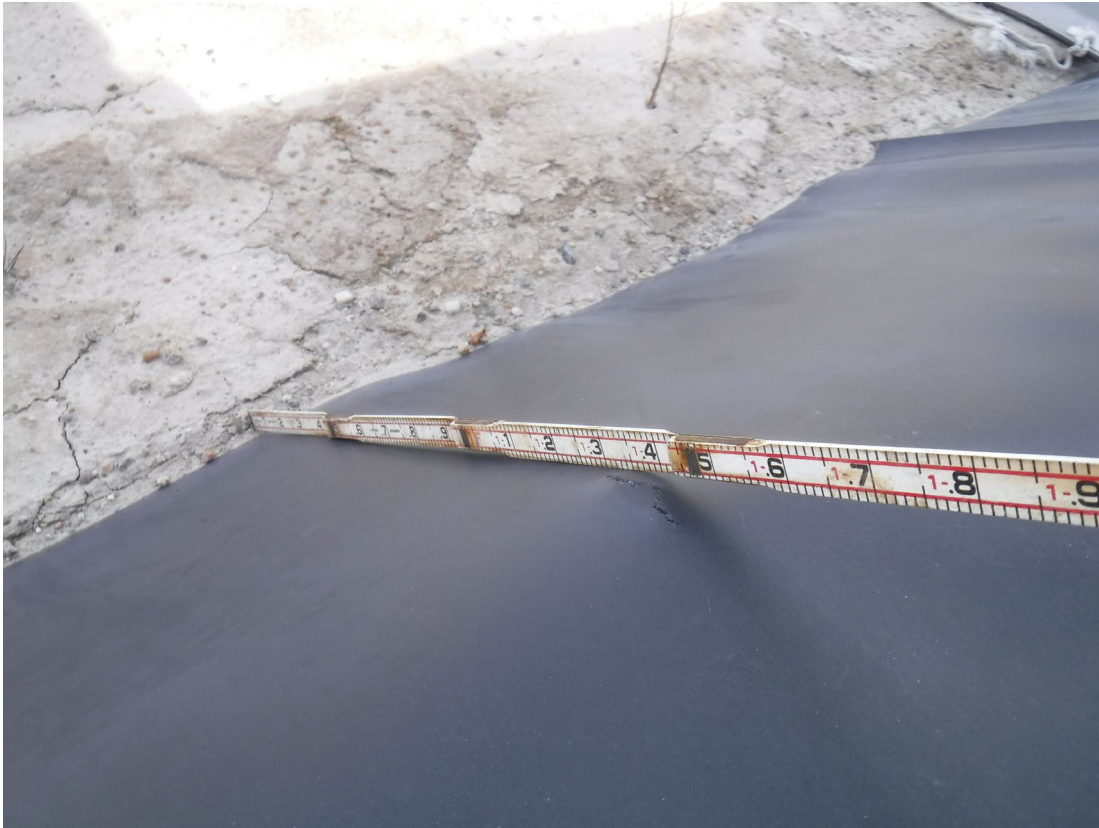
Photo 19: A view of the distance from a crack through the liner to tailings material

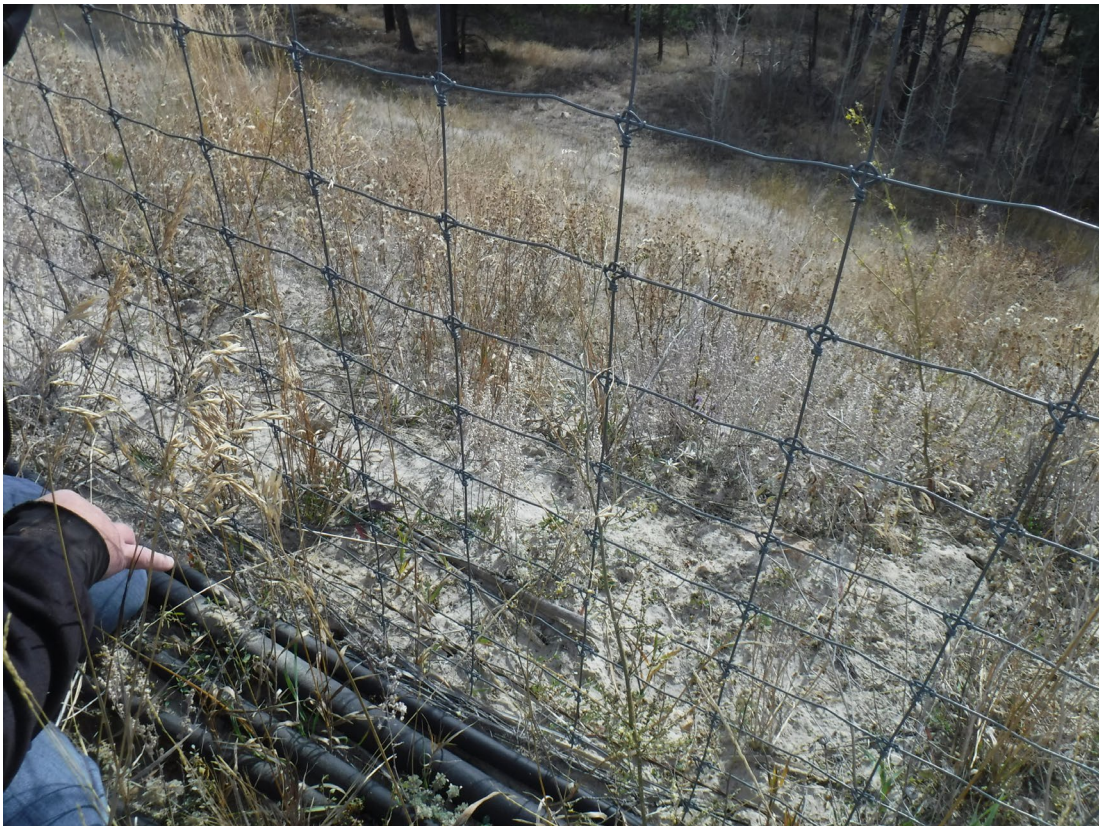
Photo 20: What appears to be tailings material deposited outside of the fence around the TSF

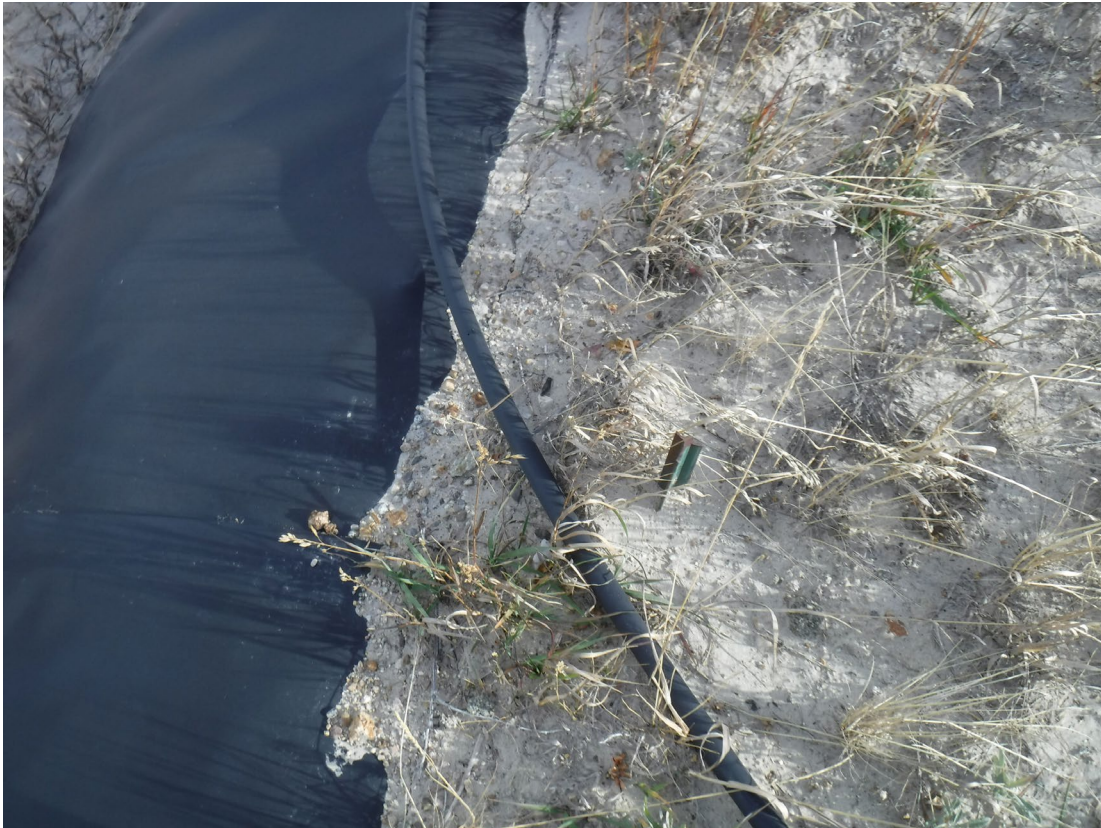
The Division observed several location around the TSF where it appears tee-posts have been driven into the embankment in the area where the anchor trench is located. Along the northwestern portion it appears the liner material that should be buried in the anchor trench has been exposed and now may only be buried by a few inches of material.

Photo 21: What appears to be tailings material deposited outside of the TSP and a tee-post driven in the location of the anchor trench

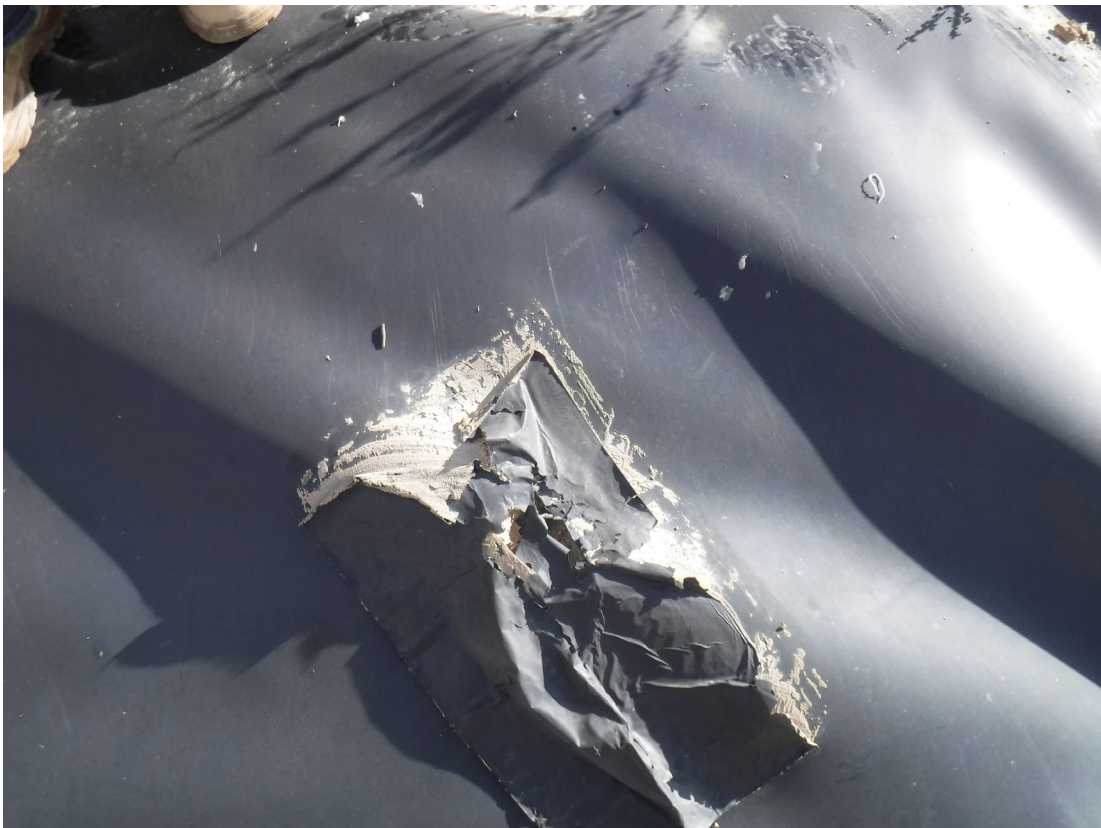
Photo 22: A TSP patch that has worn away and exposed subgrade material

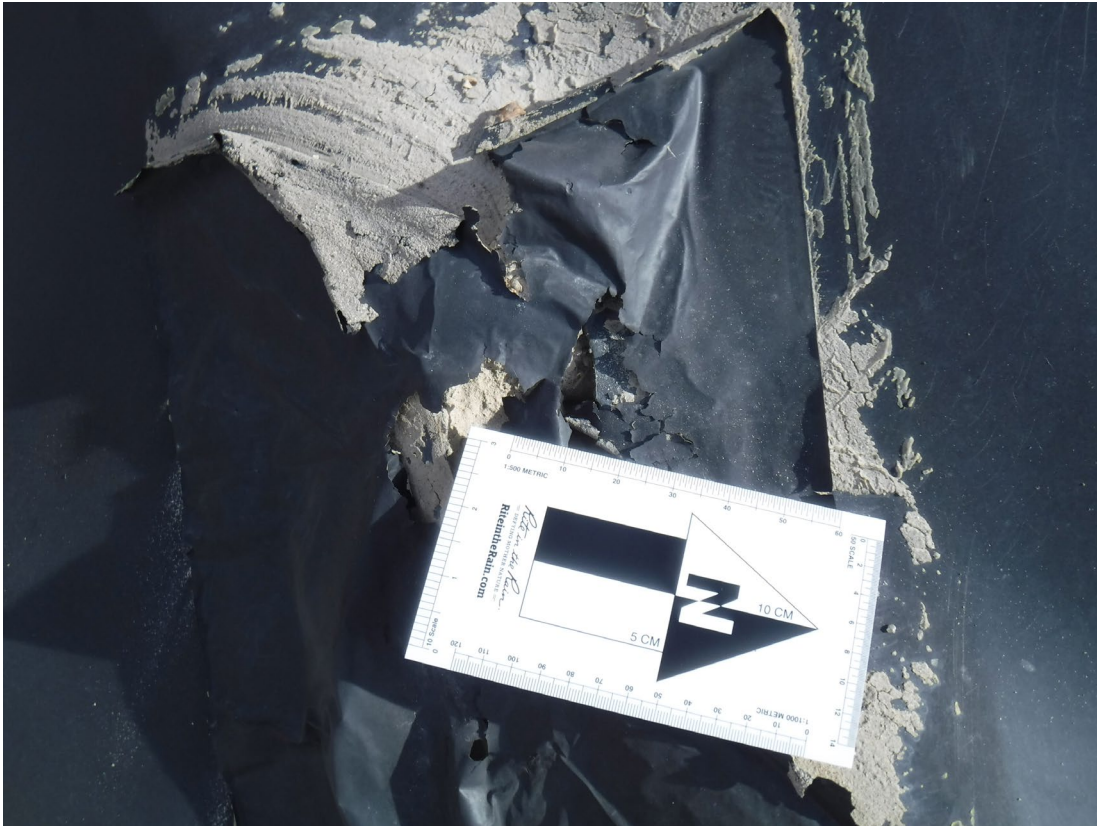
Photo 23: A TSP patch that has worn away and exposed subgrade material
