MINERALS PROGRAM INSPECTION REPORT

MINE NAME: Gold Hill Mill	MINE/PROSPECTING ID#: M-1994-117	MINERAL: Gold and silver	COUNTY: Boulder
INSPECTION TYPE: Preoperation Inspection	WEATHER: Clear	INSP. DATE: October 24, 2023	INSP. TIME: 09:00
OPERATOR: Colorado Milling Company, LLC	OPERATOR REPRESENTATIVE: Ben Langenfeld and Lewis Perkins	TYPE OF OPERATION: 110(2) - Hard Rock Limited Impact

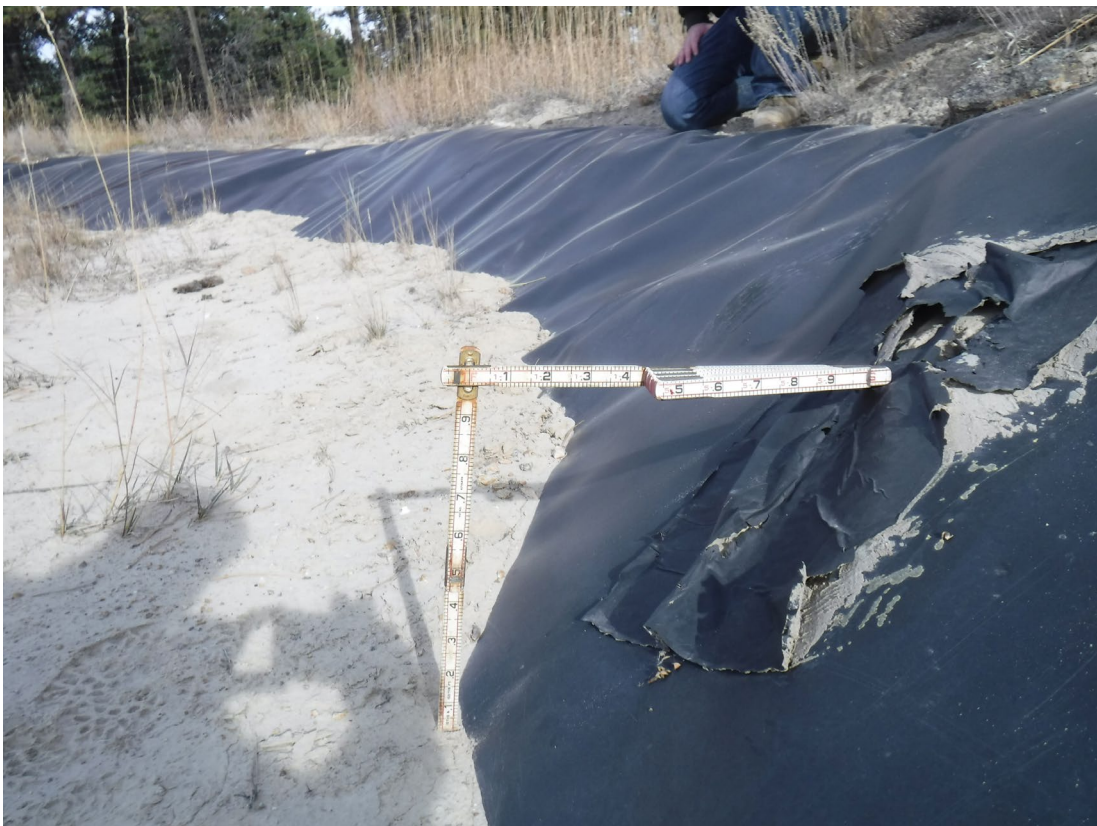
On the exposed portions of the liner the Division noted several locations where it appears patches on the liner are peeling away. Additionally, numerous cracks and tears through the liner were noted. In the eastern most area of the TSF there is patch (~ 6 inches by ~3 inches) that has peeled away and exposed the embankment material below. The Division measured the approximate depth from this patch to the tailings material in the TSF and found that it was less than 12 inches. The Division measured other areas around the TSF to determine how much available freeboard there was and found depth to tailings material varied but appeared to be 2 feet or less. In one location there was two feet of freeboard but only a foot of depth from where there was a crack through the liner.

Photo 24: The distance between the tailings material and the worn out patch

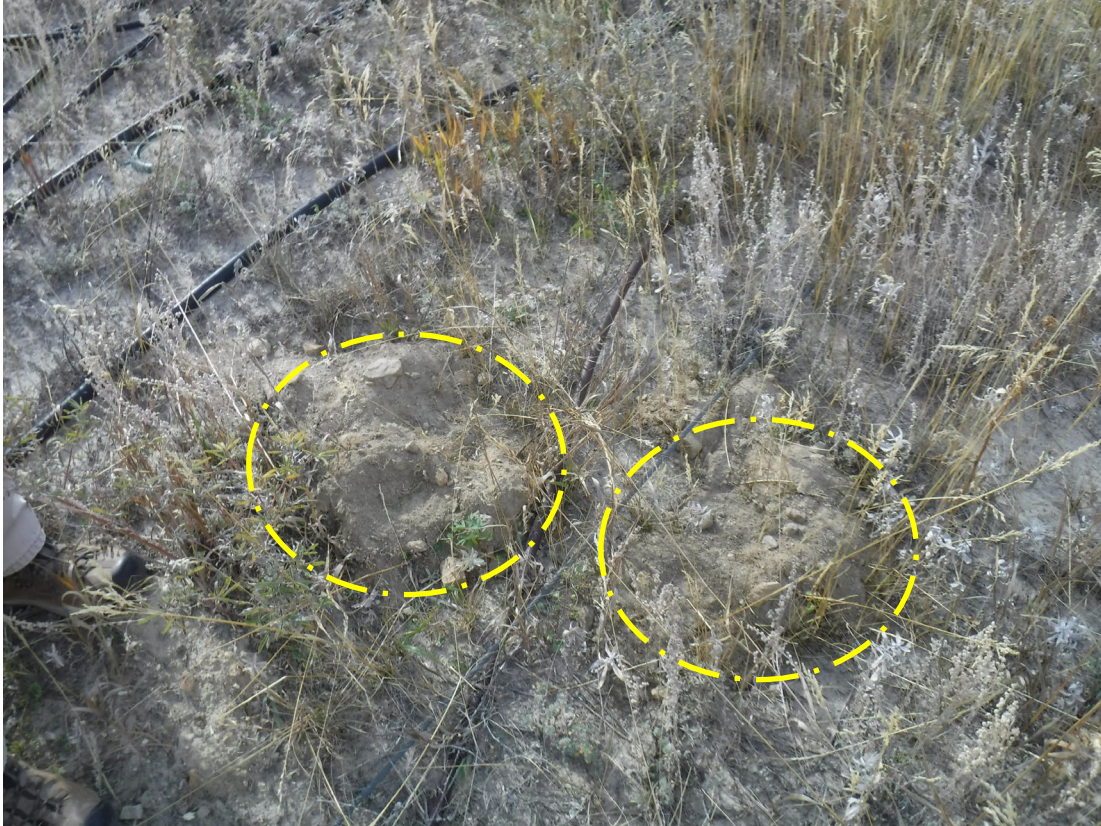
During the Tailings Storage Facility (TSF) inspection it was noted that there was woody vegetation (small coniferous trees) growing inside the TSF and along the anchor trench location. Moving around the TSF counterclockwise the Division noted animal burrows within the tailings material near the southern most portion. Animal burrows were also found along the southern portion of the TSF between the fence and the top of liner. Burrows were also noted outside of the fence as well.

Photo 25: Evidence of burrowing in the TSF embankment, yellow circles

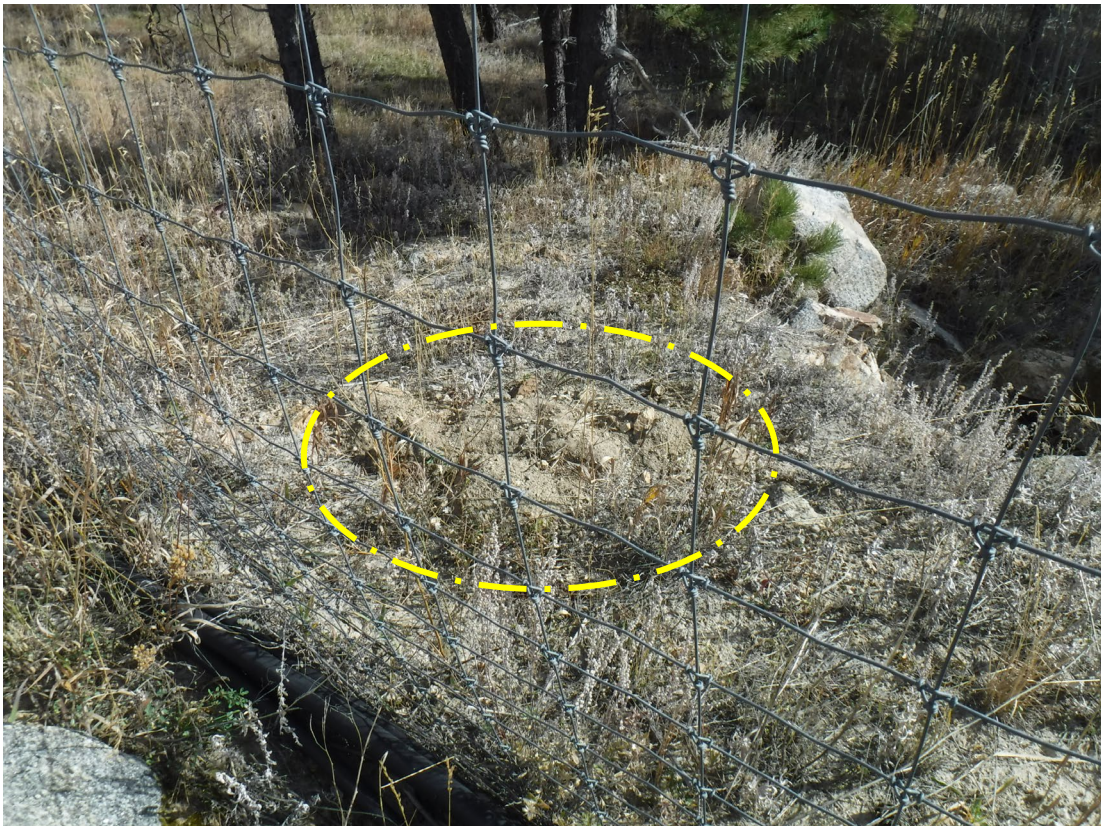
Photo 26: Evidence of burrowing in the TSF embankment outside the fence, yellow circle

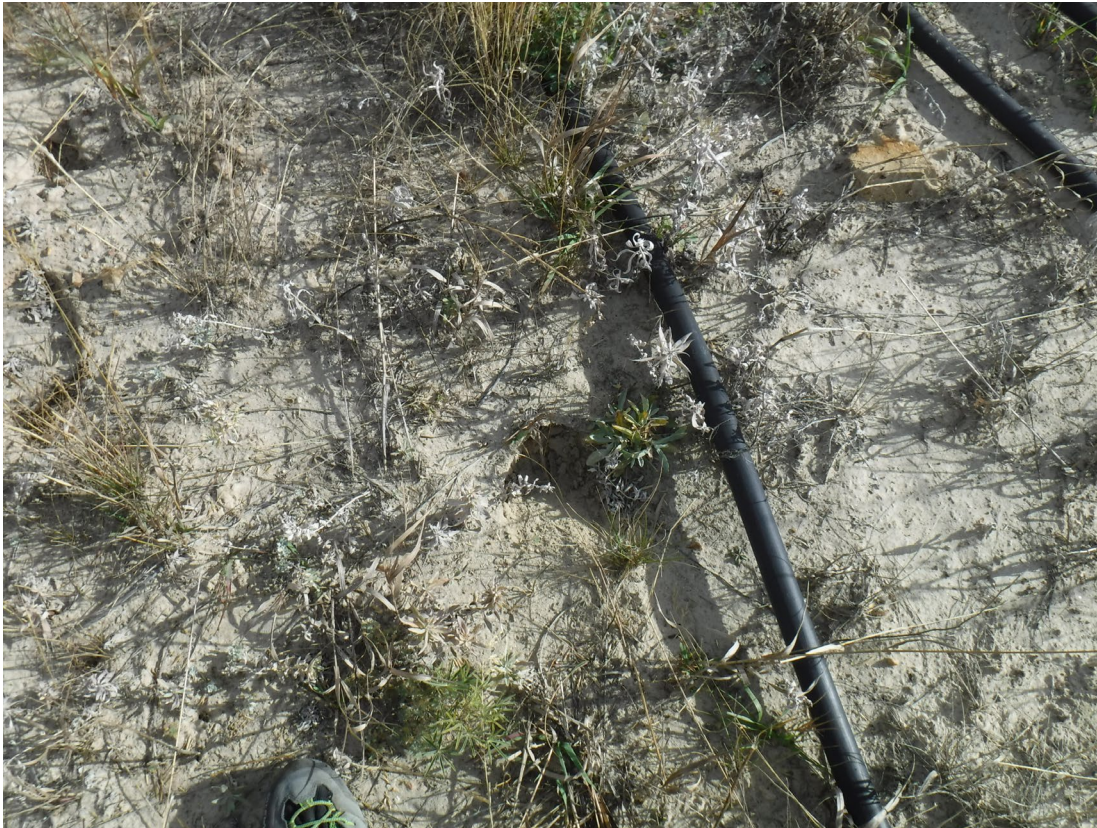
Photo 27: Evidence of burrowing in the TSF embankment, center of picture

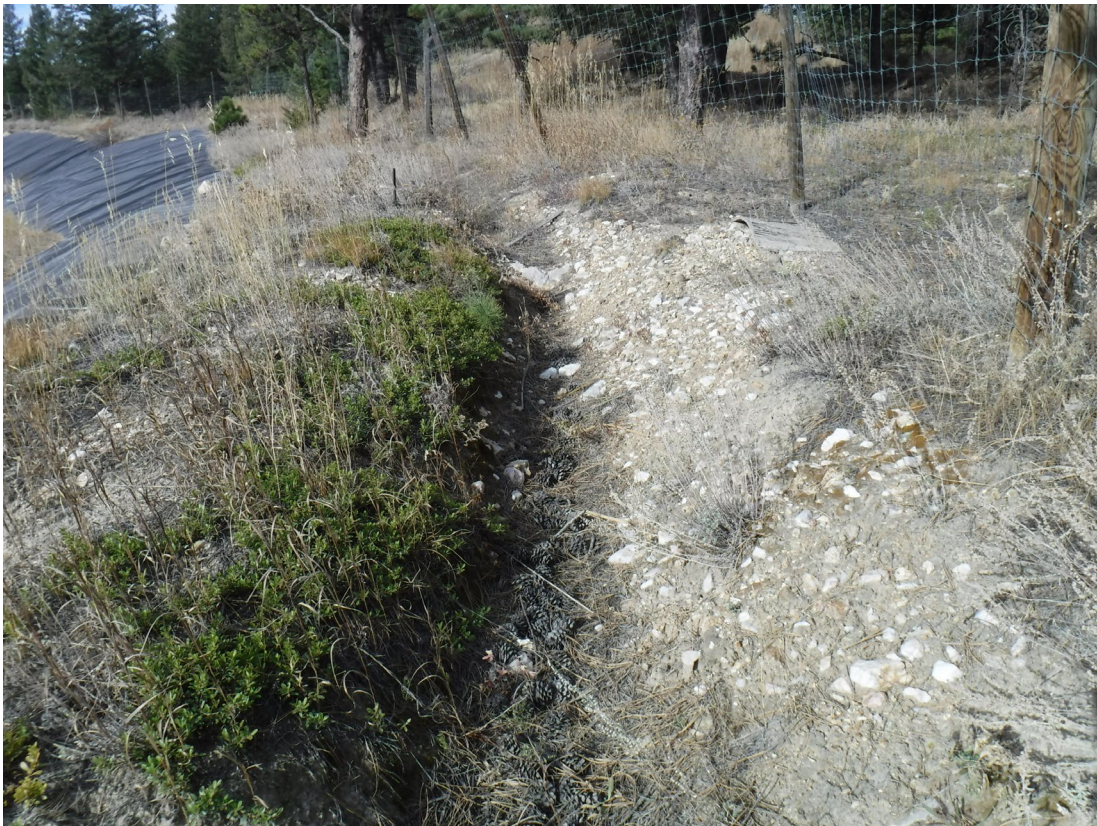
The diversion ditch along the northern perimeter of the TSF is heavily vegetated and needs maintenance to insure proper functionality. The design capacity of the diversion ditch is under review as part of CN-1 and may require improvements beyond the needed maintenance.

Photo 28: Diversion ditch around the TSF

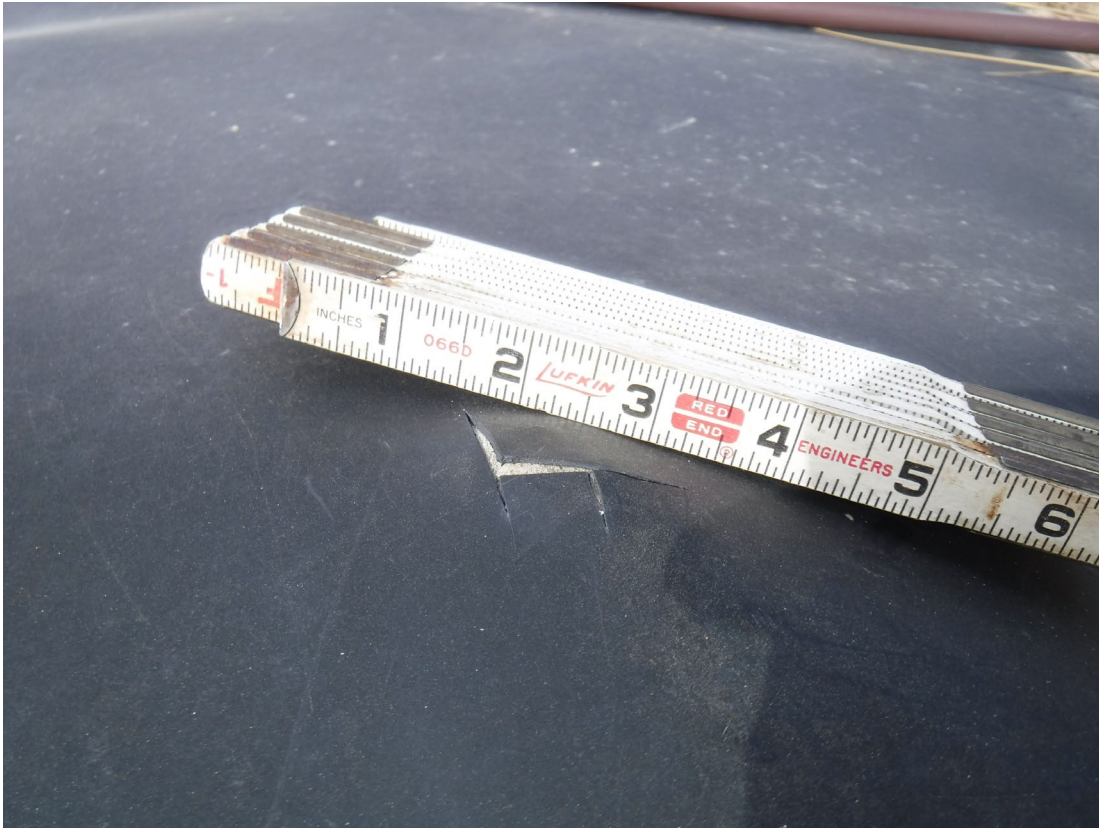
Photo 29: Crack through TSF liner

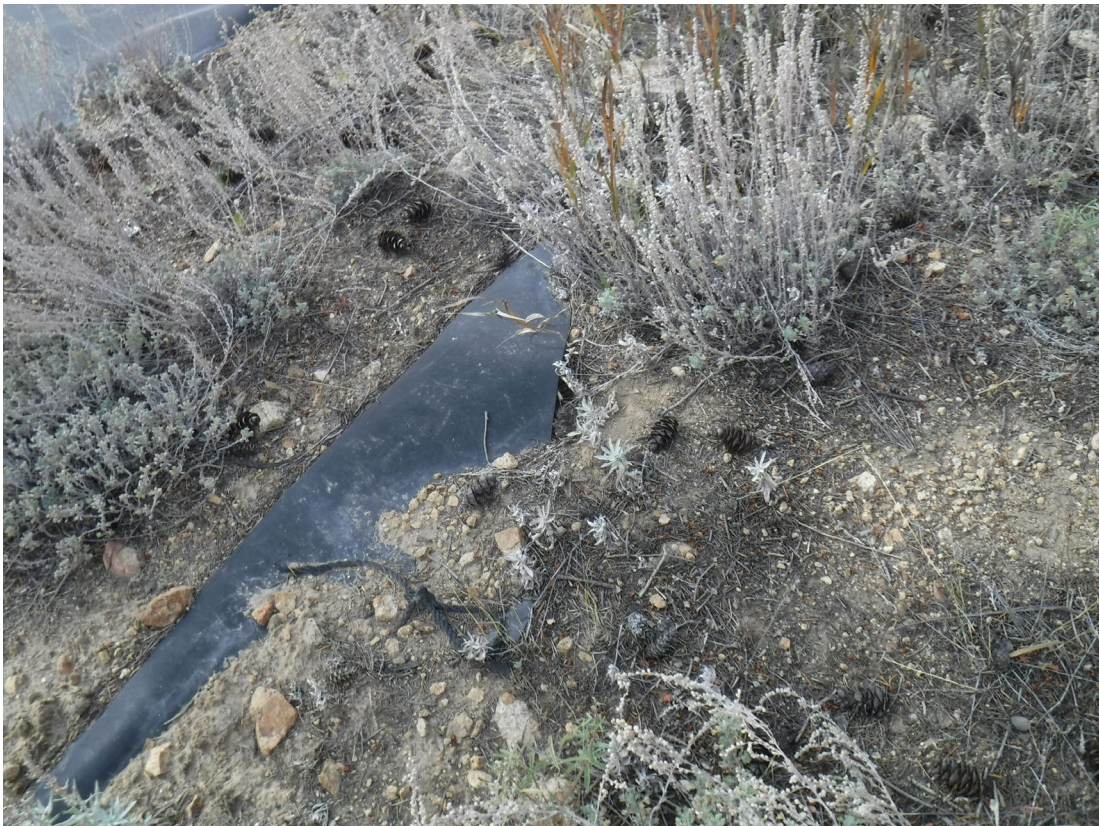
The Division observed several location around the TSF where it appears tee-posts have been driven into the embankment in the area where the anchor trench is located. Along the northwestern portion it appears the liner material that should be buried in the anchor trench has been exposed and now may only be buried by a few inches of material.

Photo 30: Anchor trench with the TSF liner apparently being uncovered

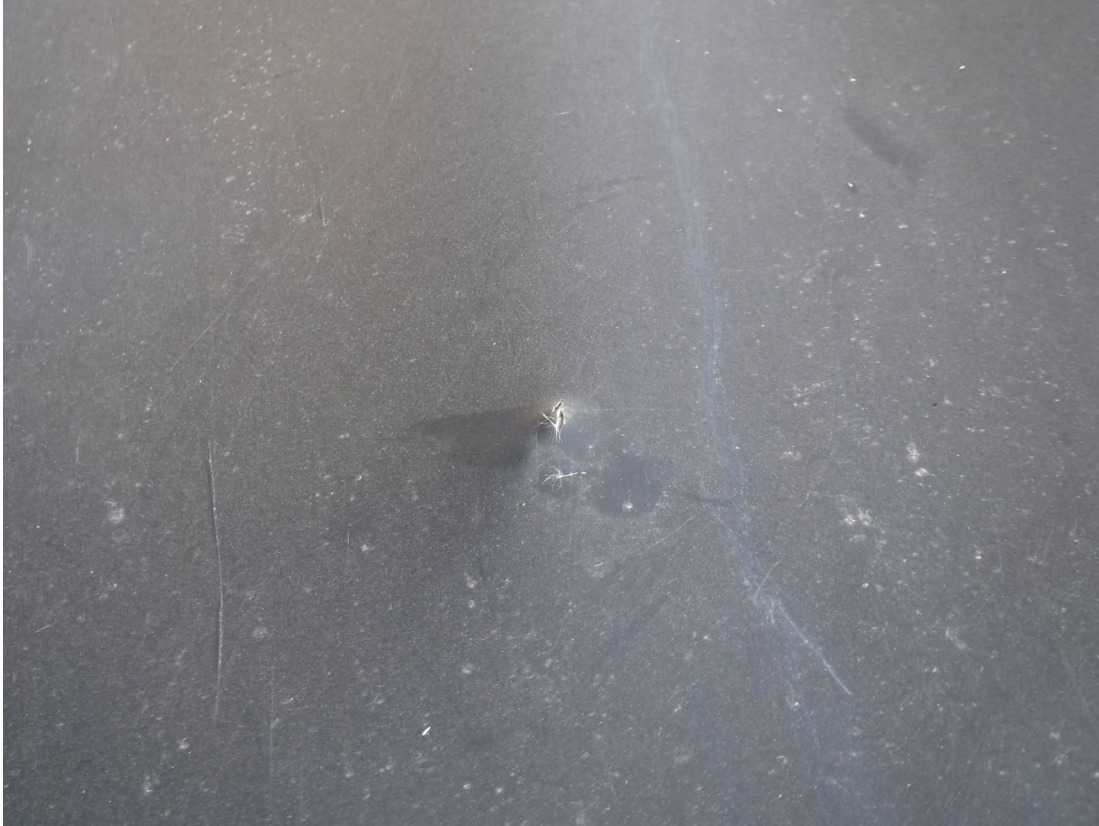
Photo 31: Crack through TSF liner

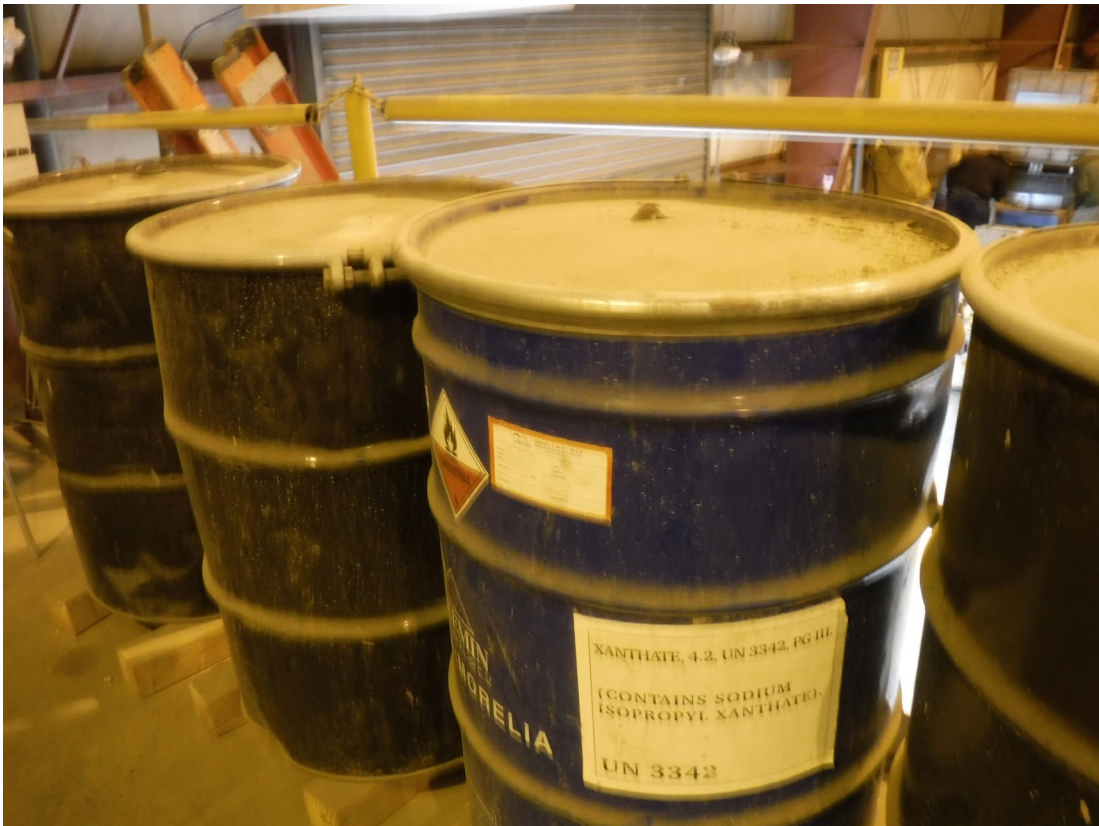
PROBLEM: Improper storage and presence of hazardous materials on site. During the inspection, 2 barrels of Xanthate, a half pallet of Soda Ash, one barrel of MIBC, several frothing and flotation agents and a few unlabeled containers were observed without secondary containment.

Photo 32: Drum of Xanthate in Mill Building

CORRECTIVE ACTIONS: All storage tanks, petroleum and any hazardous materials on site for any period of time shall have appropriate secondary containment. The operator shall provide photo documentation that all hazardous material containers have been removed from the site on or before the corrective action date. Additionally, the Operator shall provide documentation that the hazardous materials have been properly disposed of at a certified disposal facility.

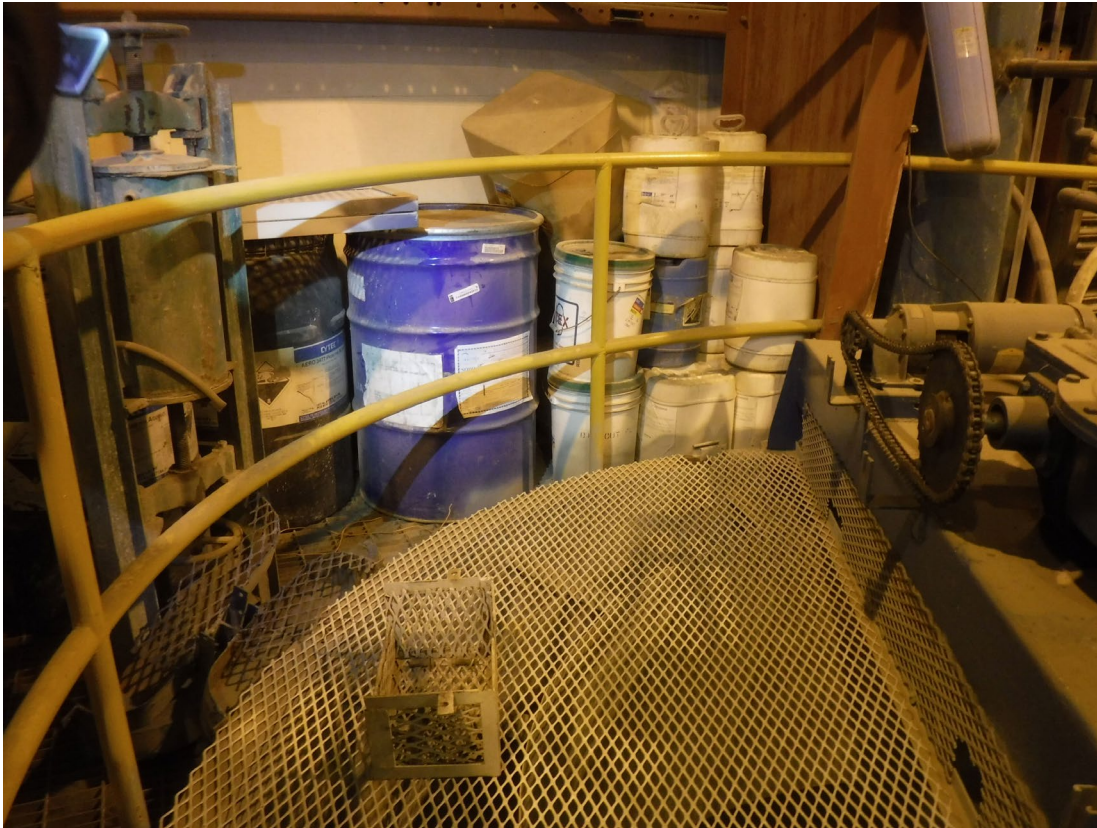
Photo 33: Drums and containers of designated chemicals in Mill Building

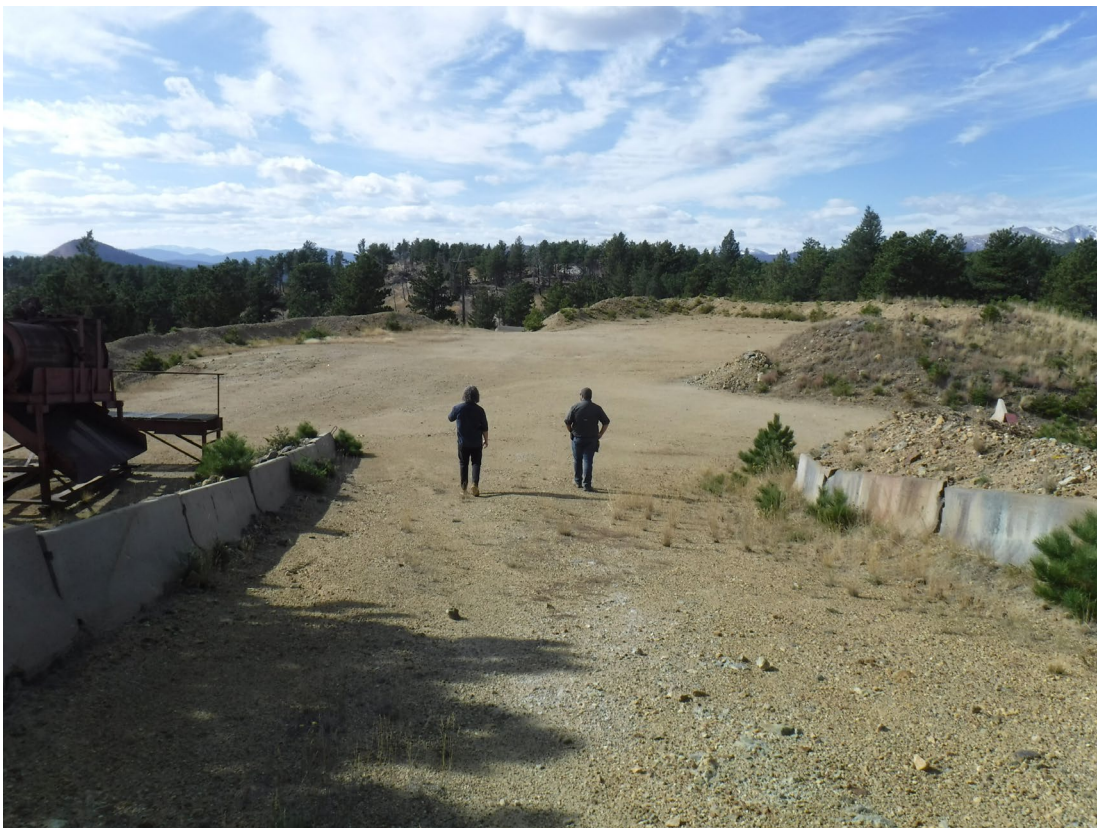
Photo 34: Ore Storage area west of Mill Building

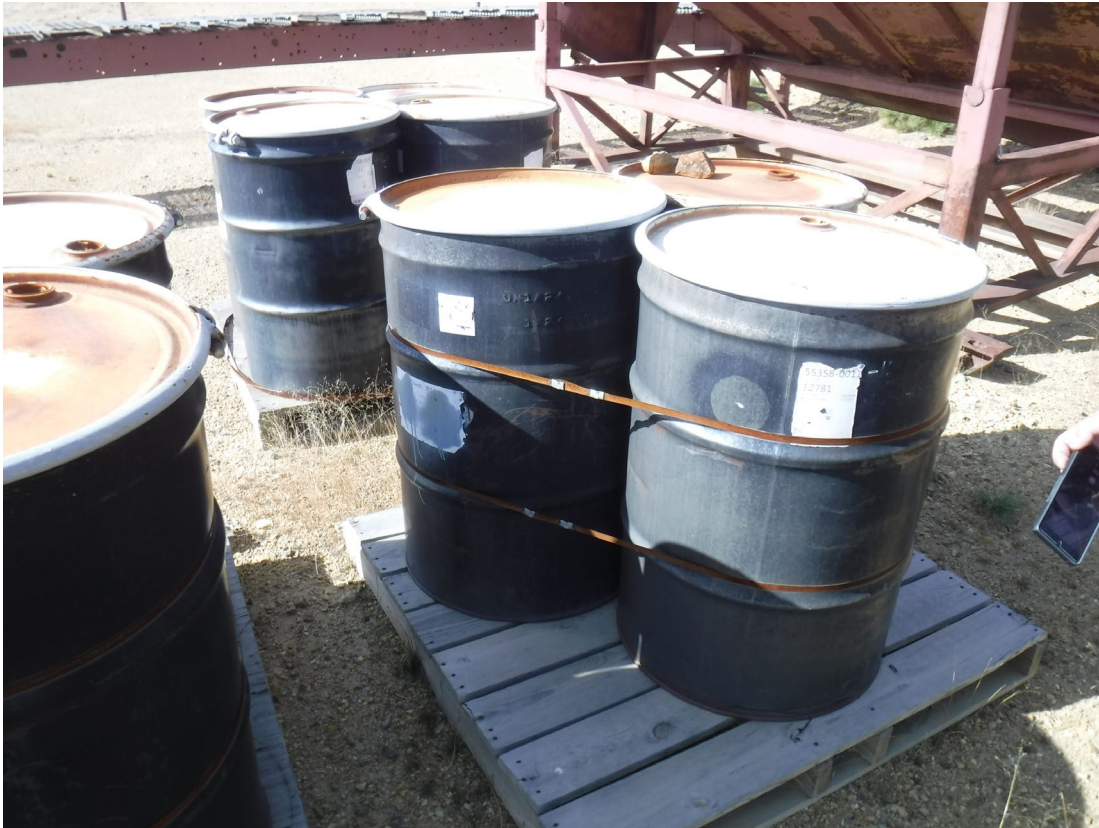
Photo 35: Drums of possible crushed ore material located in the area west of Mill Building

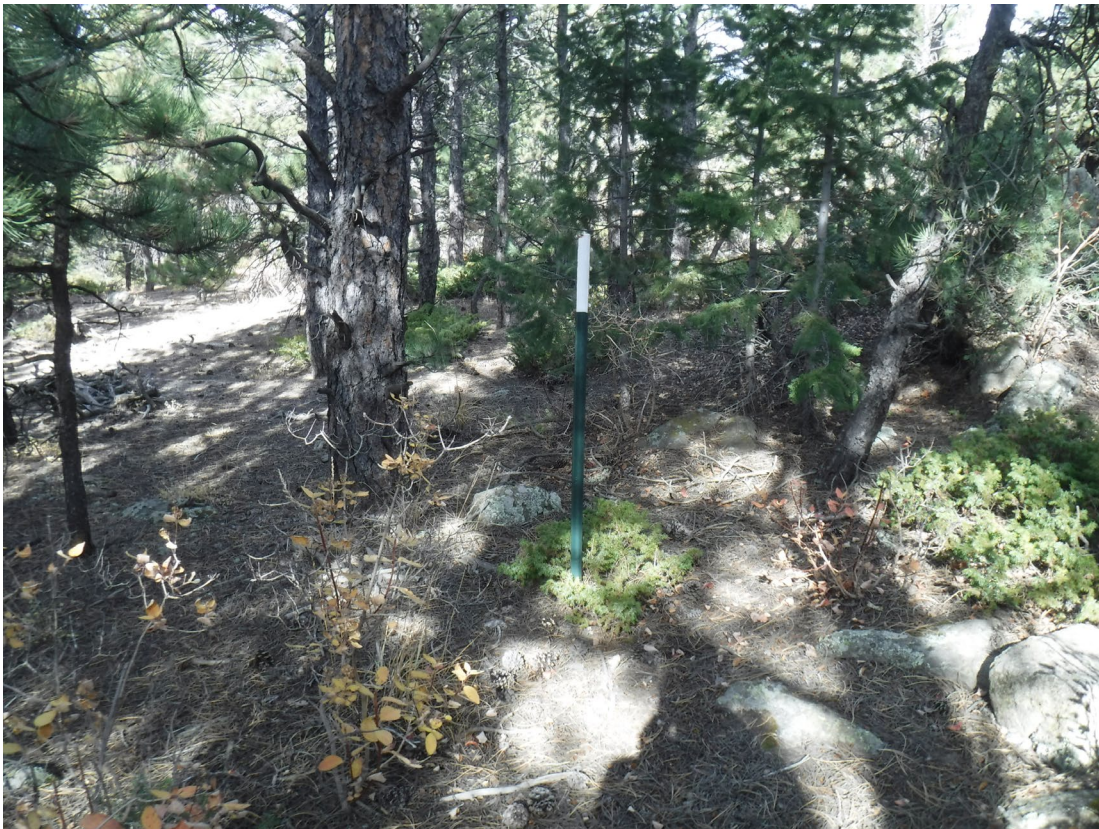
Photo 36: Typical permit boundary marker
