MINERALS PROGRAM INSPECTION REPORT
PHONE: (303) 866-3567

MINE NAME: Currier Gravel Pit	MINE/PROSPECTING ID#: M-1980-203	MINERAL: Sand and gravel	COUNTY: Mesa
INSPECTION TYPE: Monitoring	WEATHER: Clear	INSP. DATE: October 25, 2023	INSP. TIME: 09:00
OPERATOR: Currier Gravel Pit, Inc.	OPERATOR REPRESENTATIVE: None	TYPE OF OPERATION: 110c - Construction Limited Impact	
REASON FOR INSPECTION: Normal I&E Program	BOND CALCULATION TYPE: Complete Bond	BOND AMOUNT: \$15,879.98	
DATE OF COMPLAINT: NA	POST INSP. CONTACTS: DRMS	JOINT INSP. AGENCY: None	
INSPECTOR(S): Amy Yeldell	INSPECTOR'S SIGNATURE:

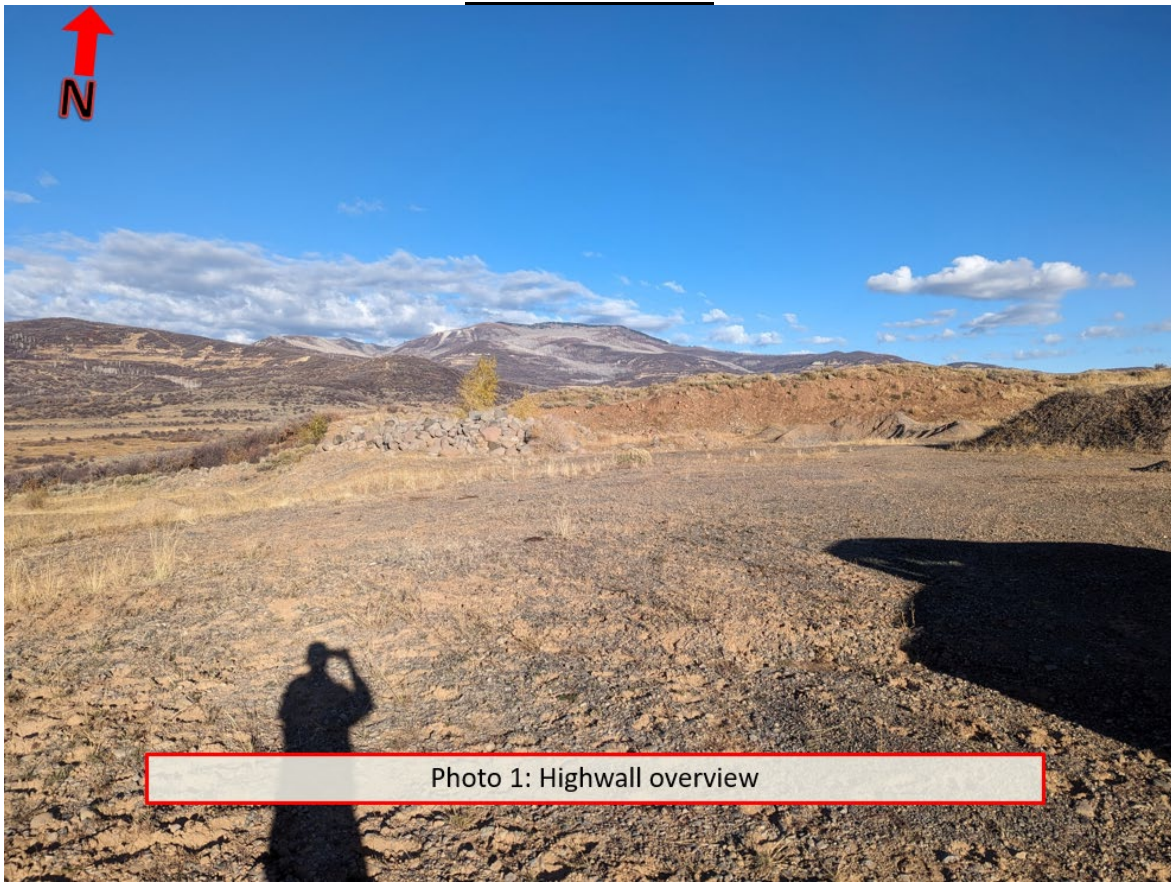
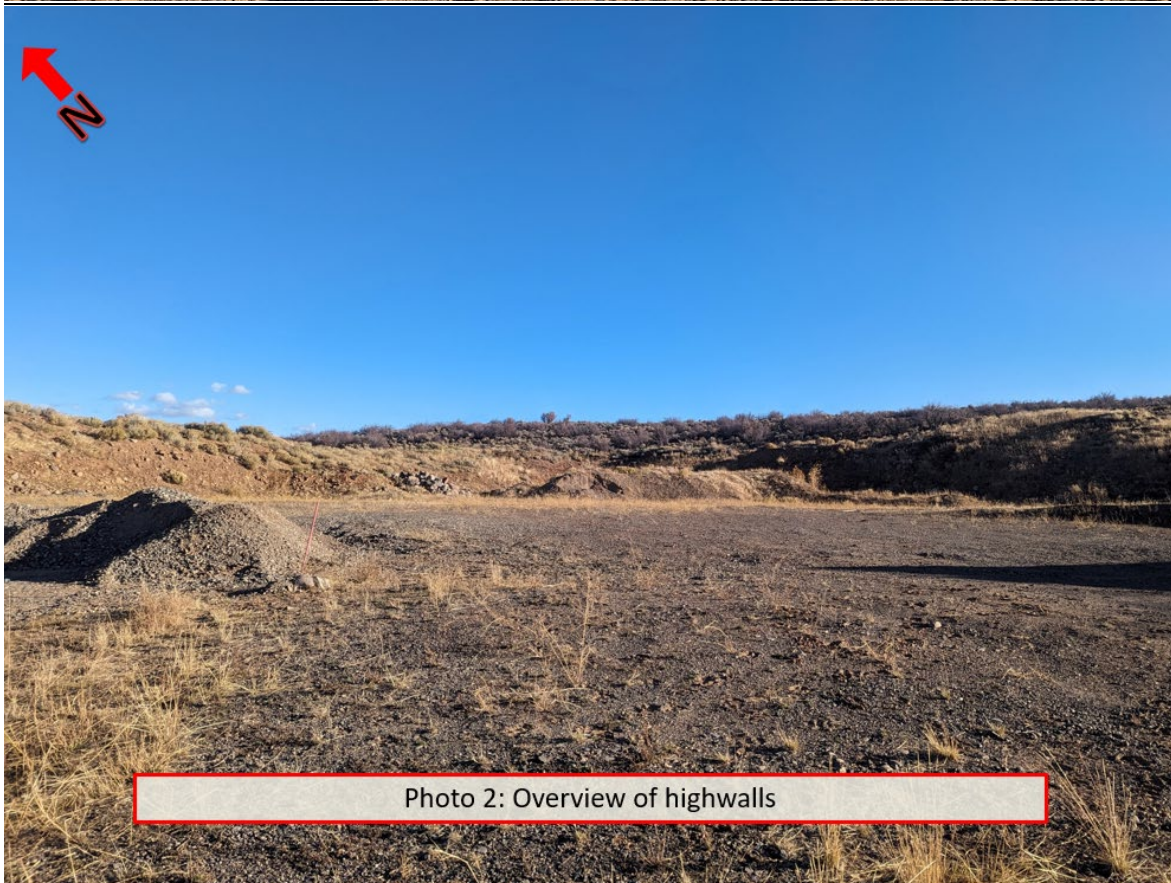
There appears to be no recent excavations. The active highwall is located to the west (Photos 1-3). It is an average of 20' H and 150 yds wide at a 1H: 1V. This slope will need to be backfilled with nearby excess material as mining has occurred up to the permit boundary. Scattered throughout the pit floor area a few miscellaneous stockpiles that are estimated to be 10' x 30' x 50' and 8' x 10' x 30'. There is a bench on the south side that daylights out and is approximately 10' high by 500' long at a 2H: 1V. There are also several small piles of oversized boulders that will need to be backfilled.

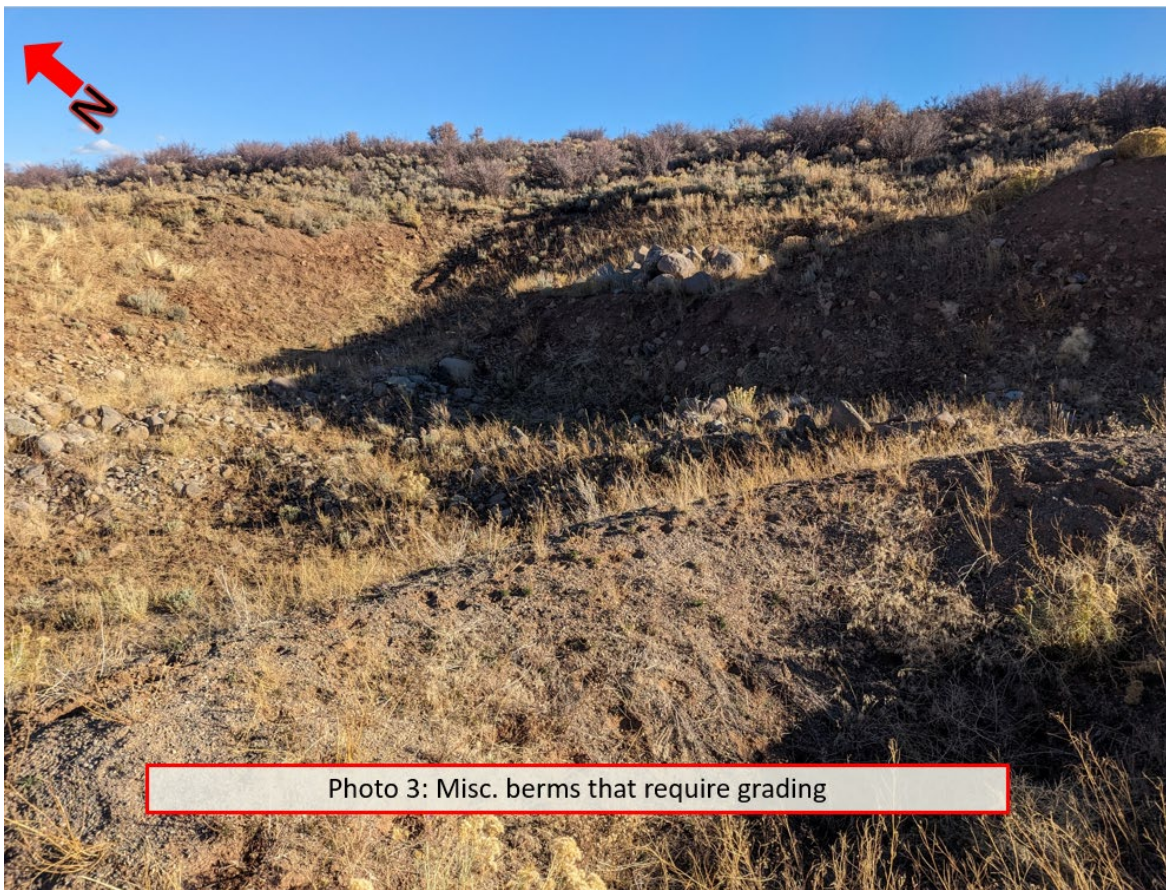
Photo 3: Misc. berms that require grading

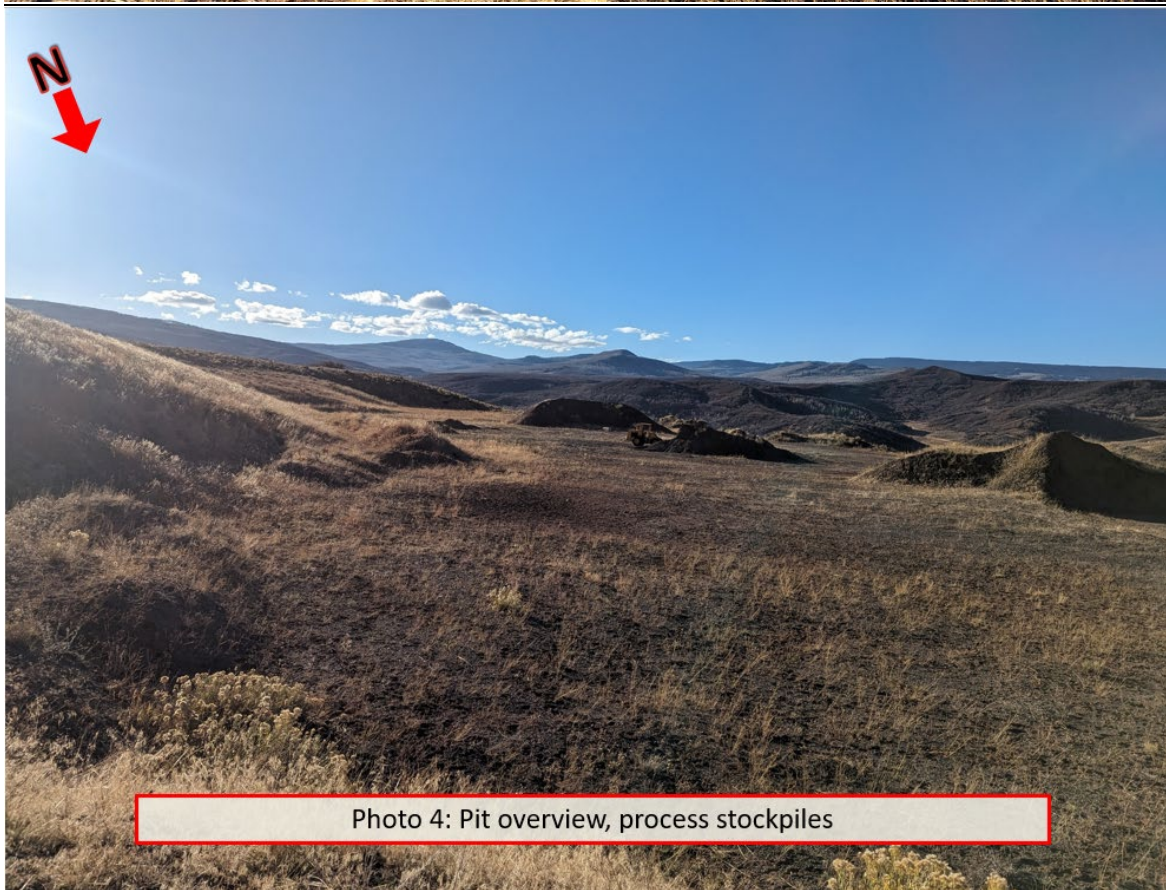
Nearly the entire permit area has been affected. The site was inactive at the time of the inspection. Previously the pit was said to be in final reclamation, however the 2023 annual report indicates it was active with mining last taking place in September of 2022. Based on the supplemental information provided no additional excavations are expected. The Operator will sell out of existing stockpiles then begin reclamation once the stockpiles have been removed. There are three main stockpiles of processed material. Stockpiles appear to have decreased in size since the Divisions last inspection but overall site conditions remain relatively unchanged. A loader was on site, no other equipment was observed (Photo 4-5).

Photo 4: Pit overview, process stockpiles

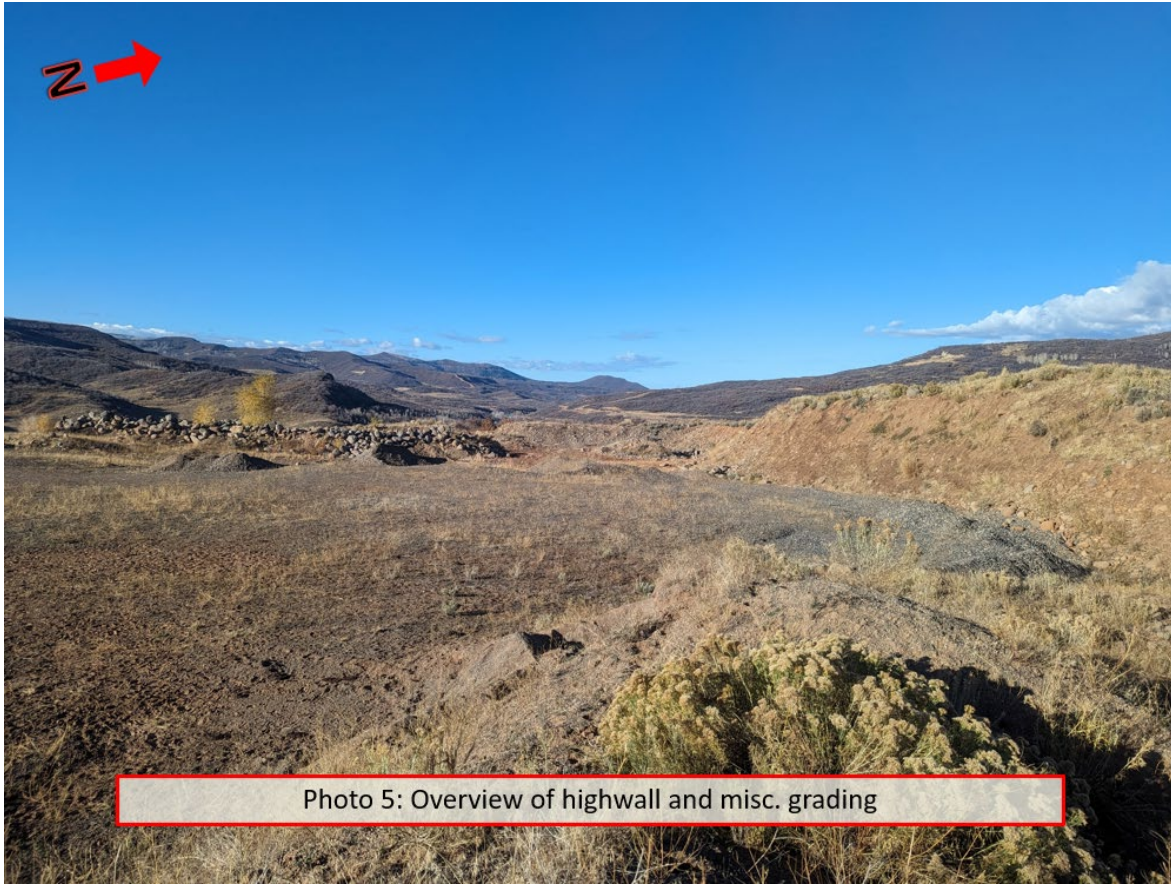
Photo 5: Overview of highwall and misc. grading

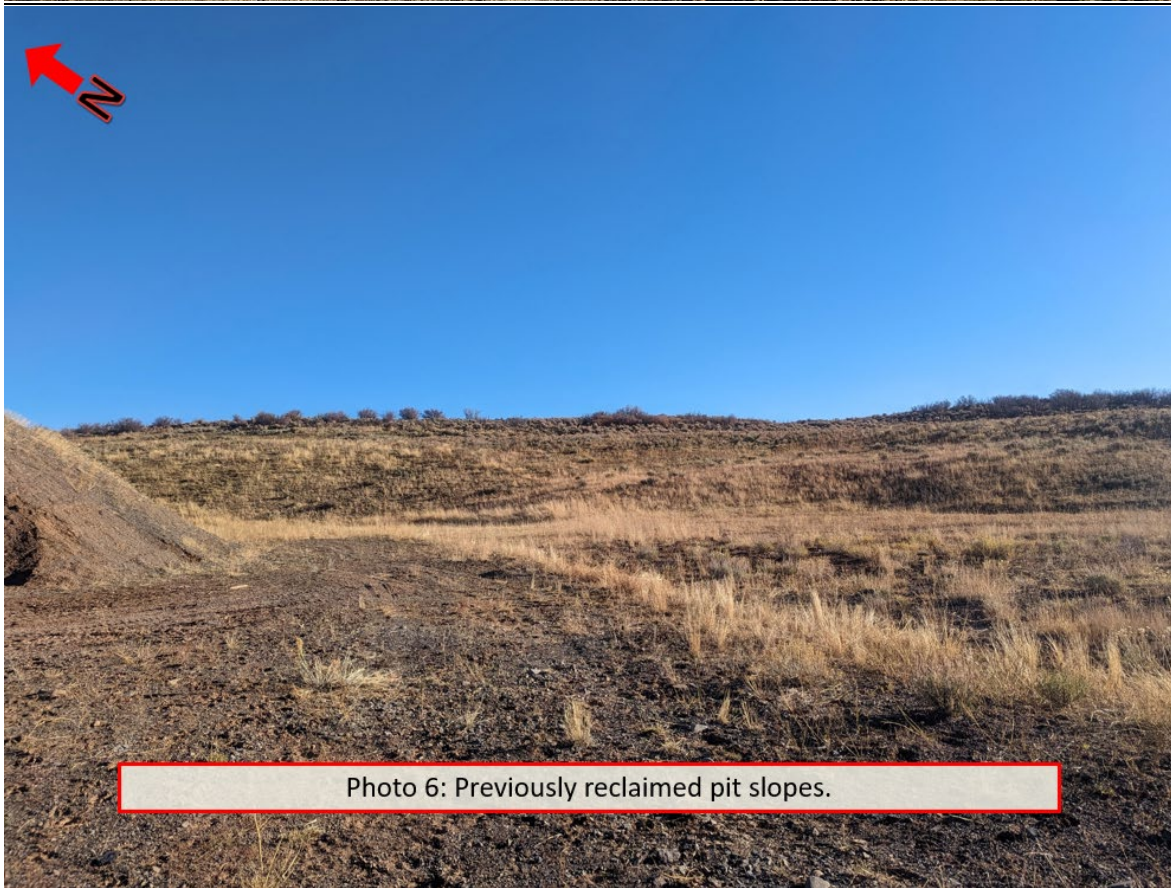
The northeast highwall has been reclaimed. Overall the slope is properly graded and blends well with surrounding topography (Photo 6). The vegetation appears to be well established. Areas were evaluated for final reclamation success during this inspection.

Photo 6: Previously reclaimed pit slopes.
