**MINERALS PROGRAM INSPECTION REPORT**  
**PHONE: (303) 866-3567**

<b>MINE NAME:</b> Nichols Gravel Pit	<b>MINE/PROSPECTING ID#:</b> M-1981-013	<b>MINERAL:</b> Sand and gravel	<b>COUNTY:</b> Mesa
<b>INSPECTION TYPE:</b> Monitoring	<b>WEATHER:</b> Clear	<b>INSP. DATE:</b> October 25, 2023	<b>INSP. TIME:</b> 11:00
<b>OPERATOR:</b> Nichols Gravel Pit, L.L.P.	<b>OPERATOR REPRESENTATIVE:</b> None	<b>TYPE OF OPERATION:</b> 112c - Construction Regular Operation	
<b>REASON FOR INSPECTION:</b> Normal I&E Program	<b>BOND CALCULATION TYPE:</b> Complete Bond	<b>BOND AMOUNT:</b> \$115,474.00	
<b>DATE OF COMPLAINT:</b> NA	<b>POST INSP. CONTACTS:</b> DRMS	<b>JOINT INSP. AGENCY:</b> None	
<b>INSPECTOR(S):</b> Amy Yeldell	<b>INSPECTOR'S SIGNATURE:</b>

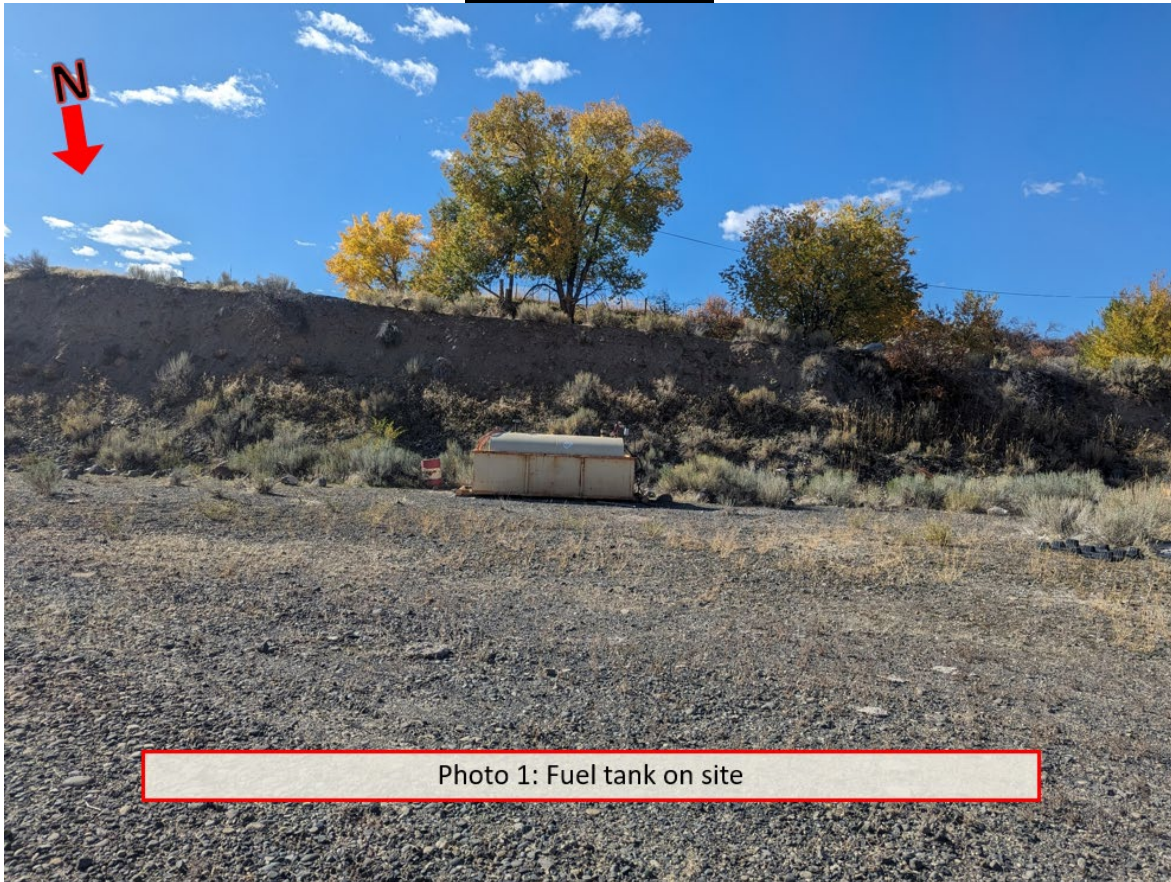
A small fuel tank is located on site and is in secondary containment (Photo One).

Photo 1: Fuel tank on site

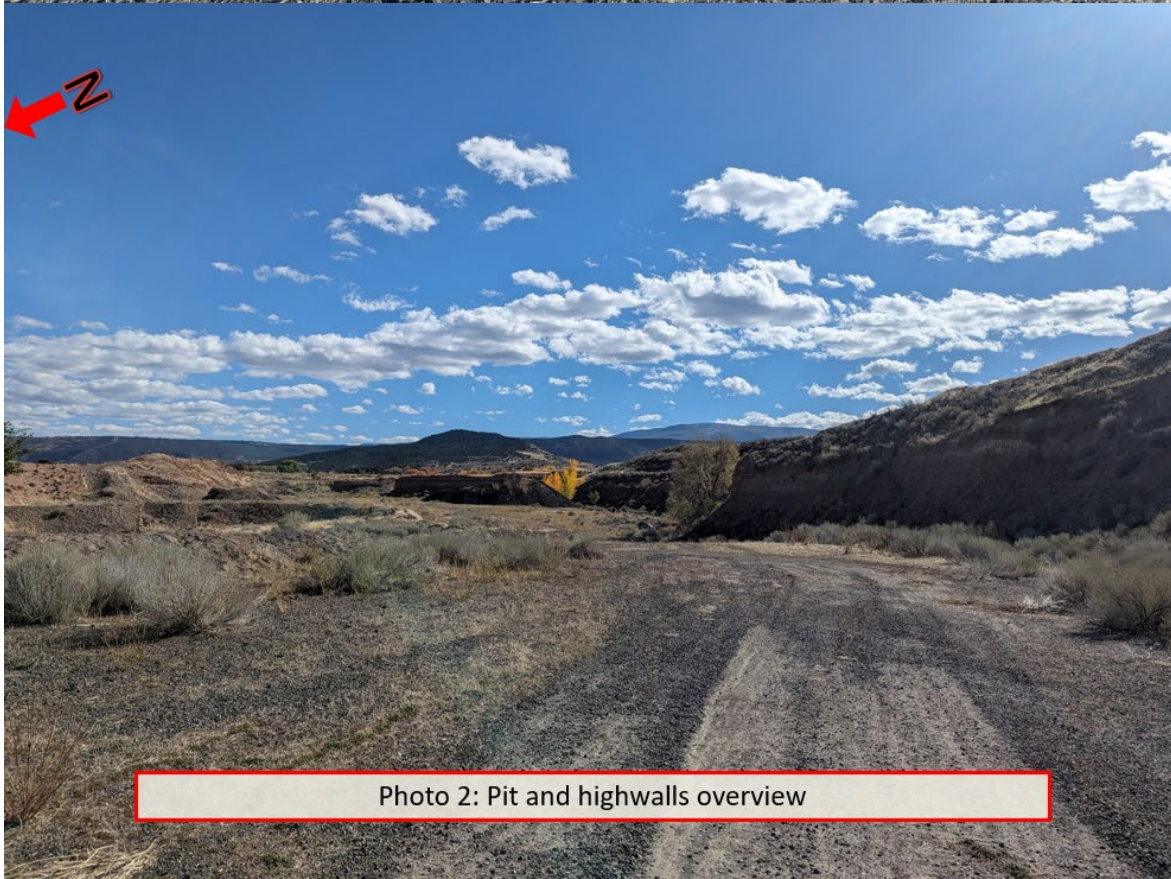
The pit consists of two main levels. Each level is approximately 20-30' deep. All slopes are well within the permit area and can be dozed down. The internal highwalls are approximately 1H: 1V to near vertical in some areas. There are several random stockpiles and cuts on the banks above the pit that will need general contouring (Photos 2-7).

Photo 2: Pit and highwalls overview

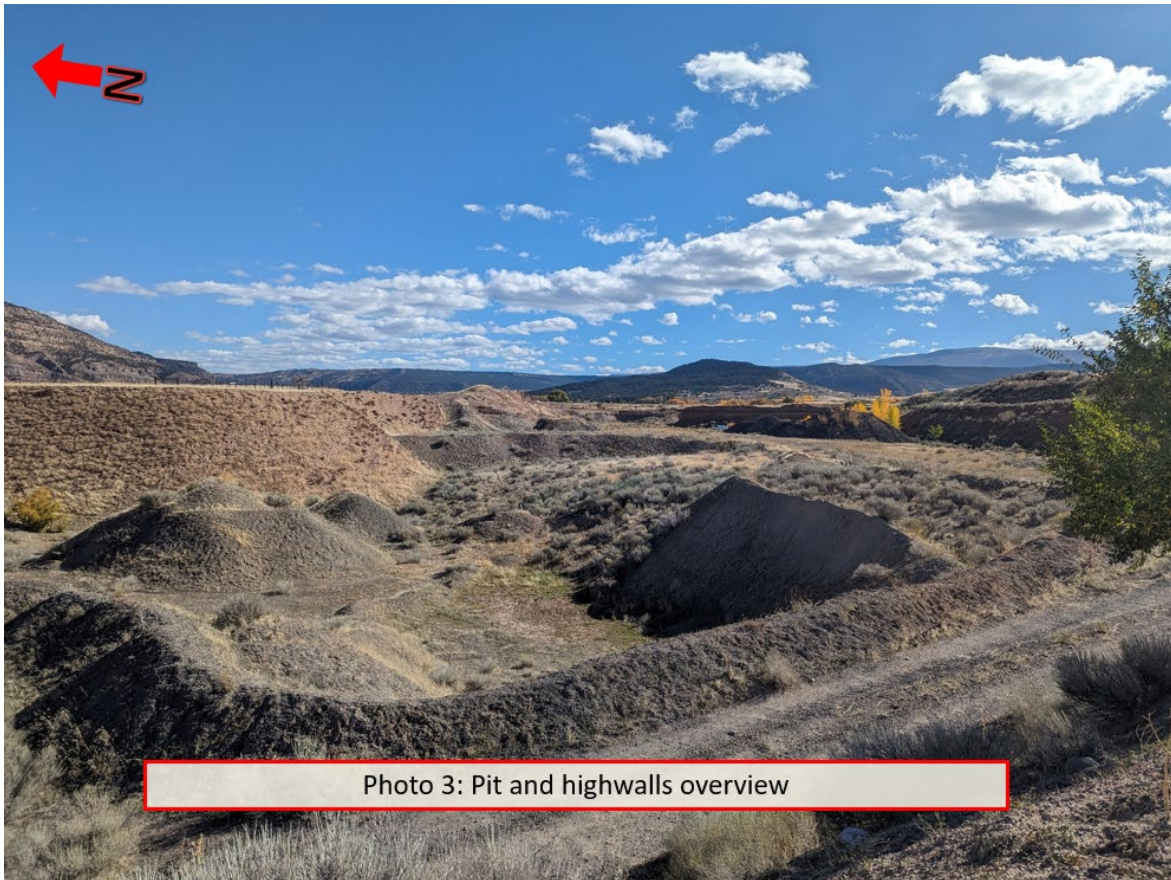
Photo 3: Pit and highwalls overview

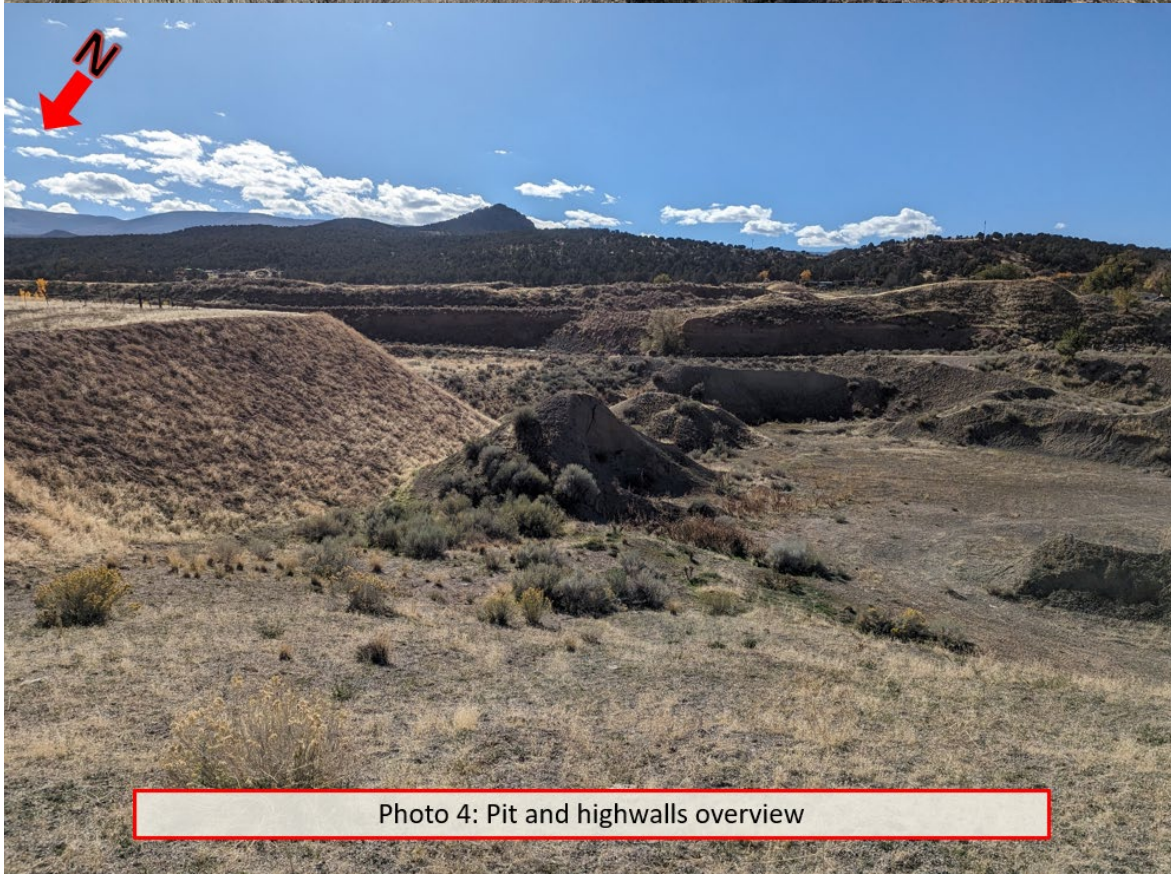
Photo 4: Pit and highwalls overview

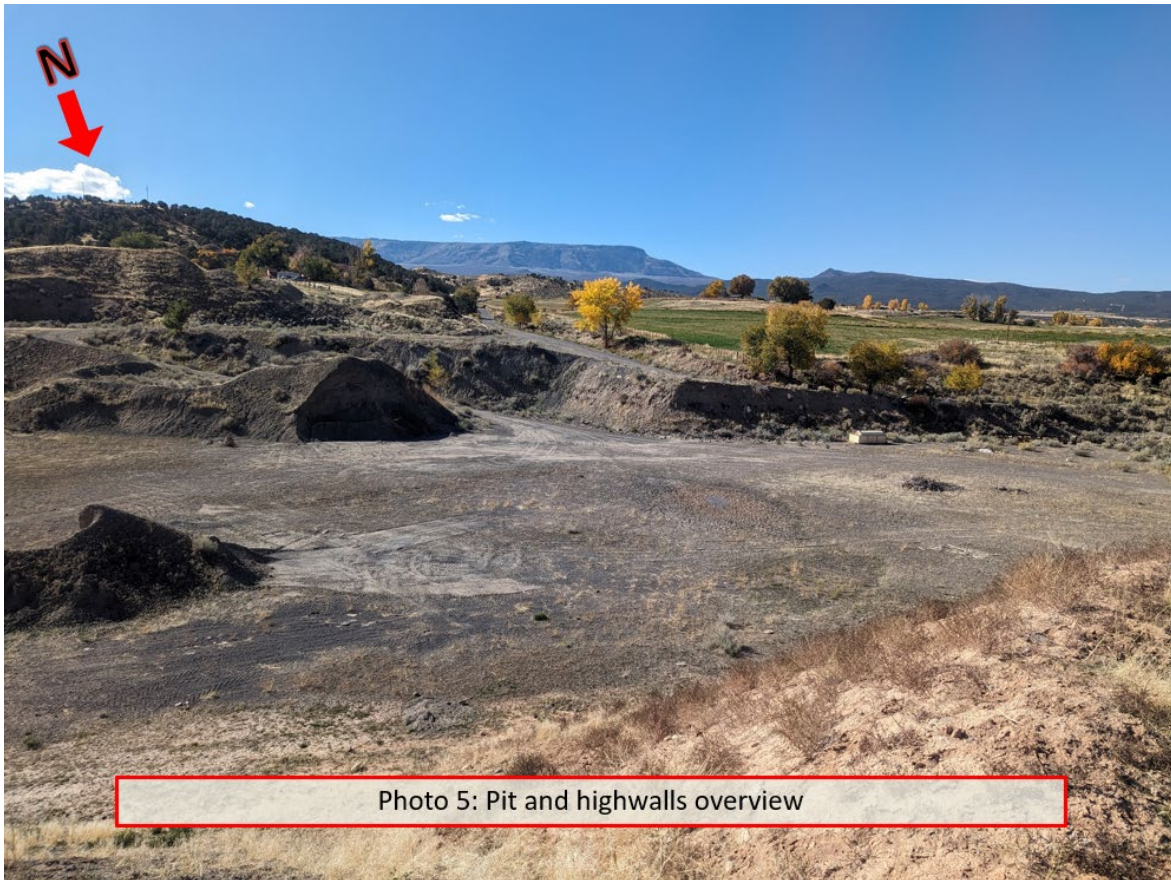
Photo 5: Pit and highwalls overview

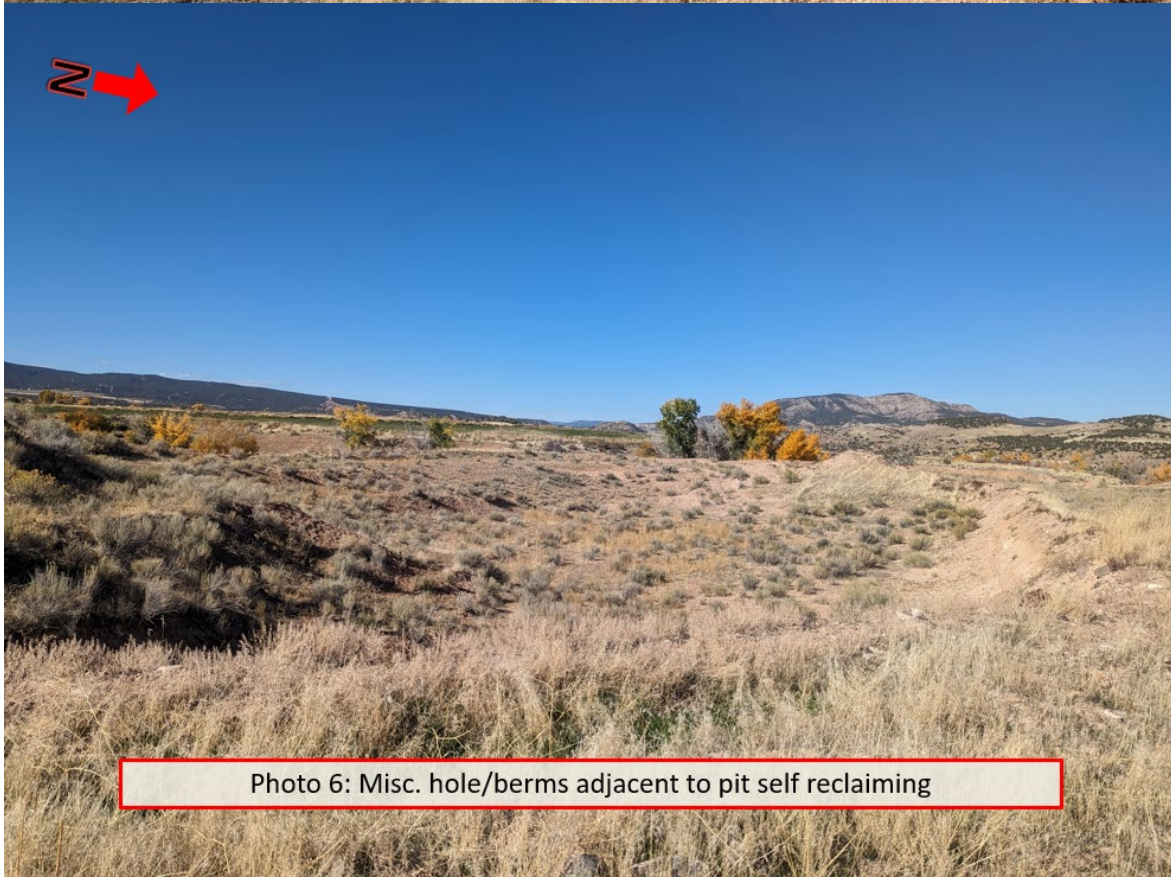
Much of the pit floor and highwalls have volunteer vegetation from areas remaining idle (Photo 6 and 7). The Operator is encouraged to interim reclaim areas where possible.

Photo 6: Misc. hole/berms adjacent to pit self reclaiming

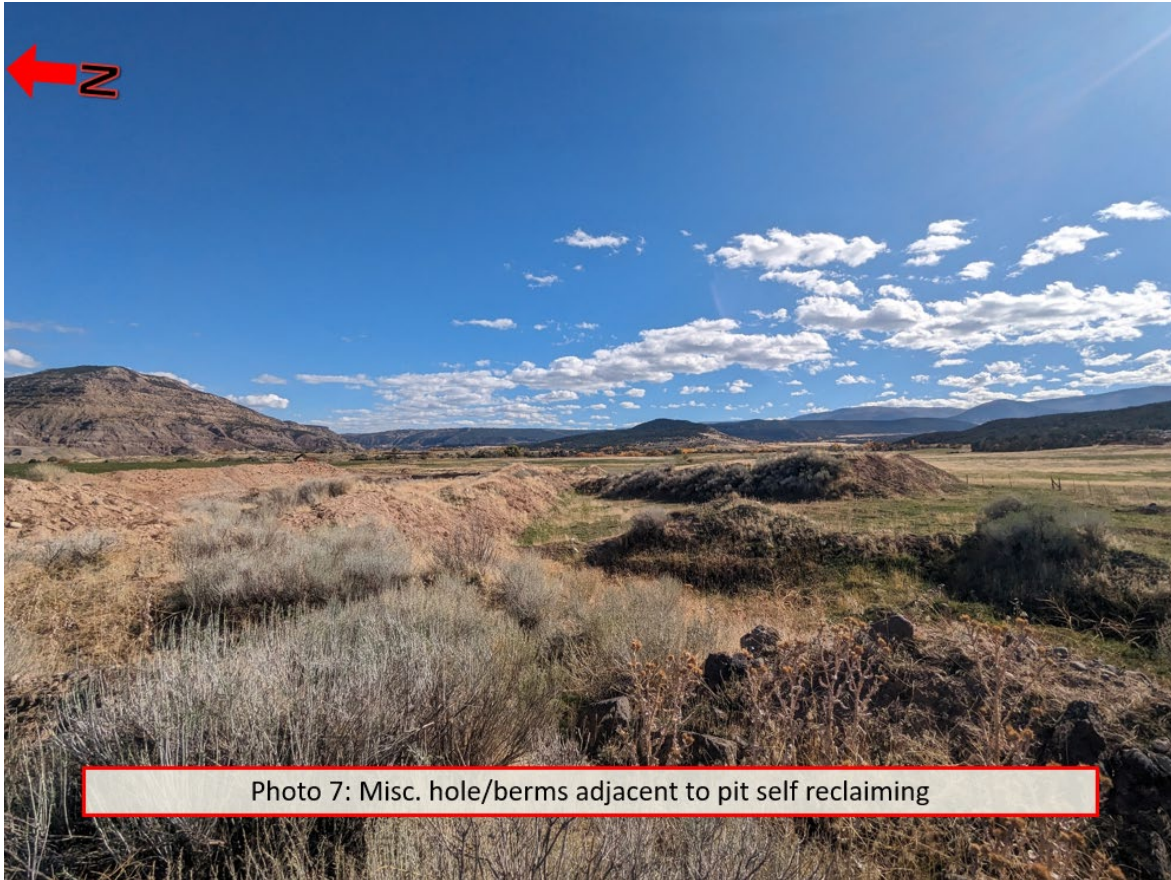
Photo 7: Misc. hole/berms adjacent to pit self reclaiming

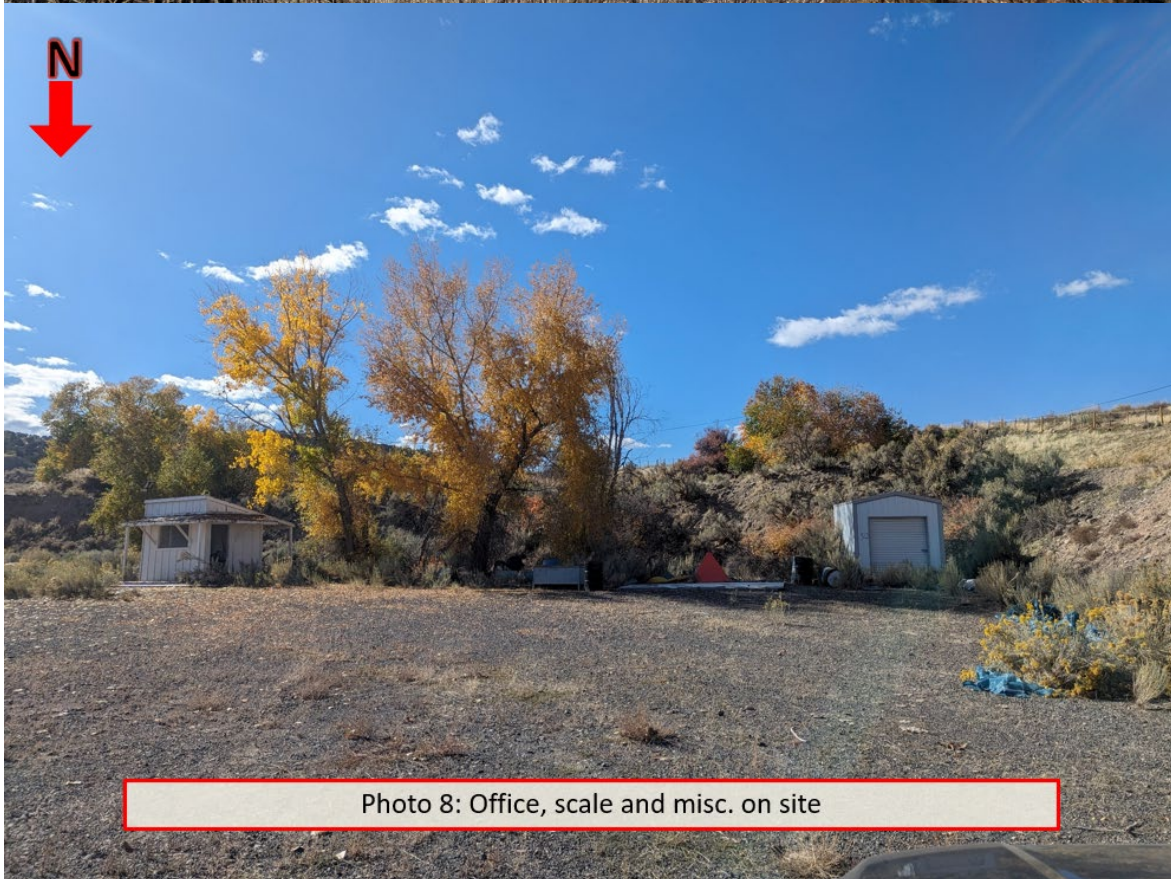
A small office and in ground scale remain in place near the lower pit entrance (Photo 8). A small shed and some misc. equipment is also stored on site in the northwest corner of the pit. There is no processing equipment located on site. It is mobilized to the site on an as needed basis.

Photo 8: Office, scale and misc. on site
