MINERALS PROGRAM INSPECTION REPORT

MINE NAME: Wedding Bell Project (Section 23 Area)	MINE/PROSPECTING ID#: P-2023-010	MINERAL: Uranium and vanadium	COUNTY: San Miguel
INSPECTION TYPE: Multi Person Inspection	WEATHER: Clear	INSP. DATE: October 18, 2023	INSP. TIME: 10:55
OPERATOR: Standard Minerals Inc.	OPERATOR REPRESENTATIVE: Nicole Gallaway-Warland	TYPE OF OPERATION: MP - Mineral Prospecting	
REASON FOR INSPECTION: Normal I&E Program	BOND CALCULATION TYPE:	BOND AMOUNT: \$9,171.00	
DATE OF COMPLAINT: NA	POST INSP. CONTACTS: None	JOINT INSP. AGENCY: None	
INSPECTOR(S): Lucas West	INSPECTOR'S SIGNATURE:

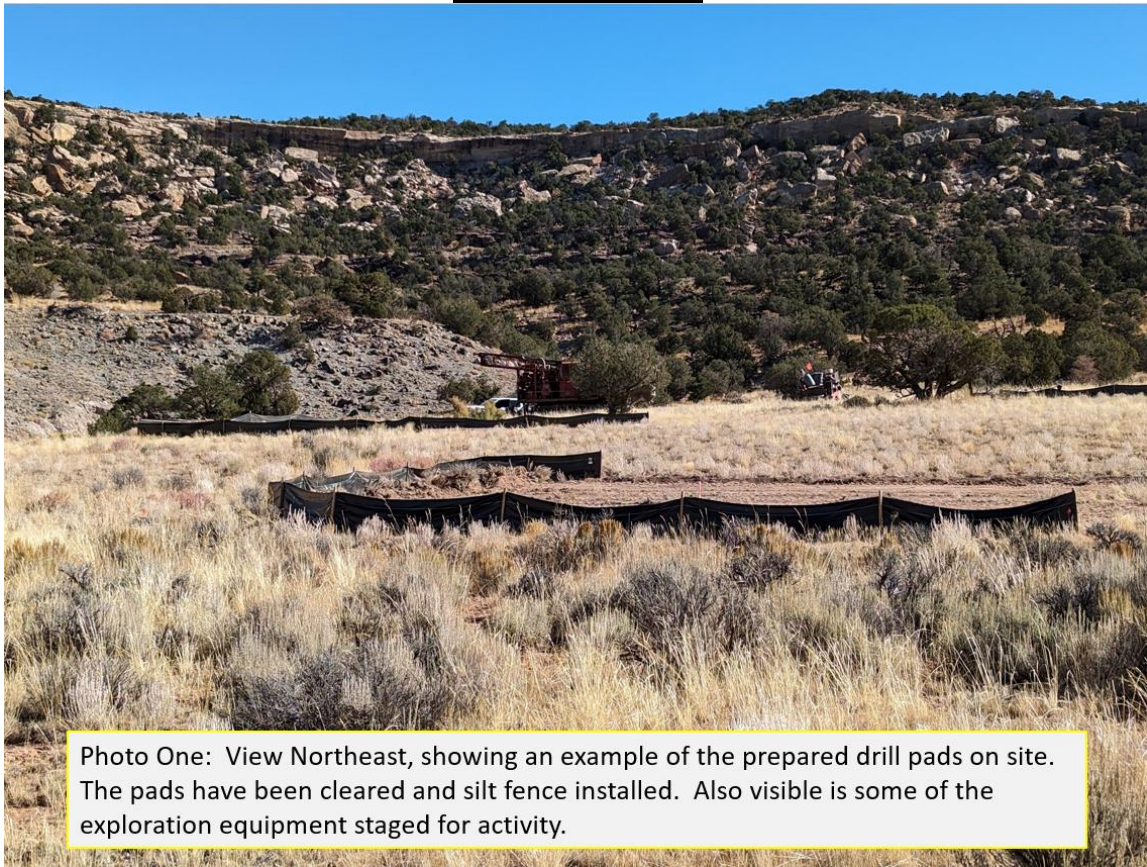
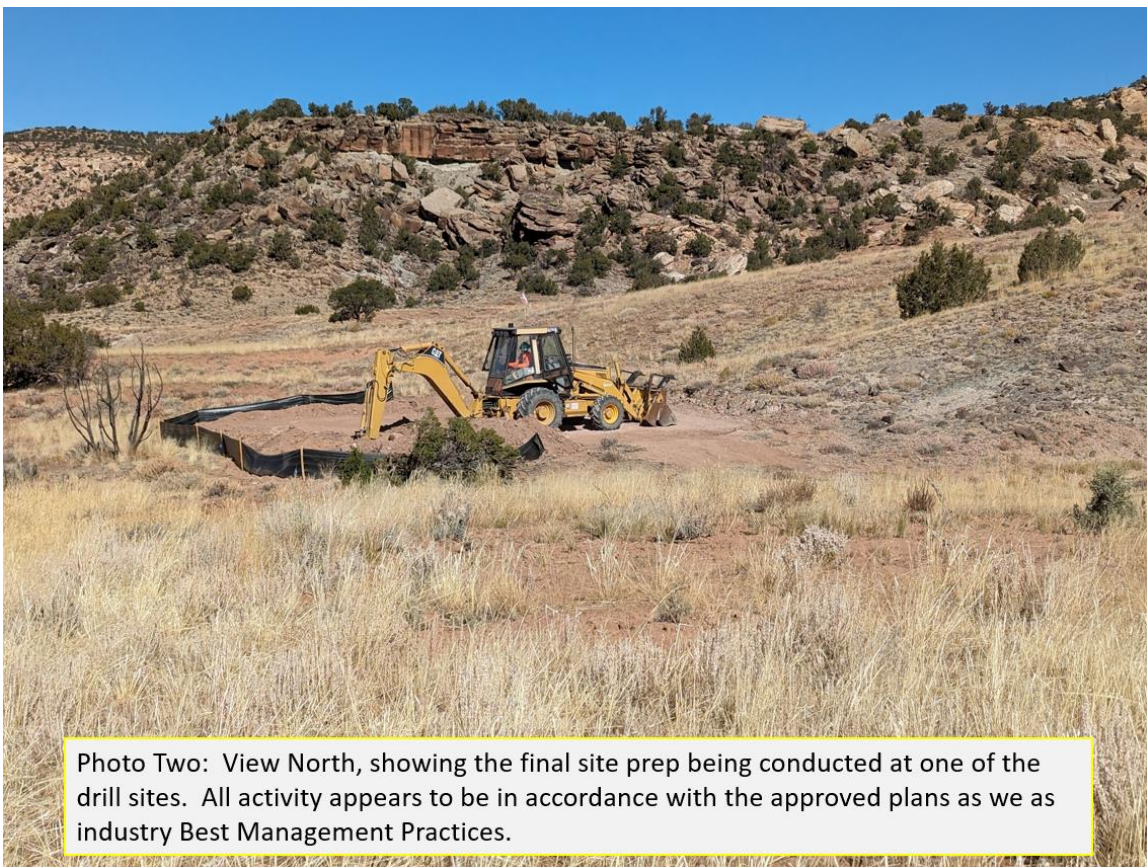
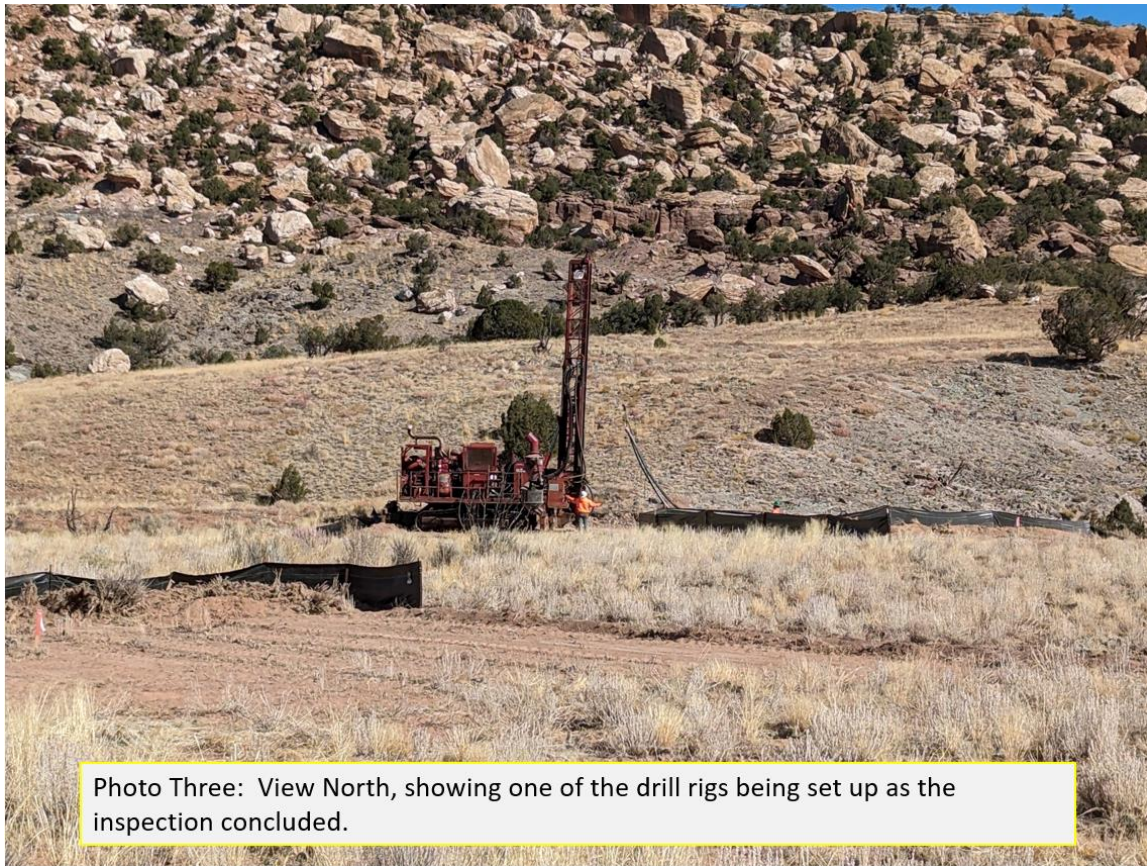
At the time of the inspection, exploration equipment was present on site. The equipment included a backhoe, drill rig, support rig and various personnel vehicles. Several of the pads have been prepared for drilling operations, all in the same manor. Vegetation and what little topsoil that exists at the sites had been cleared, and proper storm water structures have been installed. Examples of the pads can be seen in Photos One through Three. The storm water controls that were installed are berms, silt fencing and sediment traps on some of the pads. Final site prep was concluding at the time of the inspection and on site discussions were held with the driller and support crews. Drilling had not yet commenced, however would be starting later in the day after the inspection was over.

All pad locations appear to be consistent with the permitting documents, and the constructed pads were in excellent condition. No problems or possible violations were identified during the inspection and no evidence of significant erosion was noted. All responses to this report should be directed to Lucas West at the Colorado Division of Reclamation, Mining and Safety's Active Mines Program at Room 215, 1001 e. 62nd Ave. Denver, CO 80216. Direct contact can be made at the Division's Grand Junction Field Office, by phone at 303-866- 3567 Ext. 8187 or by email at lucas.west@state.co.us.
